**MINERALS PROGRAM INSPECTION REPORT**  
**PHONE: (303) 866-3567**

| <b>MINE NAME:</b><br>Cresson Project | <b>MINE/PROSPECTING ID#:</b><br>M-1980-244 | <b>MINERAL:</b><br>Gold and silver | <b>COUNTY:</b><br>Teller |
| <b>INSPECTION TYPE:</b><br>Aerial Inspection | <b>WEATHER:</b> Foggy | <b>INSP. DATE:</b><br>September 24, 2025 | <b>INSP. TIME:</b><br>11:45 |

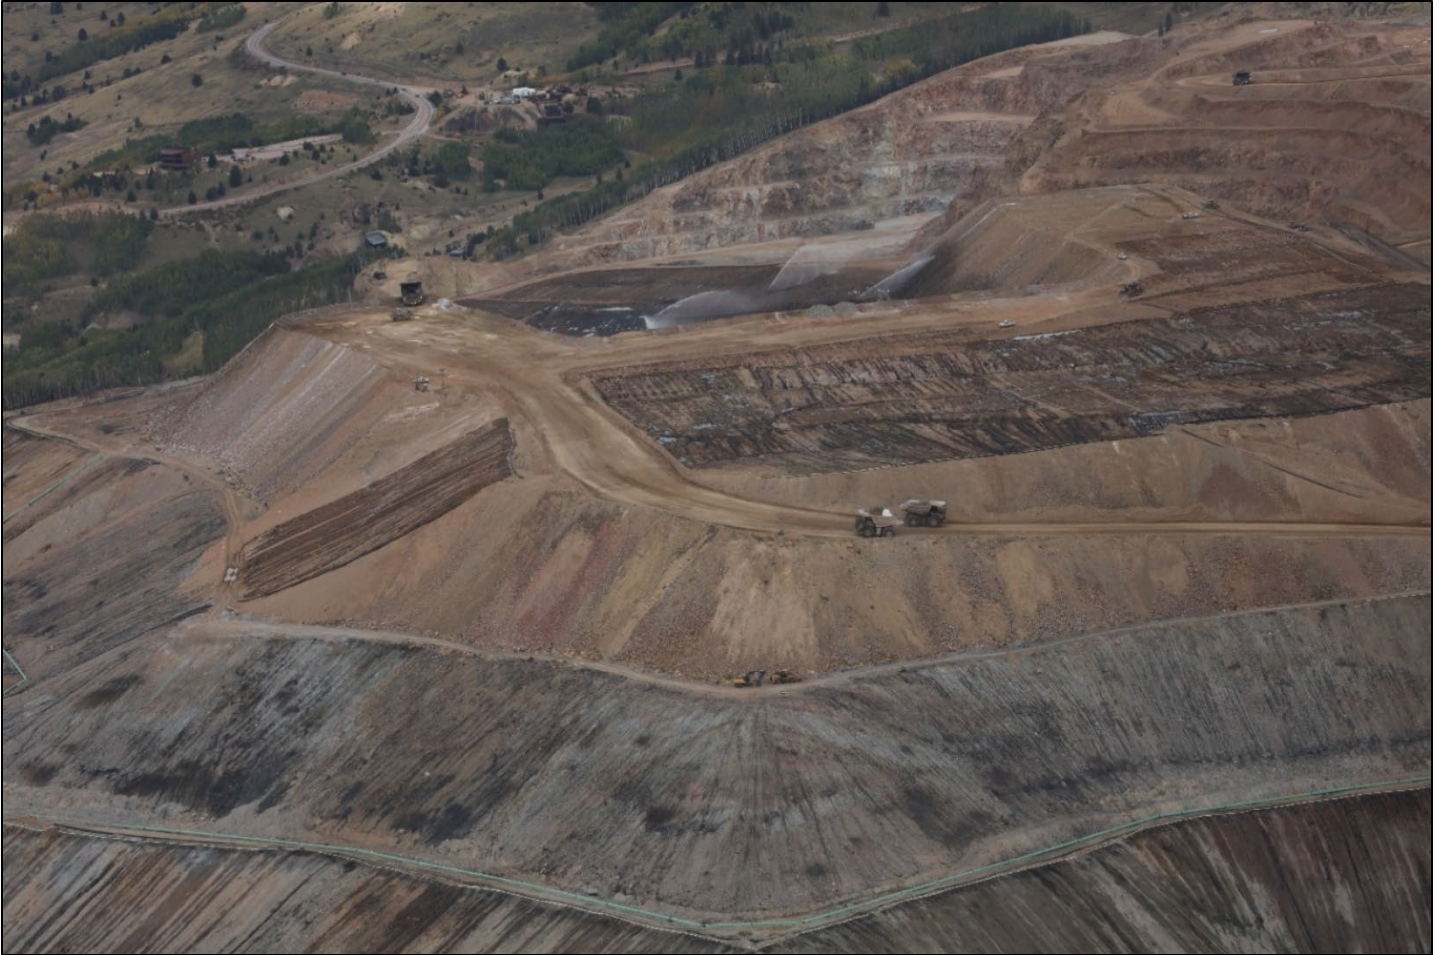
Aerial images of the two Valley Leach Facilities (VLF 1 and VLF 2) (Photos 1, 3 and 11) are used to perform a broad visual inspection for ponded solution, slope stability concerns, ore stacking compliance, and other potential issues that cannot easily be obtained from the ground. No ponded process solution was observed in the active leach areas of VLF 1. No observable issues are noted for VLF 1. No ponded process solution was observed in the active leach areas of VLF 2.

**Photo 1: View north of VLF2, active leaching activities and ore hauling observed.**

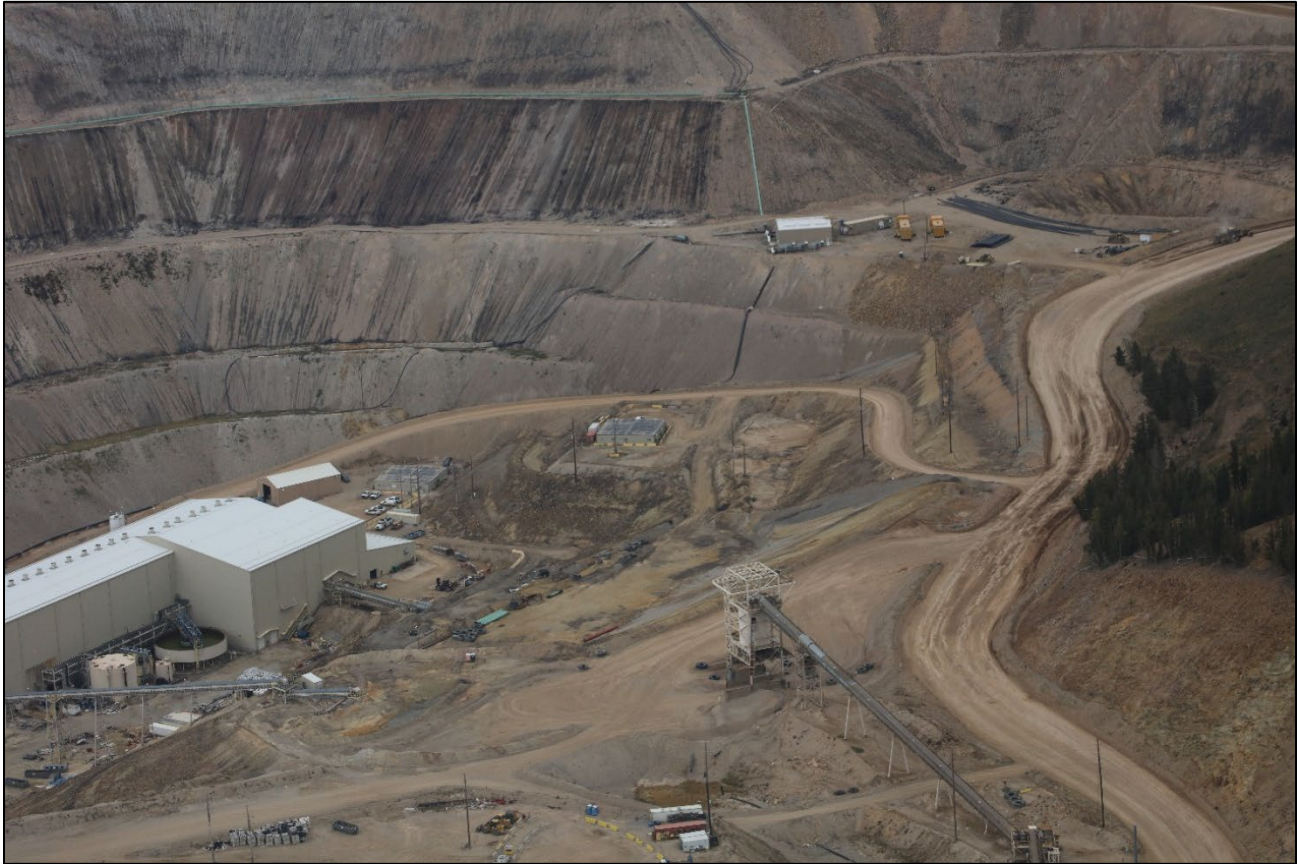
Aerial images of the two Adsorption, Desorption, and Recovery Facilities (ADR 1 and ADR 2) (Photos 12 and 13), and the High Grade Mill (HGM) (Photo 2) are used to perform a broad visual inspection for leaks, spills, secondary containment problems, and other potential issues that cannot easily be obtained from the ground. The ADR 1 is located on the south side of VLF 1. The ADR 2 is located on the west side of VLF2. The HGM is

located between VLF 1 and VLF 2. No observable issues are noted for ADR 1, ADR 2, or the HGM facilities. The Ironclad Facility and Crusher areas were also observed and noted to be free of any issues.

**Photo 2: View north of the high-grade mill area.**

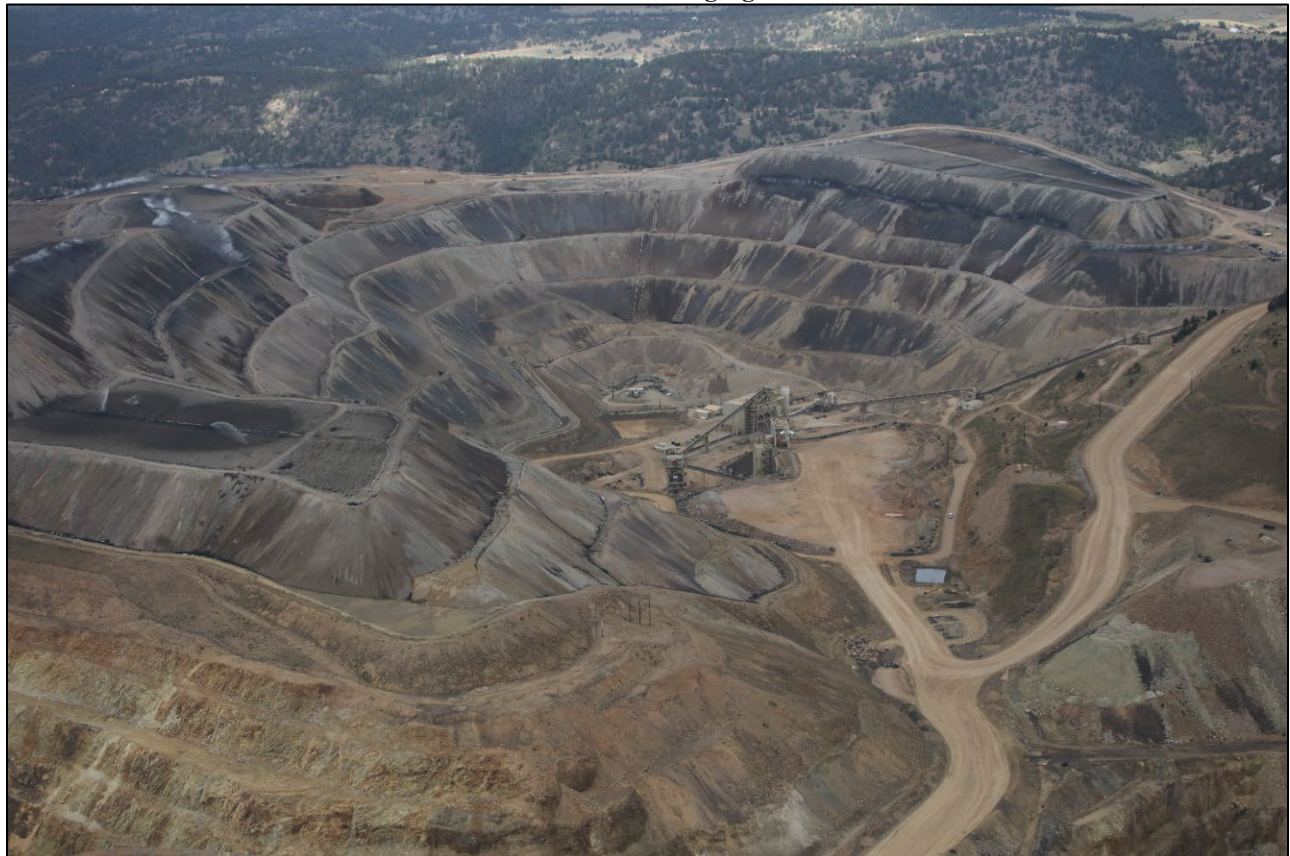
**Photo 3: View of the crusher area and VLF1.**

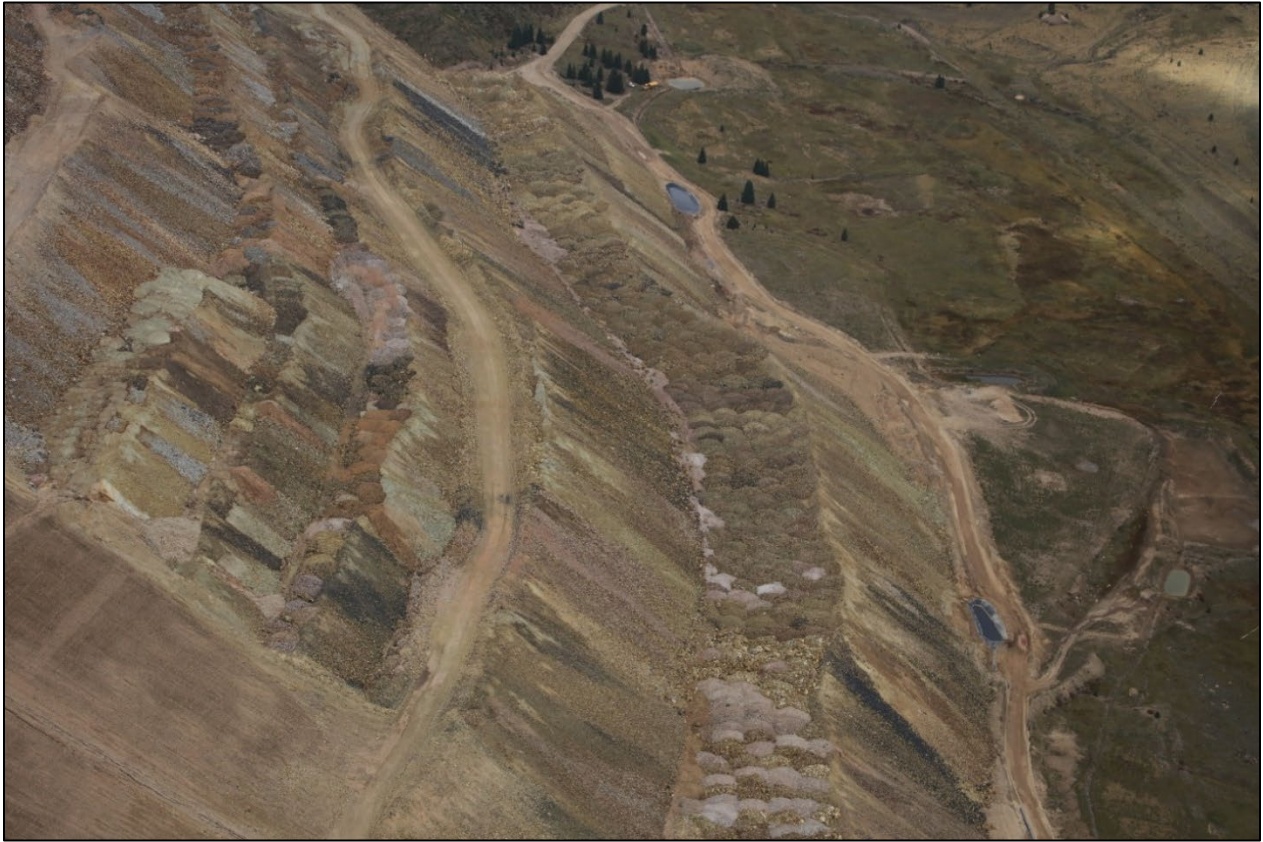
Seep areas 1 – 5 were all observed from above and were noted to be holding water (Photos 4-7). Several seeps were observed to contain affected process water, but all water looked to be contained within the collection areas. Construction of seep collection area improvements was completed in early August 2025. Pumps were observed at multiple seep locations. No ponded water was observed anywhere else on or near the ECOSA and no material was being stacked at the time of inspection.

**Photo 4: View north of the eastern side of the ECOSA, several EPFs are visible.**

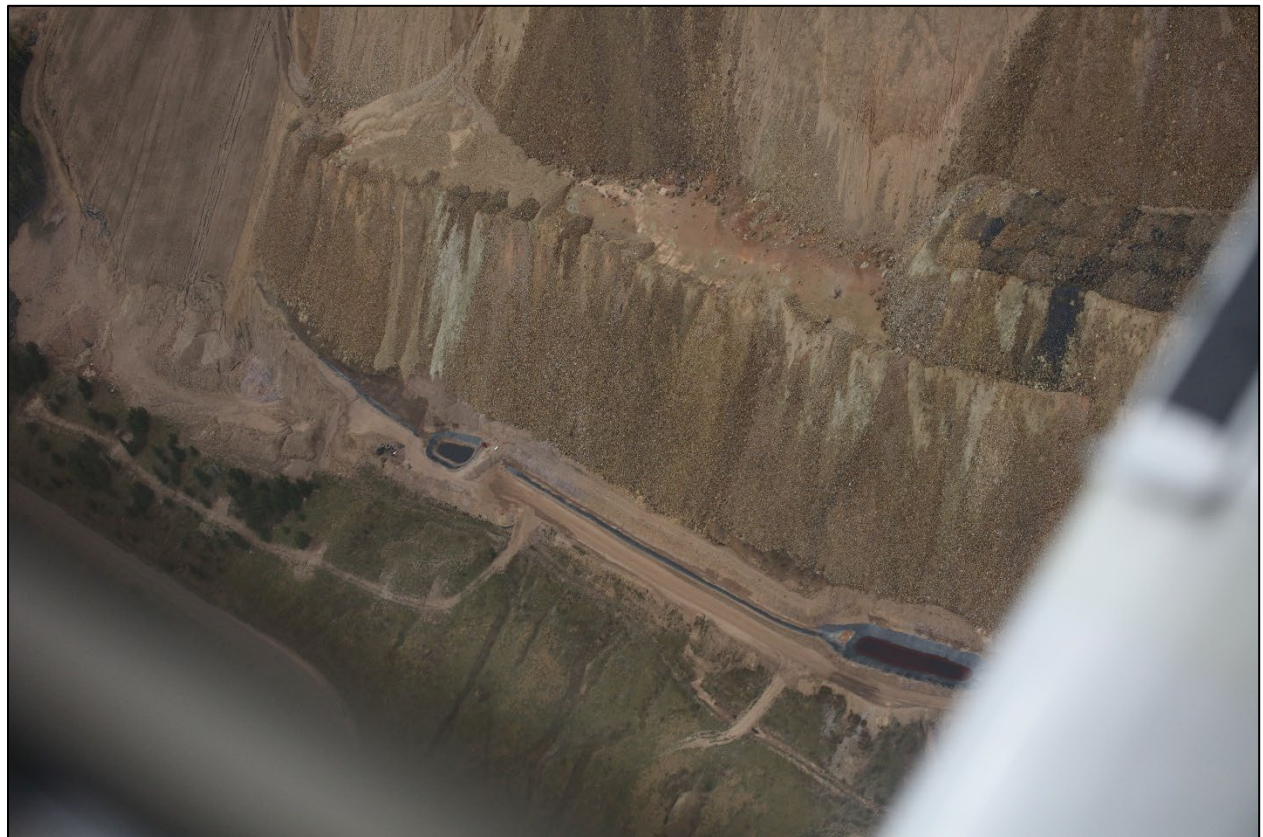
**Photo 5: EPFs at the foot of the ECOSA.**

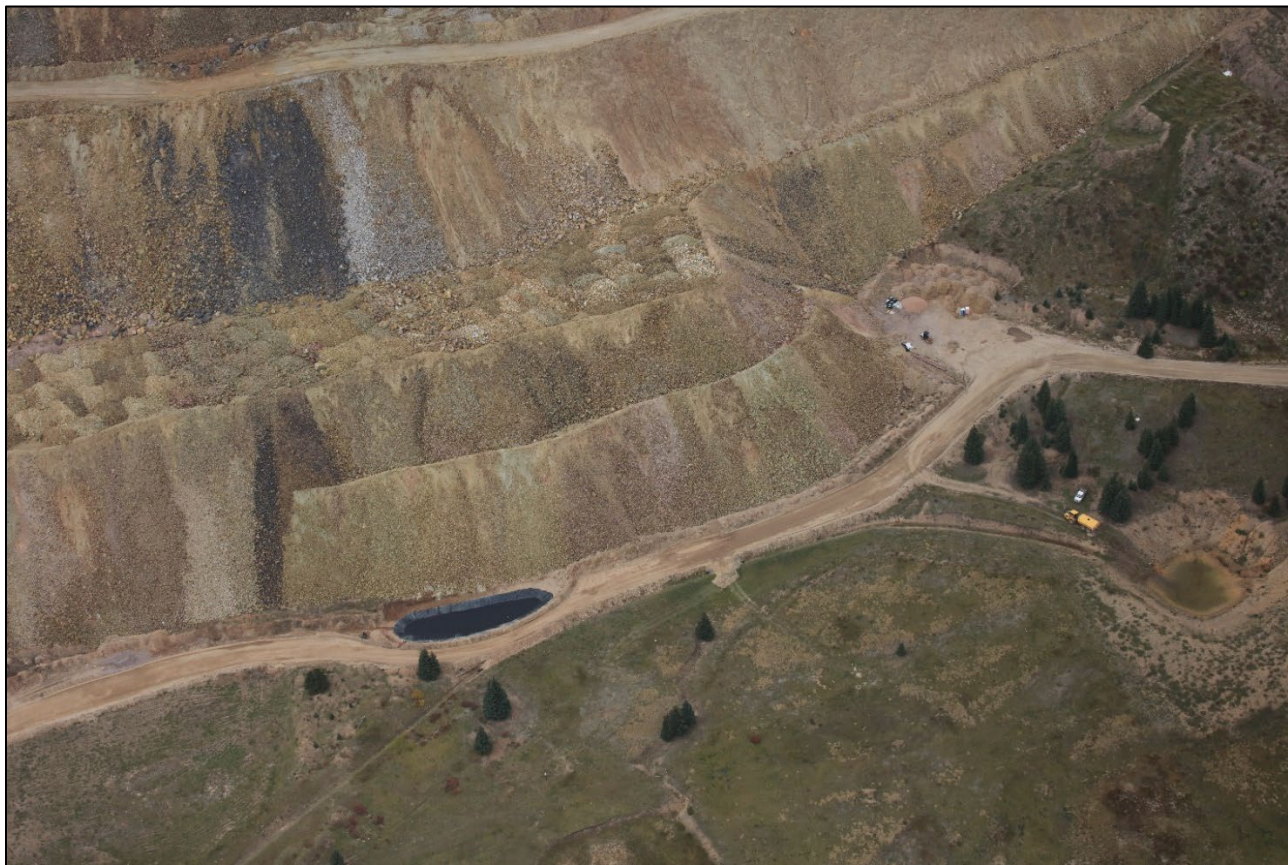
**Photo 6: EPFs at the foot of the ECOSA.**

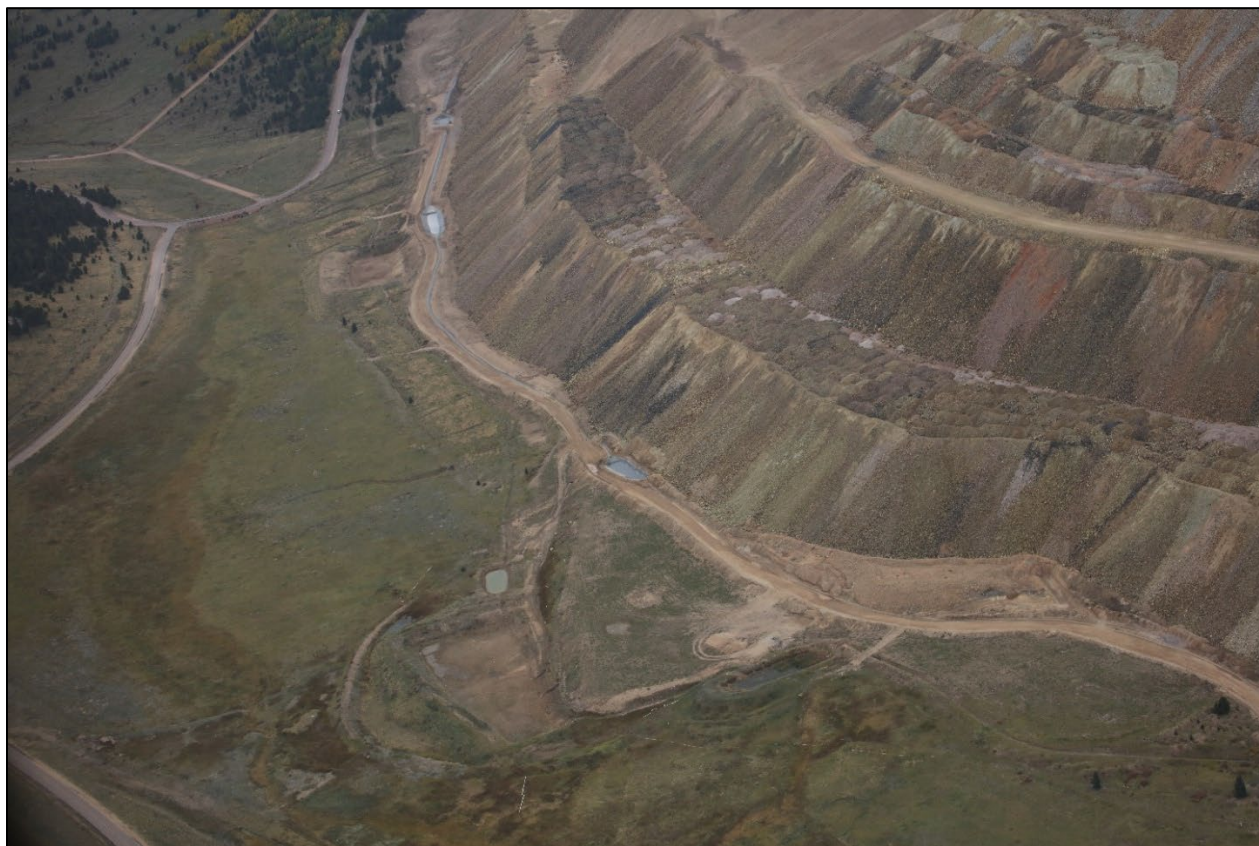
**Photo 7: View south of the ECOSA and grassy valley.**

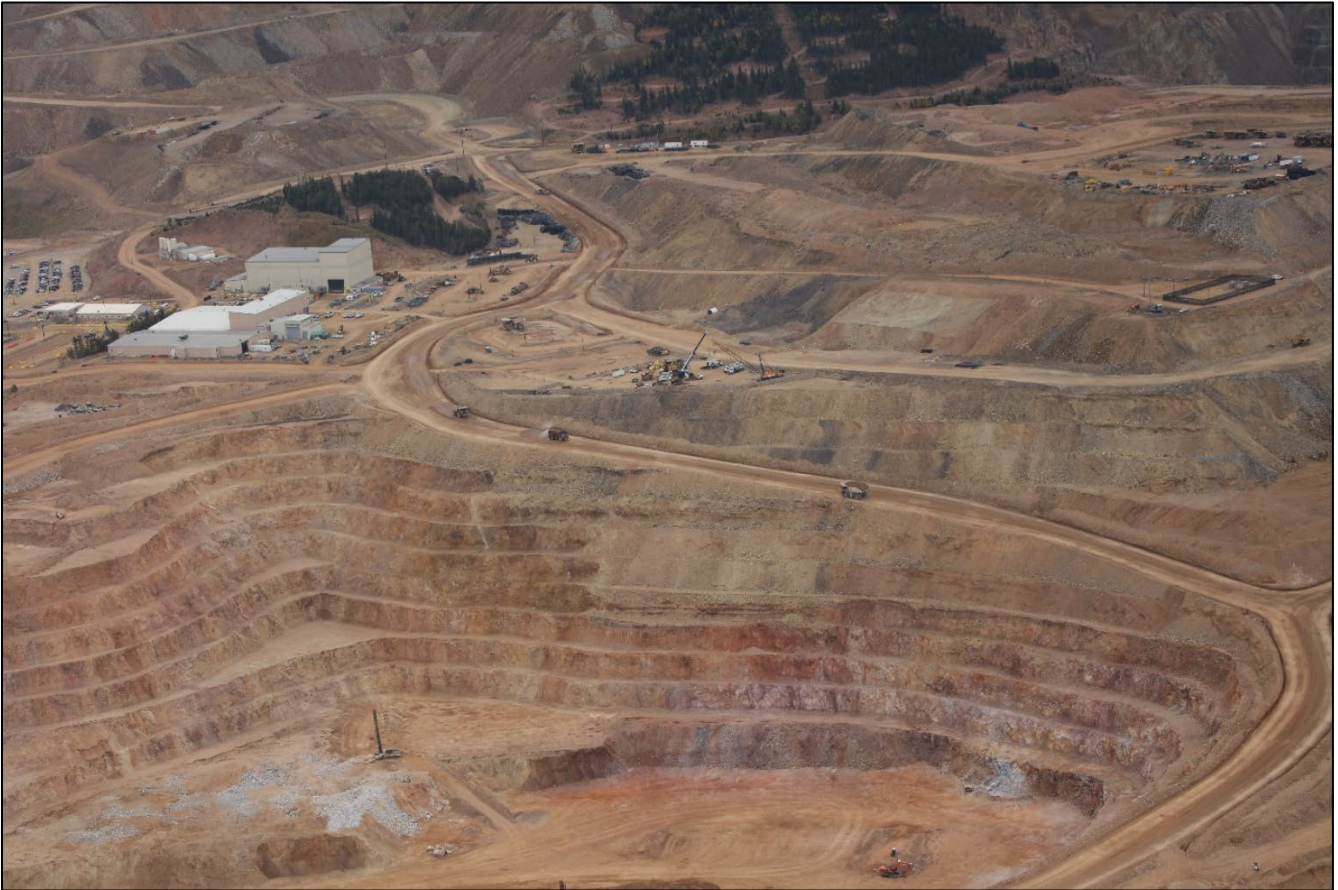
The Schist Island backfill area and Globe Hill Pit appeared to be active at the time of inspection (Photos 8, 9 and 10).

**Photo 8: View southeast of the Ironclad Facility and into Globe Hill Pit.**

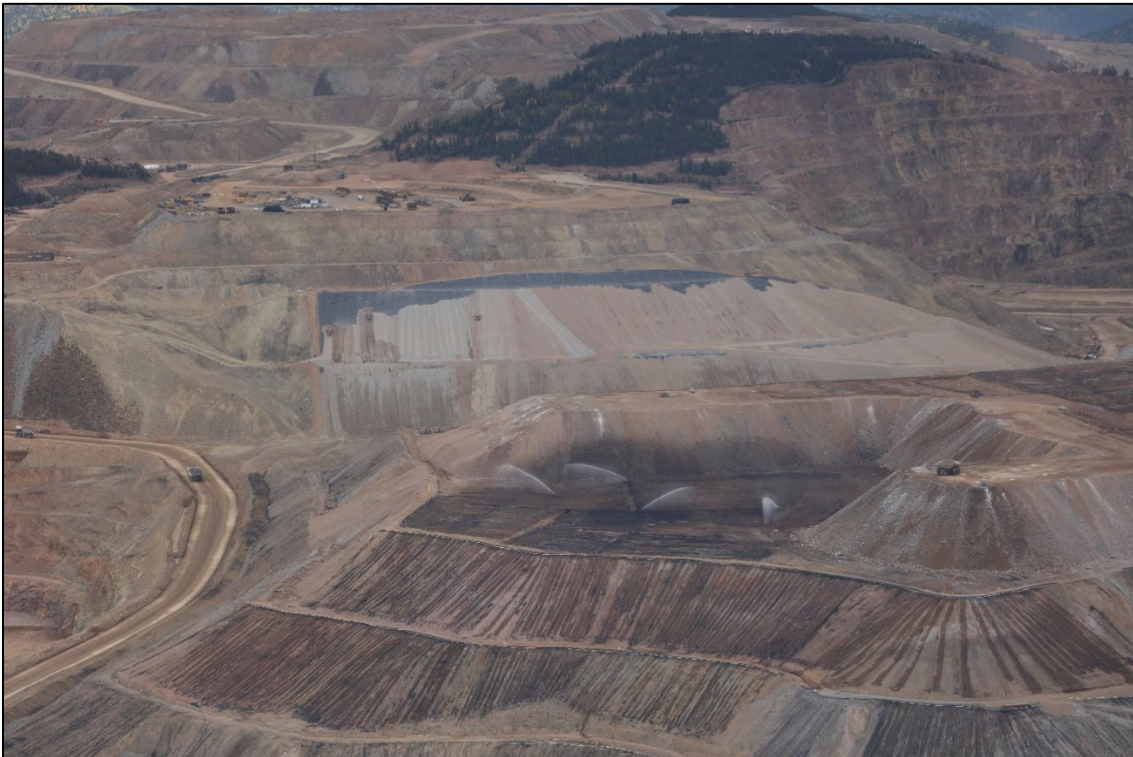
Liner installation and Drain Cover Fill (DCF) placement were observed at the Division's last inspection. Aerial images suggest that material is now being placed over these initial liner layers (Photo 9).

**Photo 9: View east, work continues on the VLF2 Phase 3 Stage B Construction area.**

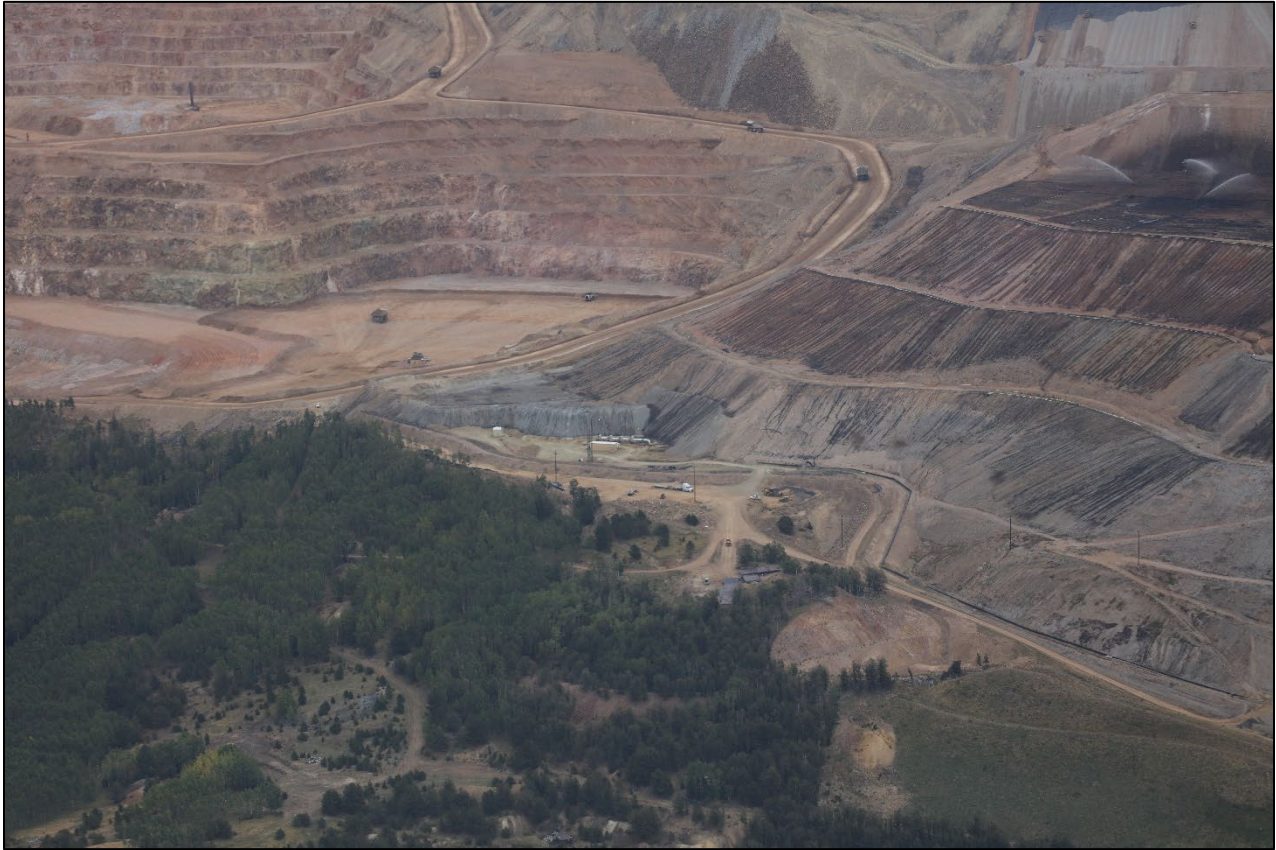
The Division received an off-liner spill notification from CC&V on June 26, 2025. The area was inspected on the ground at the Division's last site visit. Aerial photographs show that the area previously excavated had been appropriately backfilled and looked to be stable (Photo 10).

**Photo 10: View northeast into Schist Island Backfill area and VLF2 Spill Area.**

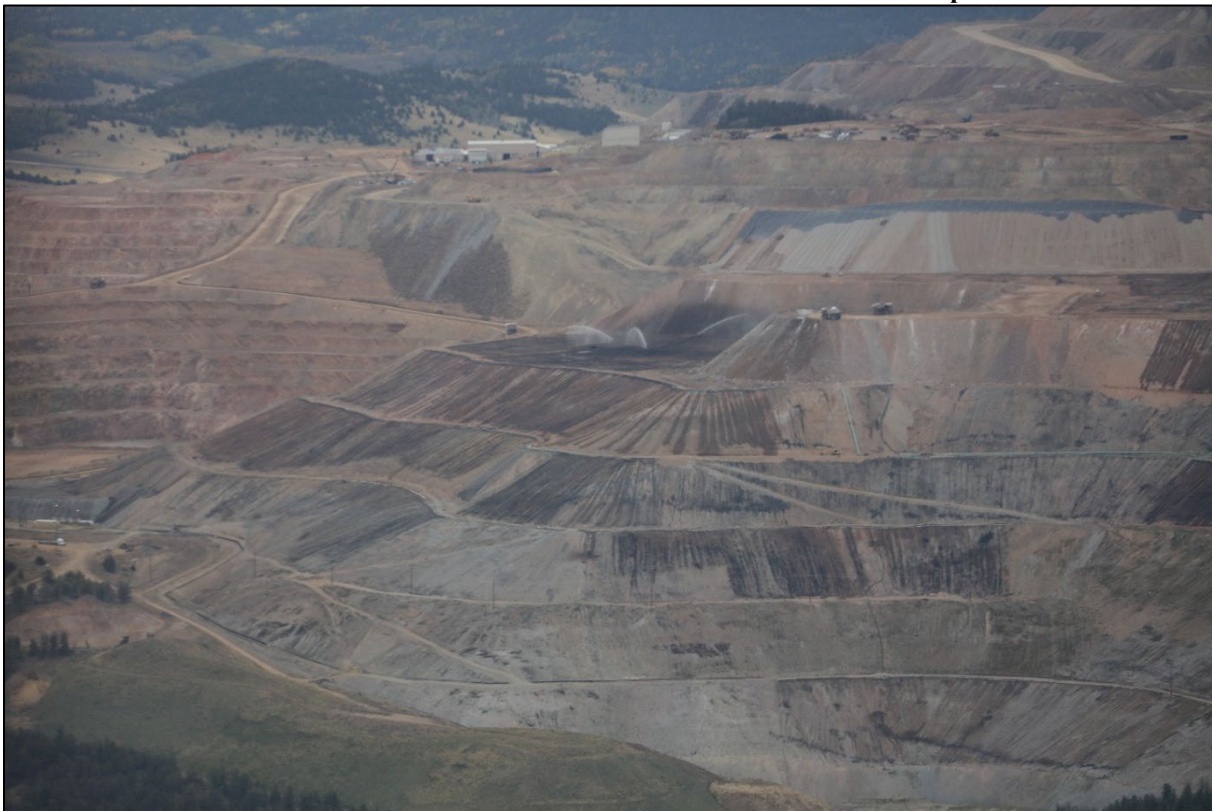
**Photo 11: Active leaching on VLF2.**

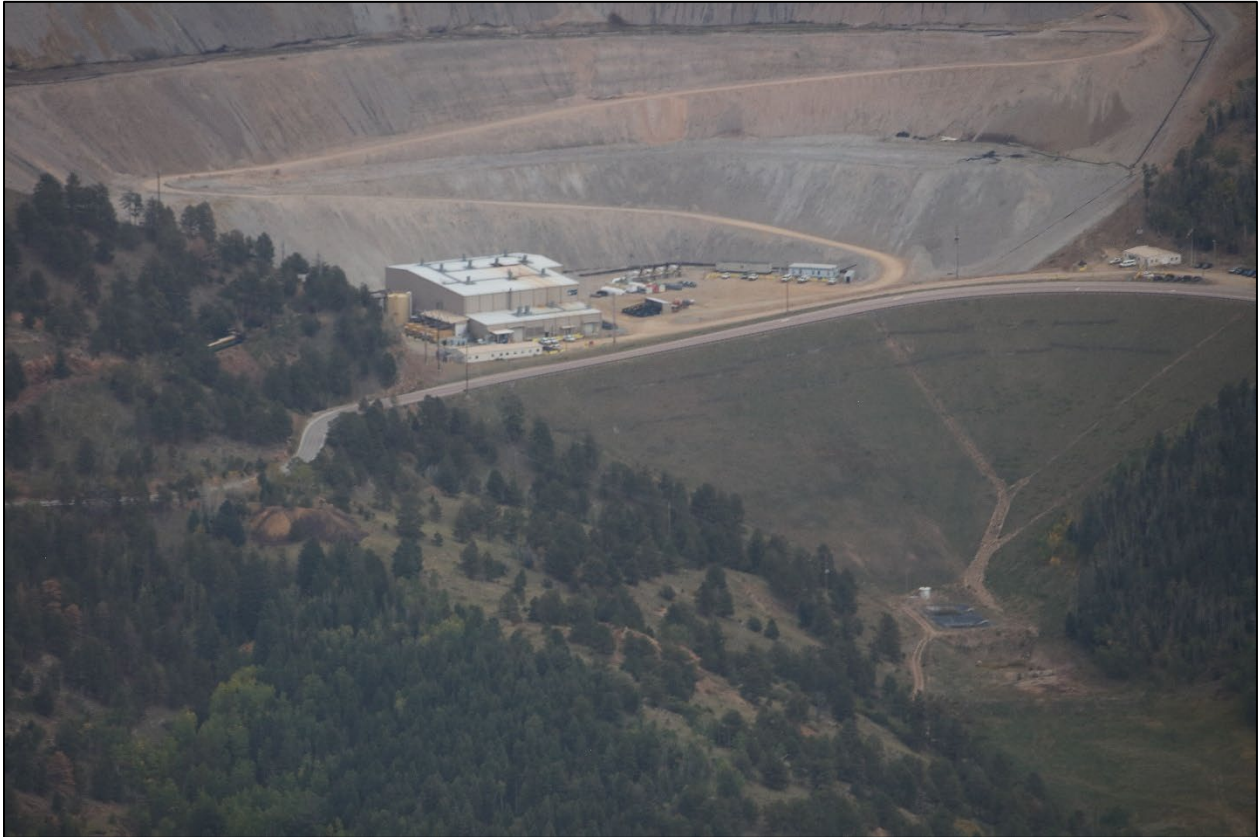
**Photo 12: View north of the ADR2 facility.**

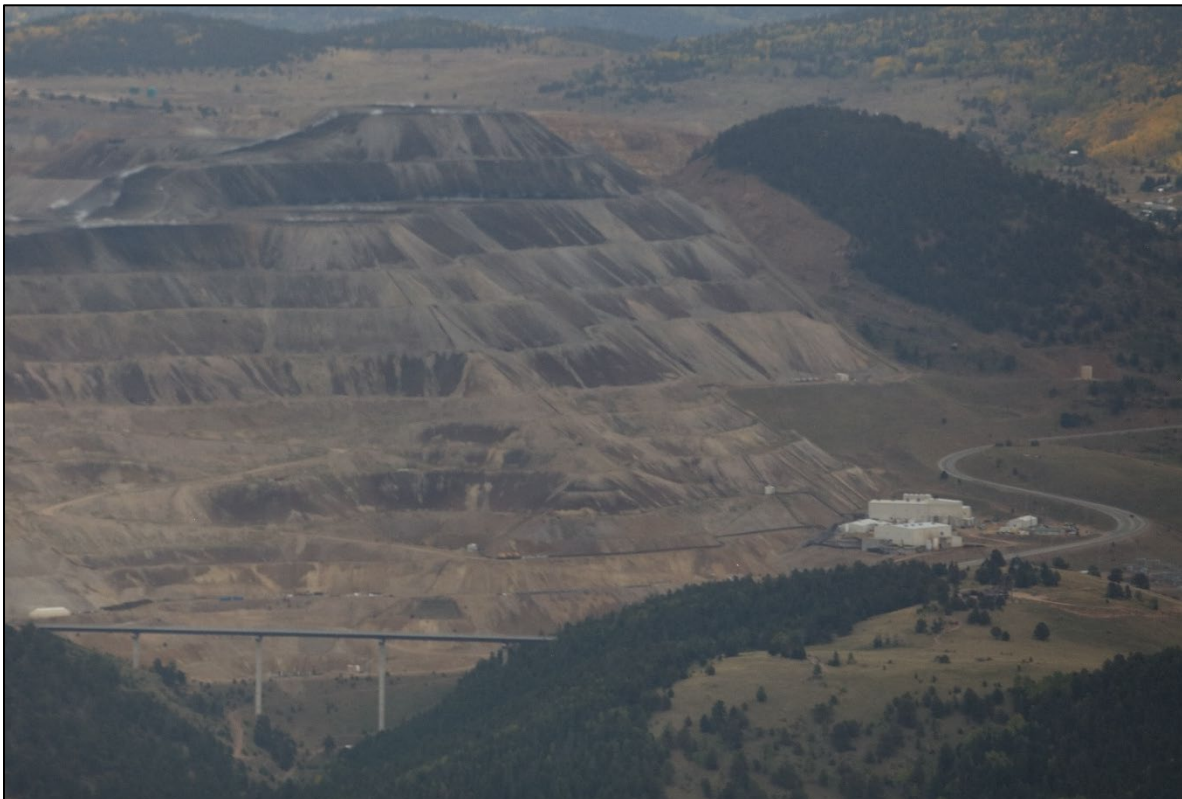
**Photo 13: View east of the ADR1 facility.**
