MINERALS PROGRAM INSPECTION REPORT
PHONE: (303) 866-3567

MINE NAME: Climax Mine	MINE/PROSPECTING ID#: M-1977-493	MINERAL: Molybdenum	COUNTY: Lake
INSPECTION TYPE: Monitoring	WEATHER: Clear	INSP. DATE: October 7, 2025	INSP. TIME: 12:40
OPERATOR: Climax Molybdenum Company, Climax Mine	OPERATOR REPRESENTATIVE: Eric Detmer	TYPE OF OPERATION: 112d-3 - Designated Mining Operation	
REASON FOR INSPECTION: Normal I&E Program	BOND CALCULATION TYPE: None	BOND AMOUNT: \$91,011,850.00	
DATE OF COMPLAINT: NA	POST INSP. CONTACTS: DRMS	JOINT INSP. AGENCY: None	
INSPECTOR(S): Amy Yeldell	INSPECTOR'S SIGNATURE: <i>Amy Yeldell</i>	SIGNATURE DATE: October 21, 2025

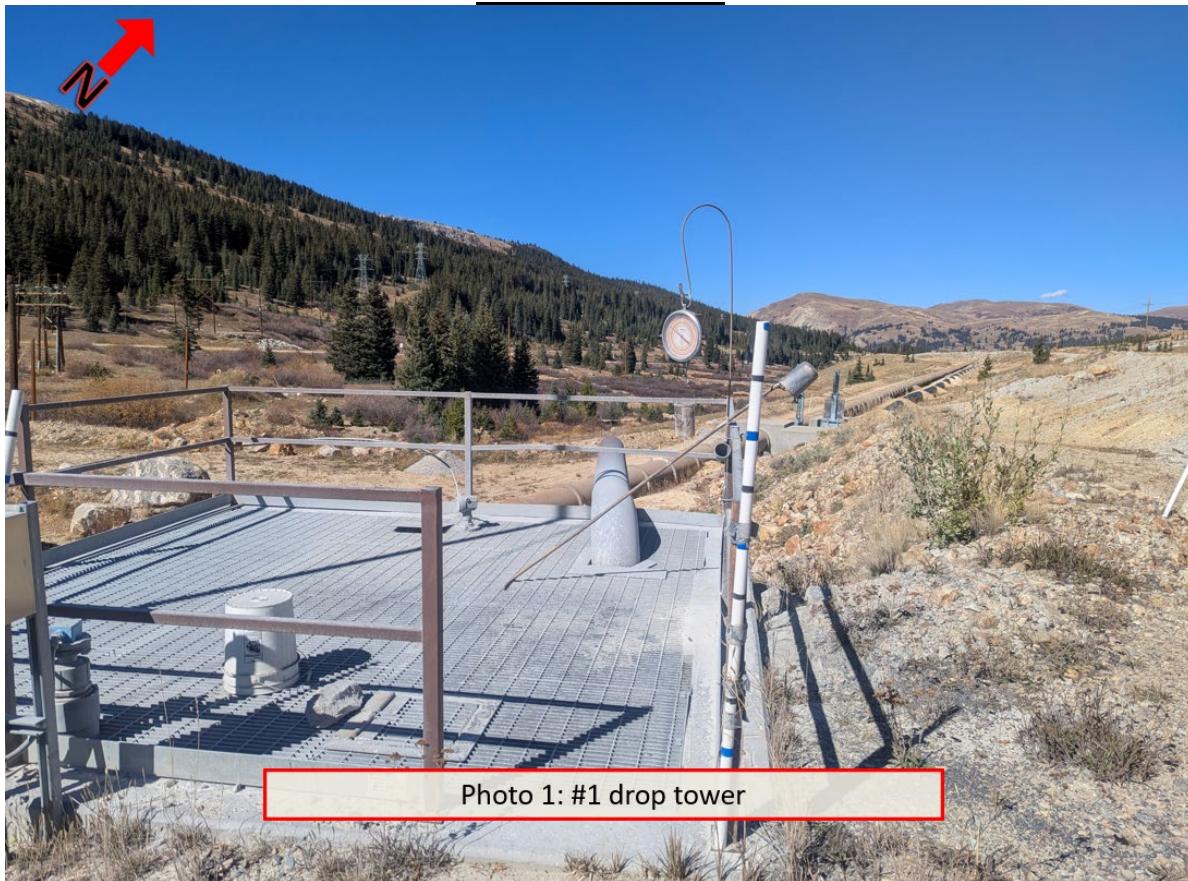
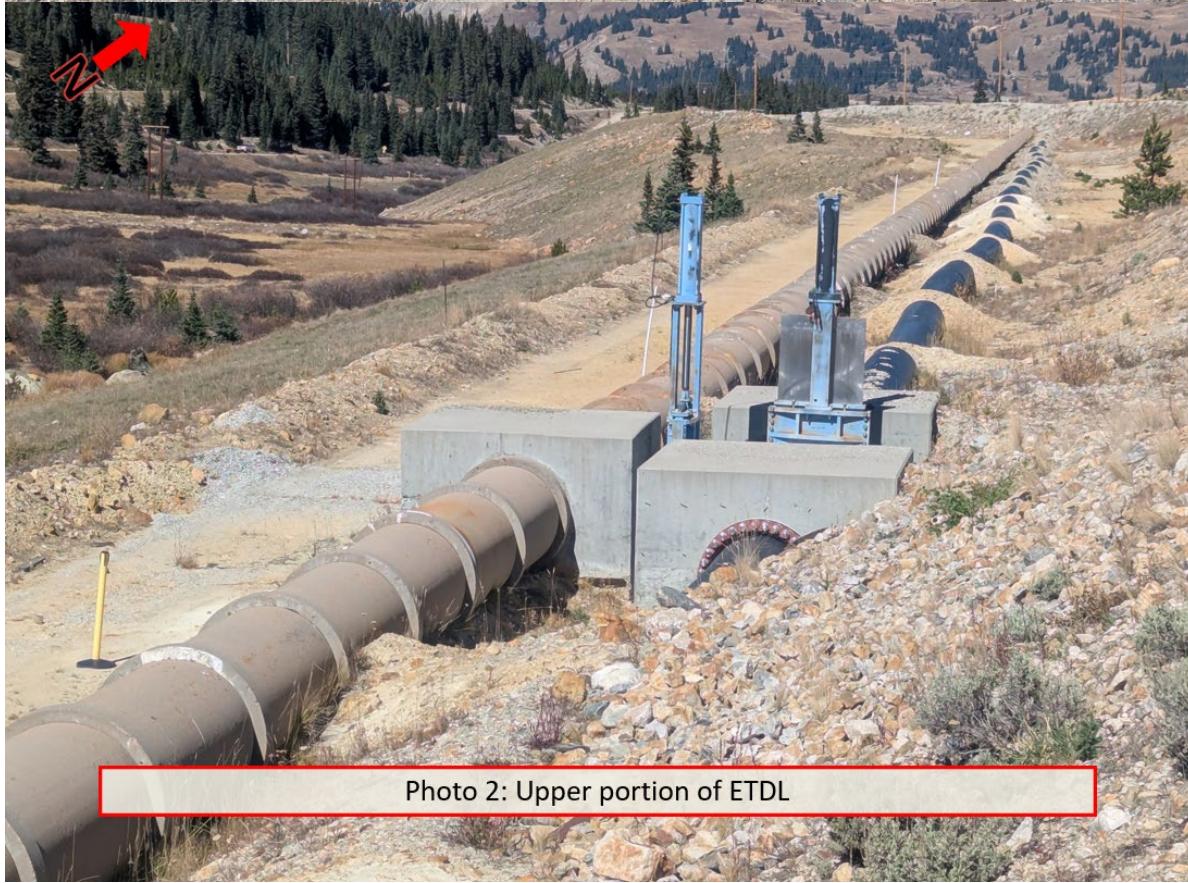
The #1 drop box is located just north of the water treatment plant. The cement pipe is the ETDL and the black HDPE pipe is tailings (Photos One and Two). This is one of the locations where the mine has the ability to switch between the two conveyance structures if need be.

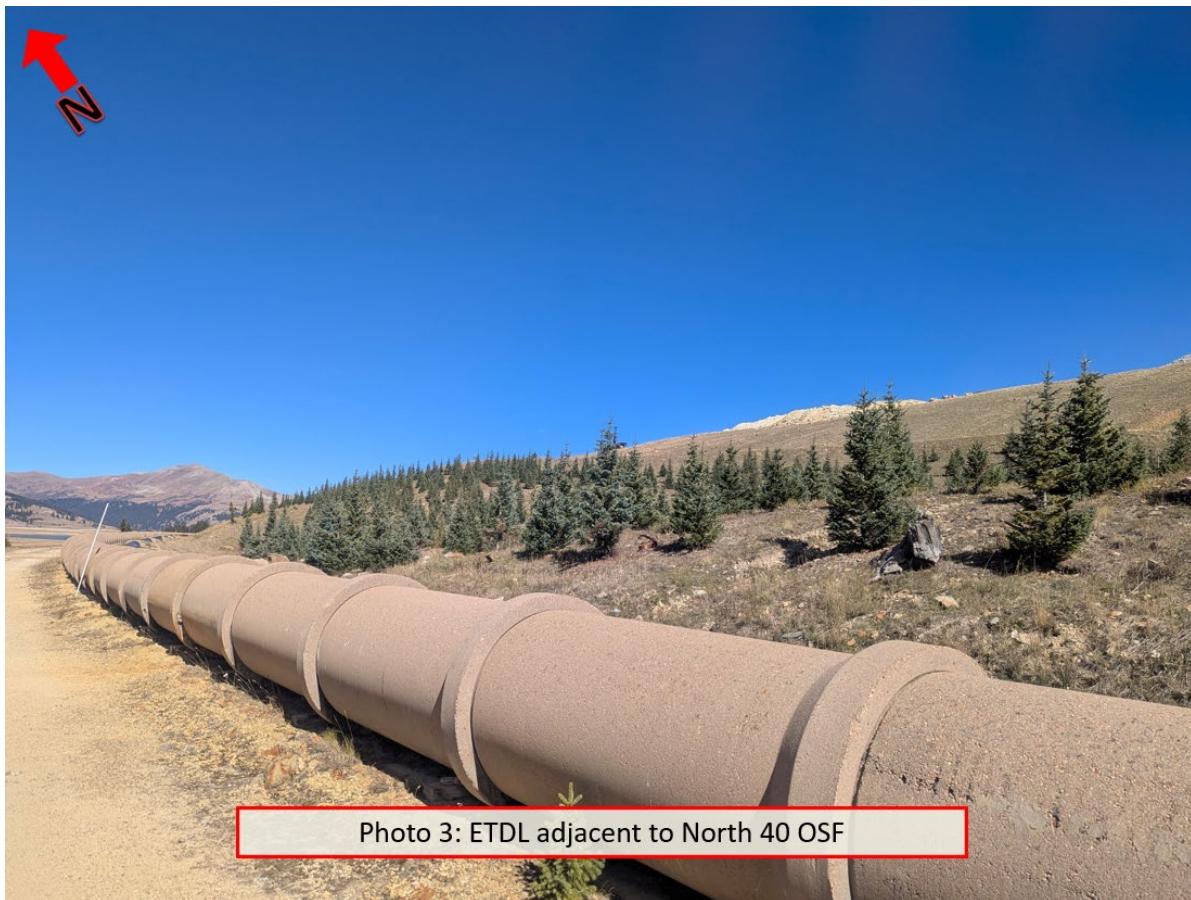
The ETDL travels on the surface till the North 40 OSF (Photo Three), at which point it briefly is buried and parallels HWY. Then it hits the drop tower and goes under the highway and resumes being above ground. The pipeline ends at the SDP.

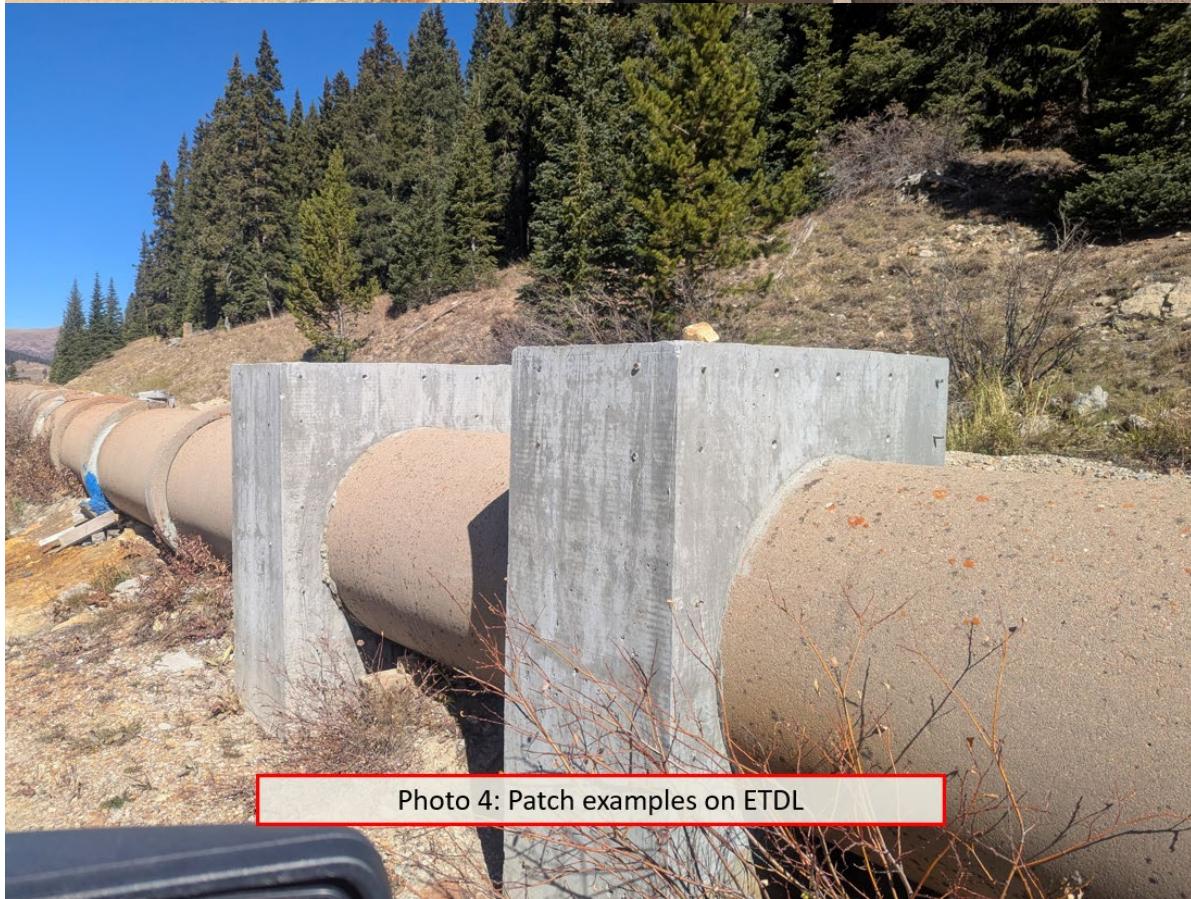
Several spots were observed where the cement pipe has been patched via pouring a cement cap (Photo Four). The CIPP lining of the ETDL is expected to start soon and be completed in stages over the next three years. To install the liner, flow will be diverted to East Side Channel to be conveyed to Tenmile TSF pond. This work includes videoing, cleaning, re-videoing, installation and curing. Climax has proposed to install 30" manholes every 700 feet for maintenance access of the ETDL. The surface disturbance will remain unchanged. A the CIPP resin liner will be installed inside the existing pipeline to prevent additional leaks or patches being needed. Given that this is maintenance of an existing EPF and the basic function will not change a TR will not be submitted but work has been authorized by the Division.

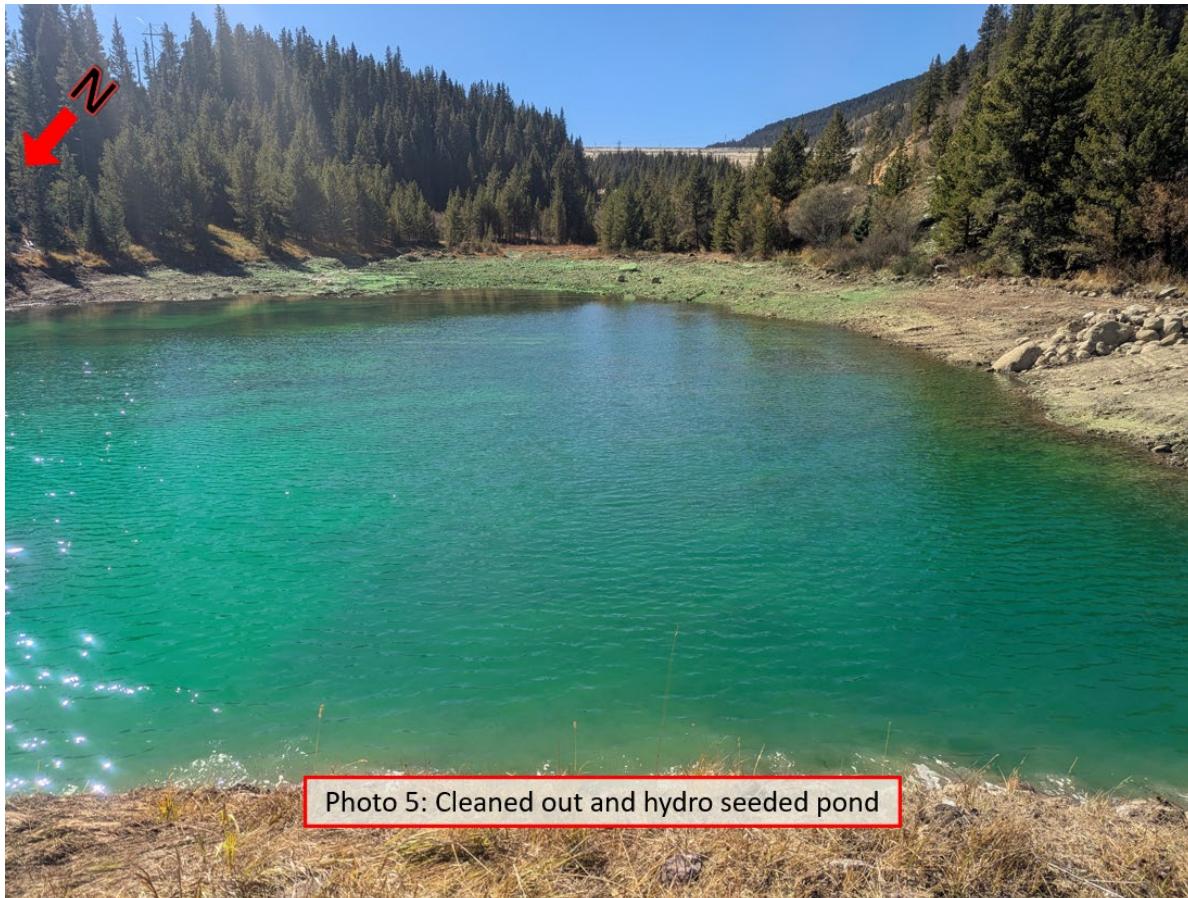
According to Mr. Detmer this used to be a historic processing pond that utilized ion exchange as a means to water treatments. This past summer (2025) the pond was mucked out. Sediment that was removed was placed in the Mayflower TSF. The area has since been hydroseeded and the pond has resumed filling (Photo Five). Once the water level rises it will overtop the spillway and continue downgradient in the existing channel. If need be there is a pump in the bottom of the pond as well.

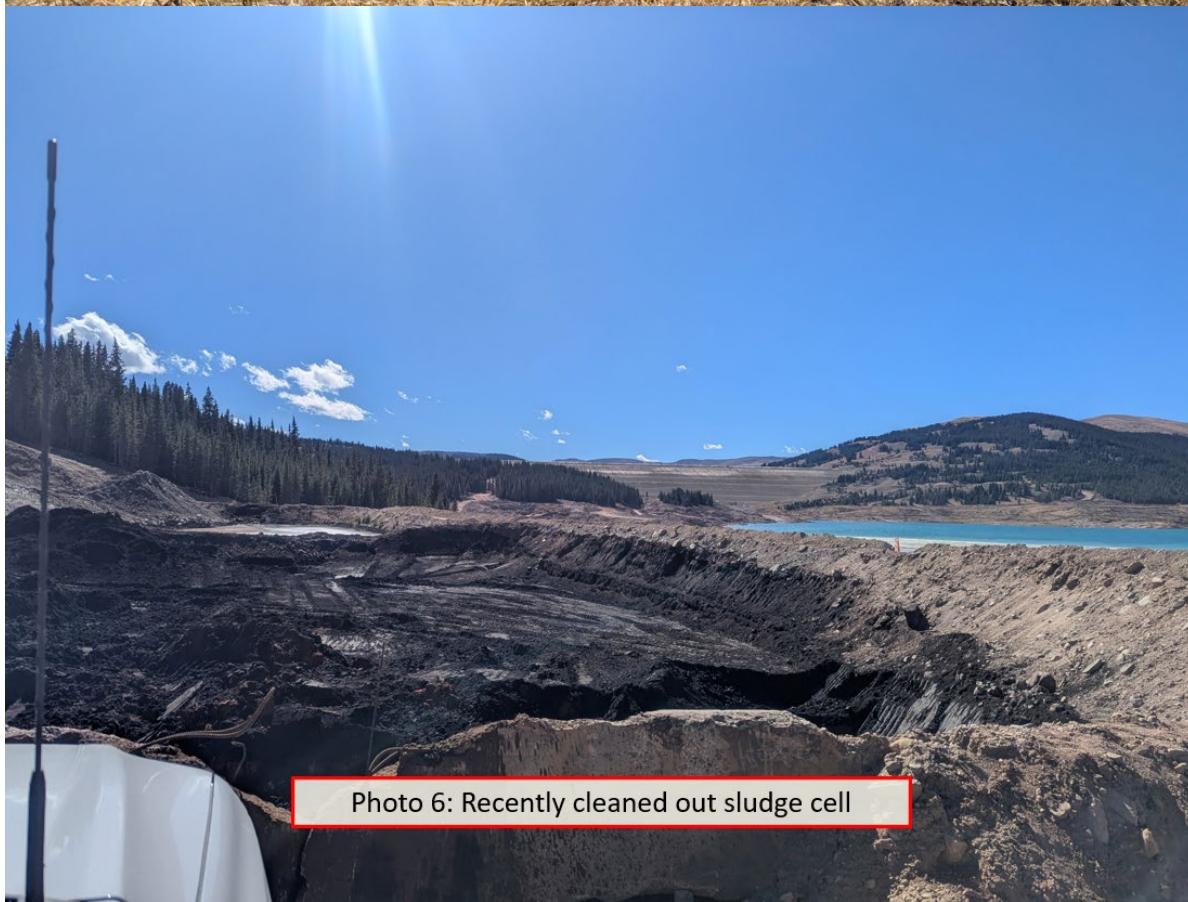
TENORM sludges were hauled off site for permanent disposal in a certified landfill(Photo Six). Mr. Detmer

estimates that approximately 3 to 4 thousand tons of sludges were removed from the northern cell. Climax alternates cells, filling one cell then allowing the other to dewater before hauling off site the following year.
