## October Inspection Report

### PERMIT INFORMATION

<b>Permit Number:</b> C-1981-018 <b>Mine Name:</b> Deserado Mine <b>Operator:</b> Blue Mountain Energy, Inc <b>Operator Address:</b> Mr Kurtis Blunt 3607 County Road 65 Rangely, CO, 81648	<b>County:</b> Moffat, Rio Blanco <b>Operation Type:</b> Underground <b>Permit Status:</b> Active <b>Ownership:</b> Private
	<b>Operator Representative Present:</b>  Kurt Blunt
<b>Operator Representative Signature: (Field Issuance Only)</b>

### INSPECTION INFORMATION

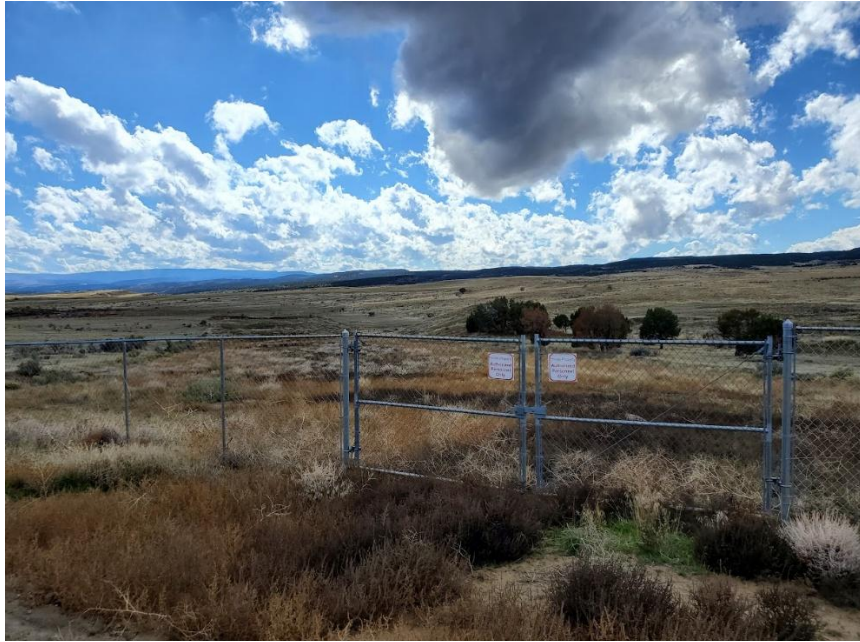
Photo 1 – View to the south of Halandras Landfill

The Halandras Landfill has been backfilled and graded to approximate original contour. No topsoil has been spread on the site. The topsoil pile that remains next to the landfill appears to be of sufficient size to complete reclamation. Volunteer vegetation has grown on the site. (Photo 1)

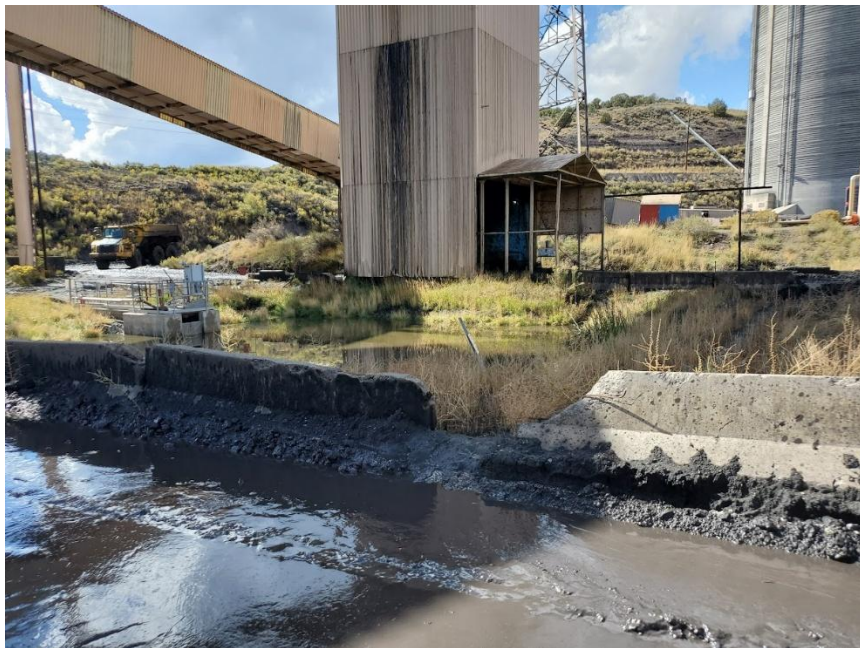
Photo 2 – View to the south of the PP-1 Pond

There are three ponds located in the main facilities area: the DP-1 Pond, the PP-1 Pond and the PP-2 Pond. The DP-1 Pond is located on the southern part of the lower facilities bench. The pond was not inspected due to excessive mud. The PP-1 Pond is located on the middle bench of the facilities area near the prep plant. The pond held water below the discharge level (Photo 2). There were no erosion or stability issues identified in the PP-1 Pond. The PP-2 Pond is located on the upper facilities bench. The pond was not observed due to muddy conditions.

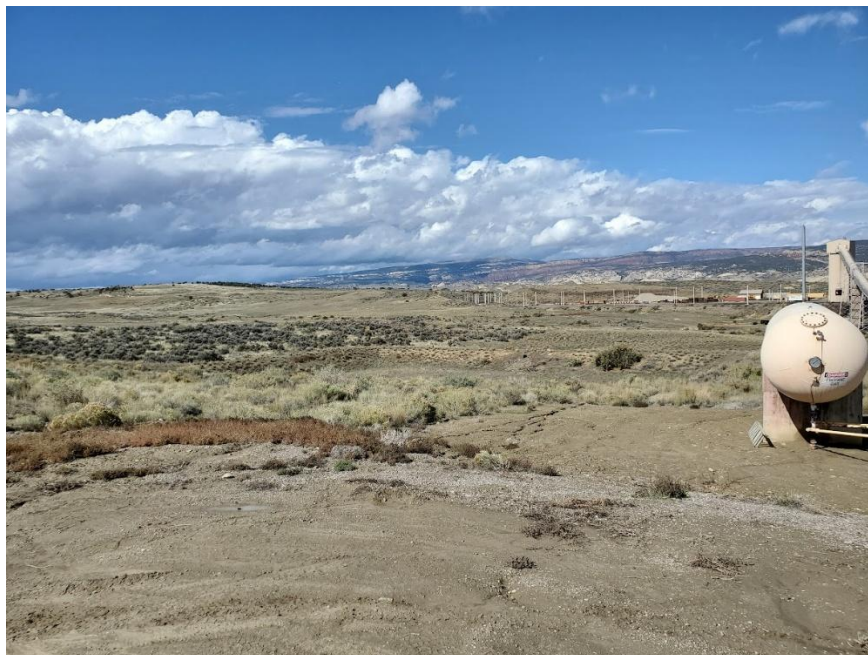
Photo 3 – View to the north of the SS-2 Pond

The SS-2 and SS-1 Ponds are located to the north of the Slot Storage Facility. The SS-2 Pond is located at the northwestern base of the Slot Storage Facility. The pond was dry at the time of the inspection (Photo 3). The embankments of the pond were well vegetated and stable with no indications of erosion. The SS-1 is located at the

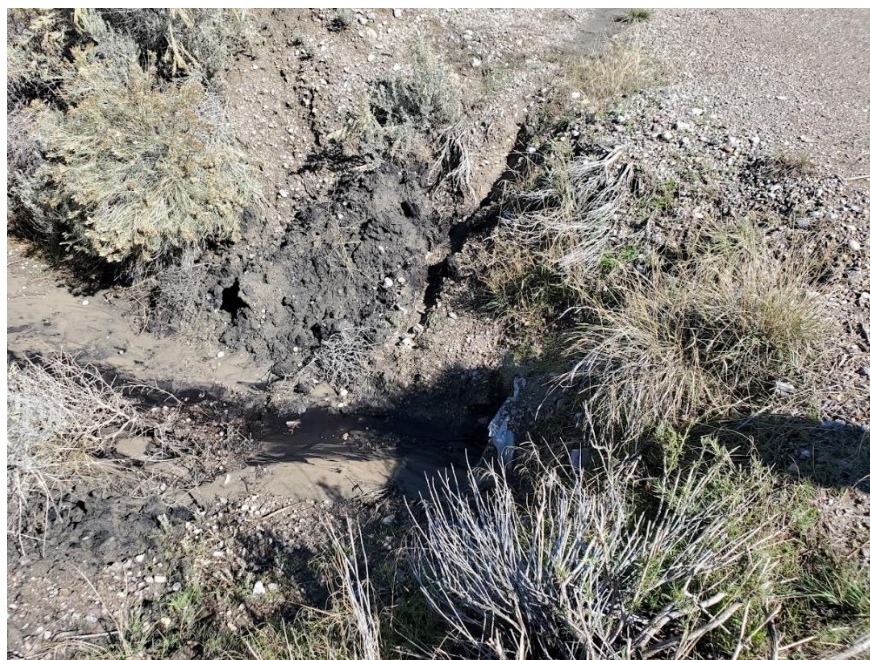
Photo 4 – View to the east of culvert above SS-1 Pond

northeastern base of the slot storage. The pond was dry at the time of the inspection. The culvert above the pond that conveys water under the road is free of sediment and able to convey water (Photo 4).

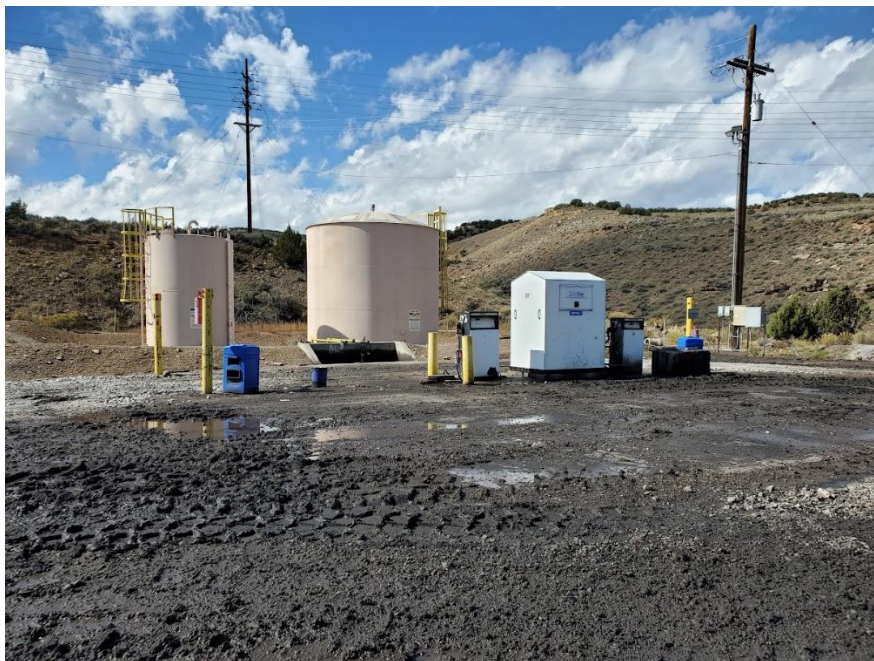
Photo 5 – View to the west of fuel station

Fuel is stored in double walled tanks near the haul road leaving the facilities area. The fuel is stored in a bermed secondary containment area. There is a secondary containment sump around the couplings to refuel the tanks. Minor amounts of meteoric water were in the containment sump. Barrels that were noted in previous inspection reports that contained bad fuel were removed from the site (Photo 5).

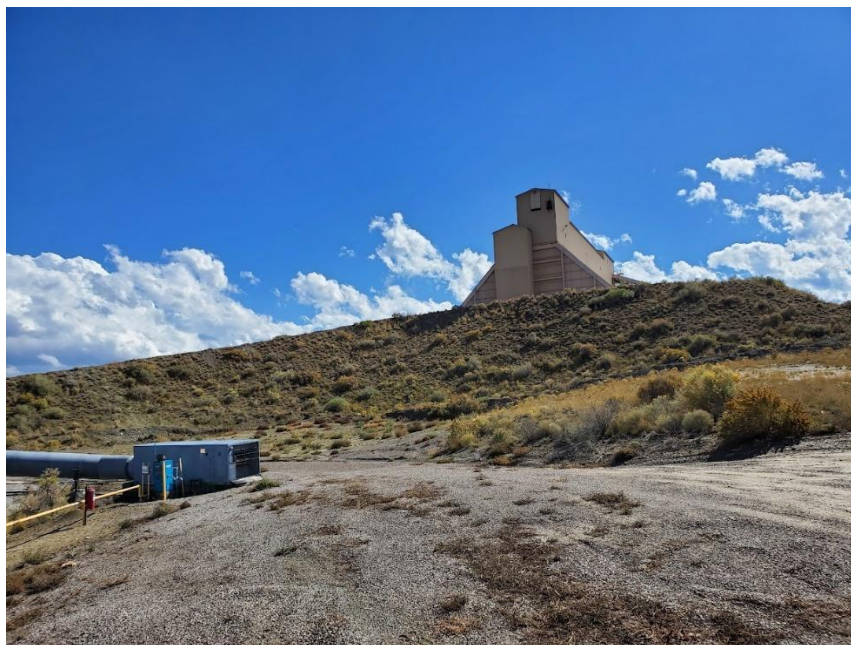
Photo 6 – View to the south of Slot Storage

The Slot Storage Facility is located just to the south of the rail loadout. The pad that surrounds the Slot Storage is in good condition with a berm to control erosion. There were no erosional features noted on the embankments below the slot storage building (Photo 6).

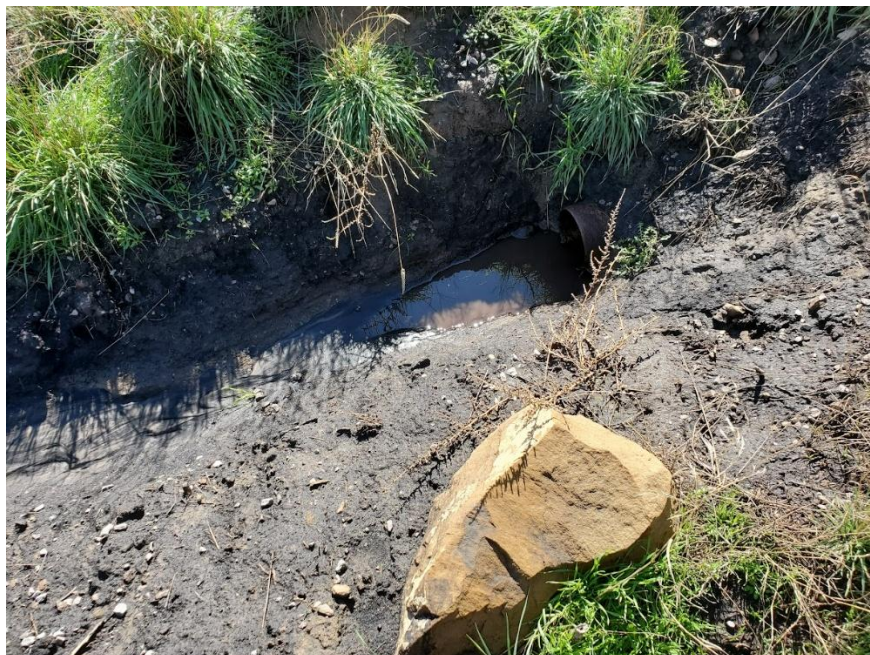
Photo 7 – View to the east of clean culvert at nitrogen plant

The Nitrogen Injection Plant is located just to the south of the Slot Storage Facility. The pad surrounding the building shows no signs of excessive erosion. The culvert that conveys water under the access road to the plant is clear and able to convey water (Photo 7).

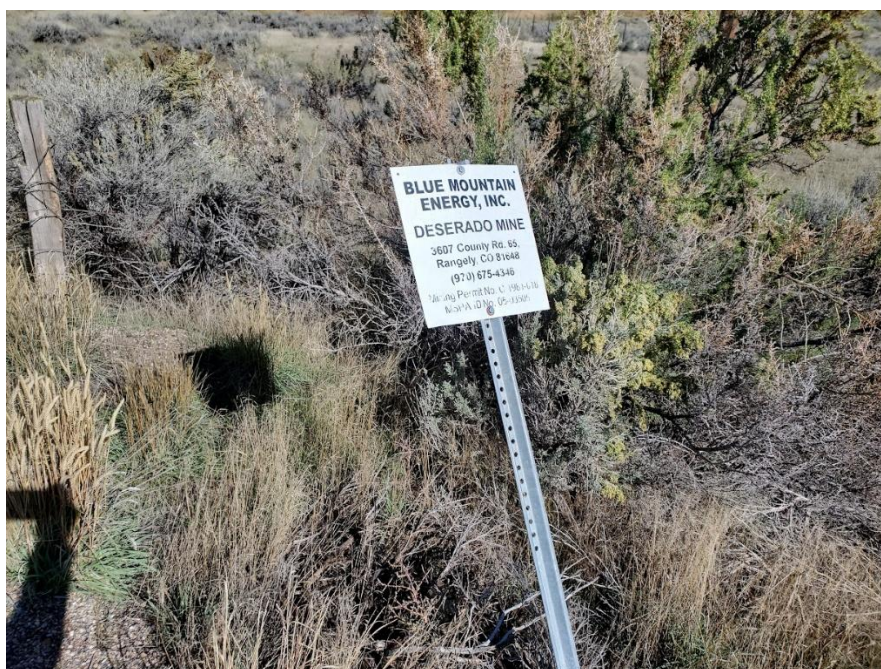
Photo 8 – View to the west of mine id signage.

A mine identification sign was observed to be posted on the right-hand side of CR-65 as the county road enters the permit boundary. The sign was placed in an unobstructed location and the text was easily legible. Information on the sign contained the mine permit number, permittee name and contact information. (Photo 8)
