**MINERALS PROGRAM INSPECTION REPORT**  
**PHONE: (303) 866-3567**

| <b>MINE NAME:</b><br>Irwin/Thomas Mine | <b>MINE/PROSPECTING ID#:</b><br>M-2016-054 | <b>MINERAL:</b><br>Sand and gravel | <b>COUNTY:</b><br>Boulder |
| <b>INSPECTION TYPE:</b><br>Surety-Related Inspection | <b>WEATHER:</b> Clear | <b>INSP. DATE:</b><br>October 22, 2025 | <b>INSP. TIME:</b><br>13:00 |

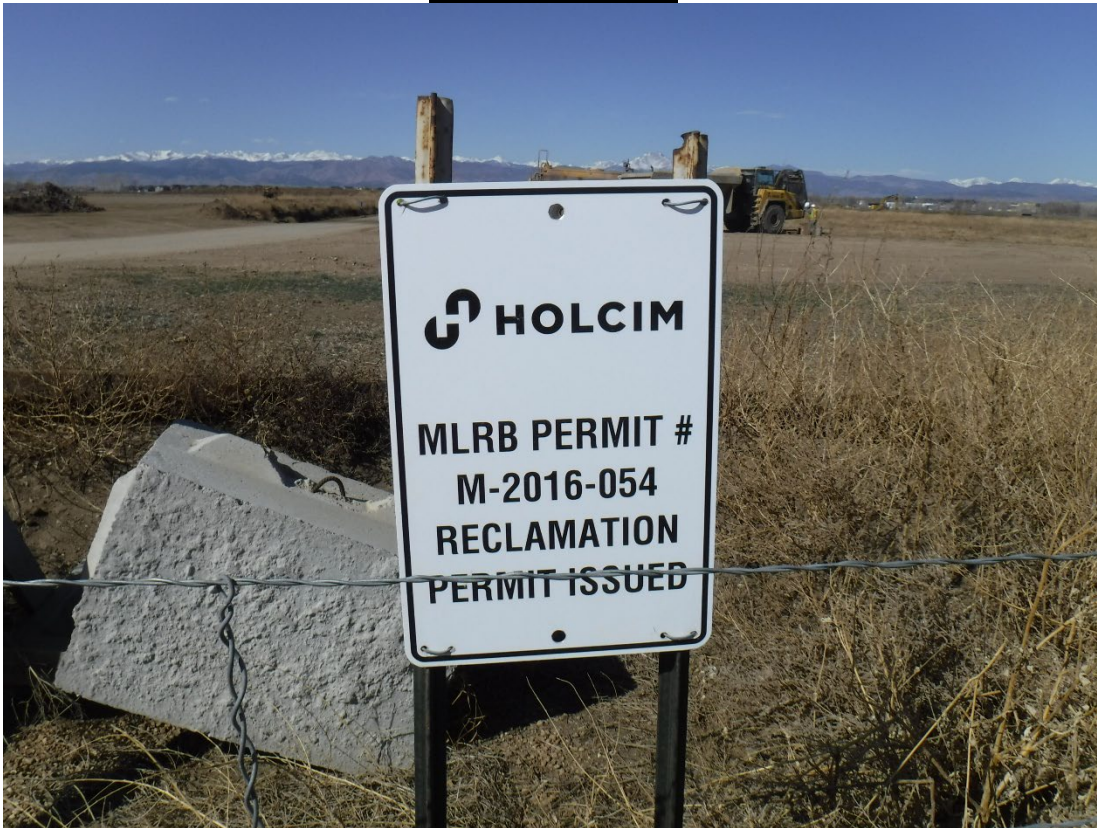
The Irwin/Thomas Mine is located in Boulder County at the southeastern edge of Longmont, Colorado and is accessed from the northeast off N 119th Street. The site is situated near the confluence of Left Hand Creek and St. Vrain Creek. The approved post-mining land use is agriculture. A mine sign was posted at the primary mine entrance pursuant to Rule 3.1.12, however the sign still lists Holcim as the Operator and needs to be updated to reflect the new Operator name.

**Photo 1:** Mine sign at the primary entrance to permit area

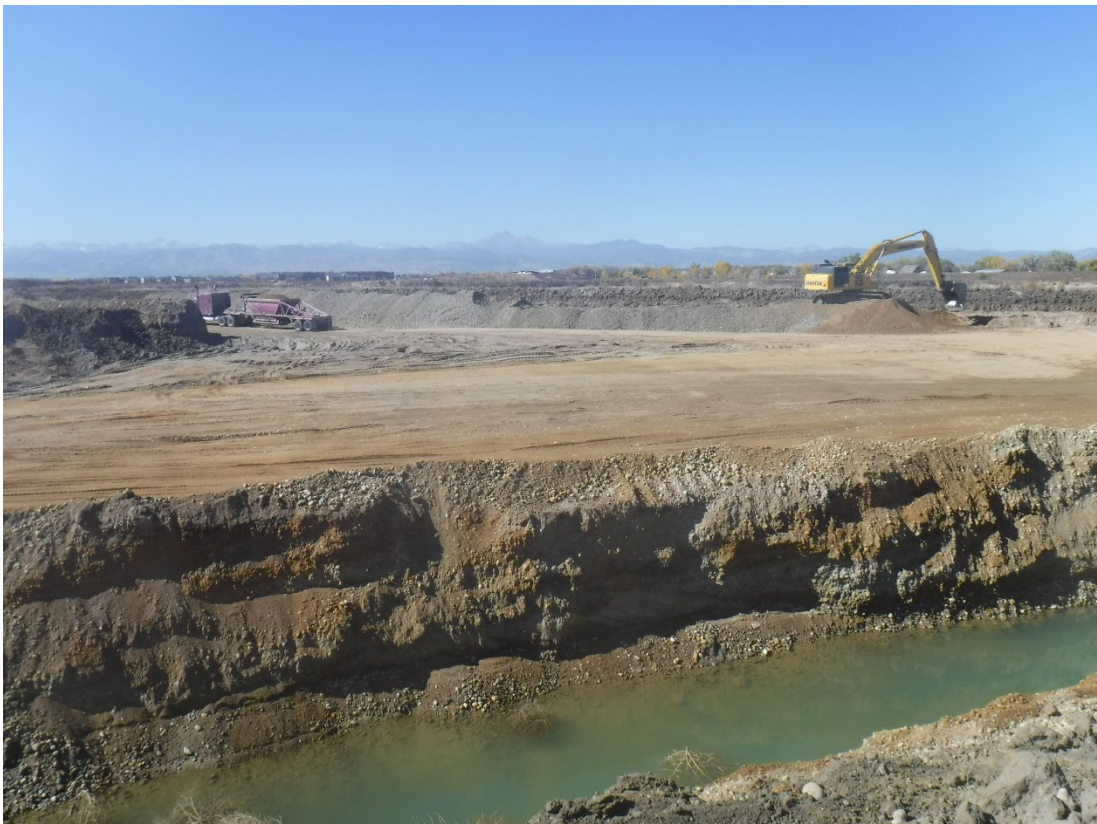
**Photo 2:** Mining occurring in the NE portion of Cell 4, dewatering trench in foreground

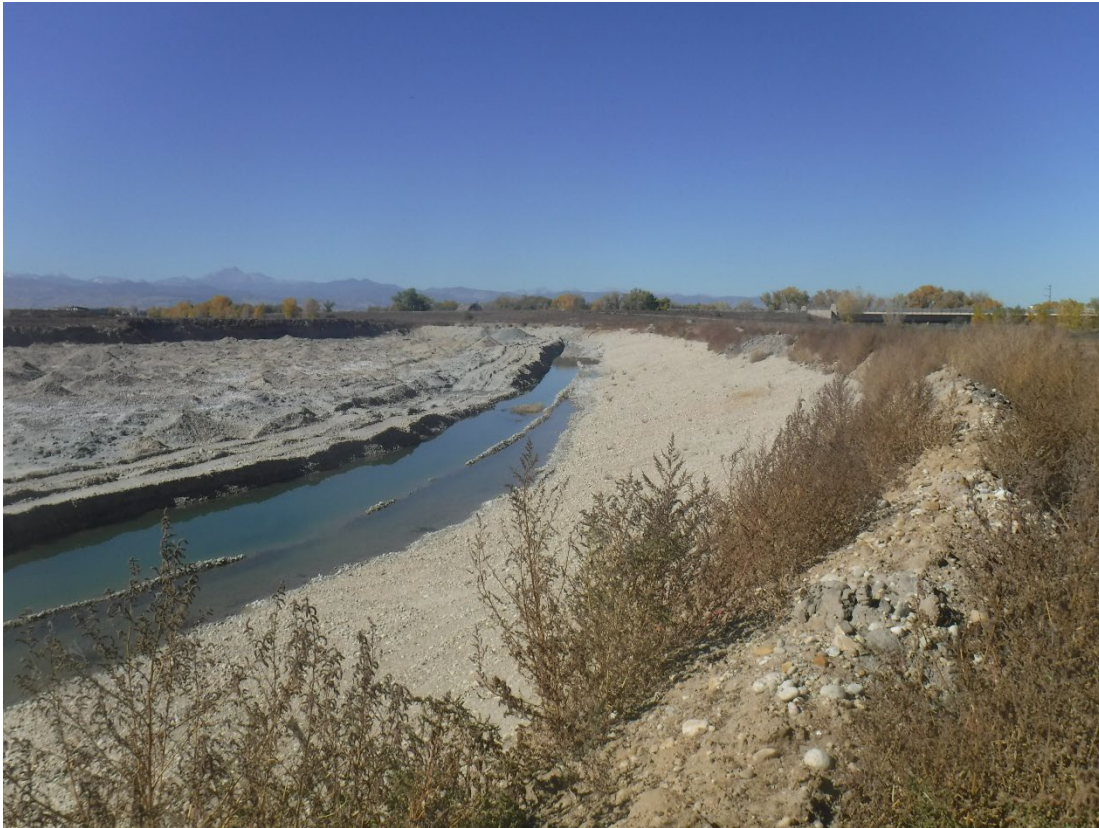
**Photo 3:** East side of the slurry wall that surrounds Cells 2 and 3

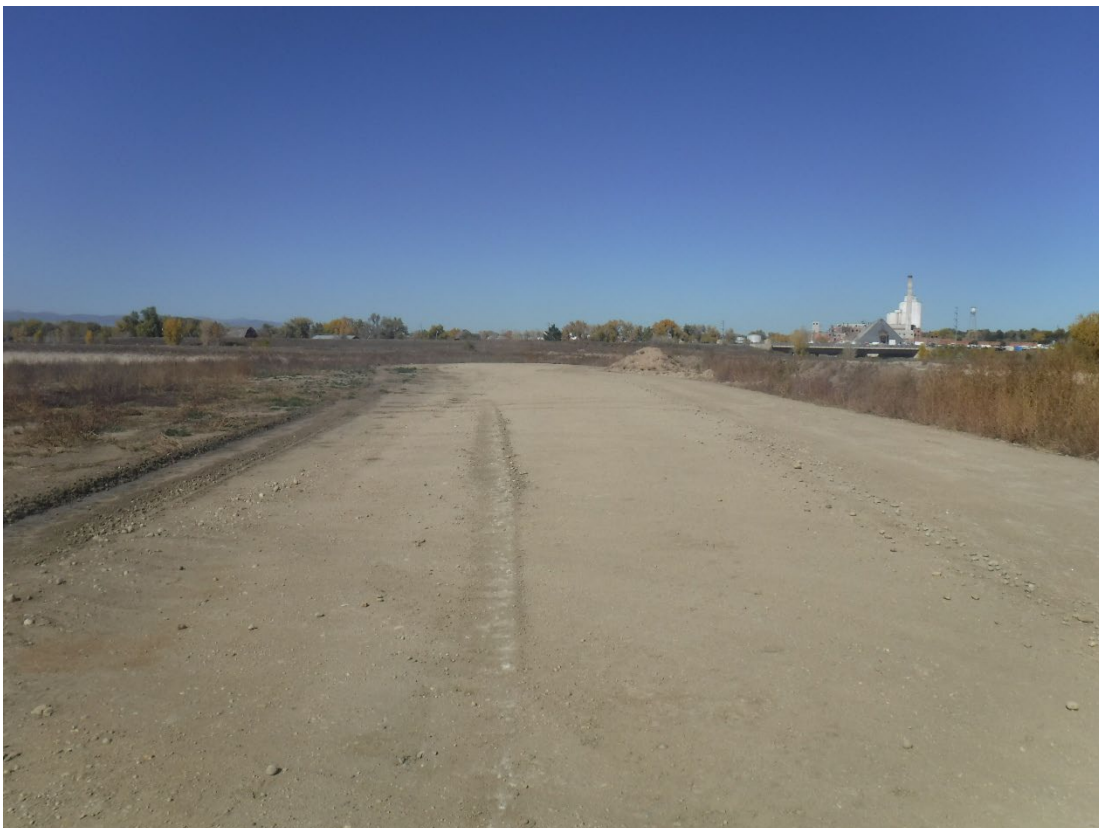
**Photo 4:** Land bridge between Cells 2 and 3

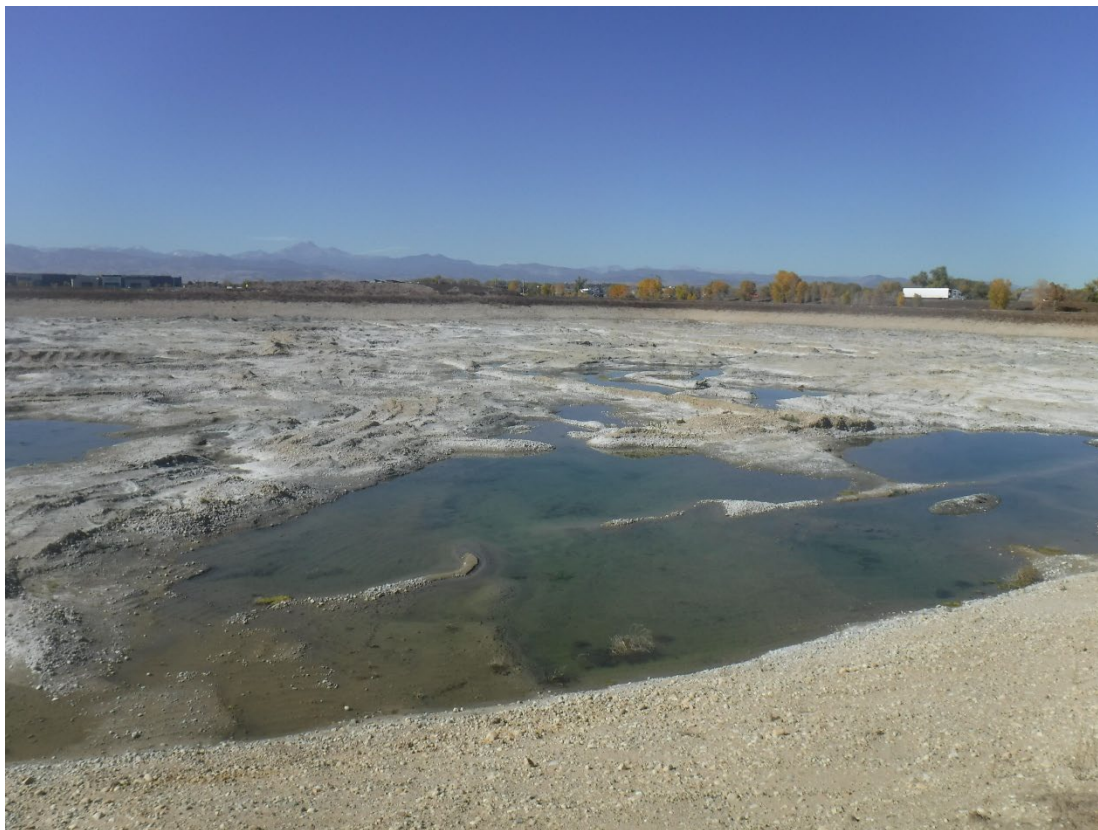
**Photo 5:** Looking west across Cell 2 from the land bridge

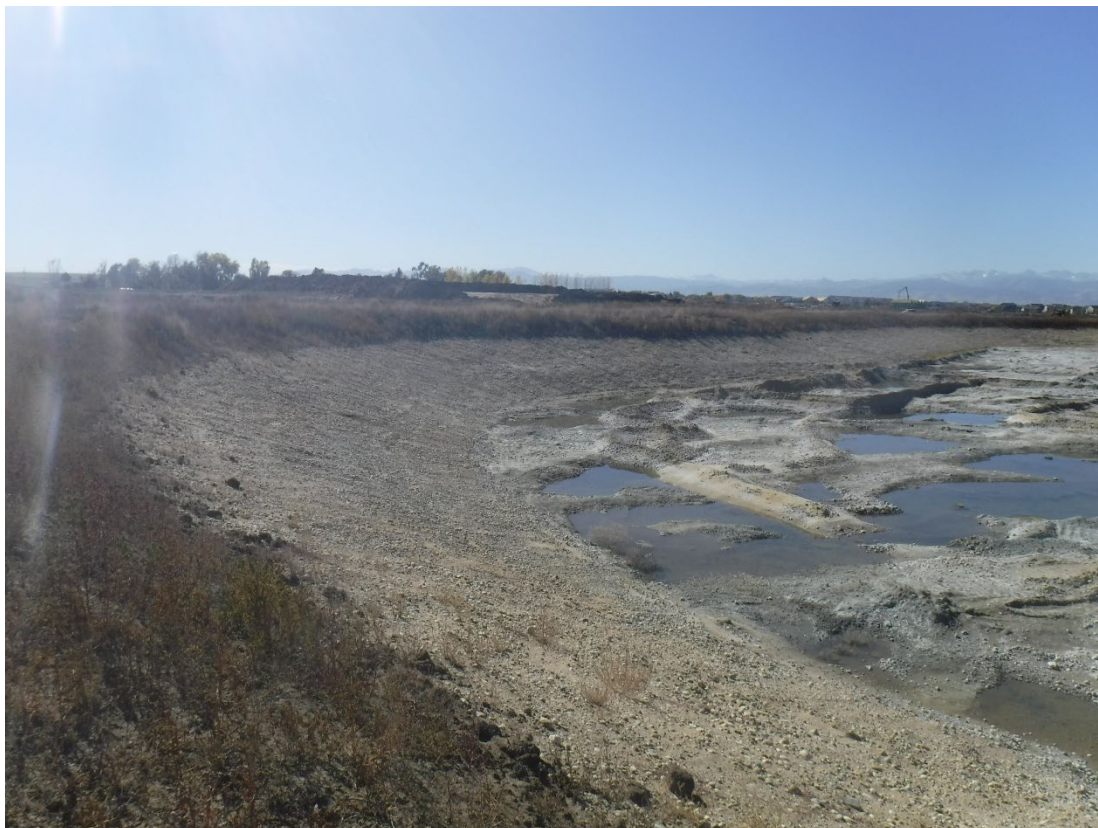
**Photo 6:** Southeast corner of Cell 2

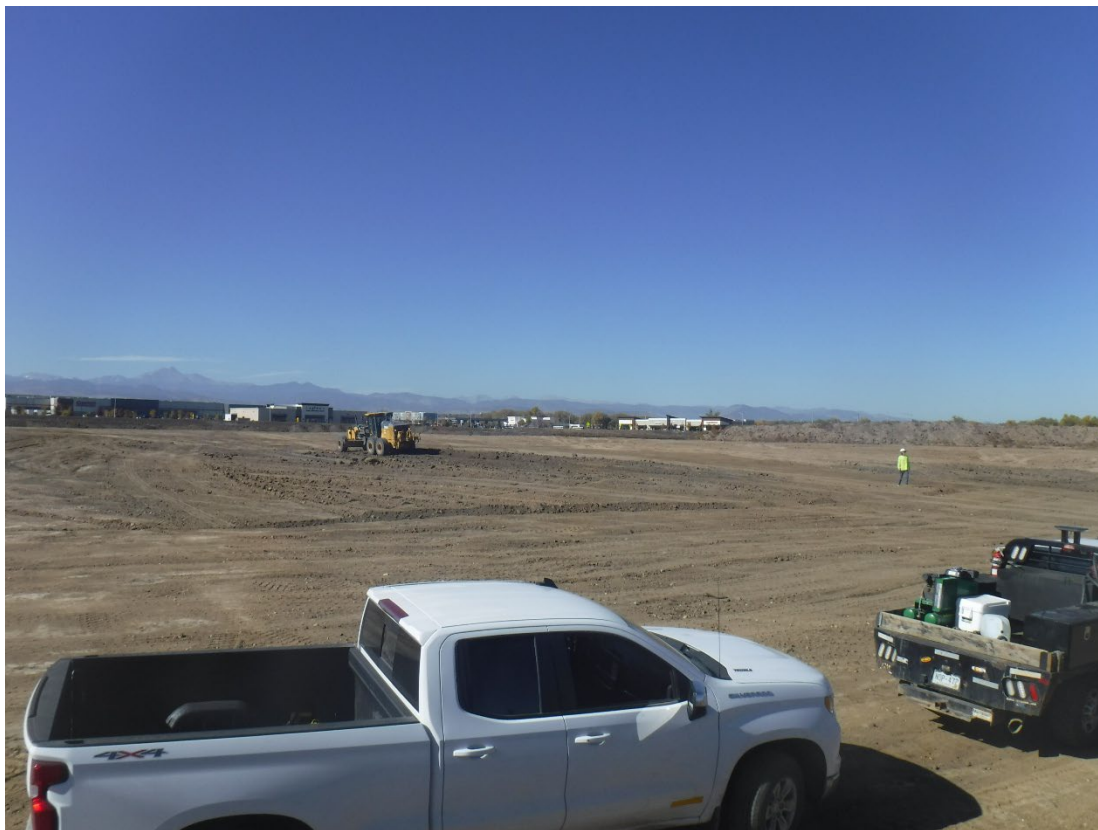
**Photo 7:** Backfilling and grading Cell 1

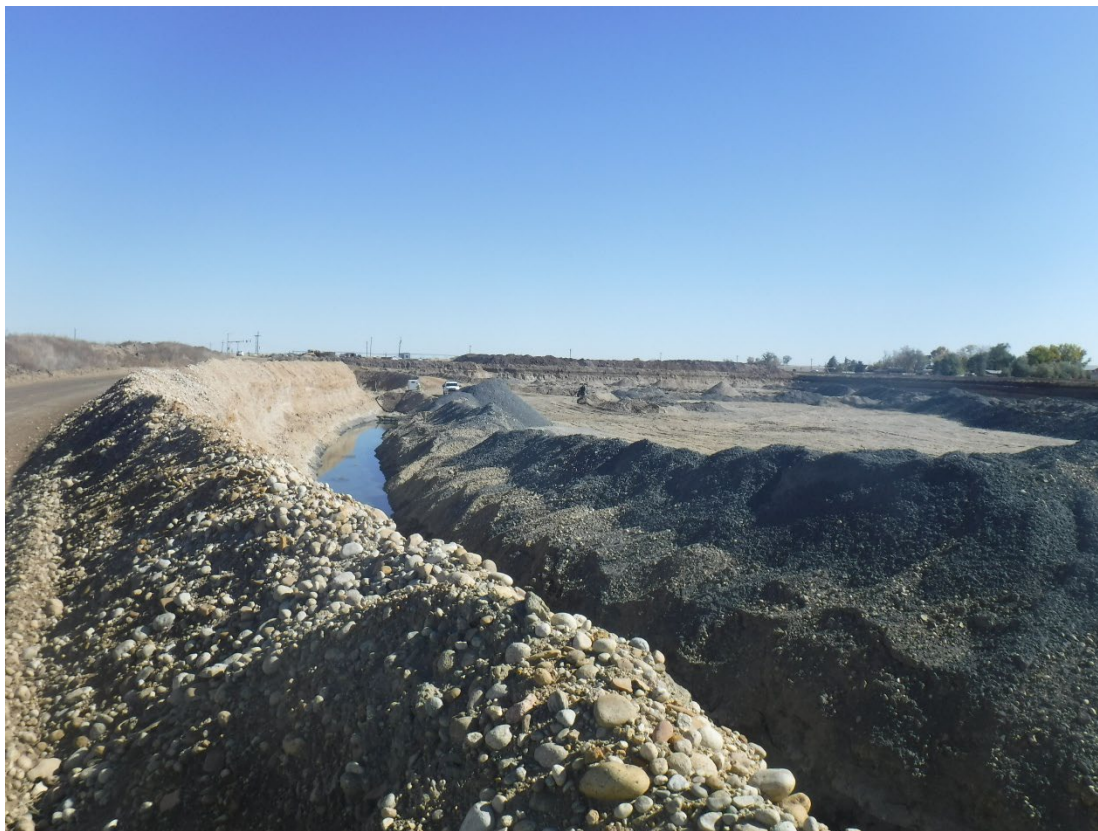
**Photo 8:** Partially mined western portion of Cell 4
