**MINERALS PROGRAM INSPECTION REPORT**  
**PHONE: (303) 866-3567**

| <b>MINE NAME:</b><br>Dill Pit | <b>MINE/PROSPECTING ID#:</b><br>M-2009-077 | <b>MINERAL:</b><br>Borrow material for construction, sand | <b>COUNTY:</b><br>Elbert |
| <b>INSPECTION TYPE:</b><br>Preoperation Inspection | <b>WEATHER:</b><br>Clear | <b>INSP. DATE:</b><br>October 15, 2025 | <b>INSP. TIME:</b><br>10:00 |

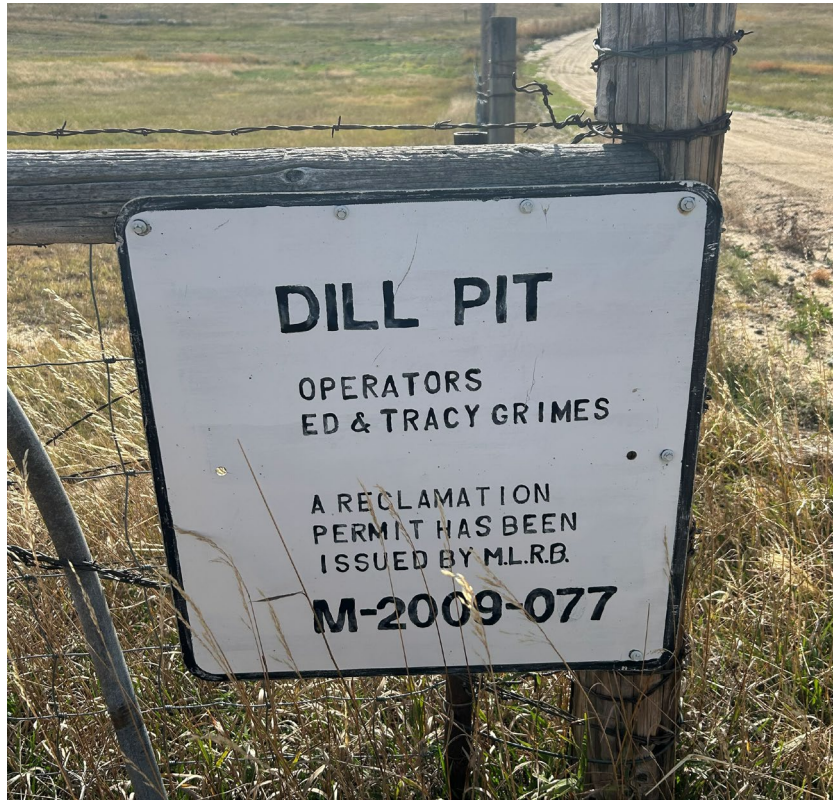
Photo 1. Mine identification sign at entrance.

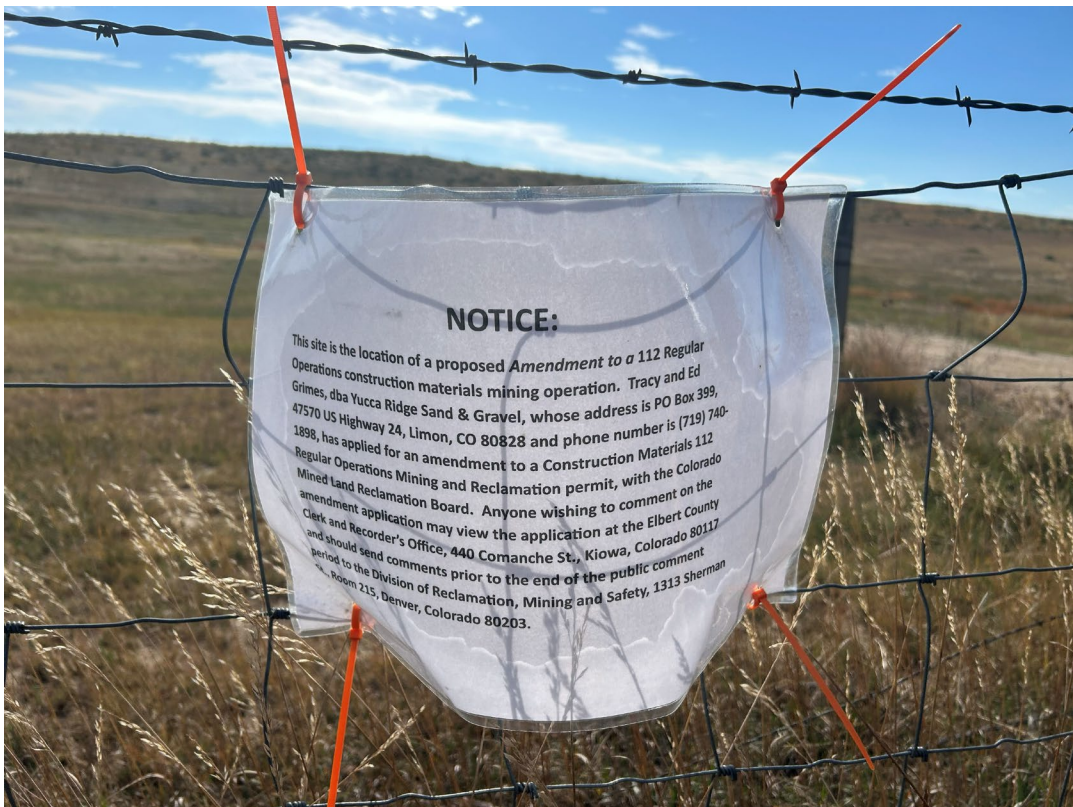
Photo 2. AM-2 notice posted at entrance.

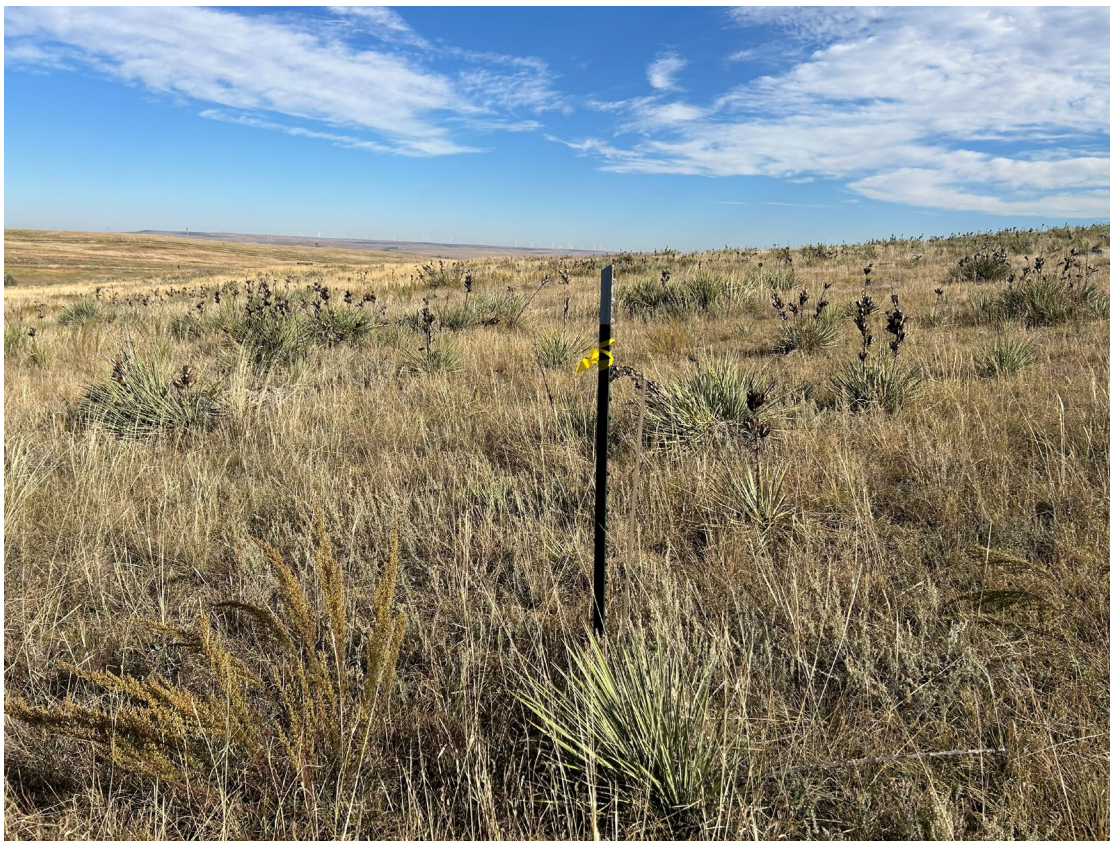
**Photo 3.** Southeast corner of the proposed Phase 4 area, looking northeast.

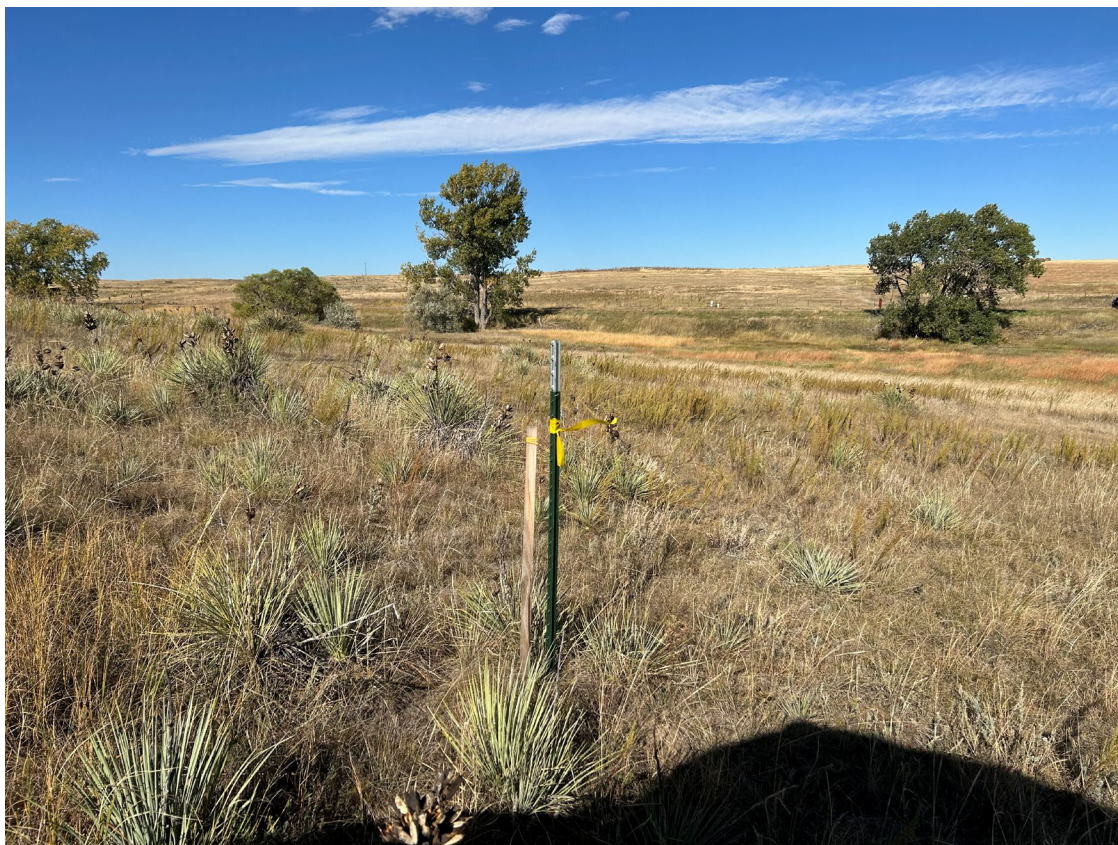
**Photo 4.** Northwest corner of the proposed Phase 5 area, looking northwest.

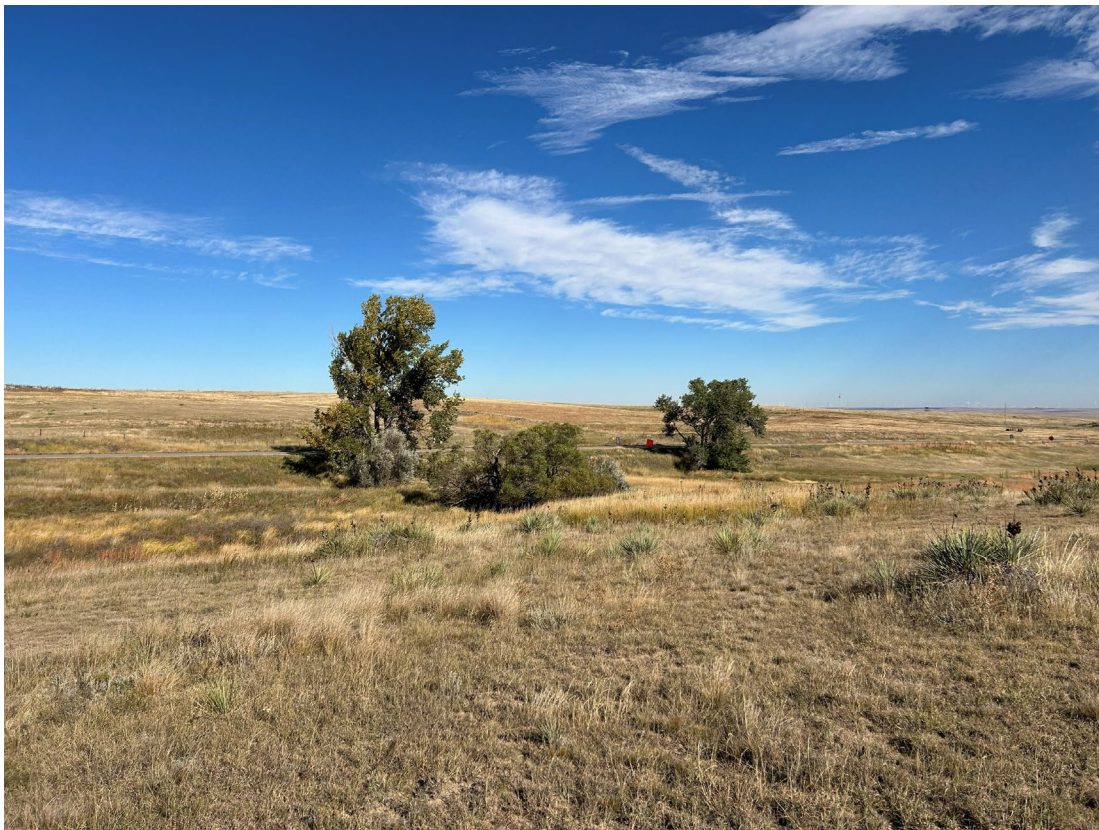
**Photo 5.** Looking north at the area outside of the proposed Phase 3 boundary.

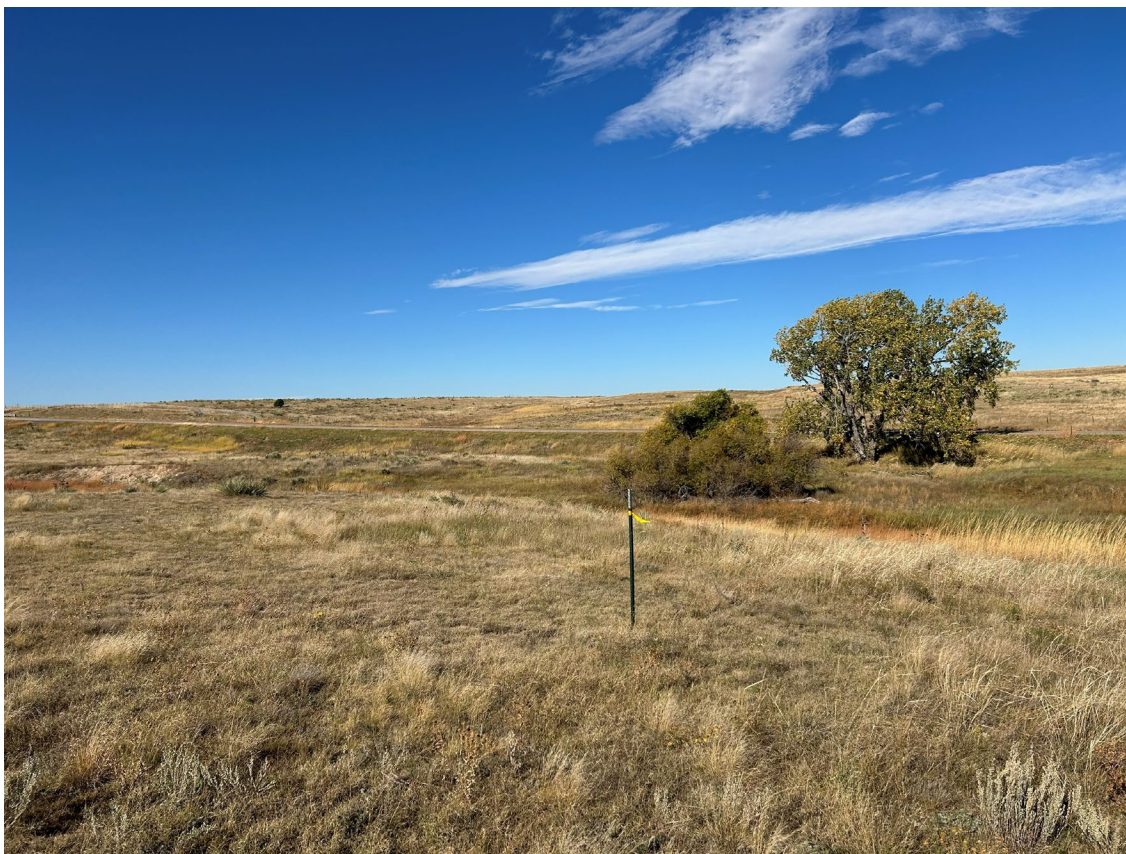
**Photo 6.** Looking west at the northeast corner of the proposed Phase 3 boundary.

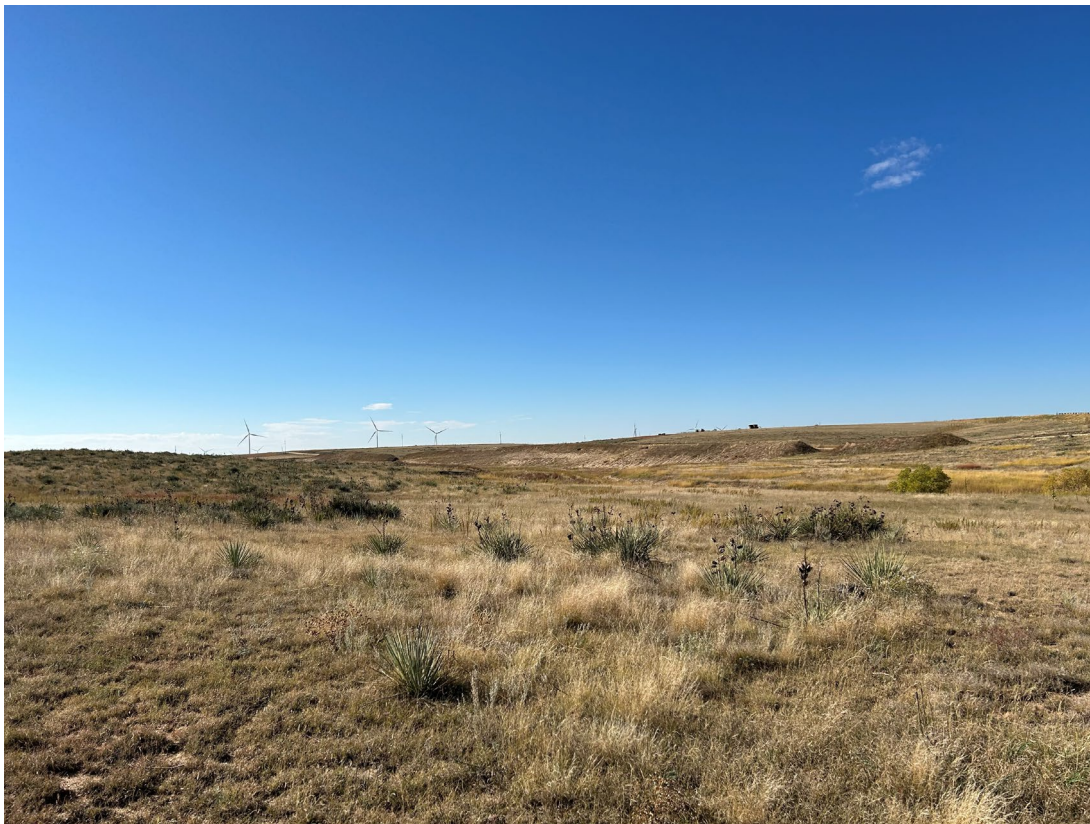
**Photo 7.** Looking southwest across the proposed Phase 3 area.

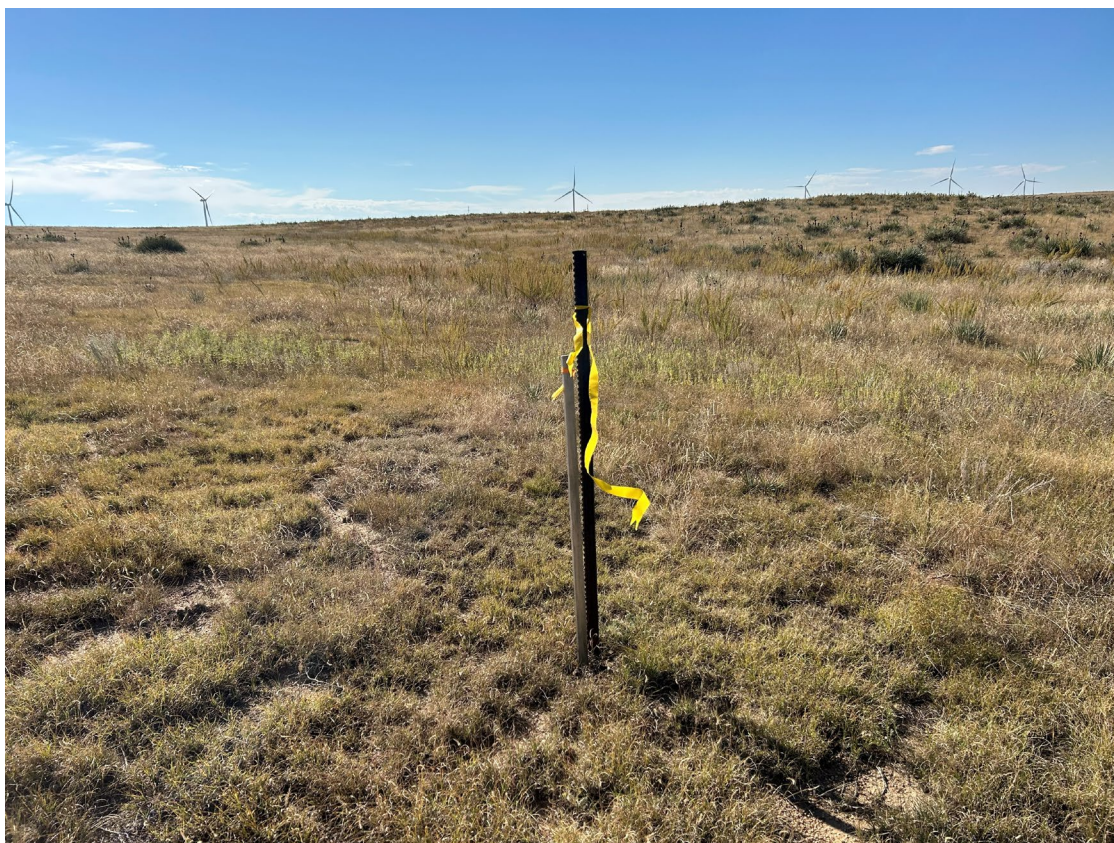
**Photo 8.** Looking southwest at the northwest corner of the proposed Phase 3 boundary.

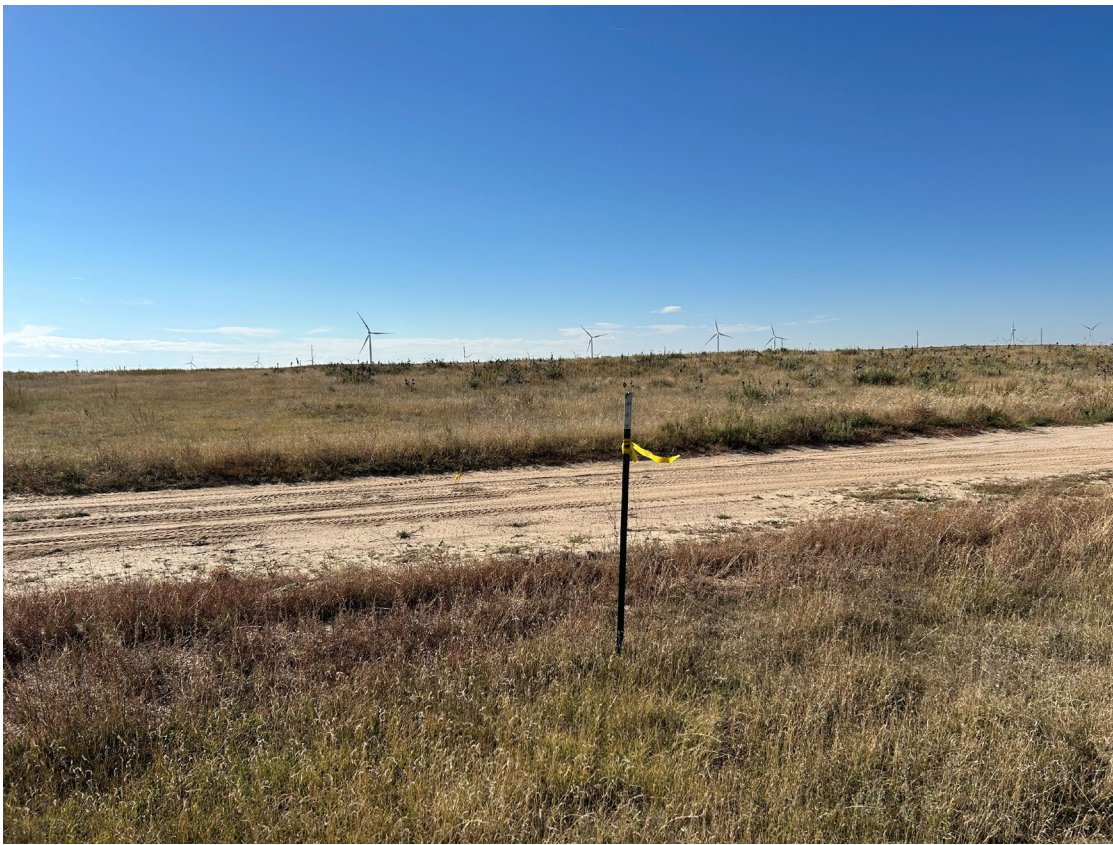
**Photo 9.** Looking south at the southeast corner of the proposed Phase 3 boundary. The access road is just south of the marker.

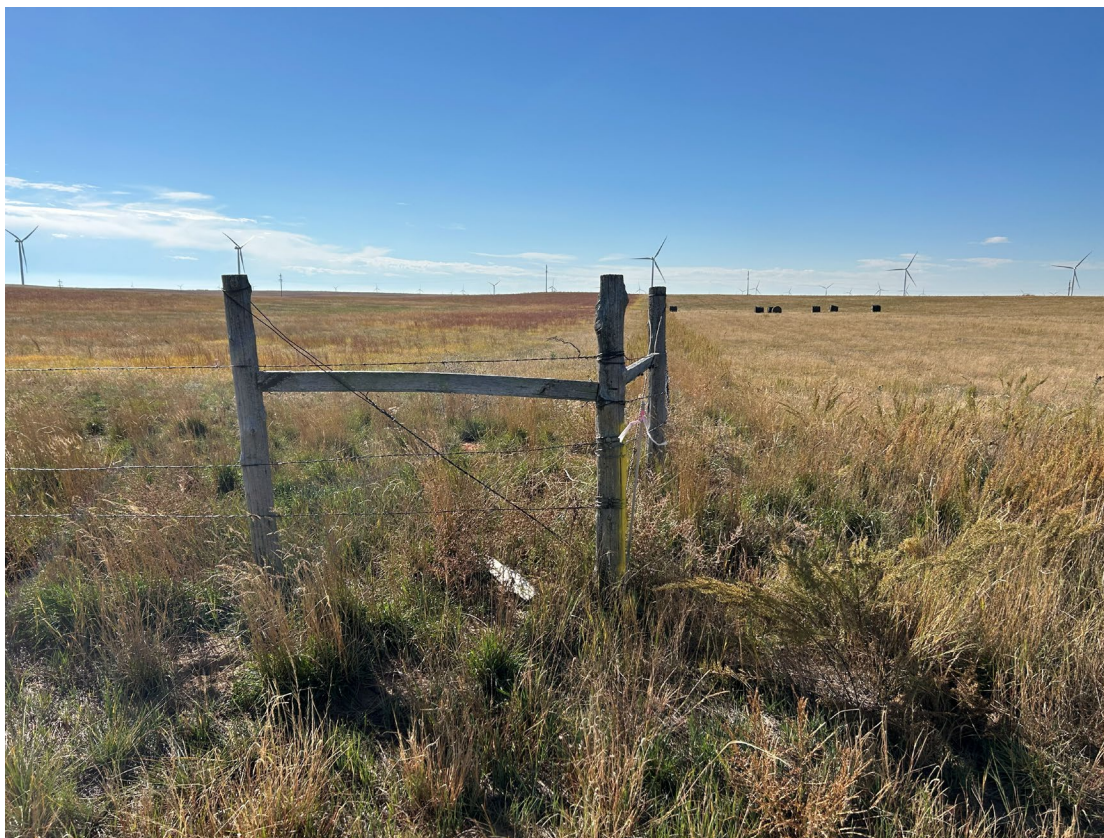
**Photo 10.** Looking south at the northeast corner of the proposed Phase 6 boundary. The operators own this fence line.

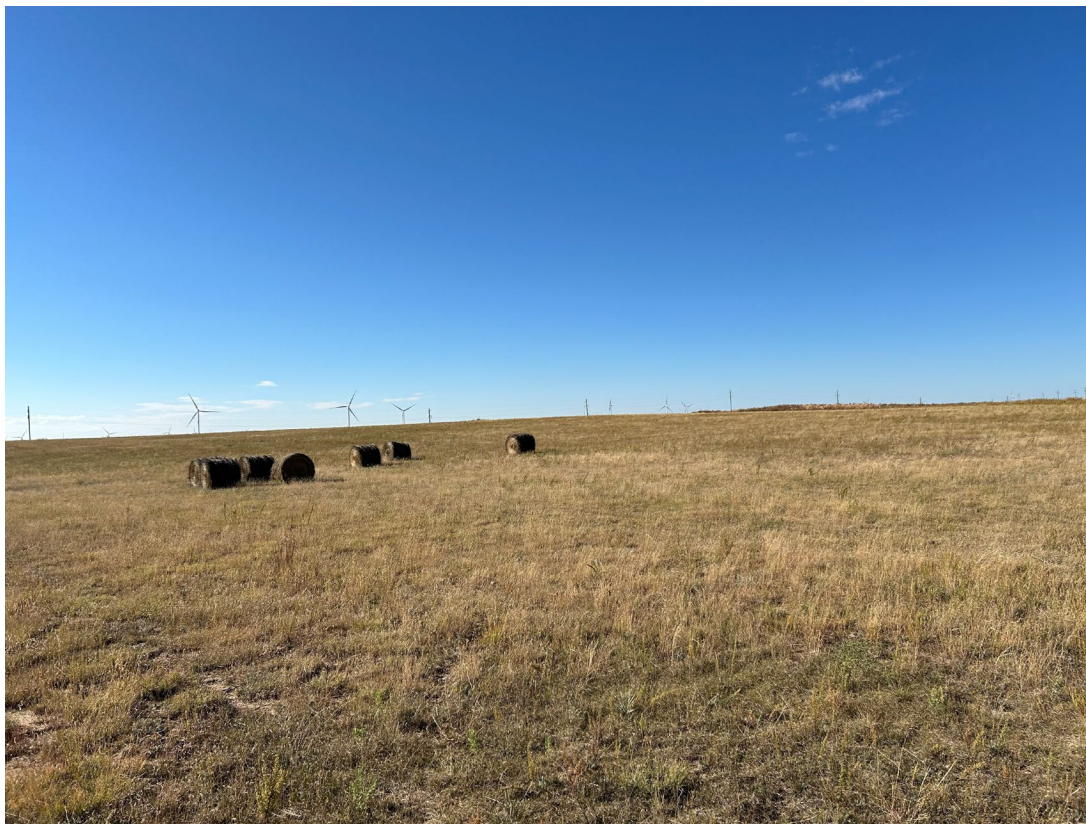
**Photo 11.** Looking southwest across the proposed Phase 6 and 7 areas.

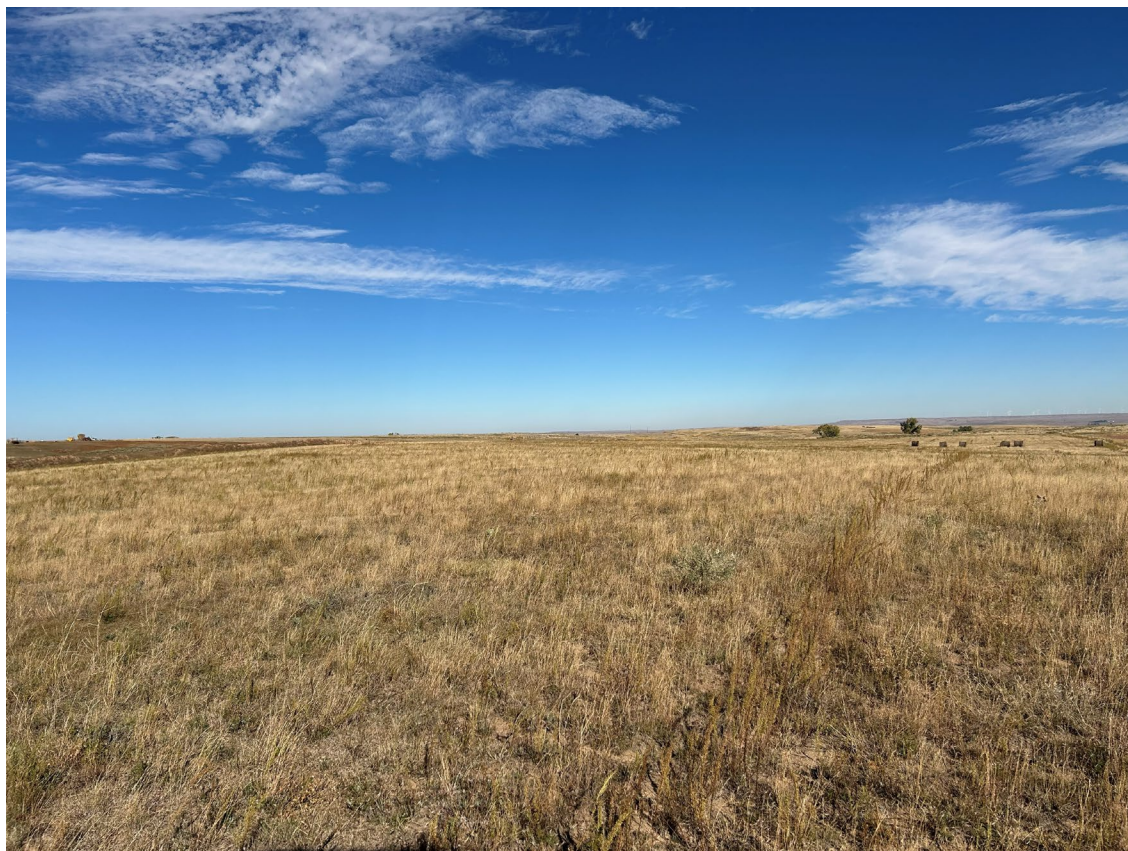
**Photo 12.** Looking north across the proposed Phase 6 and 7 areas.

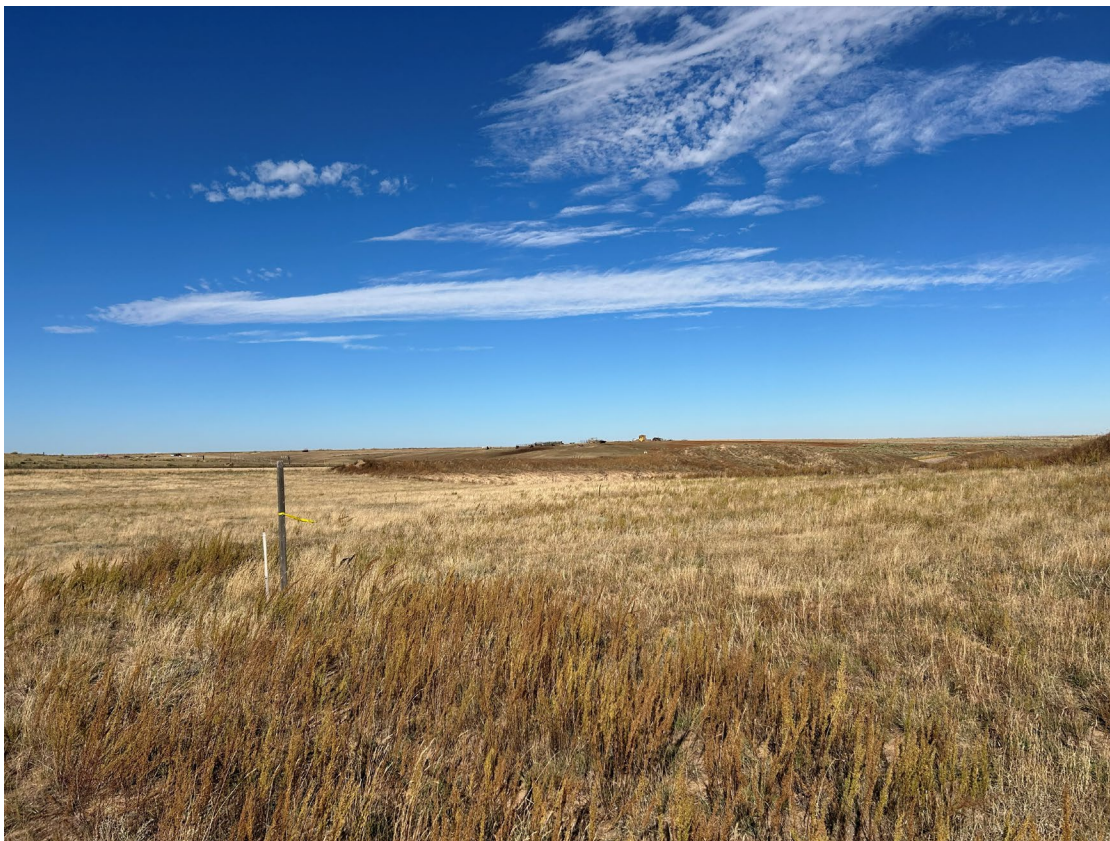
**Photo 13.** Looking west at the remaining 1 acre of mining left in Phase 1. The marker identifies the southeast corner of the existing boundary.

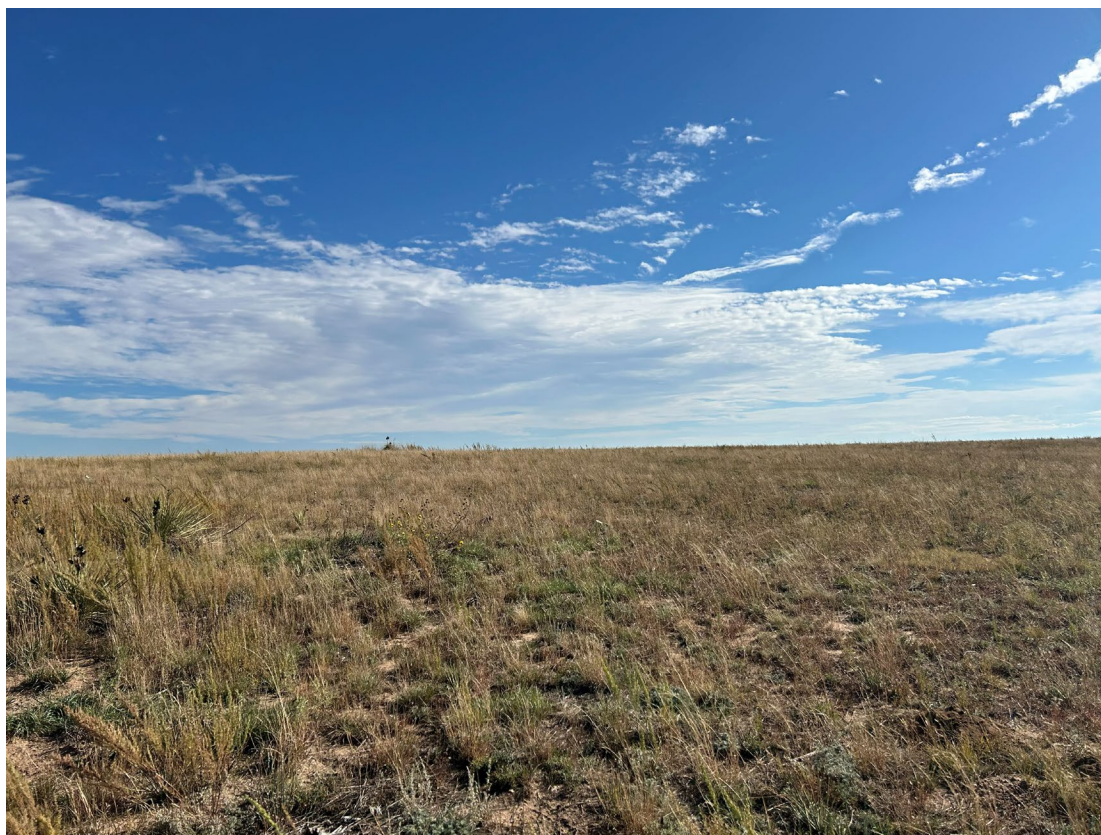
**Photo 14.** Looking north across the proposed Phase 6 area, just to the east of the existing boundary.

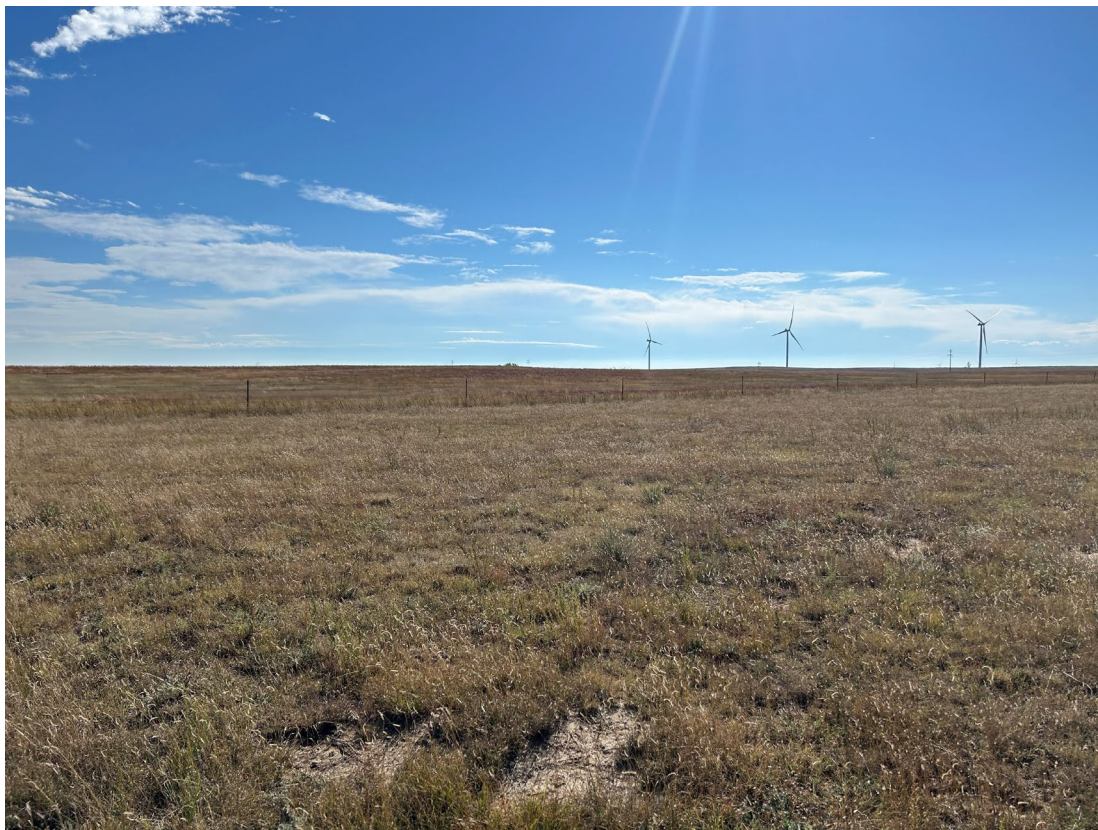
**Photo 15.** Looking southeast at the proposed Phase 6 area. The operator owns the fence line.

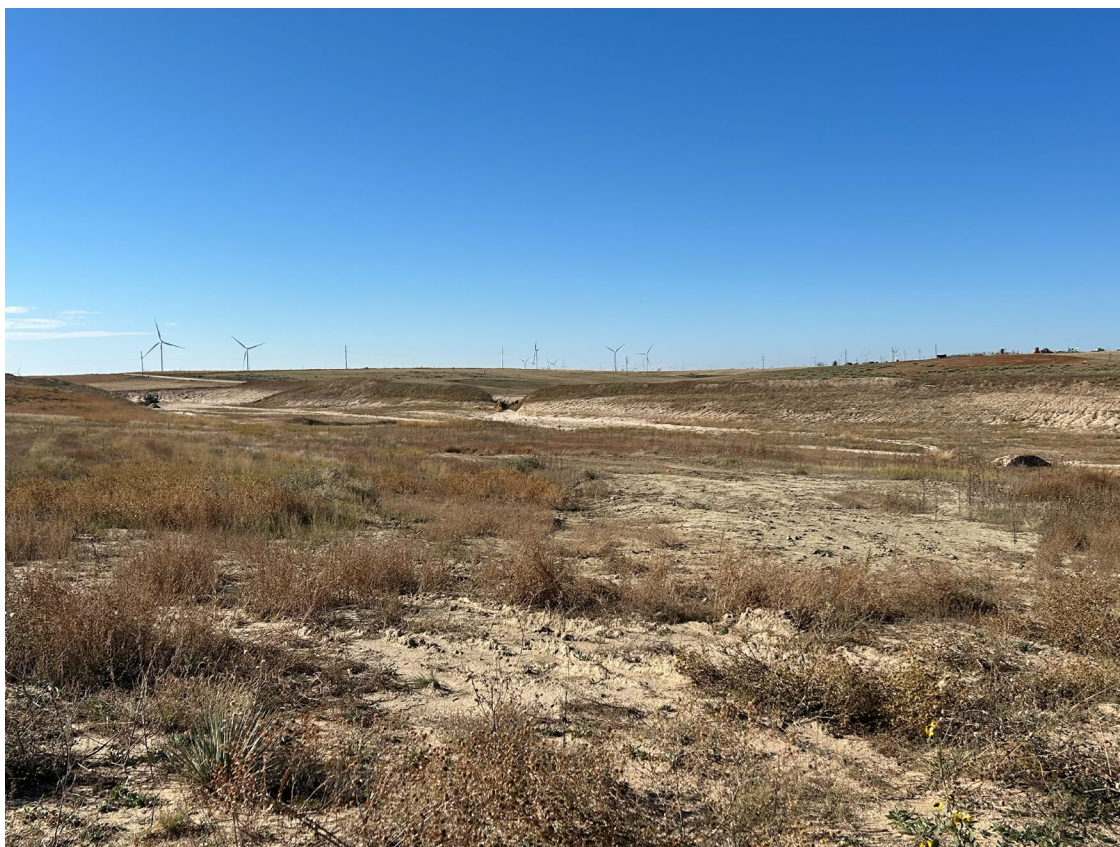
**Photo 16.** Looking south at the active pit area.

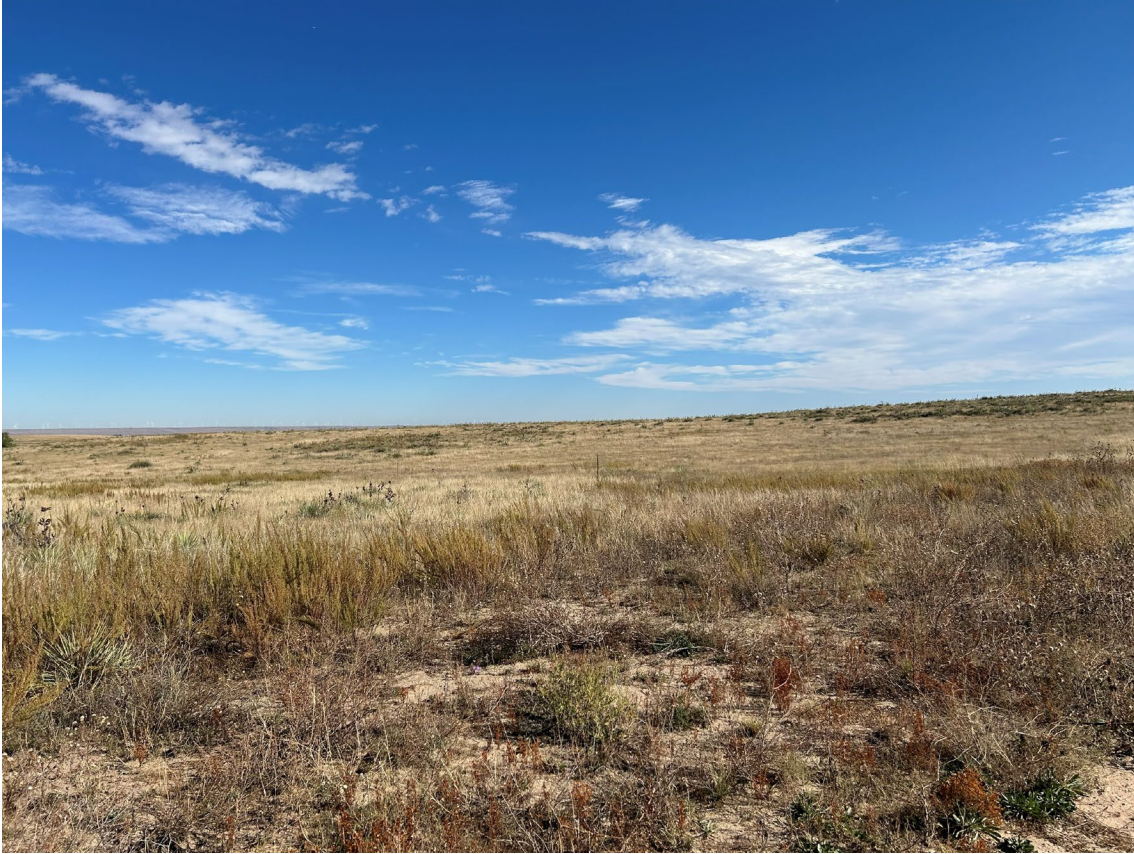
**Photo 17.** Looking north across the proposed Phase 3 area.
