Division of Reclamation,
Mining and Safety

PERMIT INFORMATION

Permit Number: C-1981-012 Mine Name: New Elk Mine Operator: New Elk Coal Company, LLC Operator Address: 12250 Highway 12 Weston, CO 81091	County: Las Animas Operation Type: Underground Permit Status: Suspended Ownership: Private
	Operator Representative Present: None
Operator Representative Signature: (Field Issuance Only)

Inspection Start Date: October 14, 2025 Inspection Start Time: 14:20 Inspection End Date: October 14, 2025 Inspection End Time: 17:08	Inspection Type: Coal Complete Inspection Inspection Reason: Normal I&E Program Weather: Cloudy
Joint Inspection Agency: None	Joint Inspection Contacts:
Post Inspection Agency: None	Post Inspection Contacts:
Inspector(s): Amber M. Gibson	Inspector's Signature:

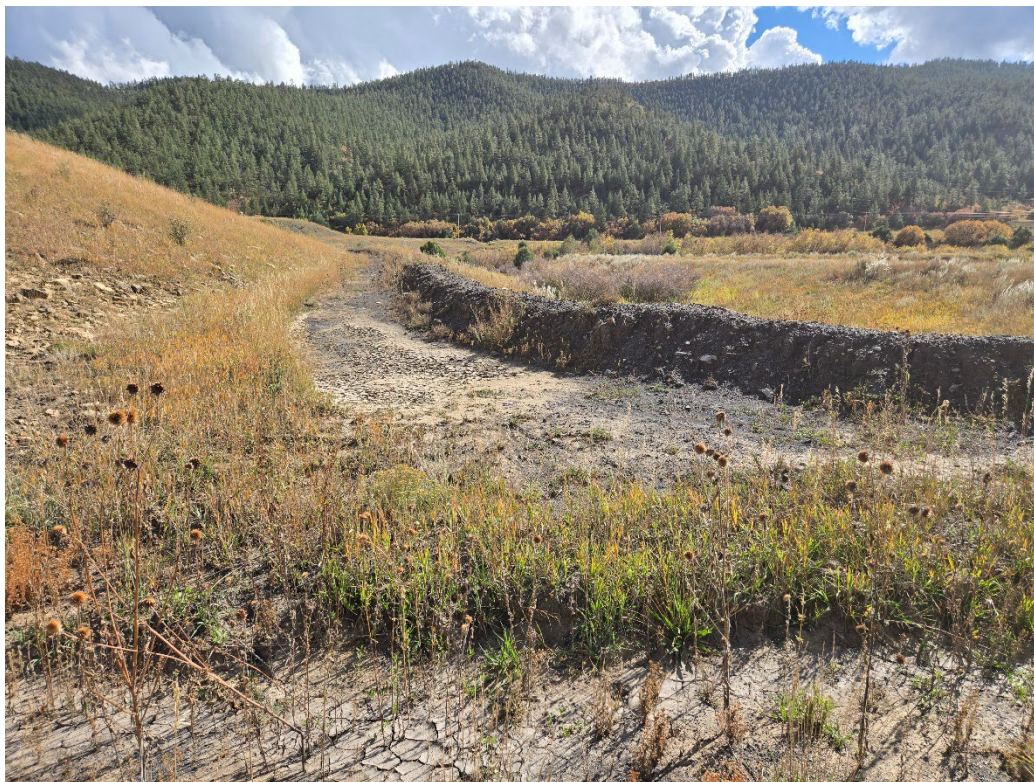
- No signs of erosion were observed along the slopes of DWDA #1. The slopes appear to be well vegetated and stable.
- Ditch D3 on the west and south side of DWDA #1 held some water at the time of the inspection. The berm appeared to be intact, with no observed erosional areas.
- **OMI:** (October 2024 report) Areas along D2, located to the north of DWDA #1, have begun to fill with sediment. Some erosion along the road leading to Pond 004A was also observed. **The Operator shall clean this ditch and stabilize the road.**

Photo 1: Looking south along the Ditch D3 on the west side of DWDA #1.

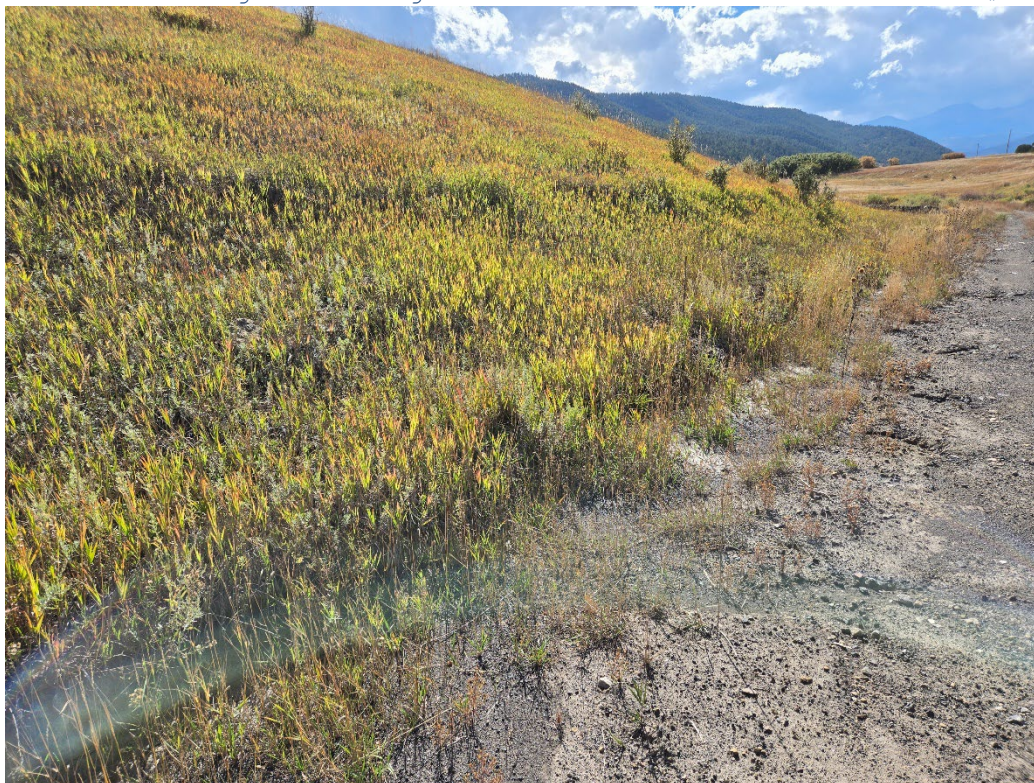
Photo 2: Looking west at an area where sediment from ditch D2 has begun to erode the

road leading to Pond 004a.

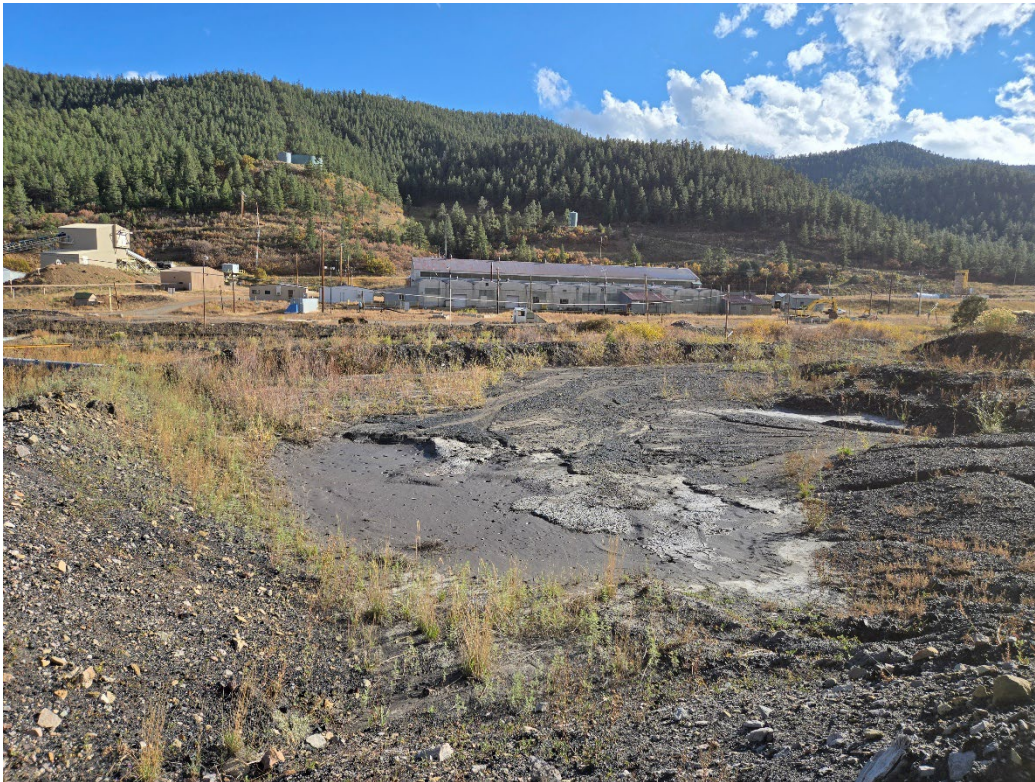
- The sediment basin at the east end of DWDA #2 held damp mud, but no standing water, at the time of the inspection.
- The inlet for culvert C13, located within the sediment basin for DWDA #2, was clear of obstructions.

Photo 3: Sediment basin on east side of DWDA #2.

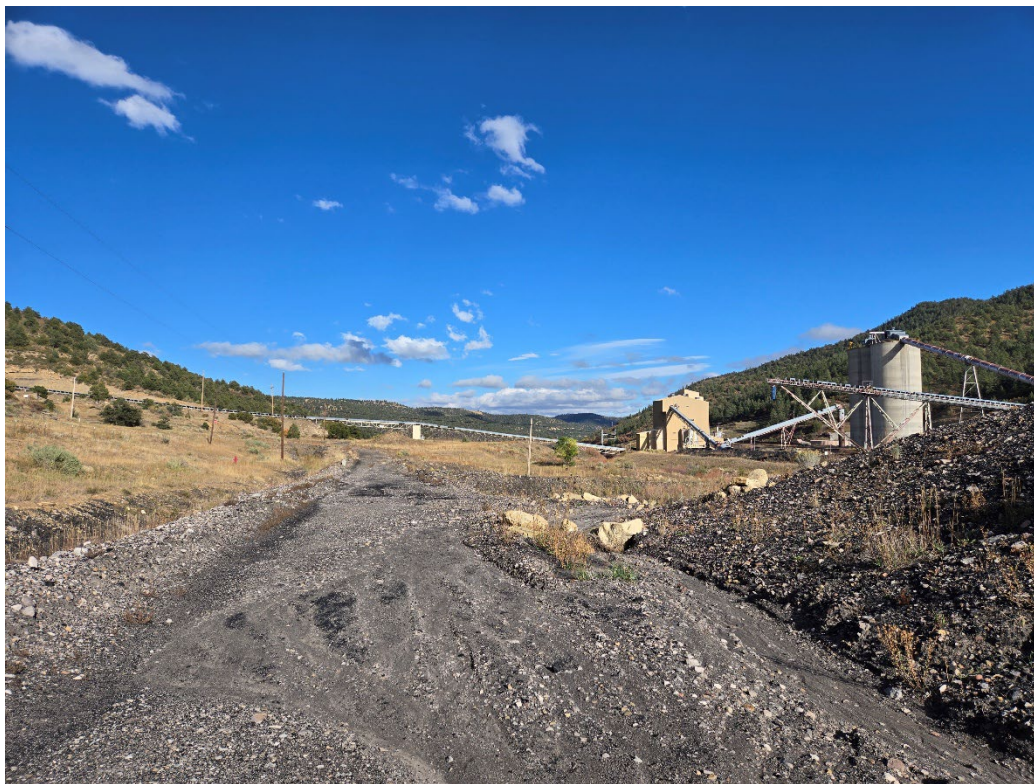
- **OMI:** (July 2025 report) Ditch 12 on the north side of DWDA #2 has filled with sediment. **The Operator shall remove this sediment and stabilize the ditch and road to ensure that the sediment control structures are functioning appropriately.**

Photo 4: Sediment in D12 along the north side of DWDA #2.

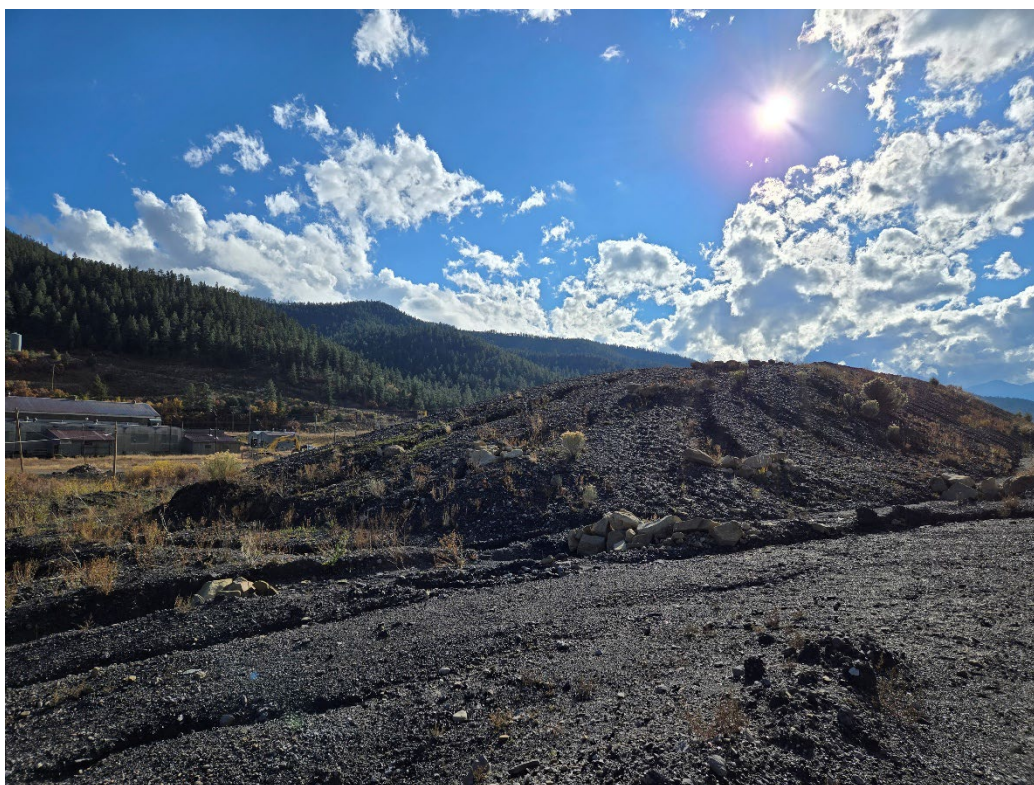
- **OMI:** (October 2024 report) The check dams along the north side of the sediment basin at DWDA #2 have filled with sediment. **The Operator shall clean the check dams of sediment and ensure that the sediment control structures are functioning appropriately.**

Photo 5: Check dams full of sediment at the east end of ditch D12. The sediment has
Number of Partial Inspection this Fiscal Year: 2
Number of Complete Inspections this Fiscal Year: 2

overflowed and cut around the check dams. Most is deposited in the sediment basin but some is cutting around on the road.

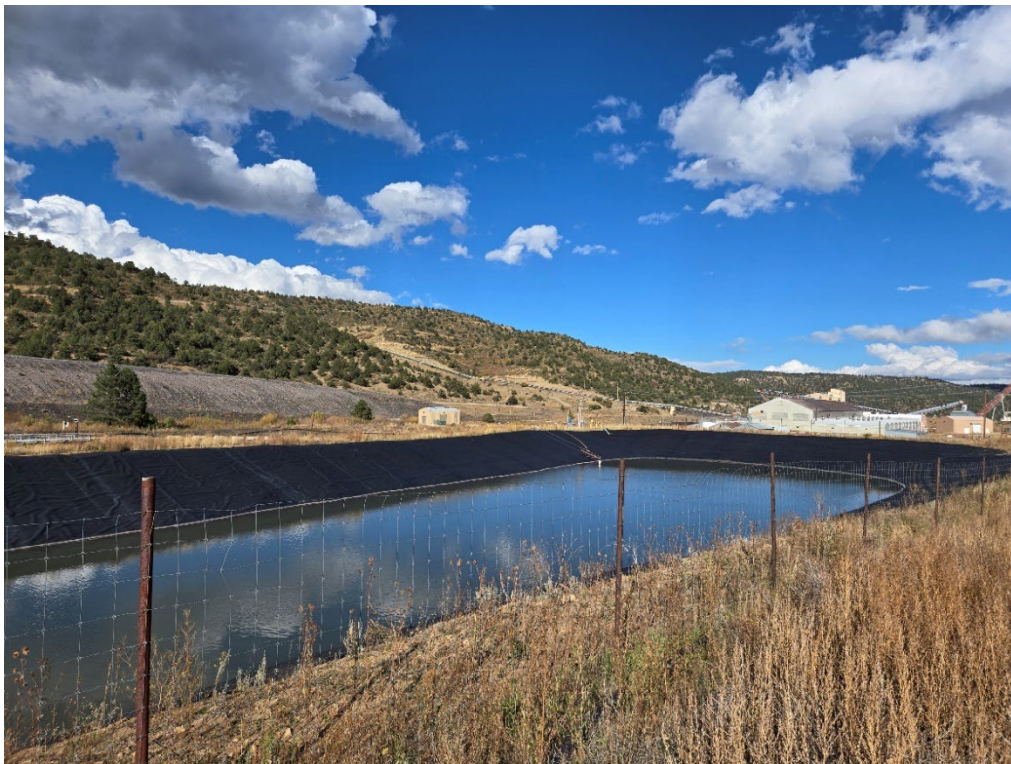
Photo 6: Pond 001a

- Pond 001A - held some water at the time of the inspection. No tears were observed in the pond lining.
- Pond 004A – was dry at the time of the inspection. The banks of the pond appeared stable and vegetated.
- Pond 006A - contained some water at the time of the inspection. The banks of the pond appeared to be stable.
- Pond 007A - the water was high at the time of the inspection but had plenty of capacity before reaching the blue marker on the white PVC pipe. The water level is below the top few holes of the principal spillway. The pond was not discharging. The banks appeared stable and the emergency spillway was clear.
- Pond 08 - contained some water at the time of the inspection and was below its capacity. The spillways appeared clear, and the banks were stable. Pond 08 was not discharging.

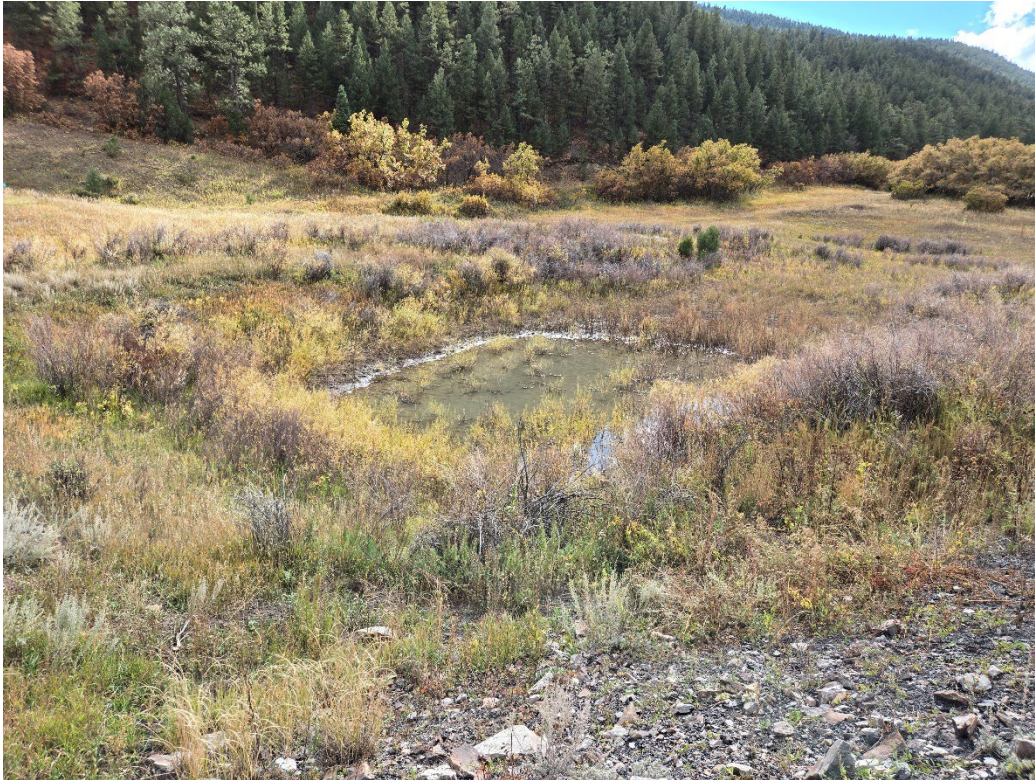
Photo 11: Containment Area 1

- Containment area #1 held water at the time of the inspection.
- Containment areas #2-4 were dry at the time of the inspection.
- Containment area #5 contained water at the time of the inspection. The containment area was still below capacity, but water was nearing the top of the embankment. There is a ditch that leads to the Pond 08 emergency spillway if the water in the containment were to the embankment. Once maintenance can resume onsite, the sediment accumulated in this containment area should be removed to help increase capacity.

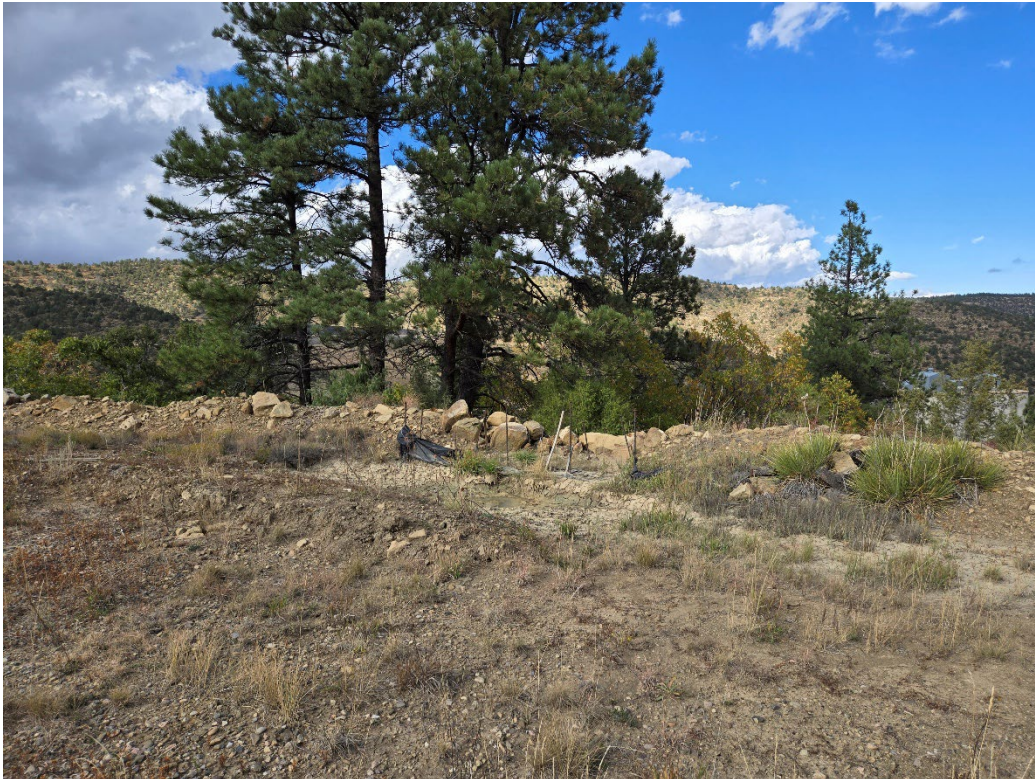
- **OMI:** (January 2024 report) **The silt fences along the road in the S.A.E south of Pond 007 are damaged and need to be repaired.**
- **OMI:** (March 2024 report) **The silt fence on the western border of the S.A.E. on the top of the hill needs to be repaired.**

Photo 16: Looking northeast at the damaged silt fence within the S.A.E. on the southside of the permit area, near the water tanks.

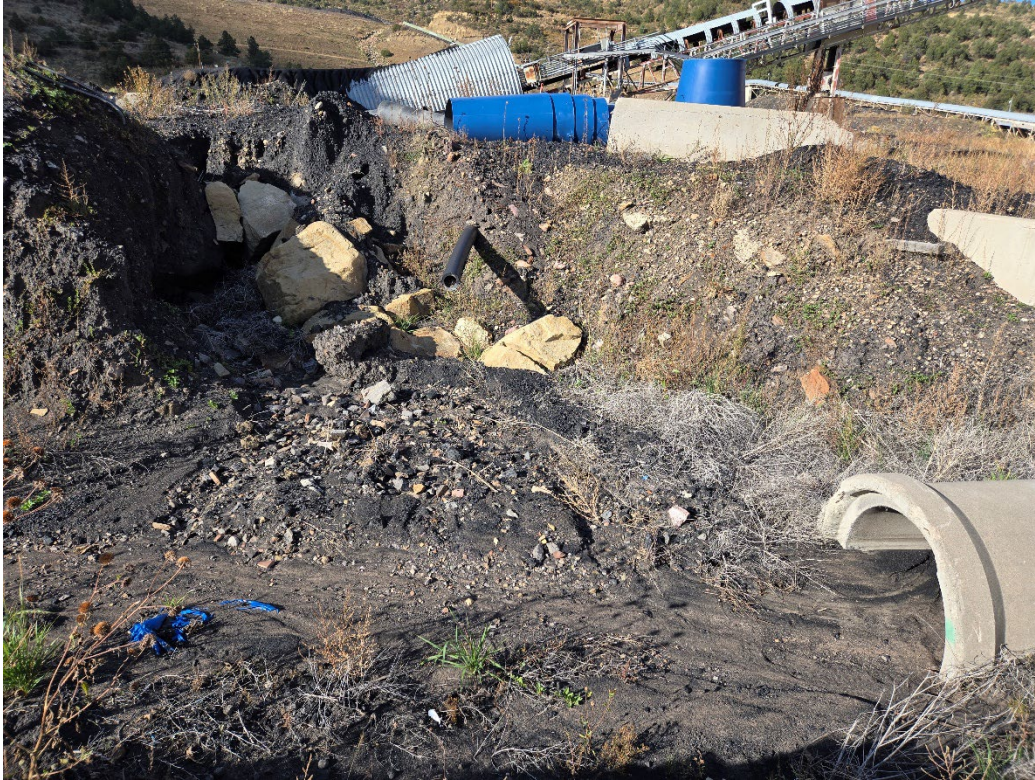
Photo 17: Check dam above C17 needs to be repaired and C17 needs to be cleaned out.

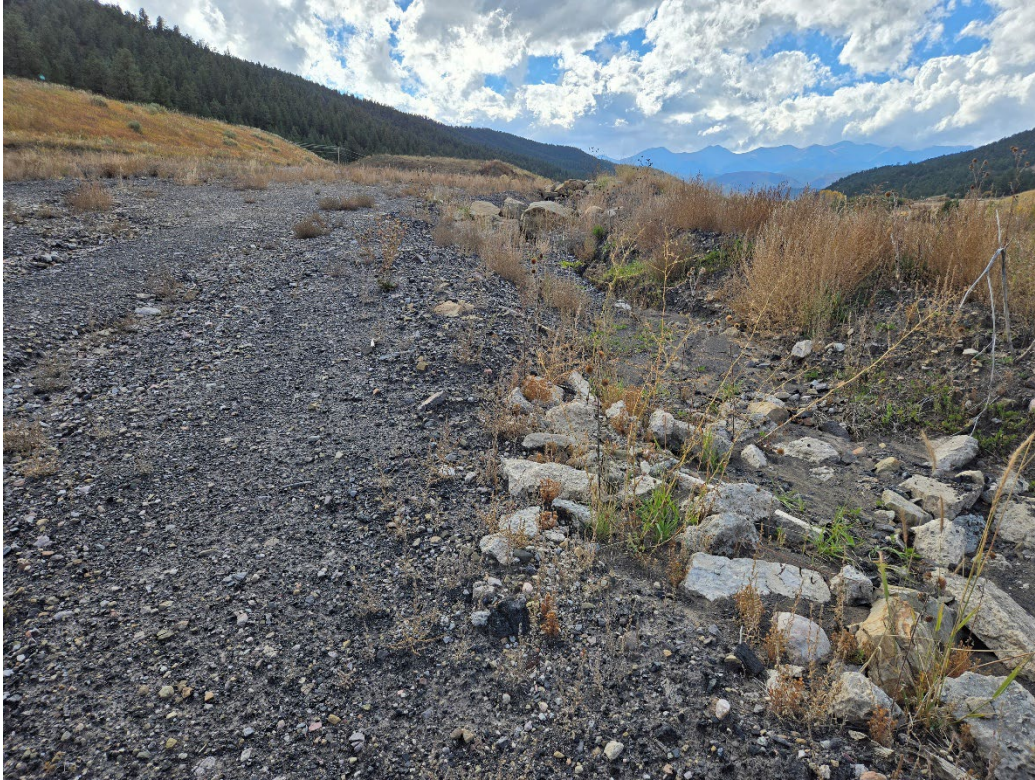
- **OMI:** (October 2024 report) The check dams located along the north side of the Soil Storage Area (in the unnamed ditch around the area) have filled with sediment in some areas, and the sides of the check dams have begun to erode. **The Operator shall clean the check dams and stabilize the erosion.**

Photo 18: Check dams within the soil storage area.

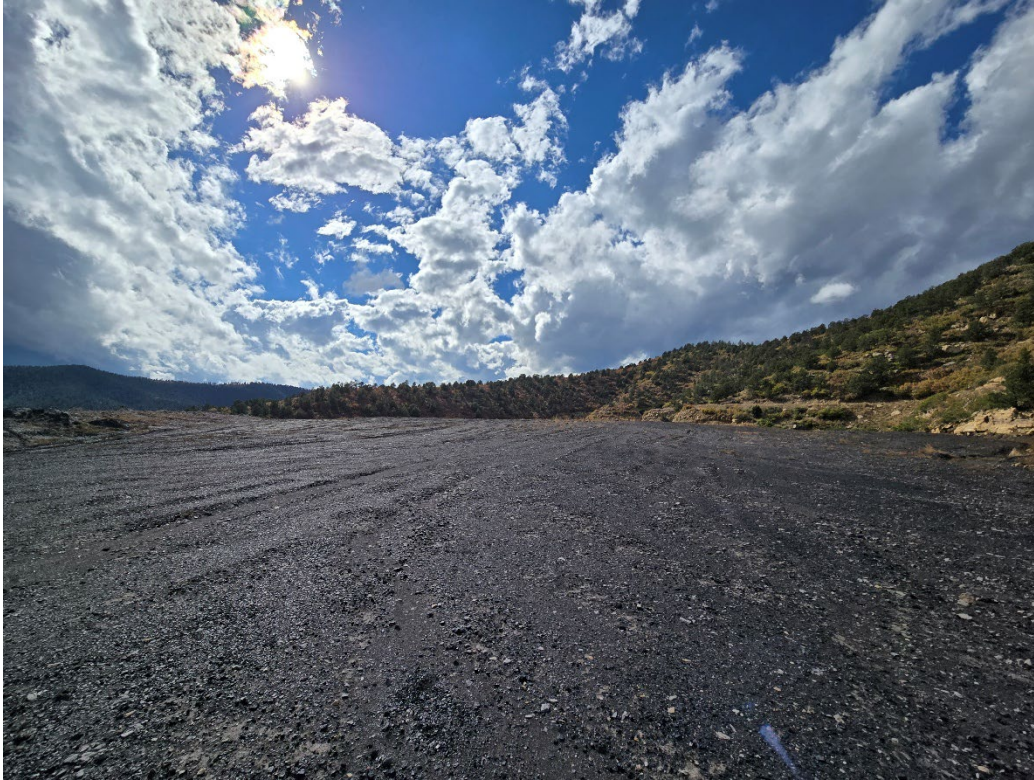
- The top of the RDA is still exhibiting positive drainage to the back and side ditches.

Photo 19: Positive drainage on RDA.

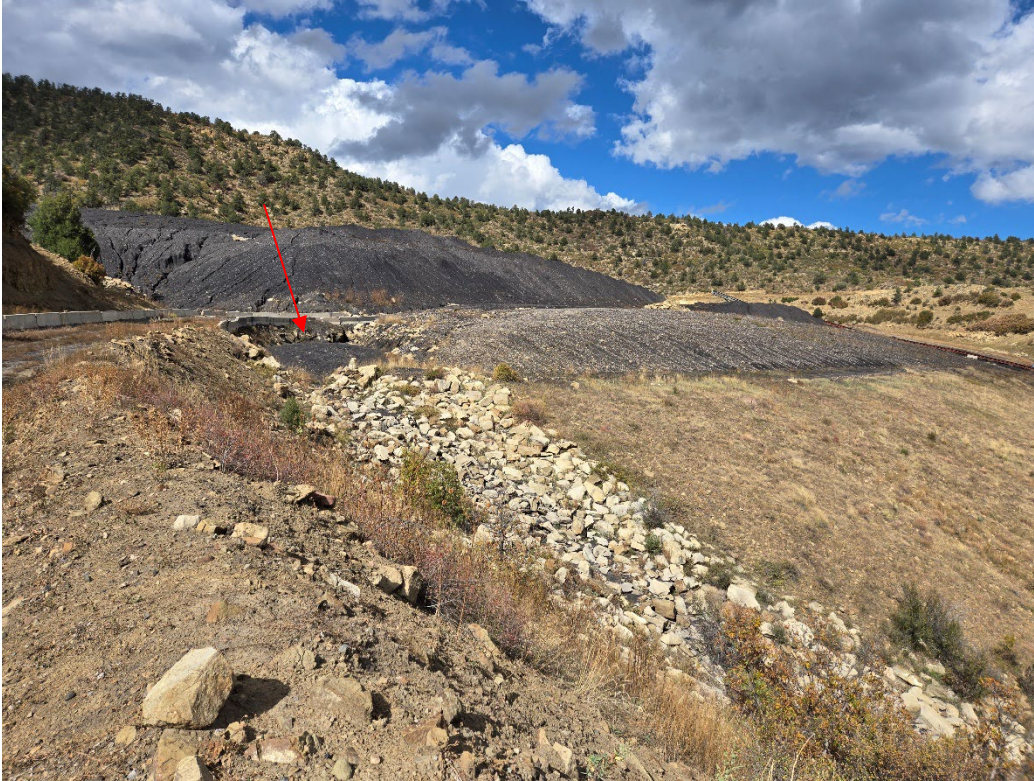
- d. The outlet side of C81 (located on the south side) ~~has been partially filled with sediment.~~
The Operator shall clean sediment out of C81 and from the area around the culvert.
****As of the August 2025 inspection, the outlet side of C81 has been completely covered by sediment.**

Photo 20: Looking east across where the un-reclaimed RDA benches meet the reclaimed benches. The arrow points to the outlet for C81.

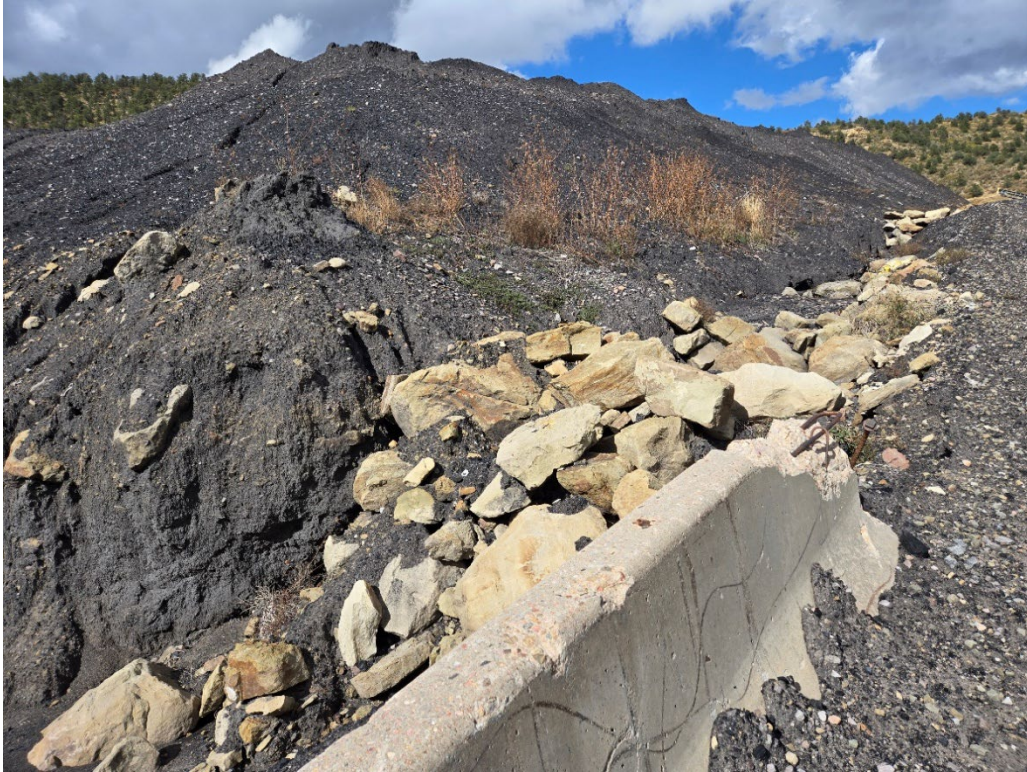
- b. The unnamed ditch east of D55, running along the west side of the RDA contains a few check dams to control run off and reduce erosion along the RDA. The southernmost check dam is damaged and is no longer functioning appropriately. It appears that water has undercut the check dam and has allowed for excess sediment to accumulate at the end of the ditch. **The Operator shall repair the check dam in the unnamed ditch leading to C81.**

- c. There is a culvert (C81) at the end of ditch D55 and the unnamed ditch that allows runoff to flow under the road and out to the ditch leading to Pond 08. ~~The inlet side of C81 (located on the north side) appears to be clear of obstructions at this time.~~ **However, the Operator shall remove some of the sediment that has accumulated in the basin to**

the north of C81 to help minimize the sediment load deposited into Pond 08. **As of the August 2025 inspection, the inlet side of C81 has begun to fill with sediment.

Photo 21. Looking at the damaged and eroded check dams within the ditches that lead to the inlet area for culvert C81.

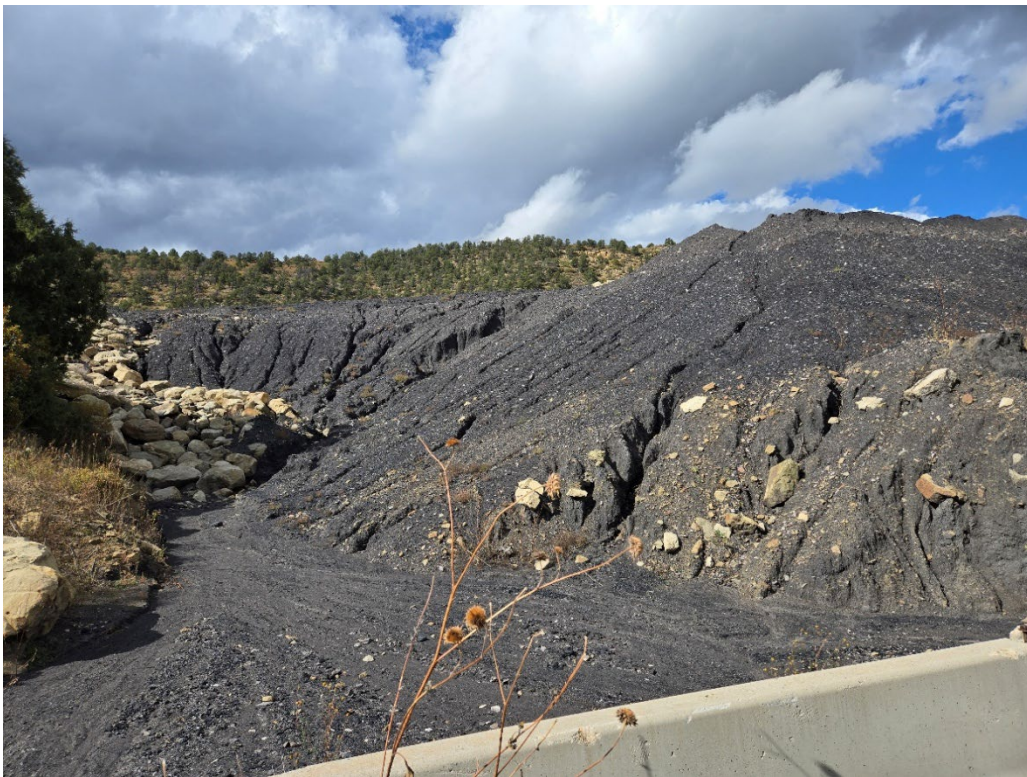
- **OMI:** (December 2024 report) RDA:
 - a. The northernmost bench, before the leveled area at the top of the RDA, has a small ditch that runs east-west toward the drainages on either side of the RDA. The west side of the bench has a check dam to help slow runoff into the area that leads to culvert C81. The check dam appears functional at the end of the ditch, but erosion has cut around on the slope next to the check dam in some areas, leading to increased sedimentation in the basin leading to C81. **The Operator shall implement additional erosion control structures along the west slope of the RDA to help reduce erosion on the slope, and stabilize the eroded slopes.**

Photo 22: Looking north at the excessive erosion on the west side of the RDA slopes.

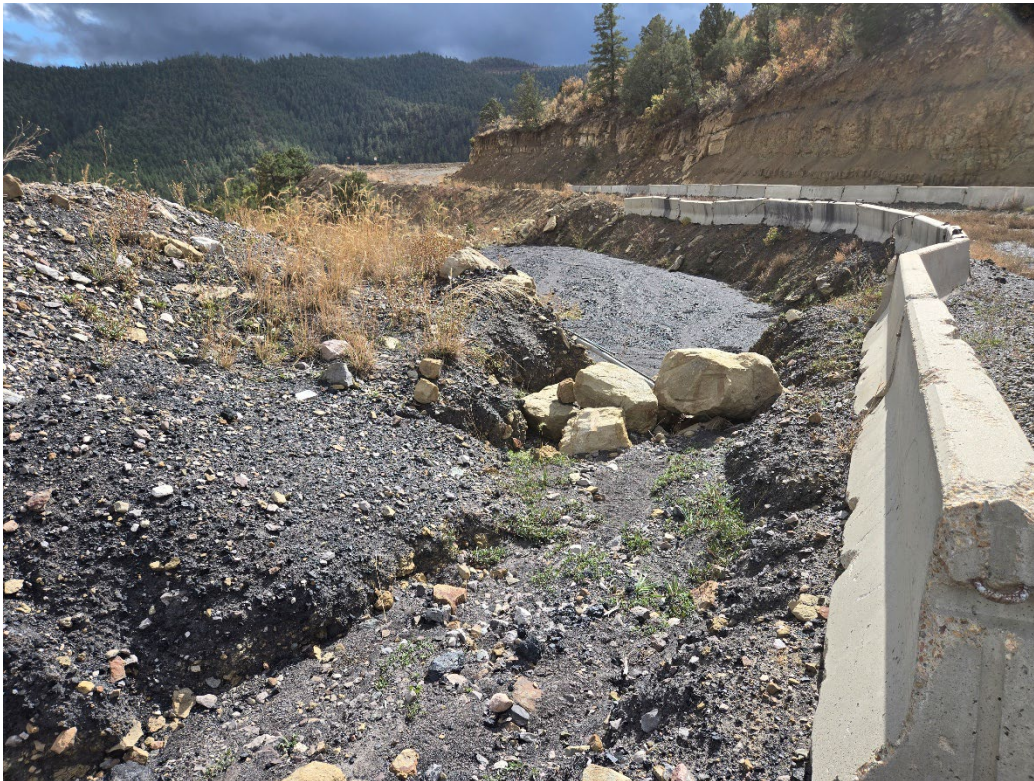
- **OMI:** (March 2025 report)
 - a. Check dams line the north and south side of the road leading to the top of the RDA. These ditches along the road have filled with sediment, and many of the check dams in the ditch need to be repaired. **The Operator will need to clean the sediment from these ditches and repair the check dams.**

Photo 23: Ditch on the south side of the haul road that leads to where the outlet for C81 is located.

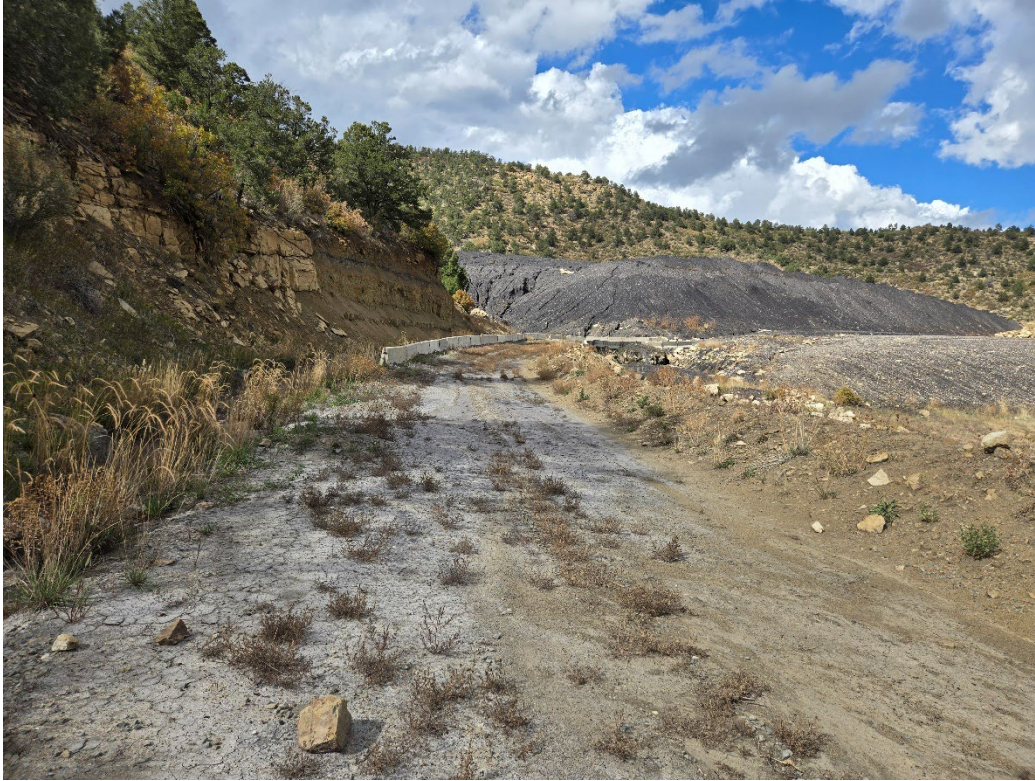
- **OMI:** (September 2025 report) Because the sediment basin leading to C81 has filled with an increased amount of sediment, the ditch on the west side of the haul road has begun to fill with sediment and water. During this inspection, recently deposited fine-grained-grey sediment was observed on the haul road. It appears to have overtopped the ditch where the road bends, and has

spread towards the armored channel that leads to Pond 08. **The Operator shall remove excess sediment from this ditch to ensure areas offsite do not become impacted by sediment generated from stormwater or snowmelt run-off.**

Photo 24: Looking north at the fine-grained grey material deposited on the road from ditch D56.

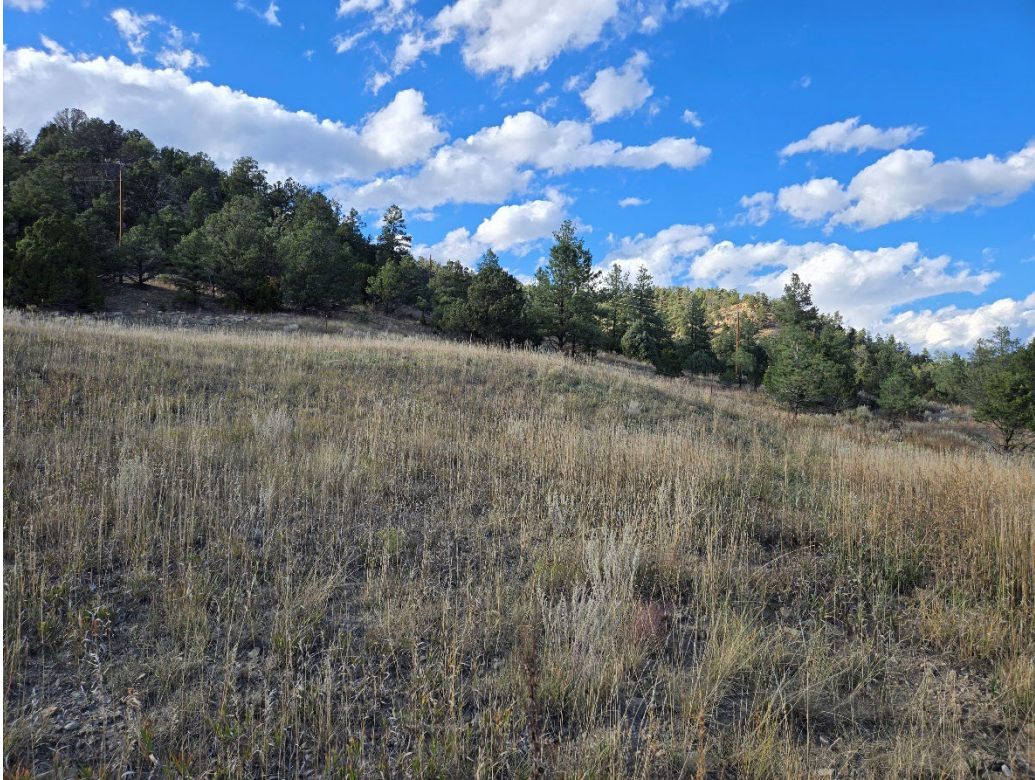
- The vegetation on the Golden Eagle Ventilation Shaft area appears to have returned and stabilized since the Division's December 2024 inspection. However, the Operator is still advised to monitor and assess this area to determine species diversity.

Photo 25: Current revegetation on the Golden Eagle Ventilation Shaft Area.

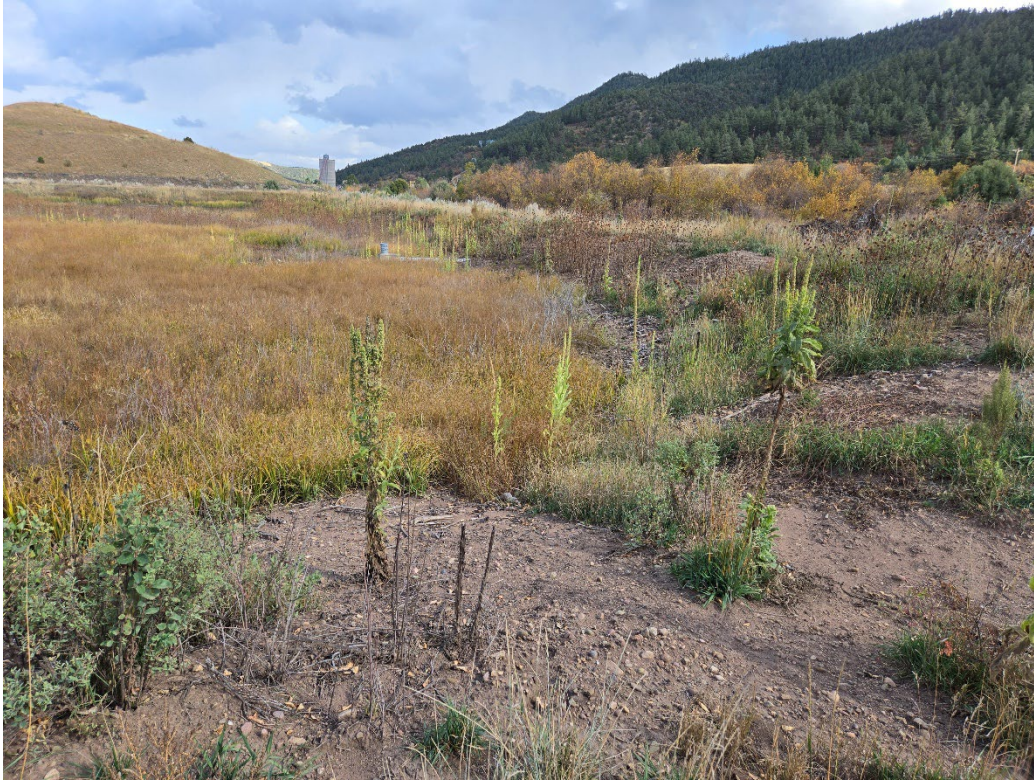
- **OMI:** (July 2024 report) The state listed noxious weed, Mullein, was observed along the light use road leading to the southwest corner of Pond 004. **The Operator shall treat and or remove the Mullein from the area around Pond 004.**
- **OMI:** (August 2025 report) Mullein was observed near the underdrain area in the northwest corner of the RDA. **The Operator shall treat and or remove the Mullein from the area around the underdrains.**

Photo 26: Mullein in the southwest corner of Pond 004a.

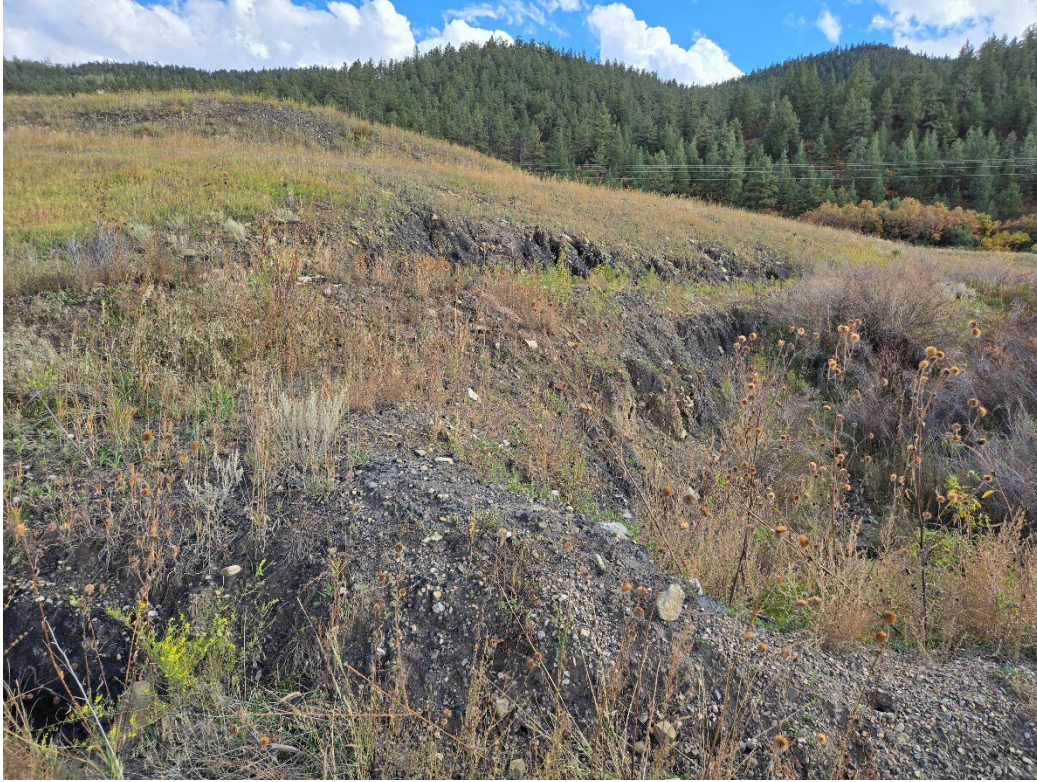
- **OMI:** (September 2023 – December 2024 reports)
During the September 2023 inspection, it was noted that the embankment slope on the northwest side of the Soil Storage Area was eroding and sluffing into the ditch that discharges to ditch D6. NECC was instructed to repair and stabilize the area. The ditch embankment separating the affected land drainage from the adjacent clear water ditch (D7) is very thin in areas. Failure of this embankment may overwhelm the ditch and cause sediment to discharge into the clean water ditch D7 that discharges to the river. During the October 2023 inspection, the Operator stated that they had hydro-mulched the northwest side of the Soil Storage Area in an attempt to stabilize the slope. They also stated that they are unable to safely get equipment in the area to mechanically stabilize the slope and berm separating the treated water run-off from the clean water ditch. NECC had been monitoring this area. As of the December 2024 inspection, it appears that the hydro-mulching and seeding of the bench has failed, as no vegetation appears to have been established. As of the July 2025 inspection, the only vegetation that appears to be establishing is the C-listed noxious weed 'bindweed'. **The Operator shall determine how to re-stabilize this bench and do so as soon as possible. (July 2025) The Operator shall also treat and remove the bindweed in this area.**

Photo 27: Looking southeast at the berm dividing the clean diverted surface water (D7) from the water contacting disturbed areas (ditch that discharges into D6). The right side has bindweed growth.

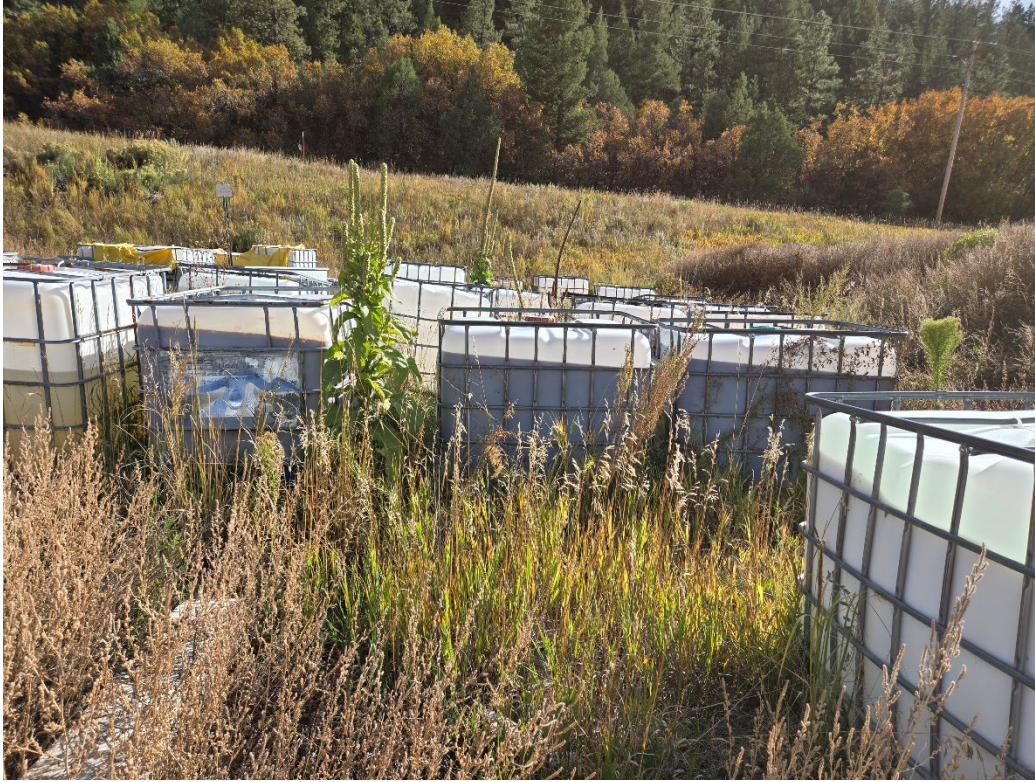
- **OMI:** (December 2024 report) The Portable Explosives and Chemical Storage area was overall stable. However, the Division observed an empty tank in the ditch to the east of the storage area. **The Operator shall remove the tank from the ditch.**

Photo 28: Tanks within the Chemical Storage area.

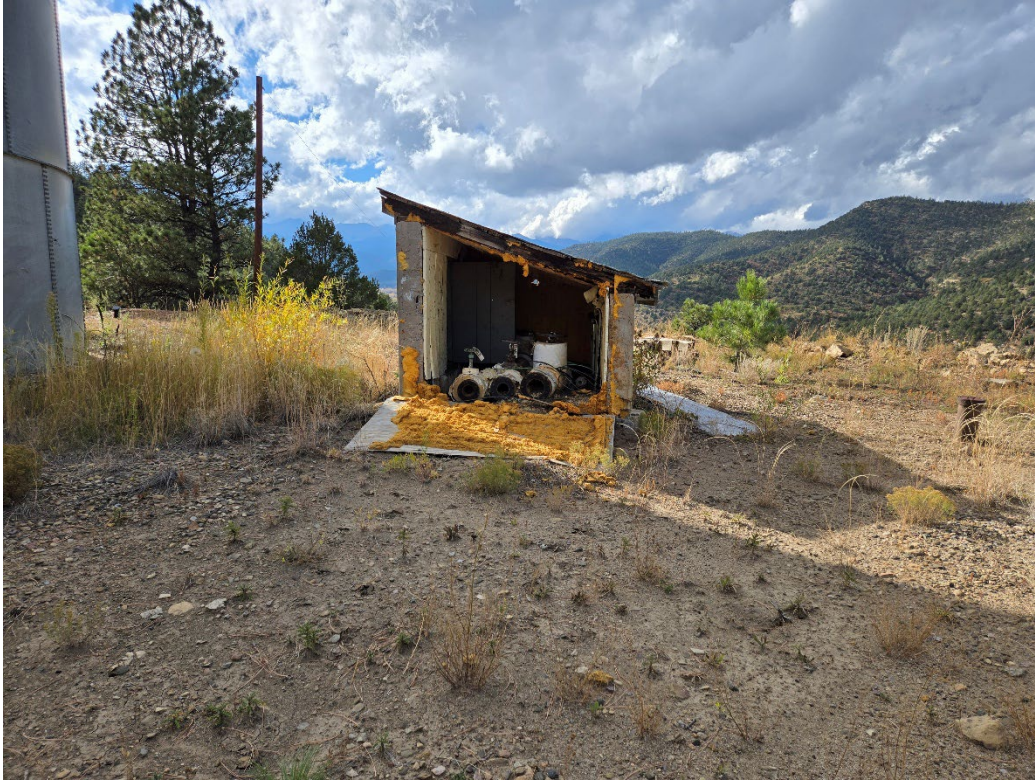
- **OMI:** (October 2024 report) During the Division's September 2024 inspection, a few barrels were observed along the west side of the wash plant building, within the raw coal storage area. One of the barrels had fallen over, and its liquid contents have spilled onto the ground next to the wash plant building. The Division believes the spilt material to be rusty stormwater. The Division observed the overturned barrel again during the October inspection and has not yet received confirmation that the spill has been cleaned. **The Operator shall provide evidence to the Division that the spill has been cleaned.**
- **OMI:** (December 2024 report) The water pump/valve cover structure near the water tanks on the south side of the permit has been damaged. **The Operator shall repair, replace, or remove this structure.**

Photo 29: Damaged water pump/valve cover structure.

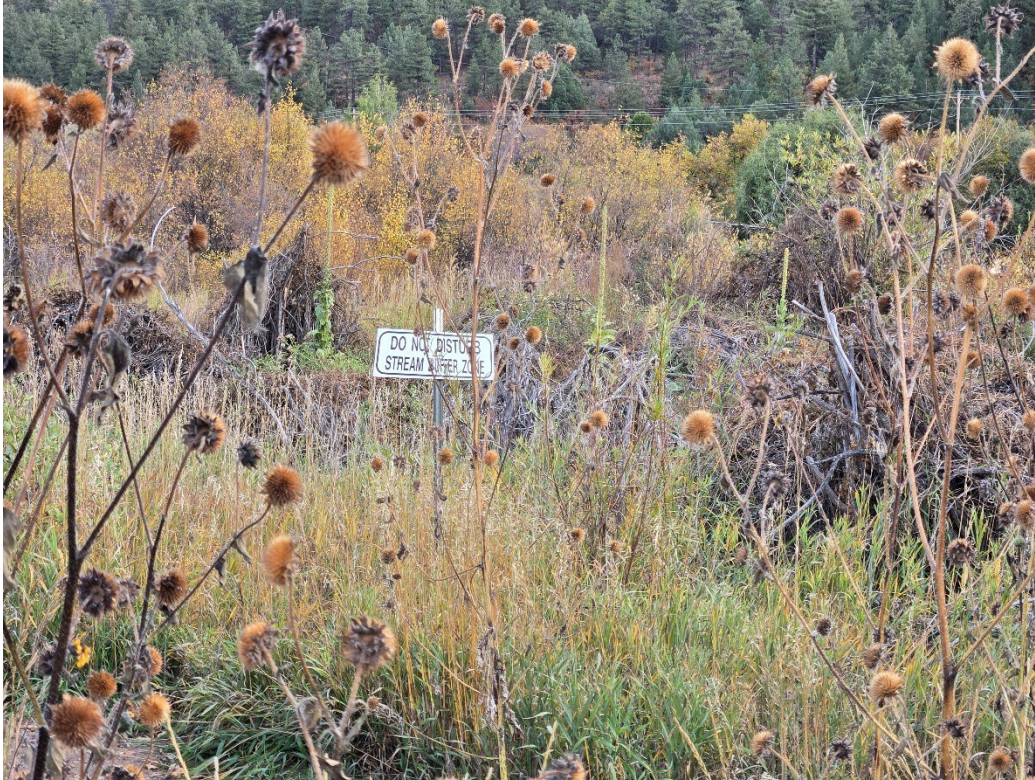
- Stream buffer zone markers were observed in place in compliance with Rule 4.02.5.
- Mine signs were observed at the main entrance to the New Elk mine site and around the permit boundary.
- **OMI:** (December 2024 report) Jansen Loadout:
 - a. The mine sign is no longer posted at the Jansen Loadout. Therefore, **the Operators shall post a new sign at the Jansen Loadout to comply with the requirements of Rule 4.02.**
 - b. **Once an Operator for the New Elk permits is restored, they will need to clarify to the Division through a revision, the operational status of the Jansen Loadout in regard to the mining operation.**

Photo 30: Stream buffer zone sign posted near Pond 004a.

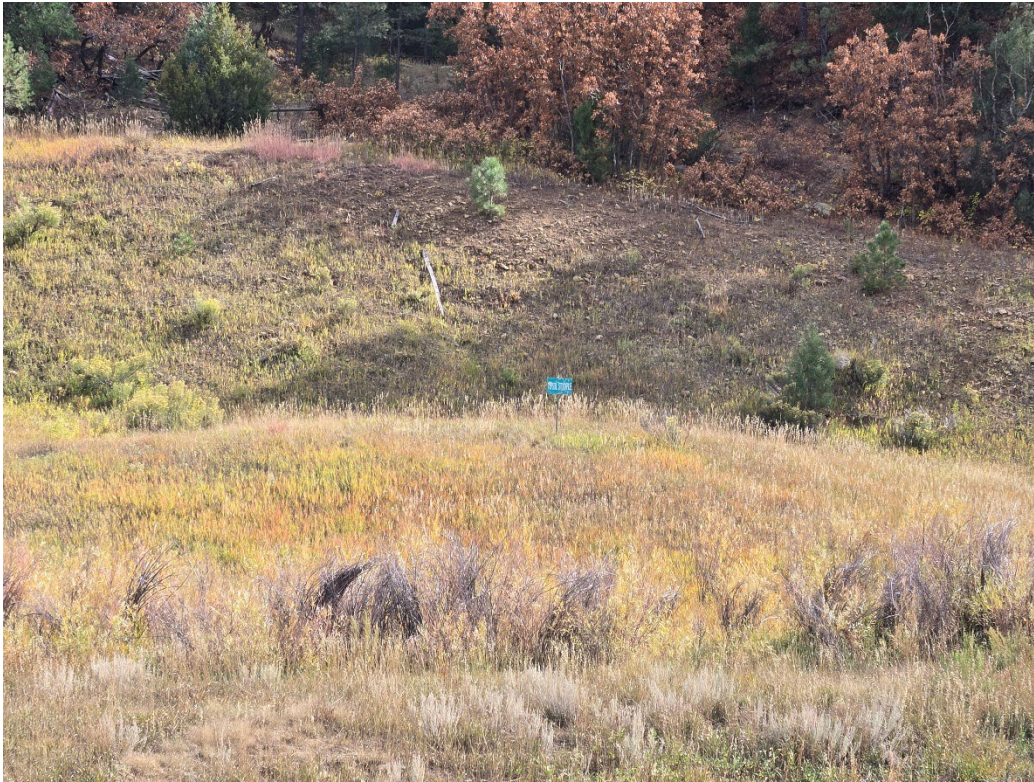
- Signs reading “Topsoil” were posted at topsoil piles #1-#3 and the new pile located near #1 in compliance with Rule 4.02.7.

Photo 31: Topsoil pile #1 with sign.
