Division of Reclamation,
Mining and Safety

PERMIT INFORMATION

Permit Number: C-1981-012 Mine Name: New Elk Mine Operator: New Elk Coal Company, LLC Operator Address: 12250 Highway 12 Weston, CO 81091	County: Las Animas Operation Type: Underground Permit Status: Suspended Ownership: Private
	Operator Representative Present: None
Operator Representative Signature: (Field Issuance Only)

Inspection Start Date: October 14, 2025 Inspection Start Time: 14:20 Inspection End Date: October 14, 2025 Inspection End Time: 17:08	Inspection Type: Coal Complete Inspection Inspection Reason: Normal I&E Program Weather: Cloudy
Joint Inspection Agency: None	Joint Inspection Contacts:
Post Inspection Agency: None	Post Inspection Contacts:
Inspector(s): Amber M. Gibson	Inspector's Signature:

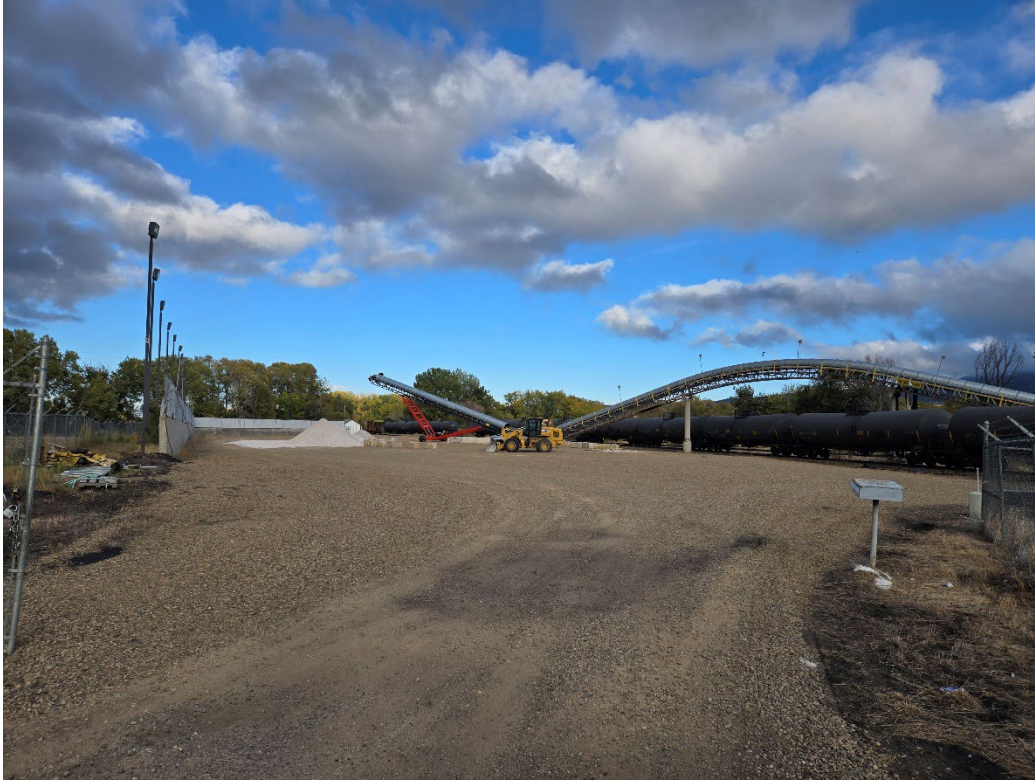
- The facilities at the Jansen Loadout were observed. All equipment on-site appears to be stable at the time of the inspection. It appeared that many portions of the conveyor system have been replaced with new parts. On the day of the inspection, the loadout appeared to be in use by a separate entity. The right of entry issues at this loadout will be addressed when there is a new Permittee in place.

Photo 32: Jansen Loadout being utilized by a separate entity on the day of the inspection.
