## MINERALS PROGRAM INSPECTION REPORT

| <b>MINE NAME:</b><br>Brent Pit | <b>MINE/PROSPECTING ID#:</b><br>M-2019-032 | <b>MINERAL:</b><br>Borrow material for | <b>COUNTY:</b><br>Lincoln |
| <b>INSPECTION TYPE:</b><br>Monitoring | <b>WEATHER:</b> Clear | <b>INSP. DATE:</b><br>October 22, 2025 | <b>INSP. TIME:</b><br>12:00 |

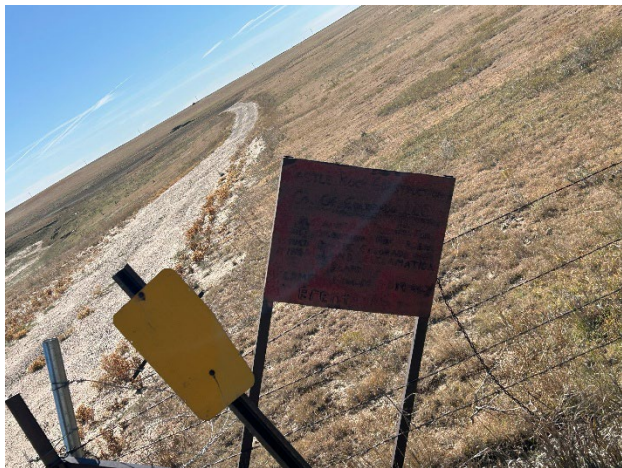
At the time of inspection the mine ID sign and boundary markers were all present and in adequate condition. Reclamation is currently underway, and according to the operator reseeding activity had taken place two weeks prior to this inspection. Evidence of recent drill seeding was observed, and the site had already been regraded.

Photo 1: Posted mine sign.

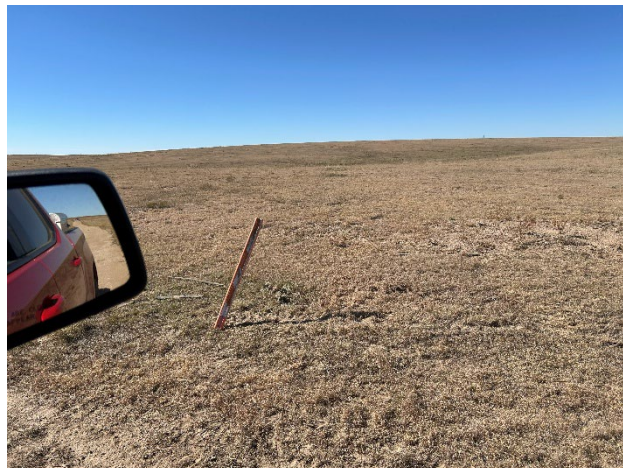
Photo 2: Western site boundary marker.

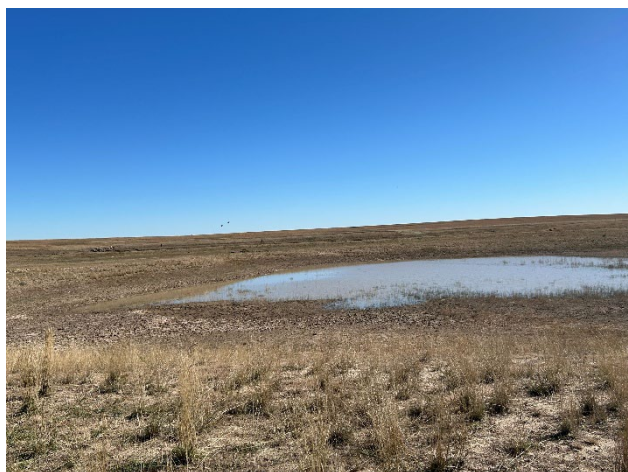
**PROBLEM/POSSIBLE VIOLATION:** Problem: The site is improperly impounding surface drainage/runoff.

No topsoil piles were observed due to the site being in reclamation. A significant amount of standing water was present in the pit, which is likely due to significant recent rainfall. No typical water plants (reeds, cattails, etc.) were observed and it is unlikely that this site is exposing groundwater. Still, a significant amount of water was held at the time of inspection. As such, please provide photographic evidence of the dry pit within 60 days of receipt of this report. As no previous evidence of improper runoff impounding has been observed, no further action will be taken beyond the request previously mentioned.

Photo 3: Pit floor shown, with reclaimed slopes shown.

**CORRECTIVE ACTIONS:** Please submit photo evidence that the pit floor dries completely through photographic evidence of the pit floor without ponded water.

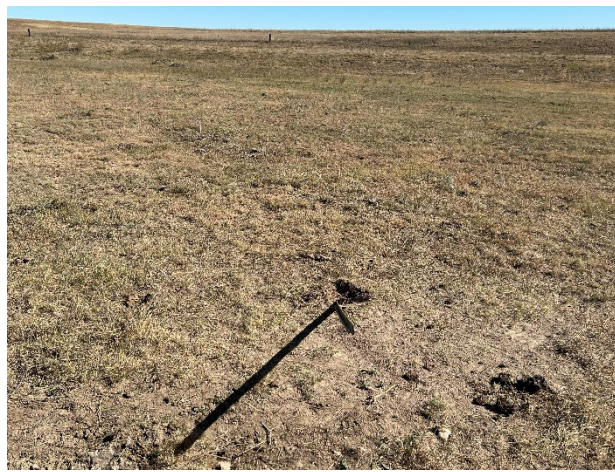
Photo 4: Damaged southern boundary marker, which was repaired during the inspection.
