**MINERALS PROGRAM INSPECTION REPORT**  
**PHONE: (303) 866-3567**

| <b>MINE NAME:</b><br>Nestor Pit | <b>MINE/PROSPECTING ID#:</b><br>M-2021-033 | <b>MINERAL:</b><br>Borrow material for | <b>COUNTY:</b><br>Lincoln |
| <b>INSPECTION TYPE:</b><br>Monitoring | <b>WEATHER:</b> Clear | <b>INSP. DATE:</b><br>October 22, 2025 | <b>INSP. TIME:</b><br>11:00 |

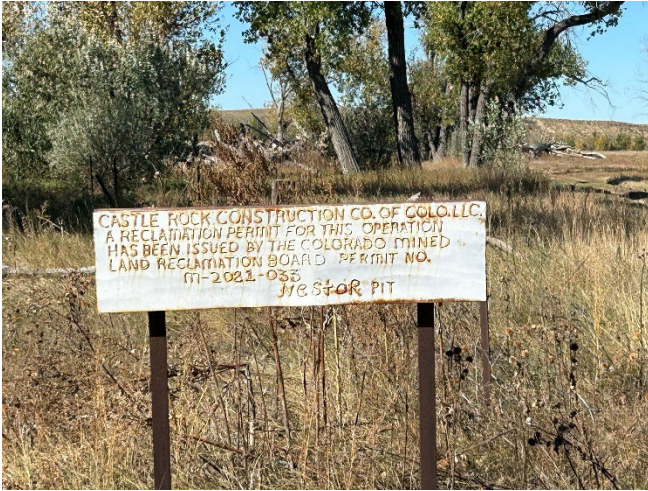
Photo 1: Posted mine sign.

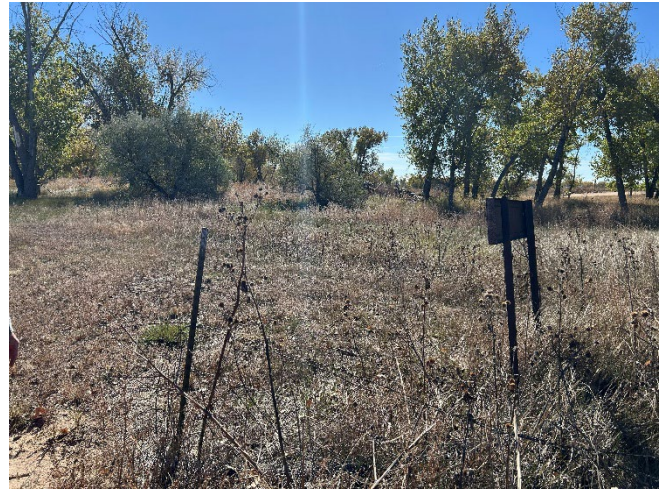
Photo 2: Boundary marker located near ID sign and site entrance.

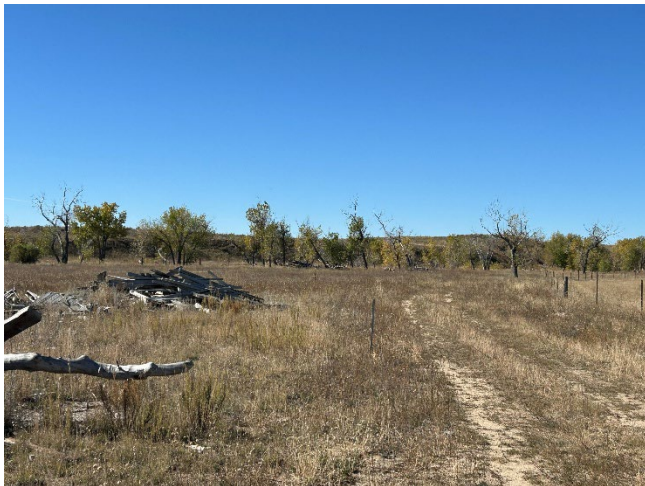
Photo 3: Northern site boundary marker.

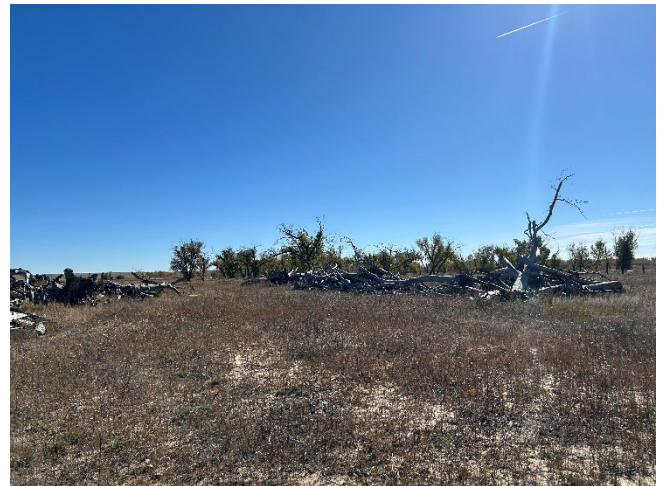
Little evidence of mining remains at this site. The mine sign and boundary markers are present, but otherwise the site is functionally indistinguishable from the surrounding grazing land. Some roadways are still present at the request of the landowner, but otherwise no significant signs of disturbance remain. Vegetation cover appears fairly complete, and this site would generally be releasable if a request was submitted during the spring.

Photo 4: Reclaimed site. Flotsam shown was placed by landowner.
