## Weber Pit No.2- Inspection Report and Cost Estimate

**MINERALS PROGRAM INSPECTION REPORT**  
**PHONE: (303) 866-3567**

| <b>MINE NAME:</b><br>Weber Pit No. 2 | <b>MINE/PROSPECTING ID#:</b><br>M-1995-056 | <b>MINERAL:</b><br>Sand and gravel | <b>COUNTY:</b><br>Archuleta |

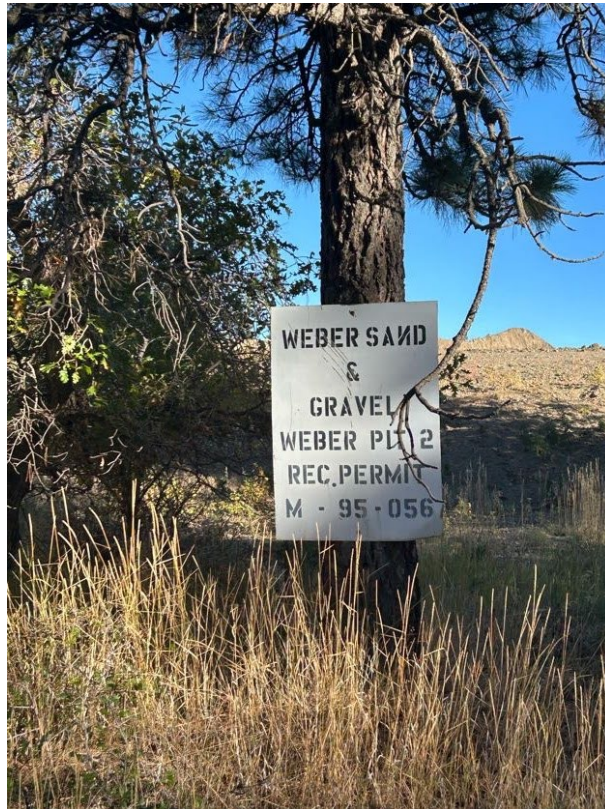
A mine identification sign was located at the entrance to the site in compliance with Rule 3.1.12 (see Photo 1). The site is located approximately 3 miles northeast of Pagosa Springs, CO. The site is accessed from the south using a gate from an access road off US Highway 160. The approved post-mining land use is rangeland.

Photo 1: Mine permit entrance sign.

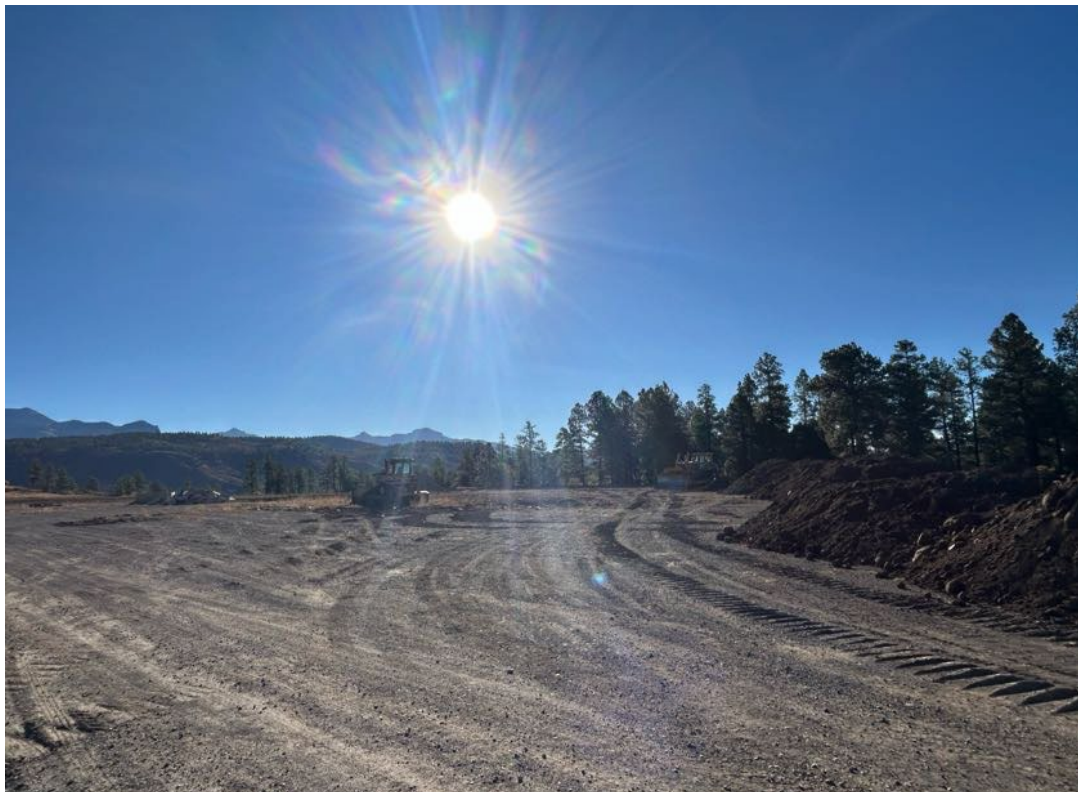
Photo 2: View of Phase 1 and 2 area, two bulldozer, and the spreading of topsoil. Facing east.

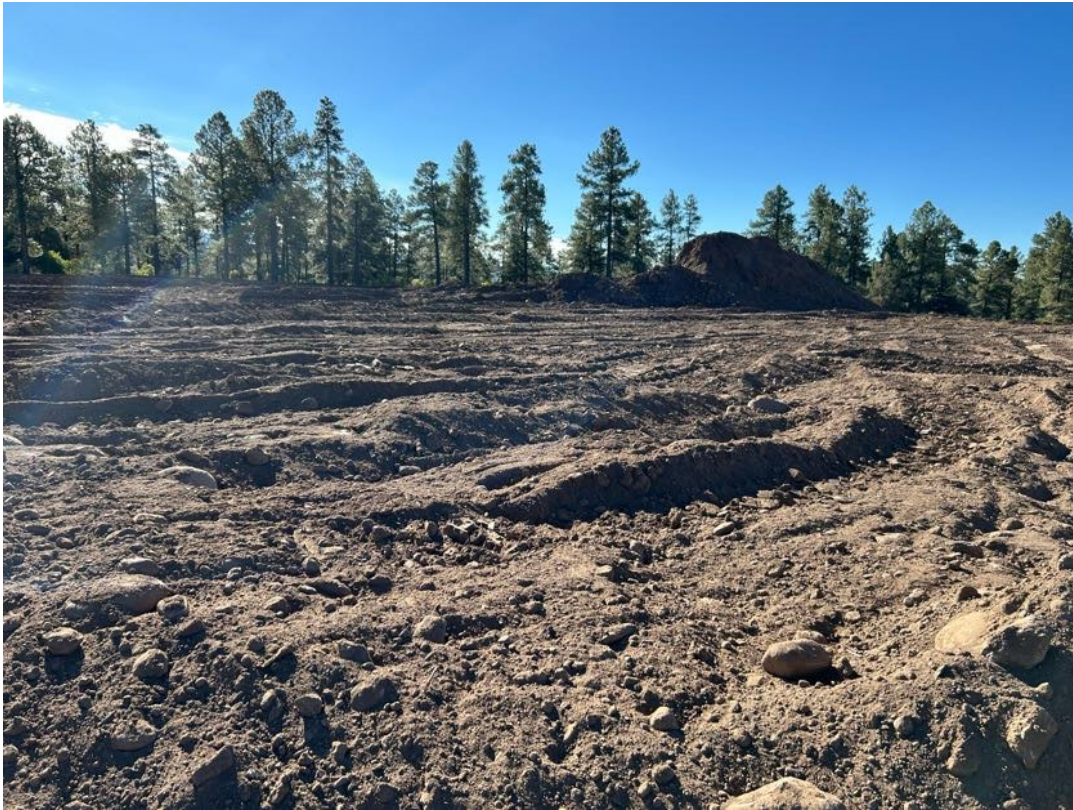
acres. The Phase 3 area is located to the south and consists of 63.70 acres. During the inspection, the Operator indicated they are currently reclaiming the entire site. Topsoil has been spread across most of the affected land in the Phase 1 and 2 areas (see Photos 3-4). The Operator indicated that topsoil has been spread in the last few weeks. The Phase 2 area maintained a slope along the northern permit boundary, which has been graded to a 3:1 horizontal to vertical configuration and showed no evidence of erosional problems (see Photos 4-5, 7). No additional grading of the former pit slope will be necessary to achieve final grade for reclamation. During the inspection, several deer were observed along the pit slope. A small portion of the pit slope, less than 1 acre, has been seeded and appears to have well-established vegetation (see Photos 5 and 7). The Operator indicated that seeding will be conducted in early November, as well as the application of straw. Several types of earthwork equipment were observed in the area, including dozers, grader, haul trucks, an excavator, and a grizzly screener (see Photo 2). Annual weeds were observed within the permit area, and no noxious weeds were observed. No problems were noted with the Phase 1 and 2 areas. Affected area boundary markers were present in the form of t-posts in the Phase 1 and 2 areas.

Photo 3: View of a topsoil stockpile and topsoil being spread in the Phase 1 and 2 areas, facing south.

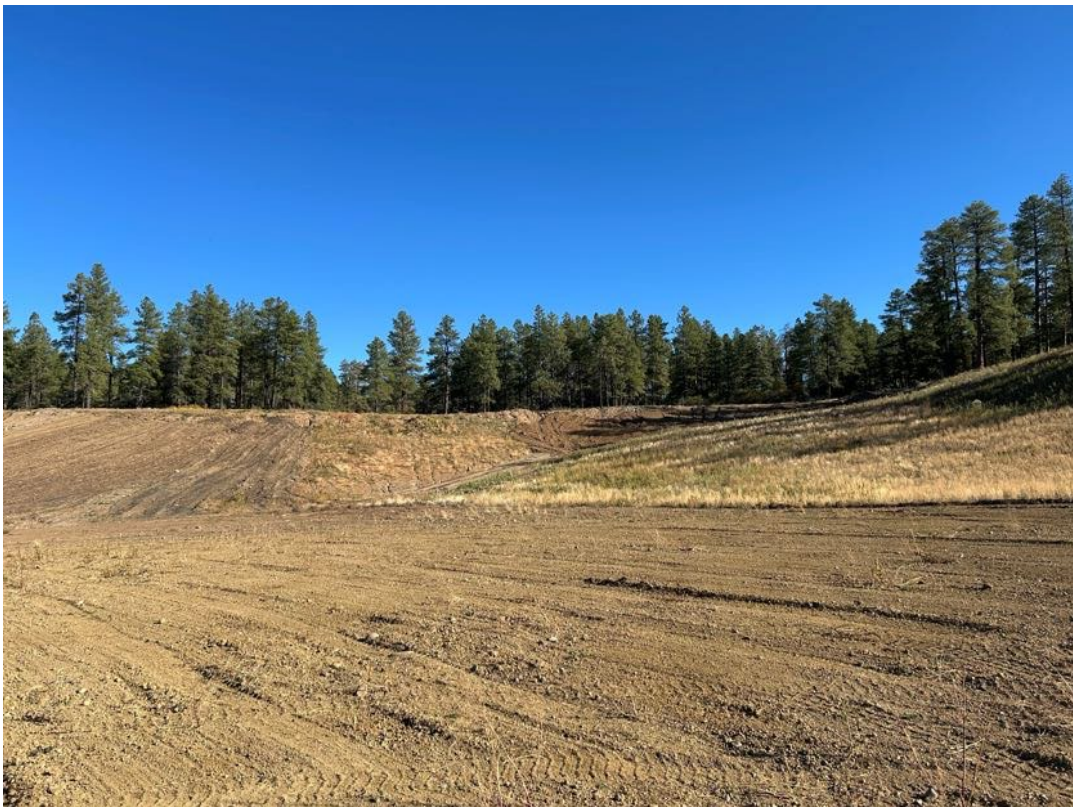
Photo 4: View of the graded pit slope at a 3:1 configuration, facing north.

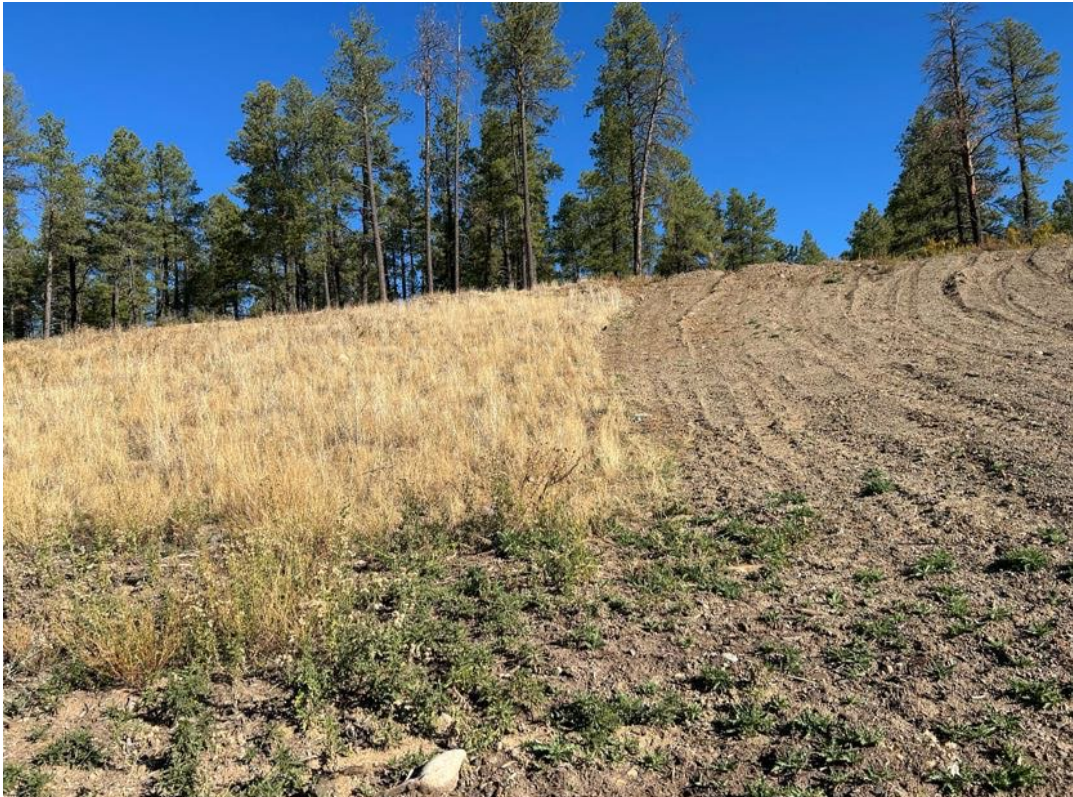
Photo 5: View of the pit slope where the slope has been seeded to the left, facing north.

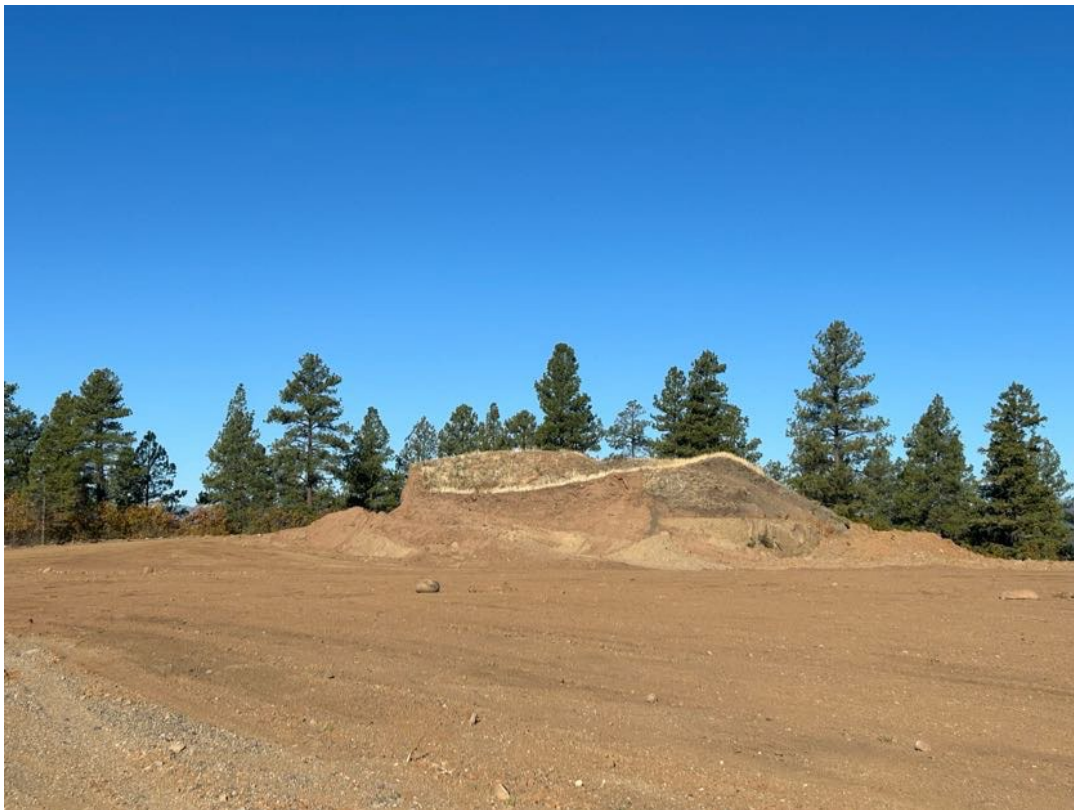
There was a stockpile of mined material along the Phase 1 western permit boundary corner, and a small pile of concrete was also observed (see Photos 6-7). The Operator stated that both stockpiles of material will be hauled offsite. During the inspection it was discussed that there is a dispute between the Operator and PAWSD and/or SJWCD regarding the terms of a sale agreement for the mined product. This issue is outside of the Division's jurisdiction.

Photo 6: View of a stockpile of mined material in the western corner of the Phase 1 Area, facing west.

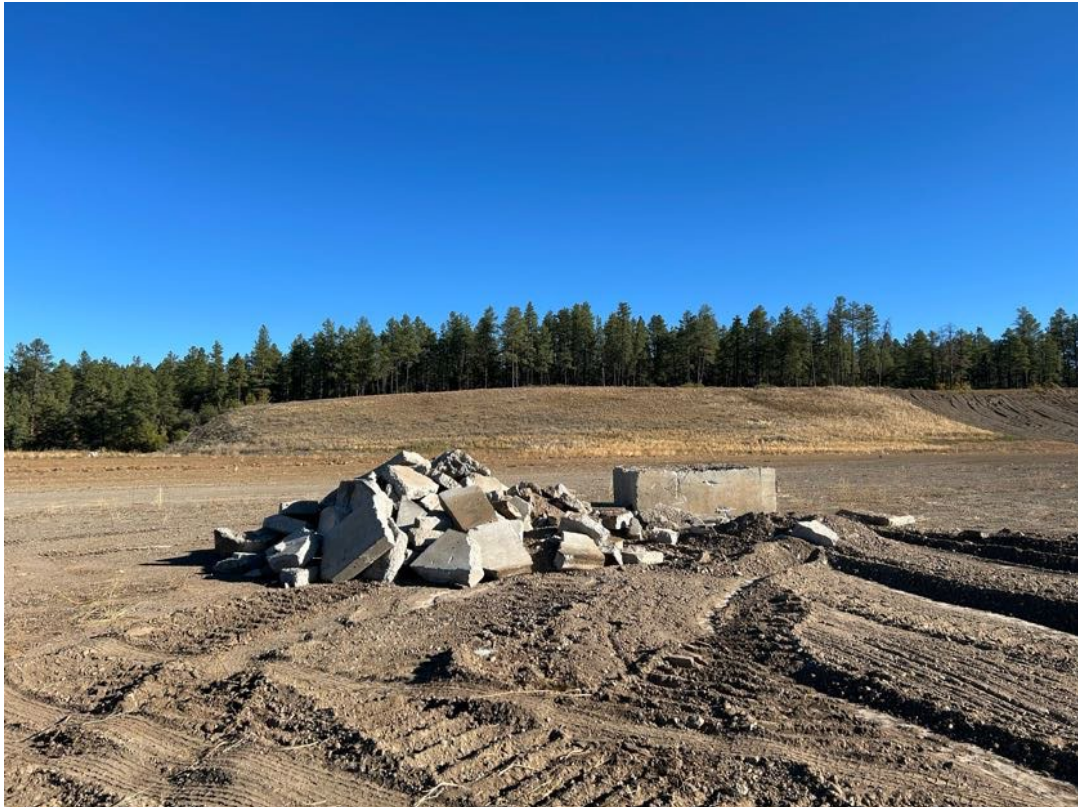
Photo 7: View of a pile of concrete, as well as the portion of the pit slope that has been revegetated facing north.

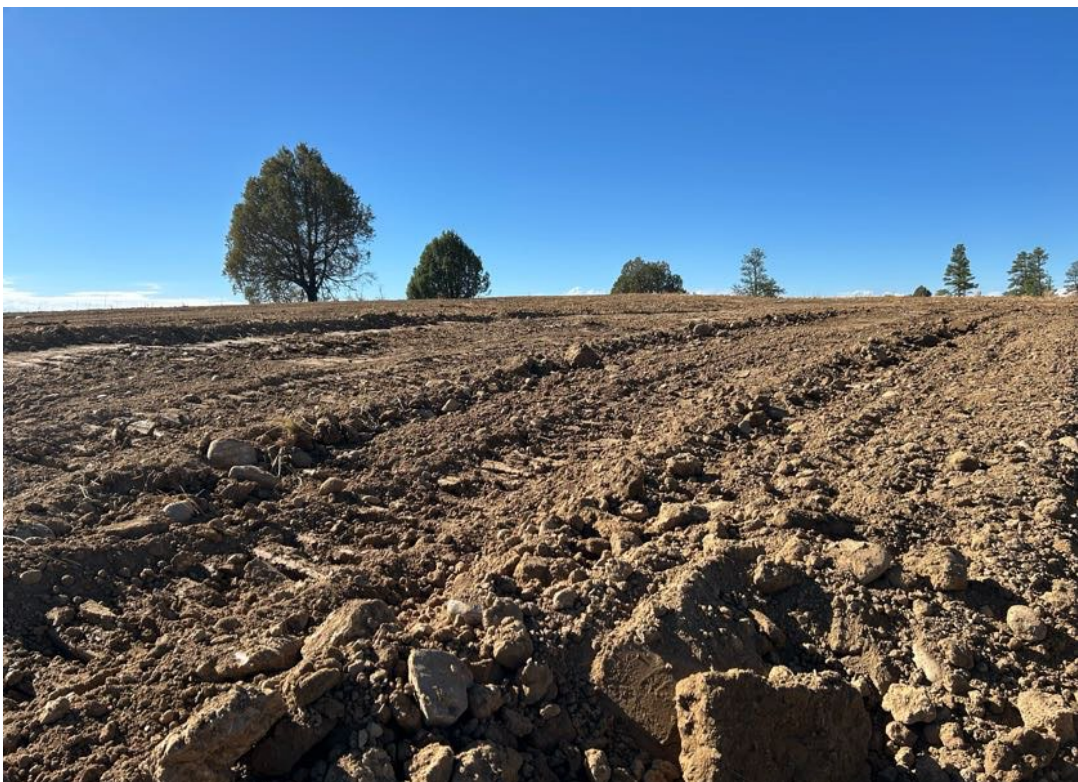
Photo 8: View of spread topsoil within the Phase 3 area, facing south.

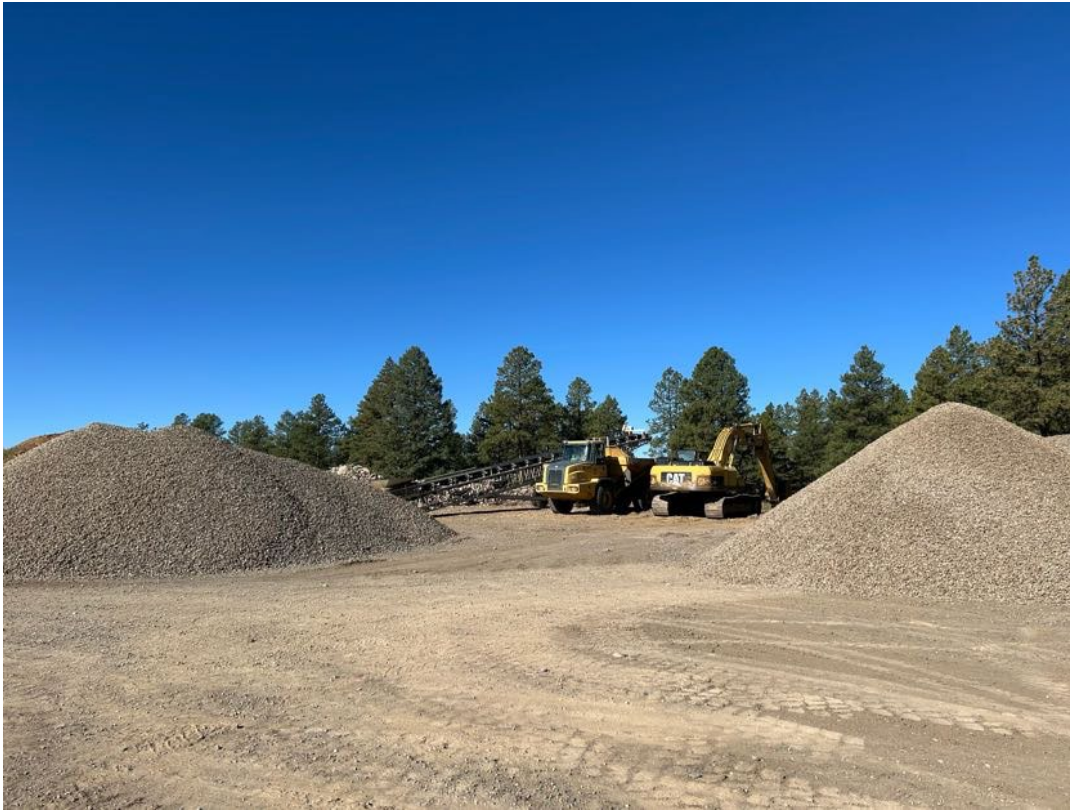
Photo 9: View of stockpiles of mined material and equipment within the Phase 3 area, facing west.

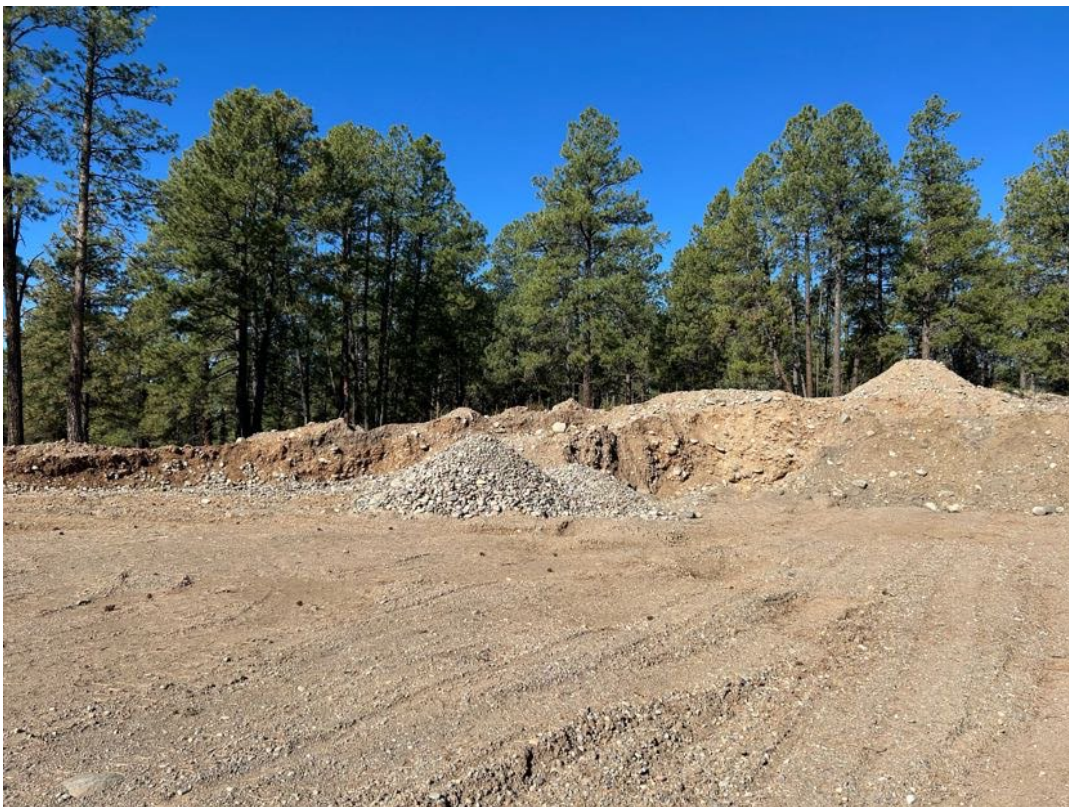
Photo 10: View of a stockpiled material on the north edge of the affected area boundary within the Phase 3 area, facing west.

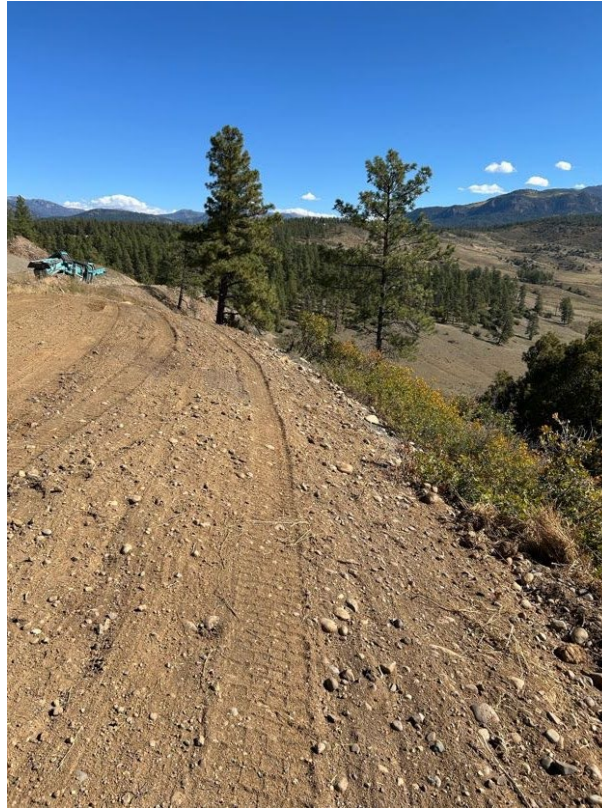
**PROBLEM:** Land may have been affected outside of the approved affected area boundary and permit boundary.

the Operator may have affected land outside of the approved affected area boundary (see Photo 11 and Figure 1). This issue is cited as a problem. The Operator shall conduct a survey of the current affected land. In addition, the Operator will resurvey the permit boundary and the approved affected area boundary as designated in AM-1. The Operator will subsequently replace the affected area boundary markers in the correct locations.

Photo 11: View affected land potentially outside of the approved affected area boundary on the east side within the Phase 3 area, facing north.

**CORRECTIVE ACTIONS:** The Operator shall conduct a survey of the current affected land, the Amendment Application (AM-1) permit boundary, and the approved affected area boundary. Please provide documentation when the survey is complete, this shall include a map depicting the approved permit boundary, affected area boundary, and the actual affected land that conforms to the map requirements of Rule 6.2.1(2).

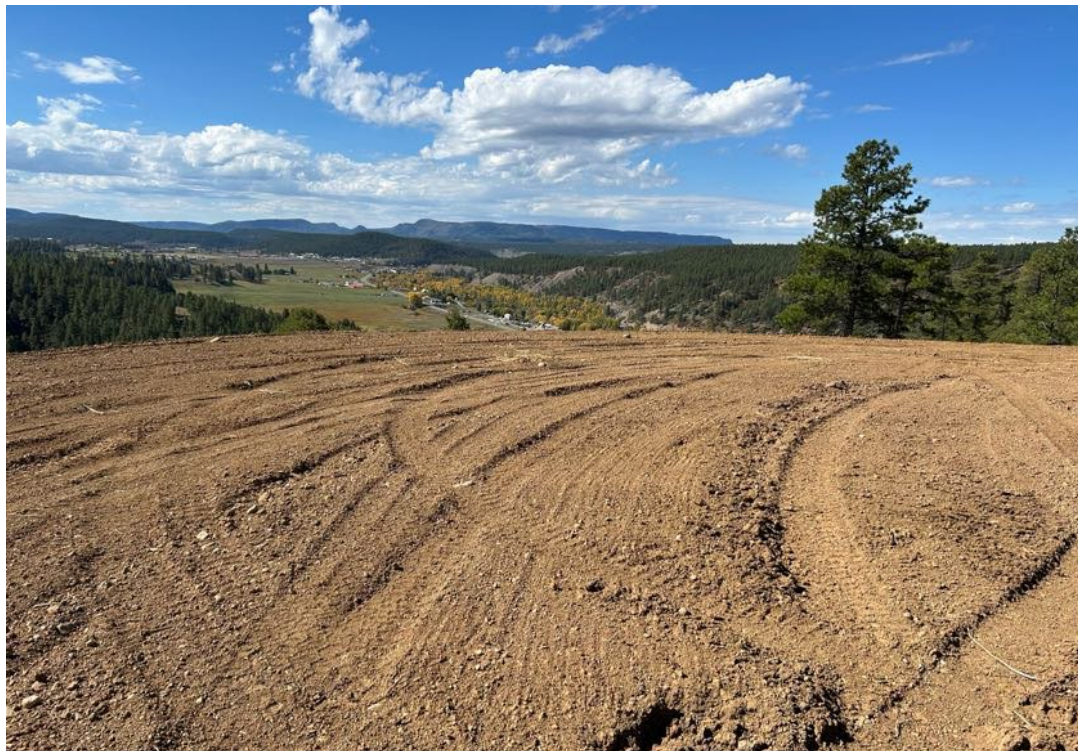
Upon inspection of the southern end of the Phase 3 area, land has been affected, and topsoil has been spread to the very edge of the hill of the Phase 3 Area. Using ArcGIS Field Maps, DRMS collected an extent of where the land has been affected, and the topsoil has been spread in the Phase 3 area and compared it to the permit boundary and affected area boundary in the updated mining plan map submitted in AM-1. Based on the polygon measurement collected by the DRMS, the Operator may have affected land outside of the approved affected area boundary on the south side (see Photos 12-14 and Figure 1). Along the eastern side of the area,

Photo 12: View of affected land potentially outside on the approved affected area boundary on the southern toe of the Phase 3 area, facing south.

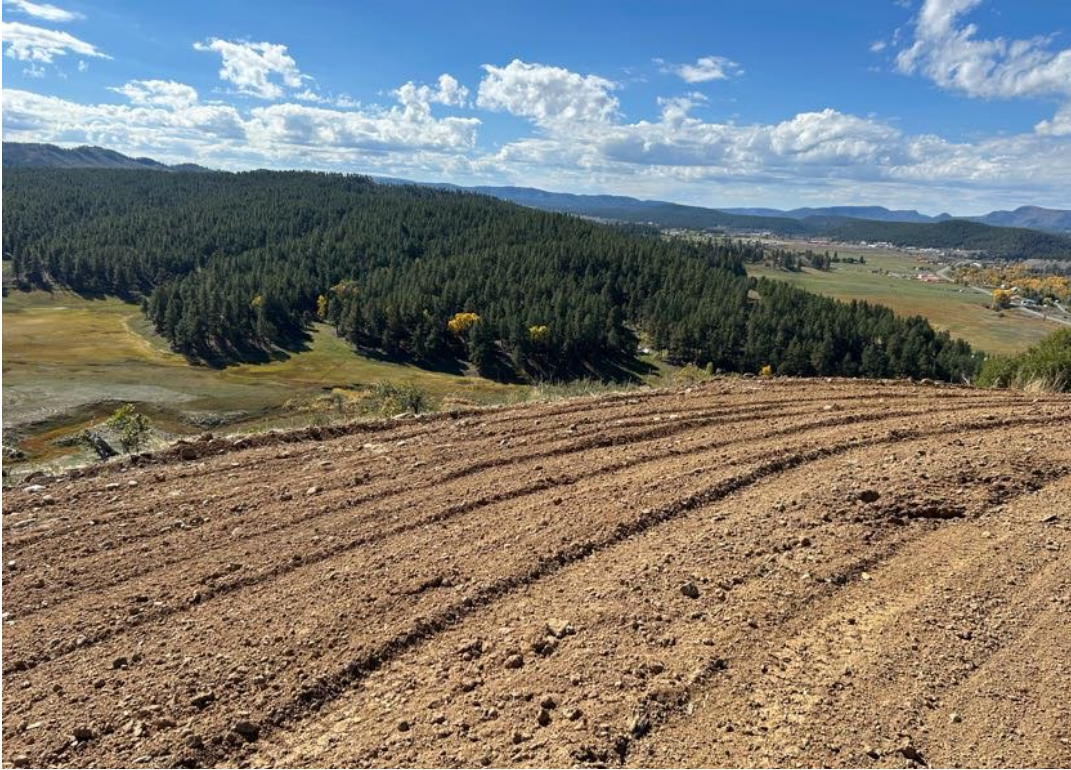
Photo 13: View of affected land potentially outside on the approved affected area boundary on the southern toe of the Phase 3 area, facing southeast.

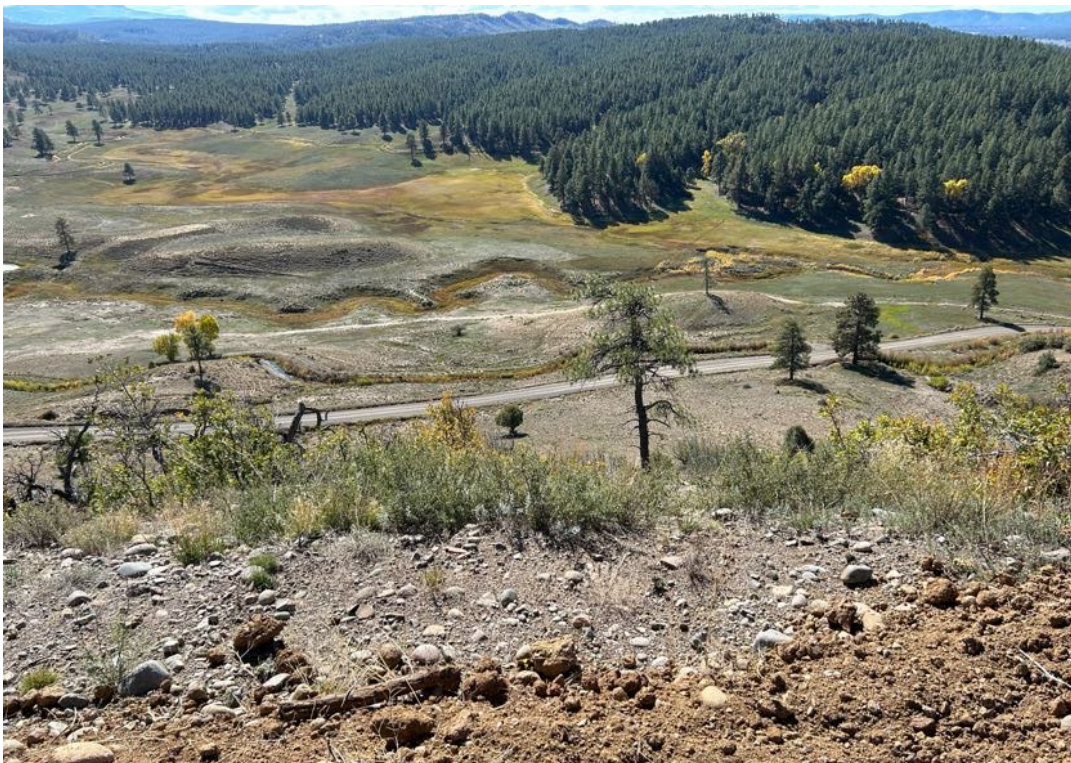
Photo 14: View of affected land potentially outside on the approved affected area boundary and permit boundary on the southern toe of the Phase 3 area, facing southeast.
