**MINERALS PROGRAM INSPECTION REPORT**  
**PHONE: (303) 866-3567**

| <b>MINE NAME:</b><br>Stout - Amick Pit | <b>MINE/PROSPECTING ID#:</b><br>M-1981-275 | <b>MINERAL:</b><br>Sand and gravel | <b>COUNTY:</b><br>Rio Blanco |
| <b>INSPECTION TYPE:</b><br>Surety Release Inspection | <b>WEATHER:</b><br>Clear | <b>INSP. DATE:</b><br>October 28, 2025 | <b>INSP. TIME:</b><br>10:00 |

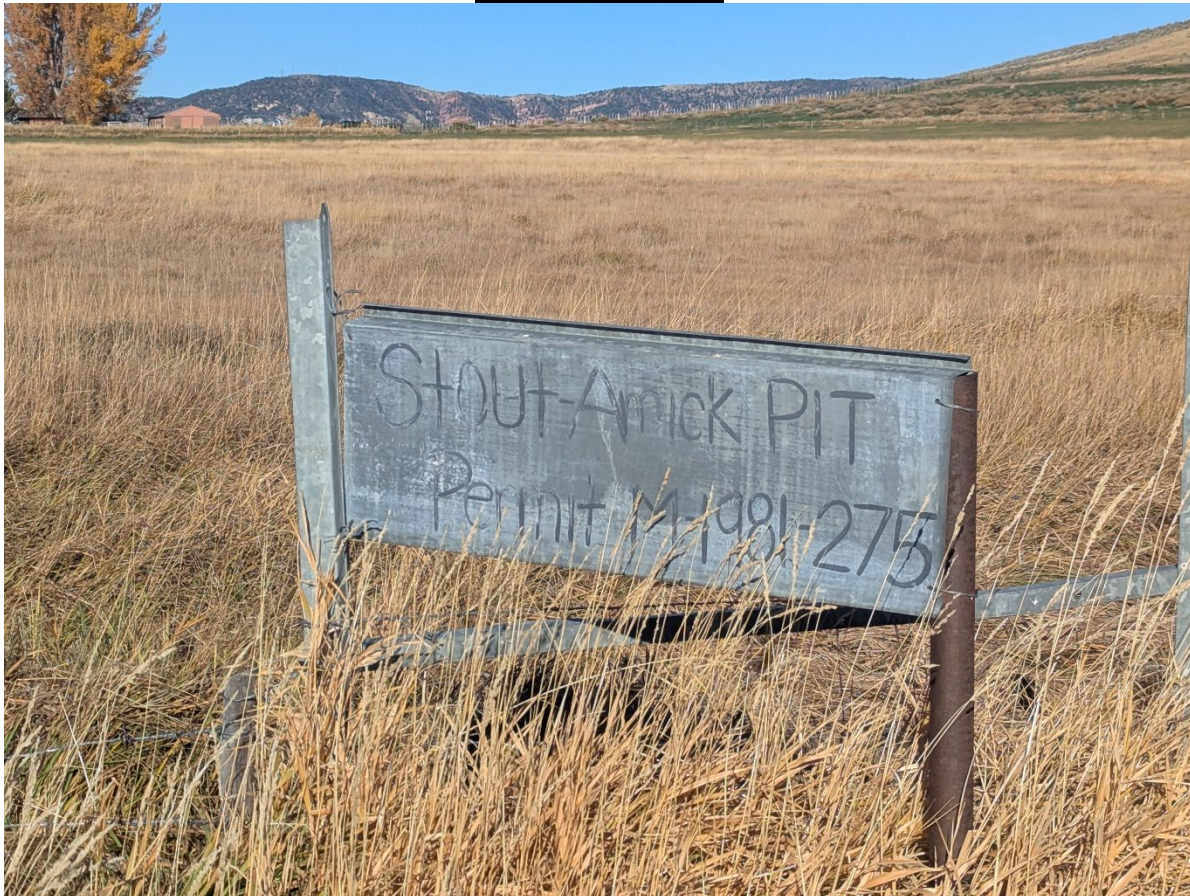
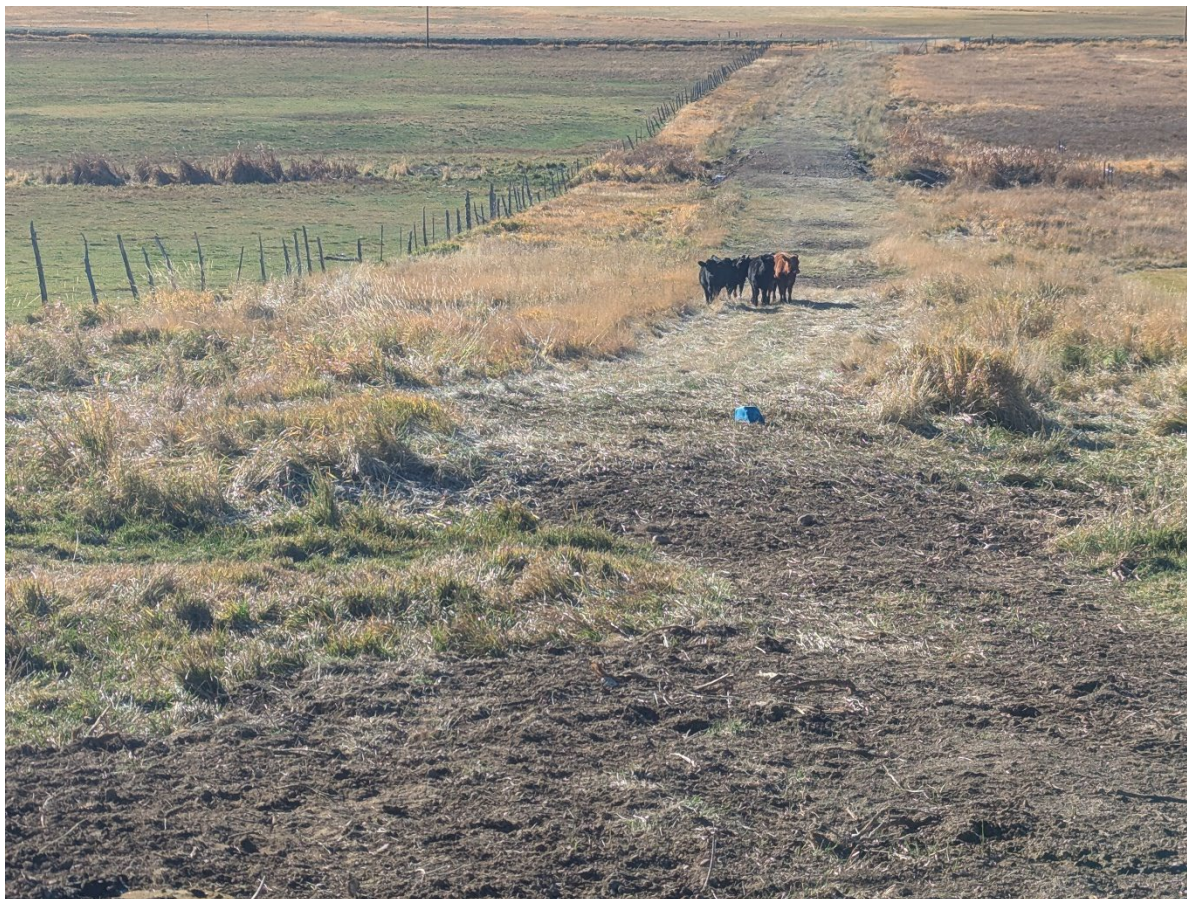
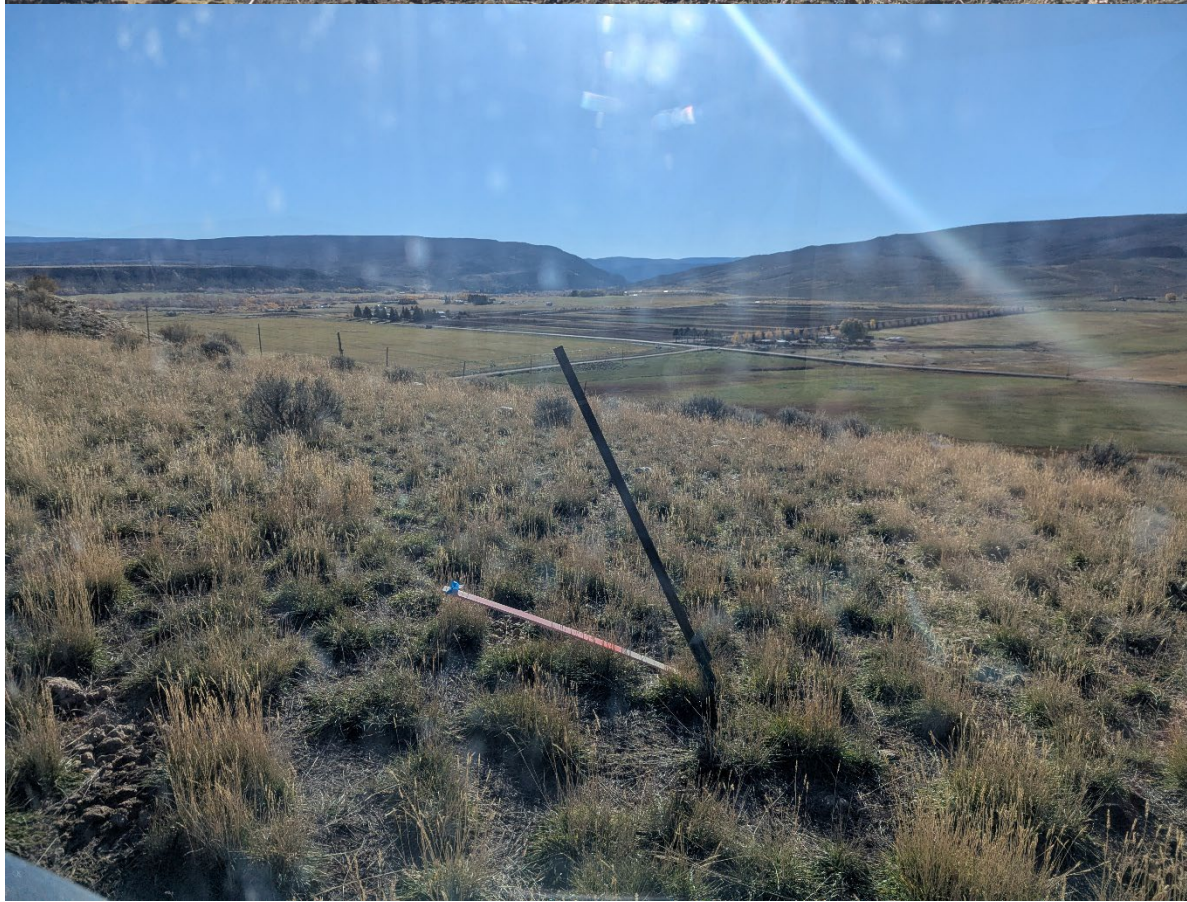
Mining at this site has not yet commenced. (Photos One-Three)
