## C1981022, Elk Creek Mine, October Inspection Report

<b>Permit Number:</b> C-1981-022 <b>Mine Name:</b> Elk Creek Mine <b>Operator:</b> Oxbow Mining, LLC <b>Operator Address:</b> Mr Doug Smith 3737 Hwy 133 P. O. Box 535 Somerset, CO 81434	<b>County:</b> Delta, Gunnison <b>Operation Type:</b> Underground <b>Permit Status:</b> Active <b>Ownership:</b> Private
	<b>Operator Representative Present:</b>  Doug Smith
<b>Operator Representative Signature: (Field Issuance Only)</b>

<b>Inspection Start Date:</b> October 30, 2025 <b>Inspection Start Time:</b> 09:30 <b>Inspection End Date:</b> <b>Inspection End Time:</b>	<b>Inspection Type:</b> Coal Partial Inspection <b>Inspection Reason:</b> Normal I&E Program <b>Weather:</b> Clear
<b>Joint Inspection Agency:</b>  None	<b>Joint Inspection Contacts:</b>
<b>Post Inspection Agency:</b>  None	<b>Post Inspection Contacts:</b>
<b>Inspector(s):</b>  Leigh Simmons	<b>Inspector's Signature:</b>

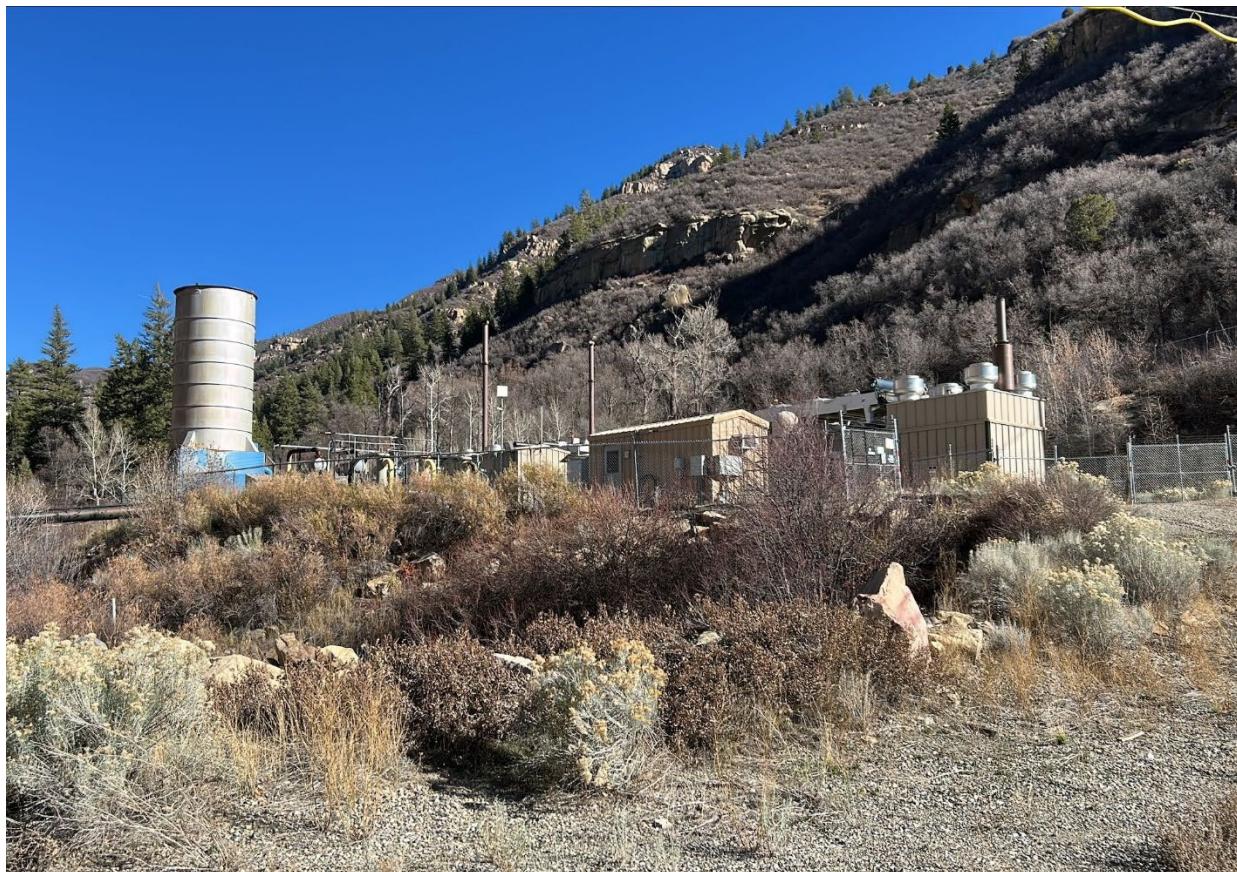
The methane facility at the upper Elk Creek Pad was not operating. Plans were being made to remove one or more of the three methane powered electrical generators to be refurbished and reused at another site, out of state.

Figure 1: Elk Creek methane facility

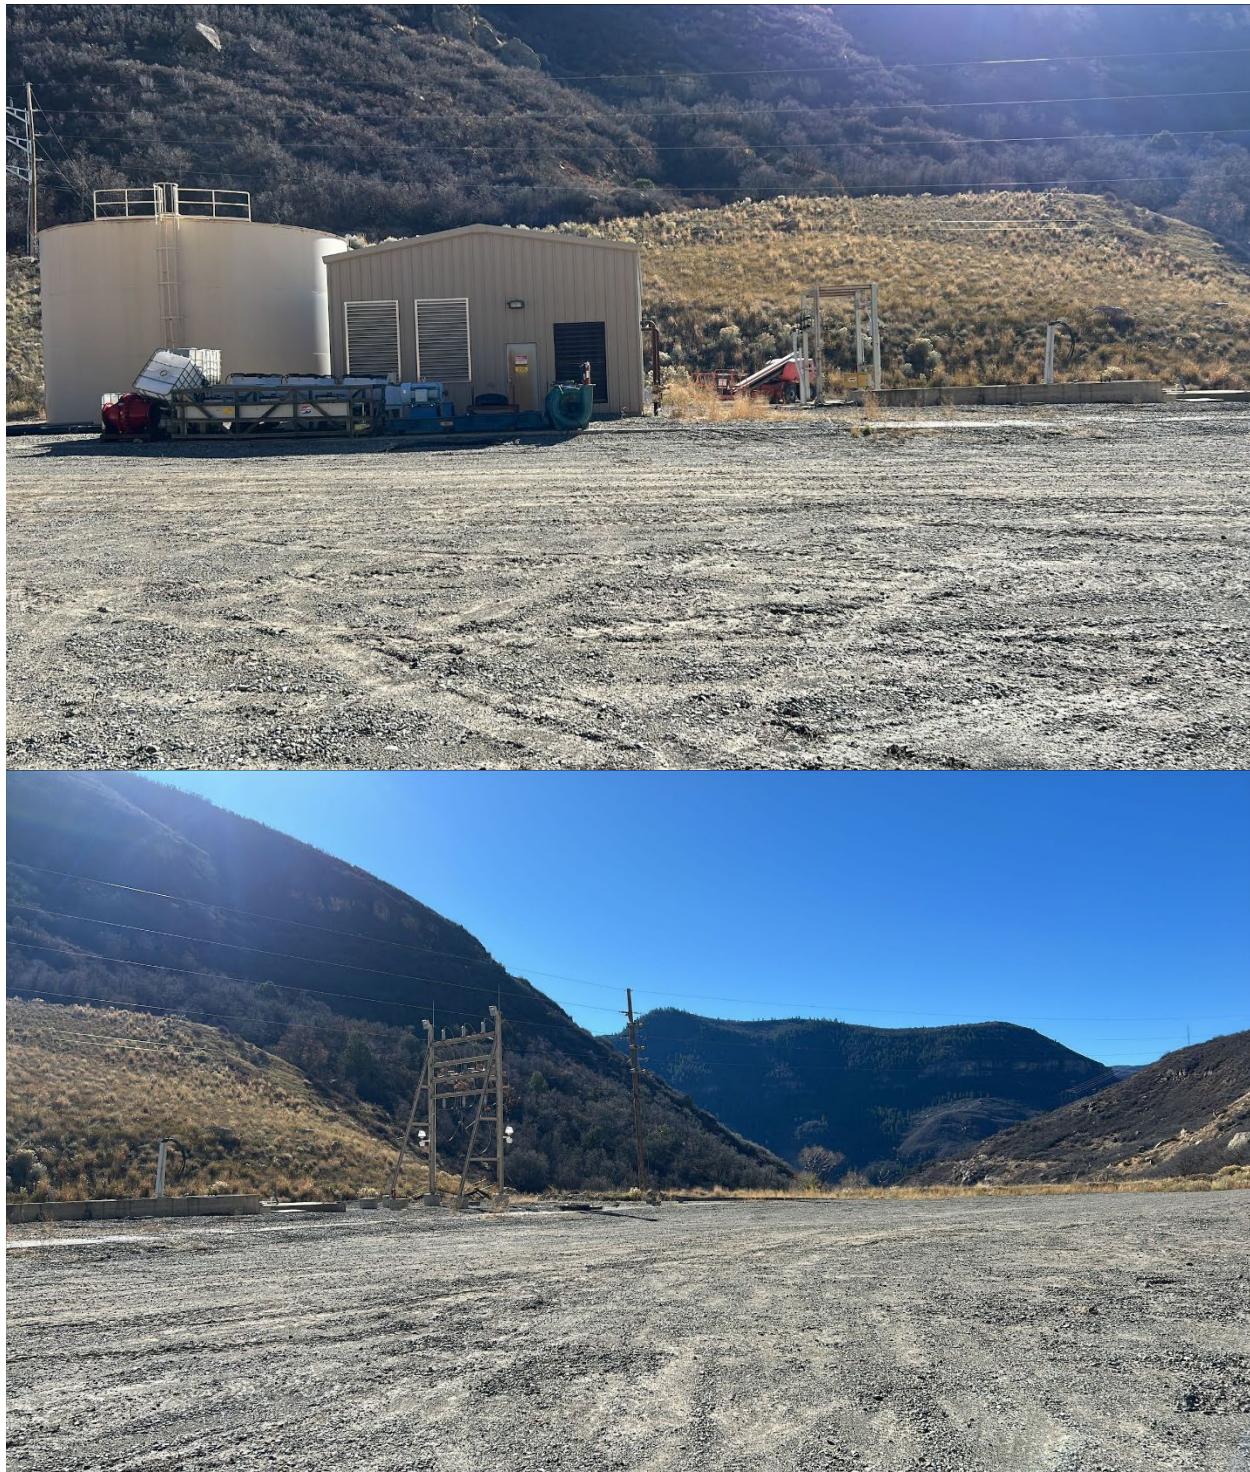
The substation at the upper Elk Creek pad had been dismantled and removed.

*Figure 2: Substation removed from upper Elk Creek pad*

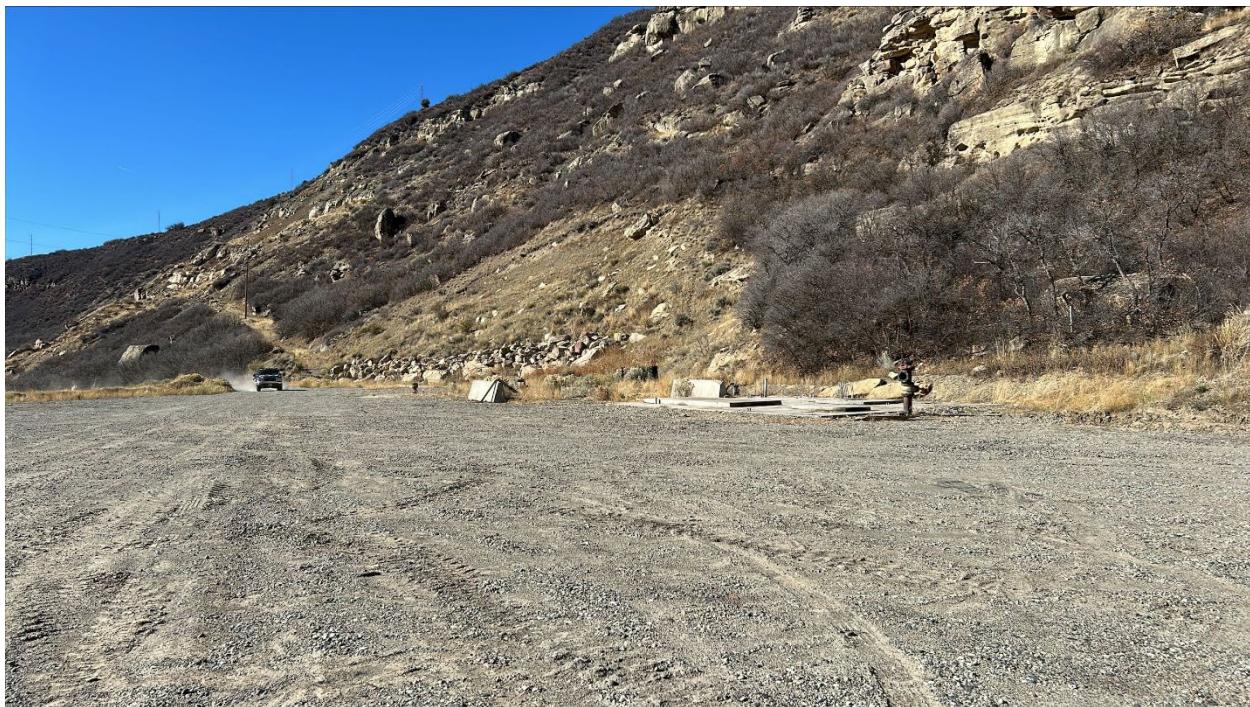
Figure 3: R2B2 well

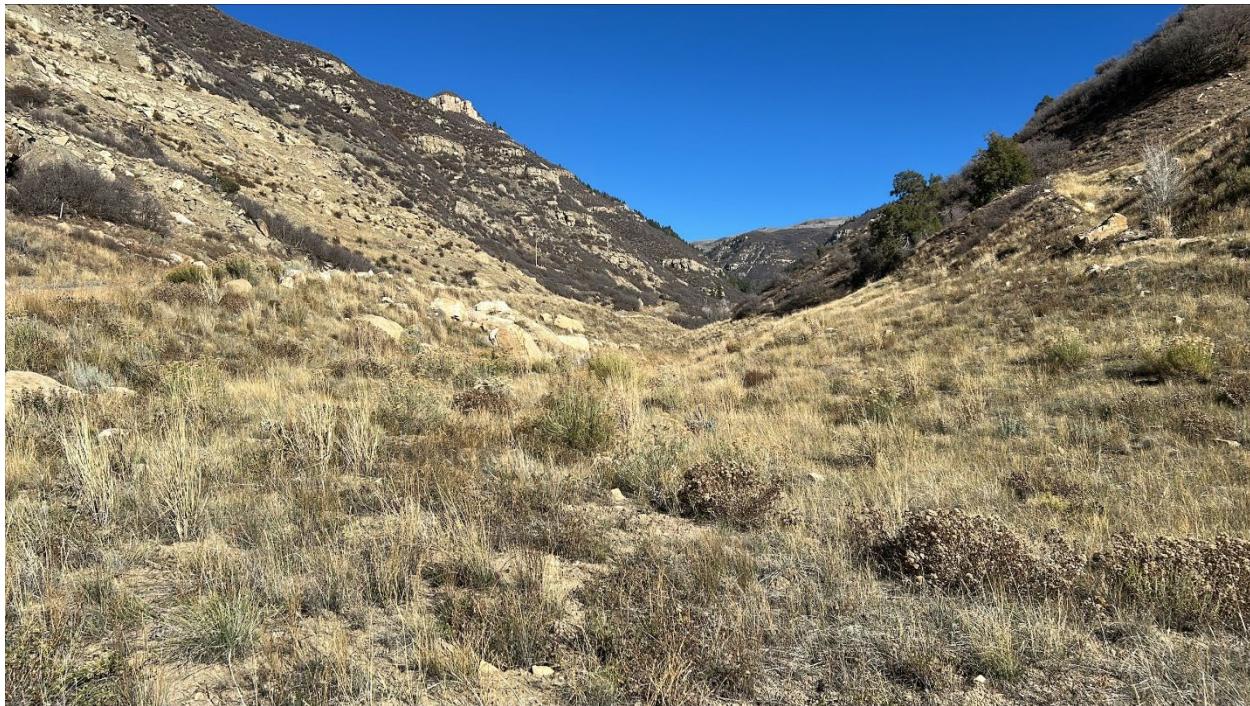
Figure 4: Reclaimed Elk Creek channel

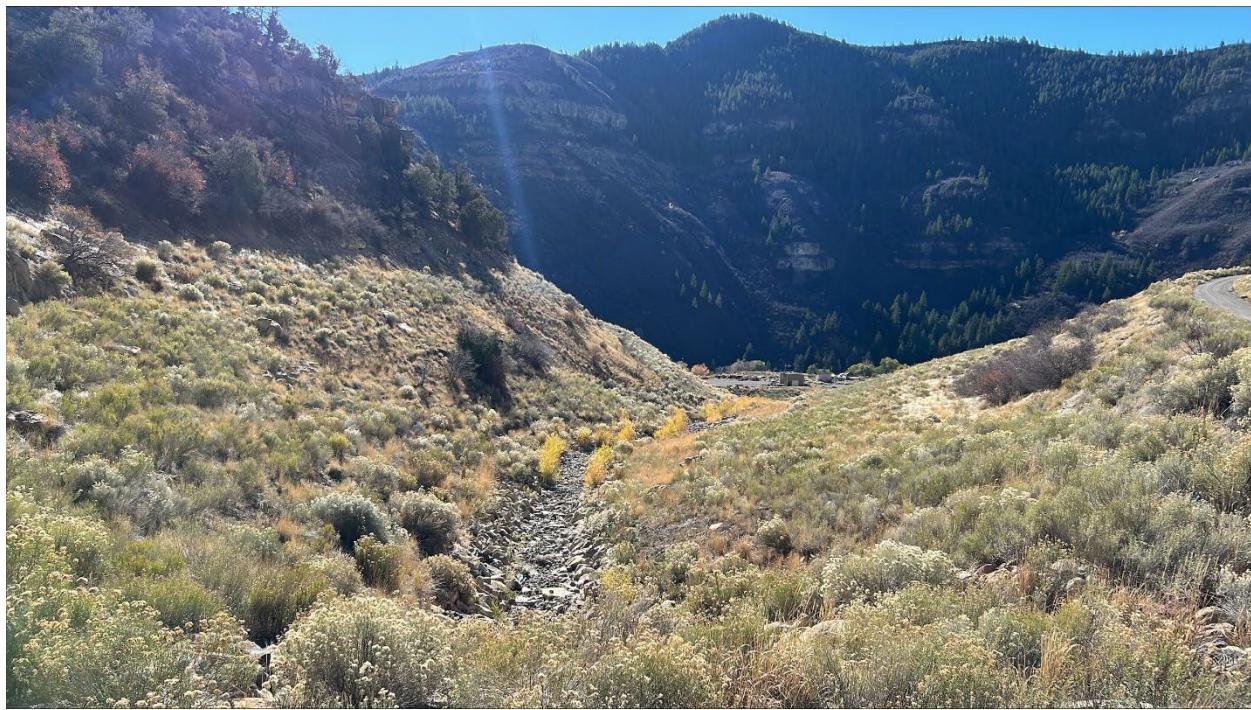
*Figure 5: Lower section of reclaimed Elk Creek channel*

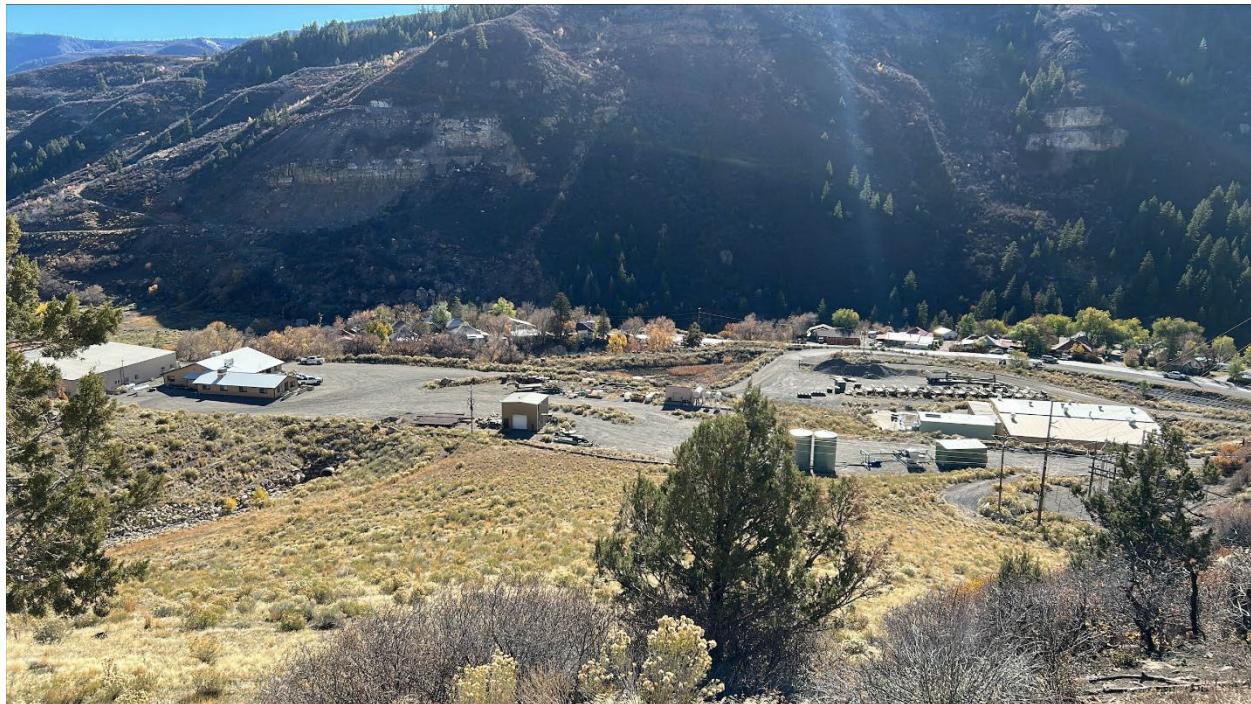
*Figure 6: Overview of lower facilities*

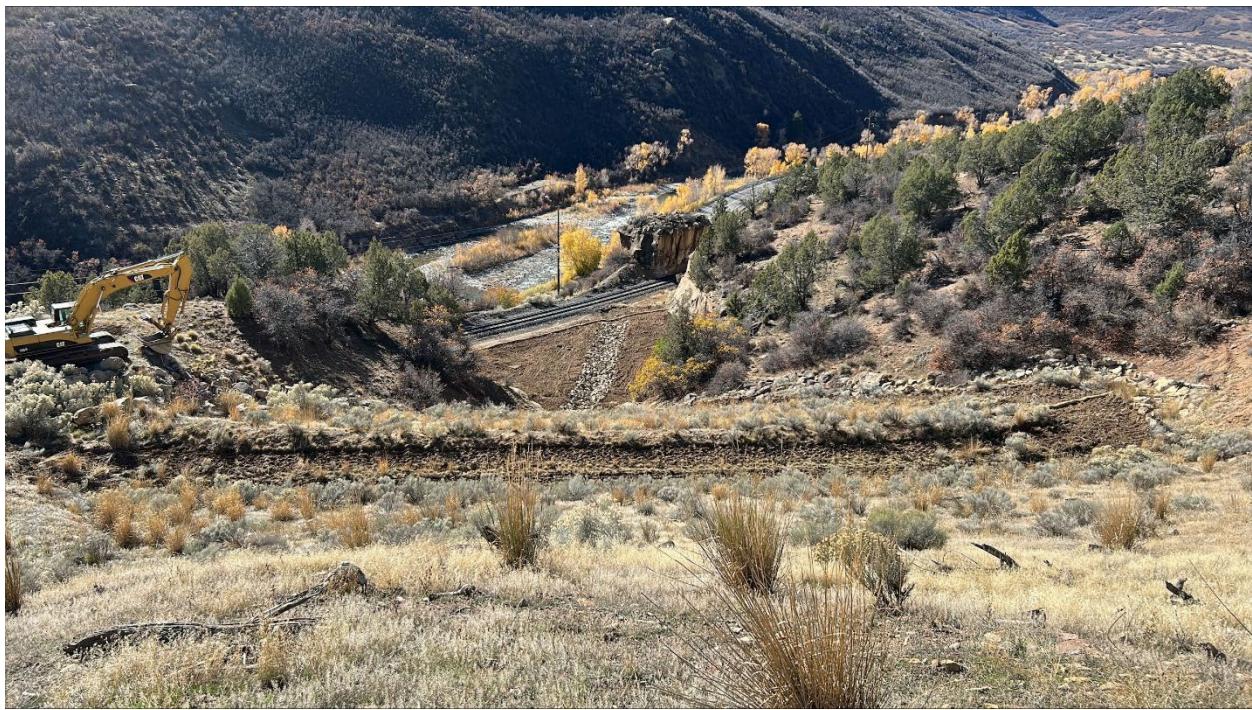
The demolition and burial of the embankment of Pond E was complete, and the armored drain of the II-West Valley Fill had been extended across the flat area where the pond used to be, to the railroad culvert. The small amount of disturbance created by the reclamation of the pond had been seeded and protected by straw wattles placed along the contour. An excavator had been left just above the pond with the intention of reclaiming the access road on the way out.

Figure 7: Pond E

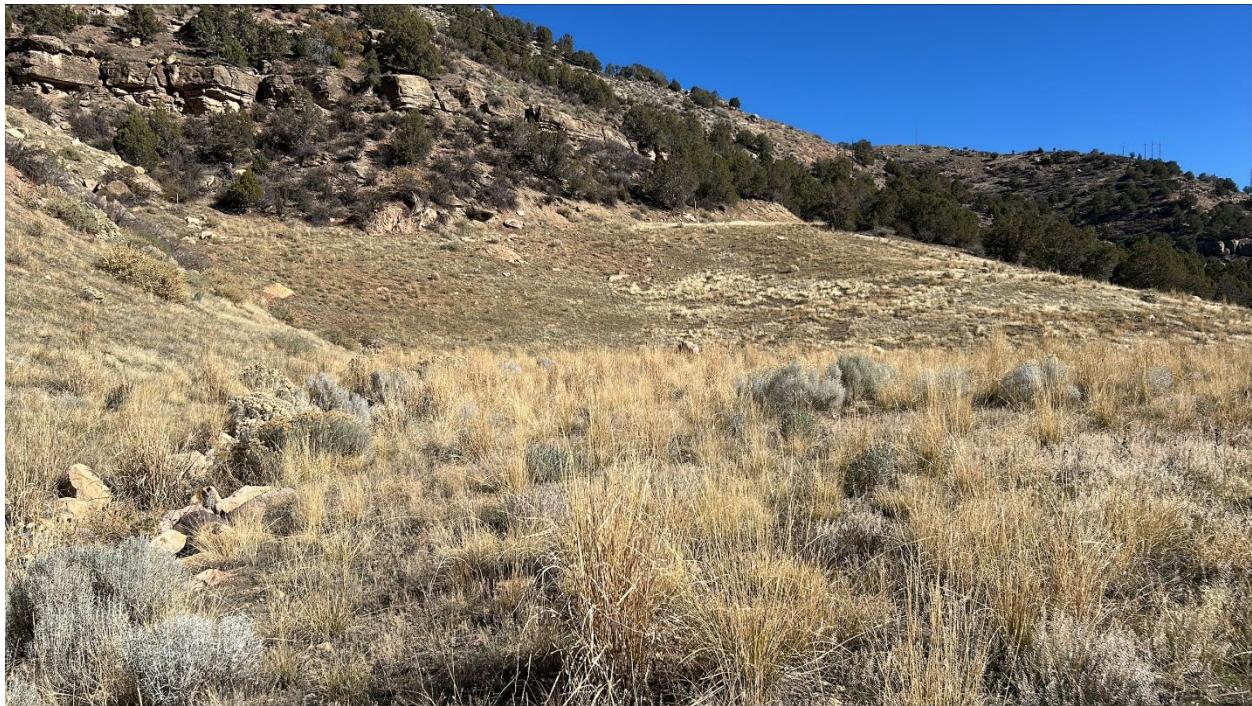
Figure 8: II West Valley Fill

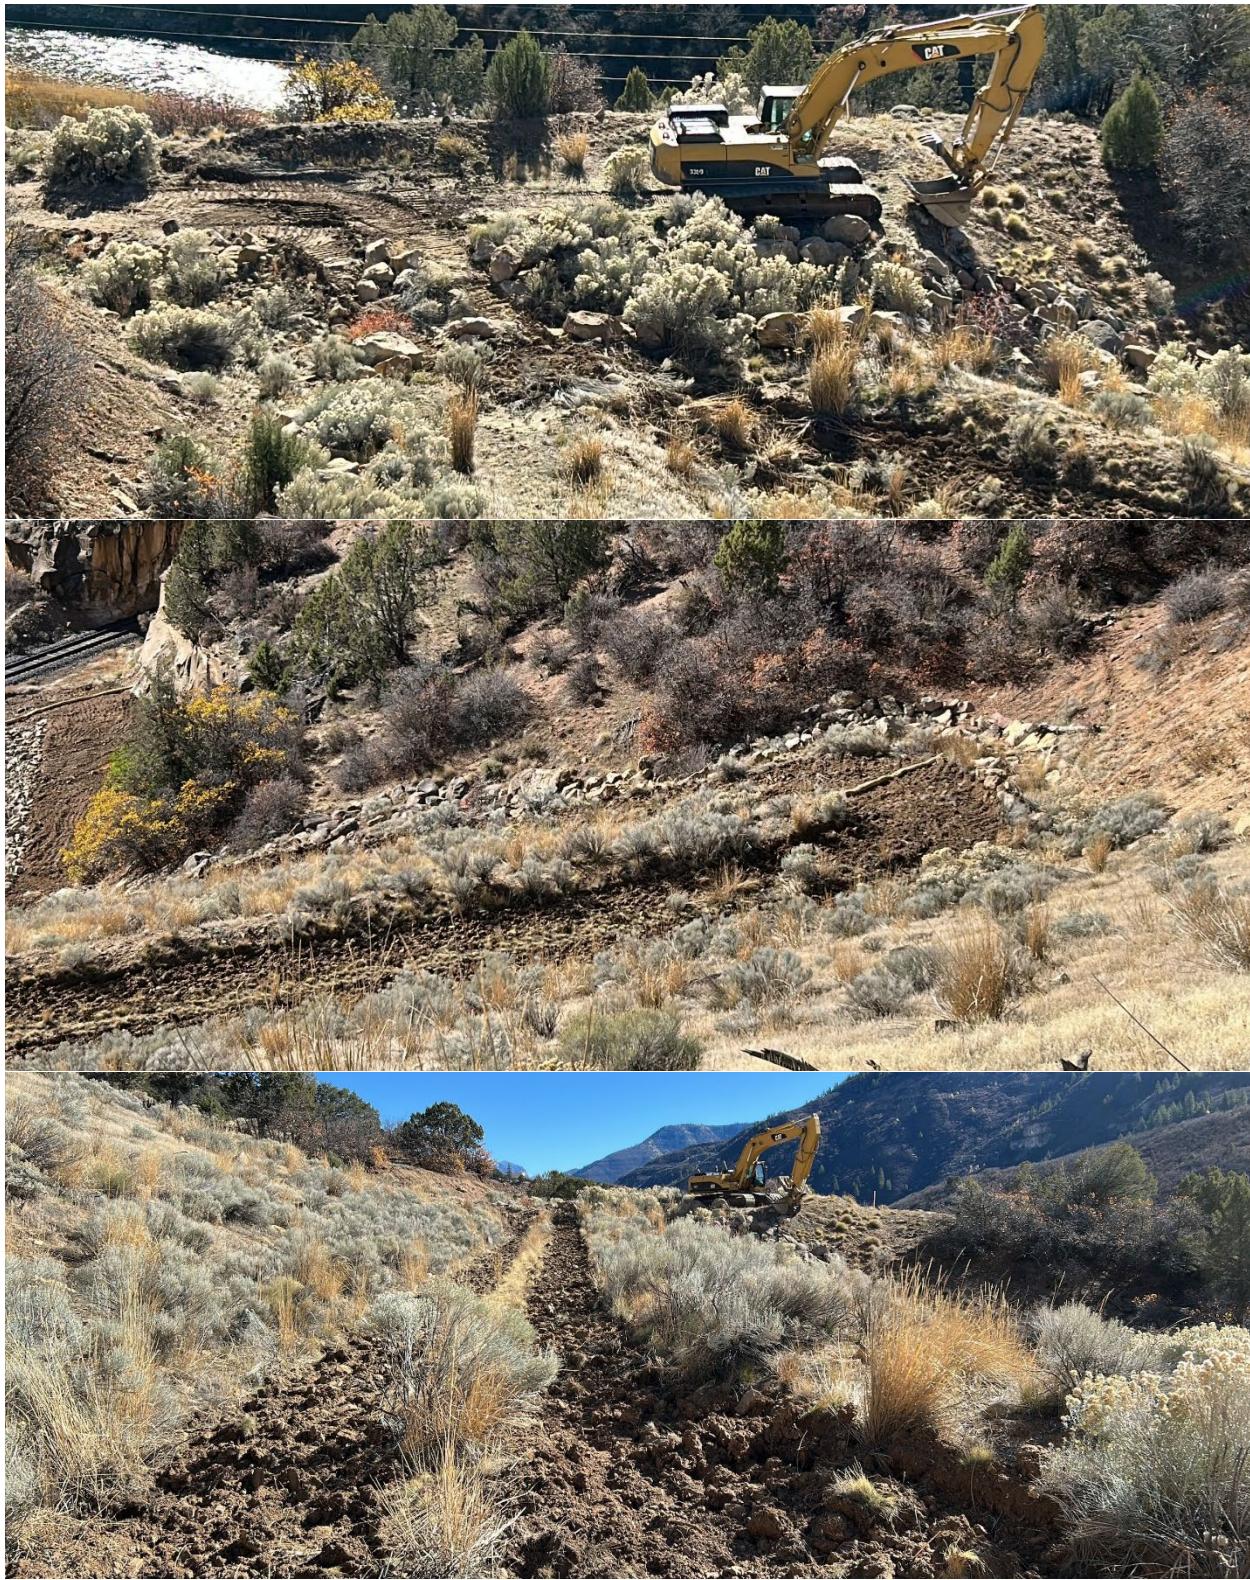
*Figure 9: Excavator access to Pond E*

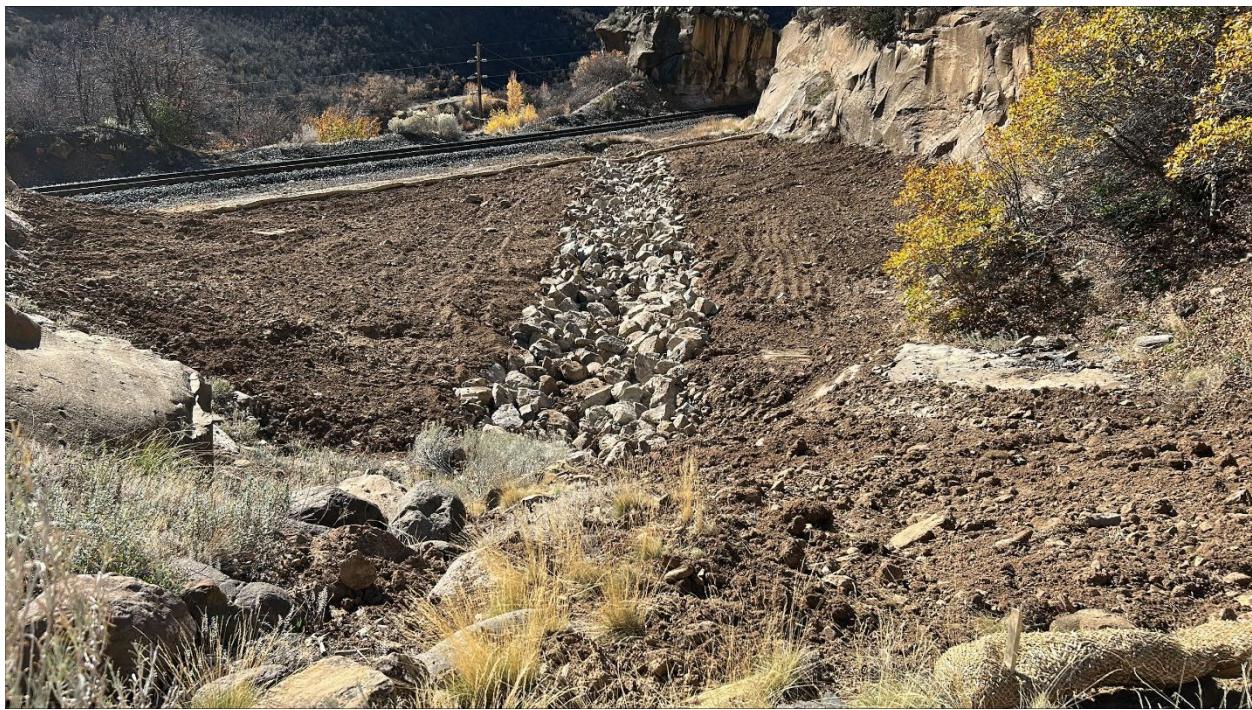
*Figure 10: Extension of armored drain*

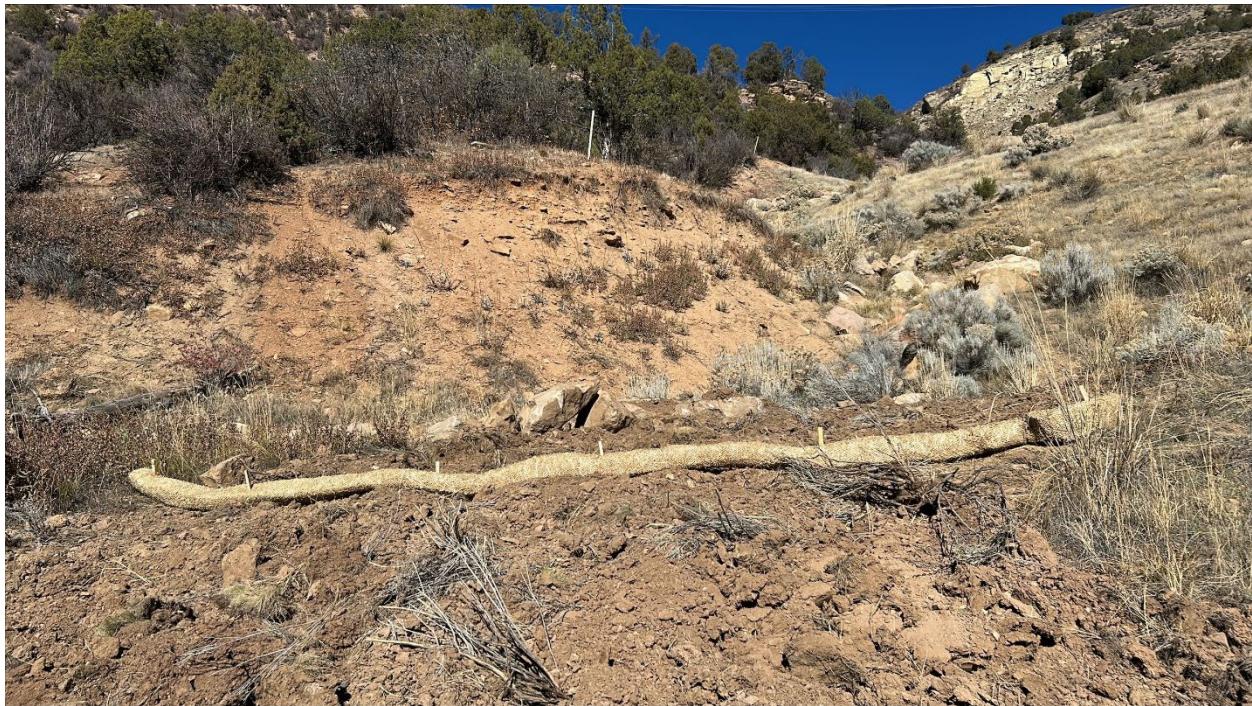
*Figure 11: Sediment control*

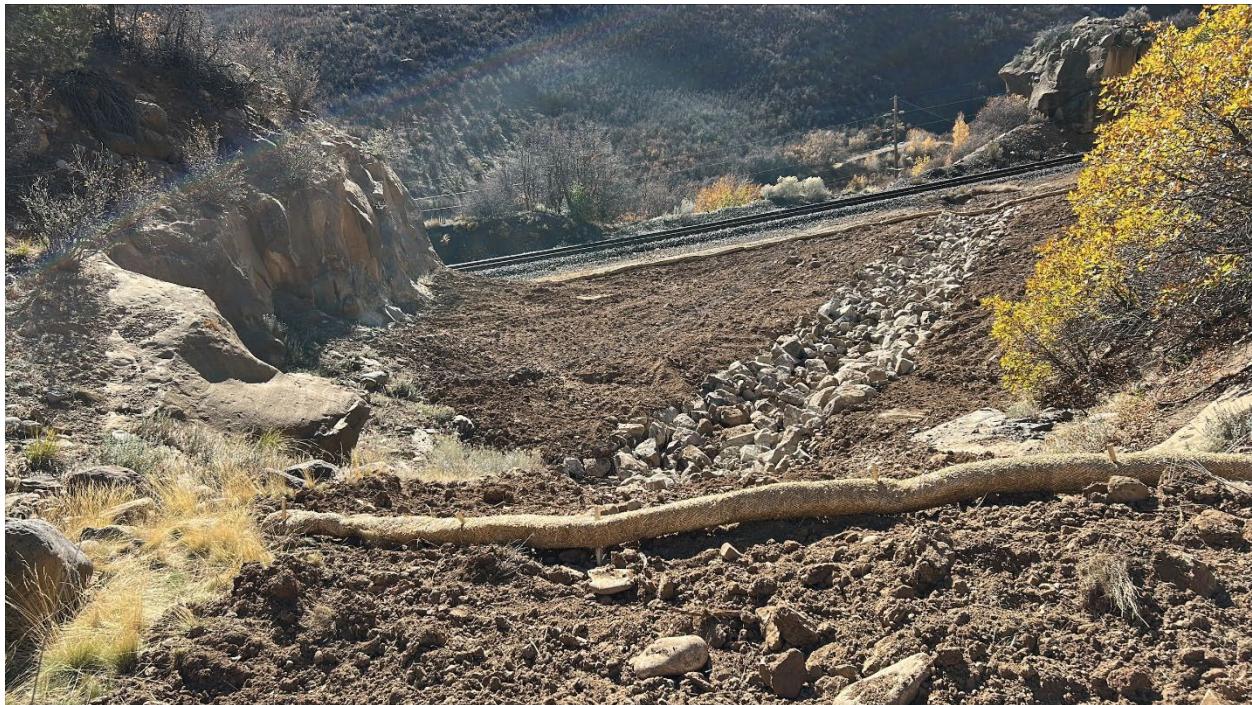
Figure 12: Reclaimed Pond E

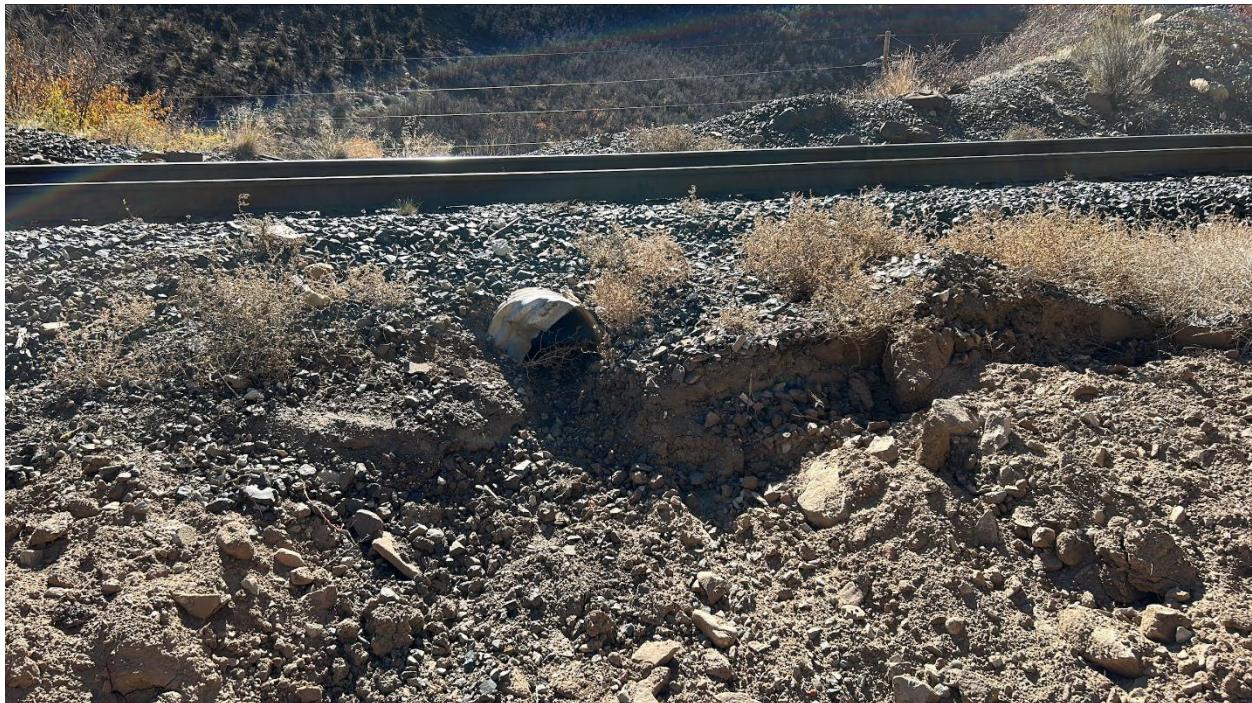
Figure 13: Railroad culvert (not the responsibility of Oxbow)

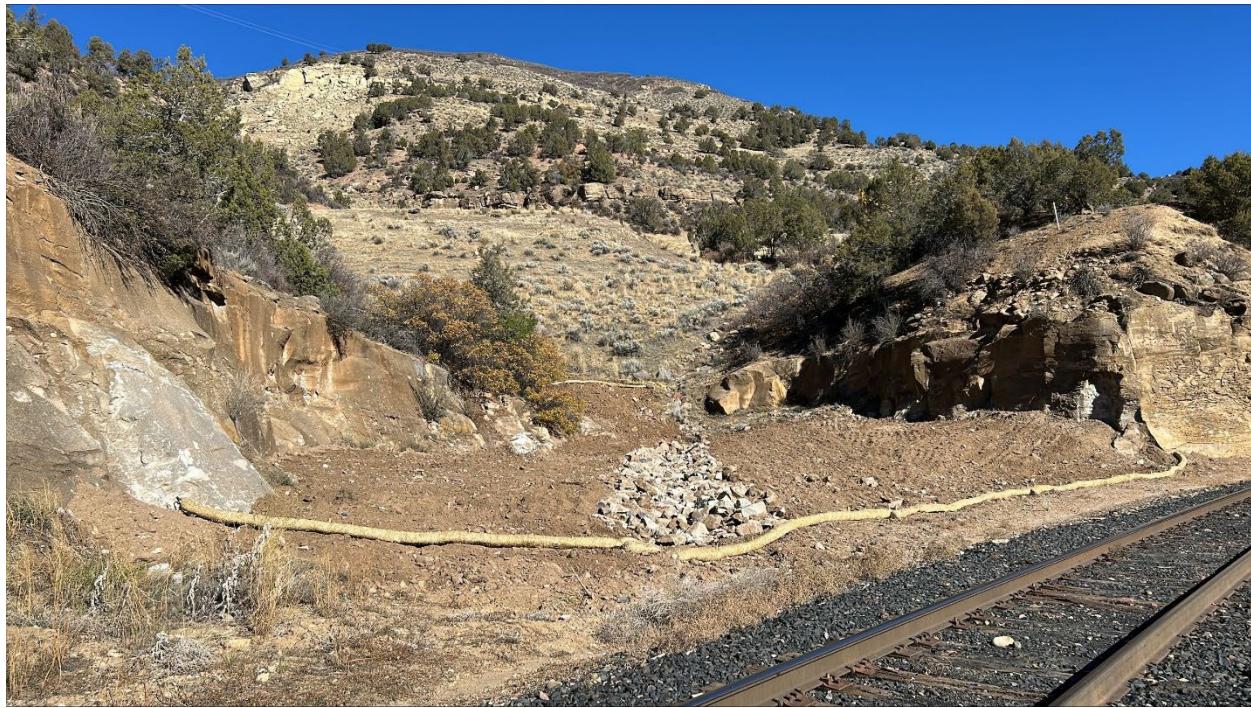
Figure 14: II-West Valley Fill and reclaimed Pond E from railroad

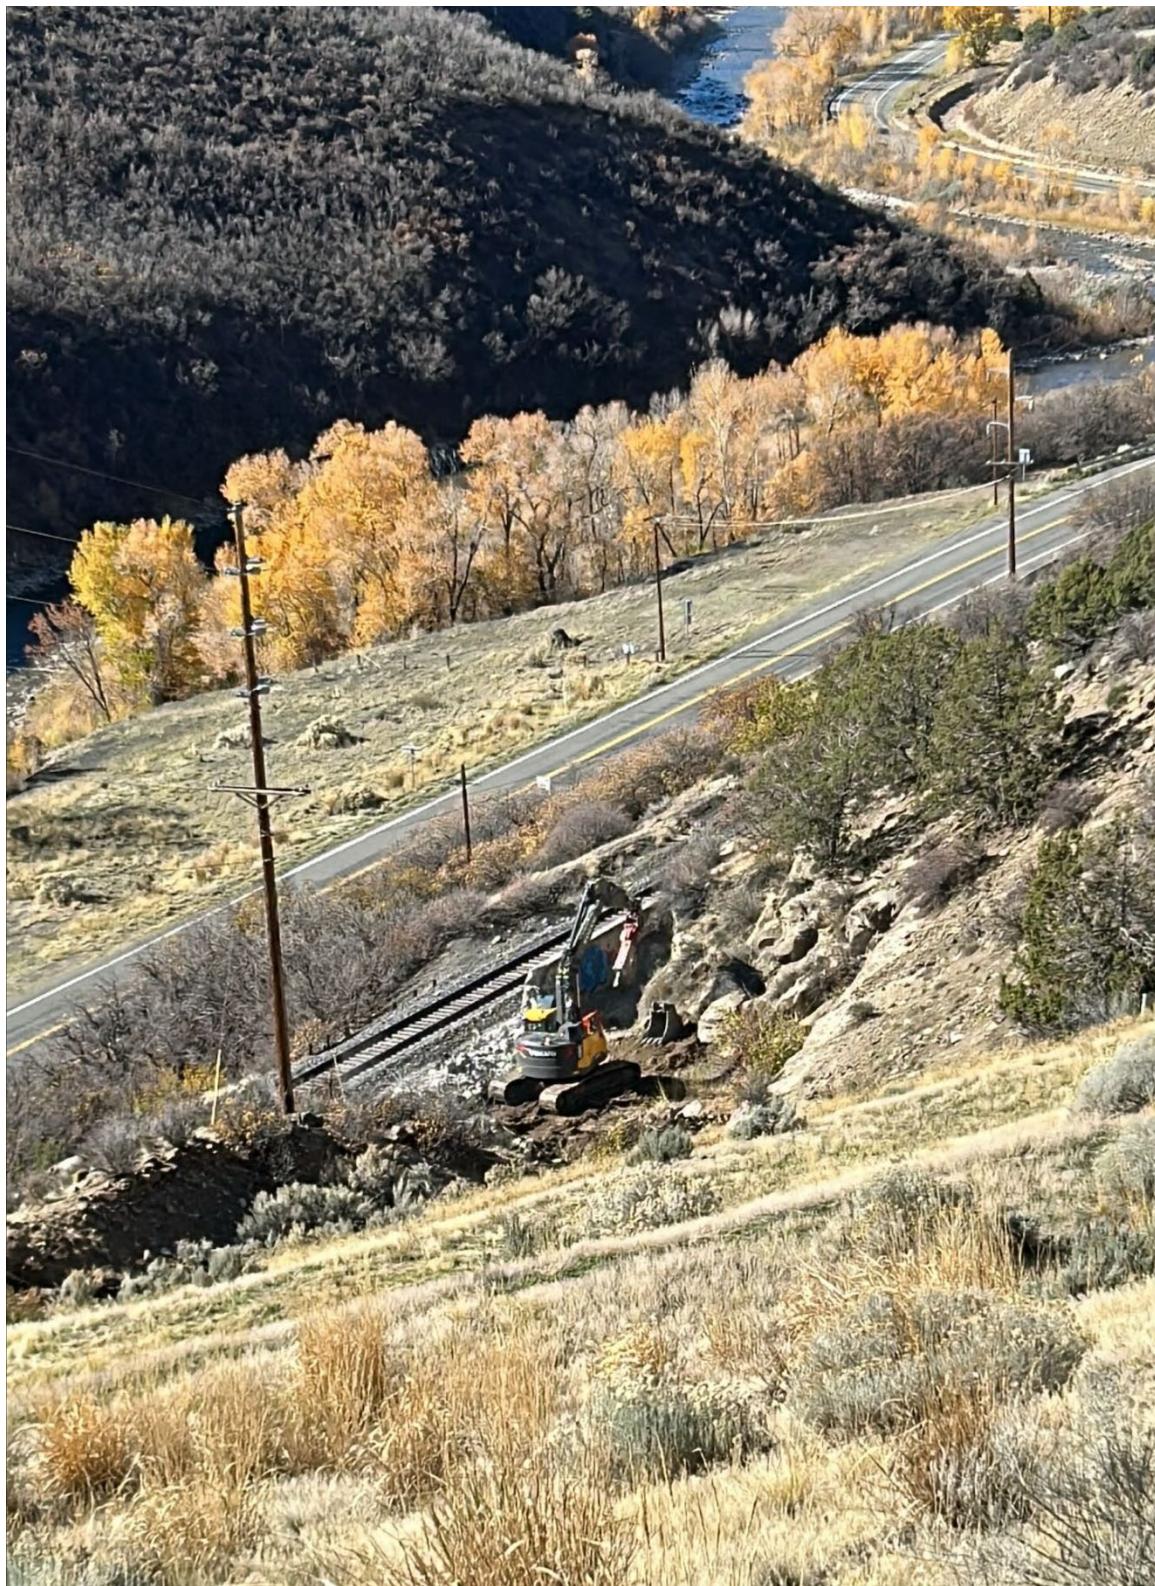
*Figure 15: Pond C from top of West Valley Fill*

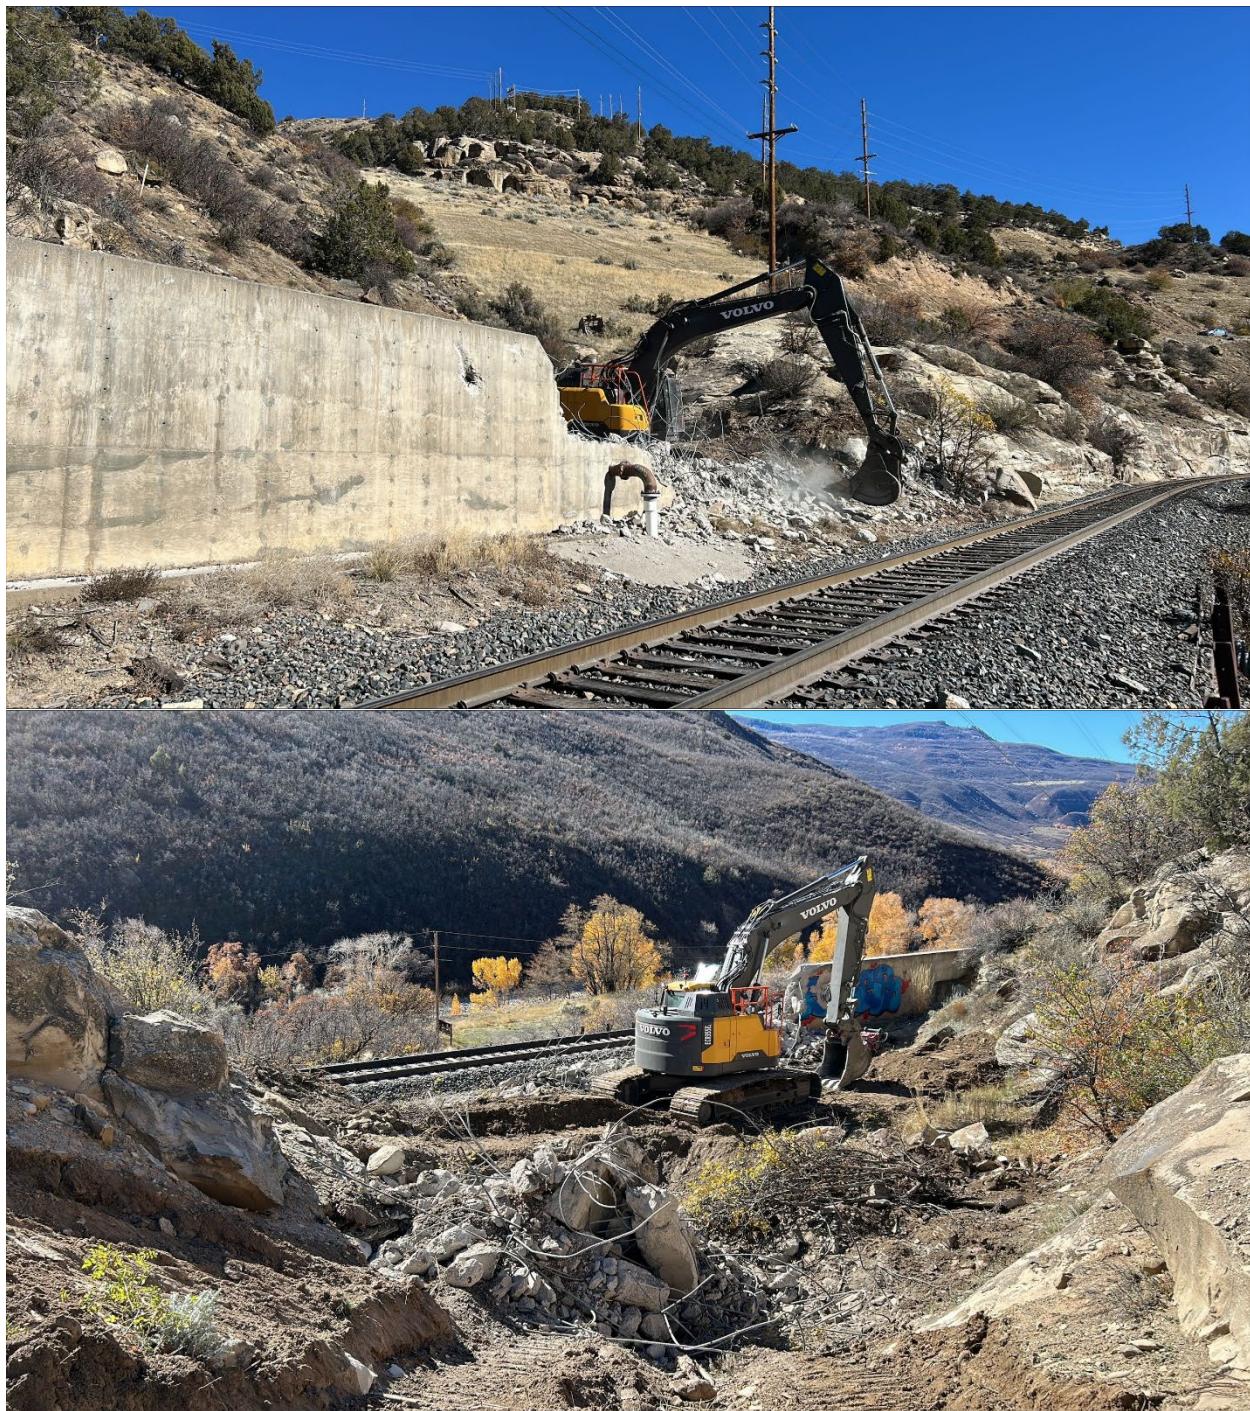
Work was in progress to reclaim both Ponds C and E. Seth Tribble, with Tribble and Sons Construction of Hotchkiss, Colorado, was working on the demolition of the concrete embankment of Pond C at the time of the inspection. A single excavator was being used, with the operator alternating between a bucket and a hammer attachment. Debris was being buried onsite in an excavated pit.

Figure 16: Demolition work in progress

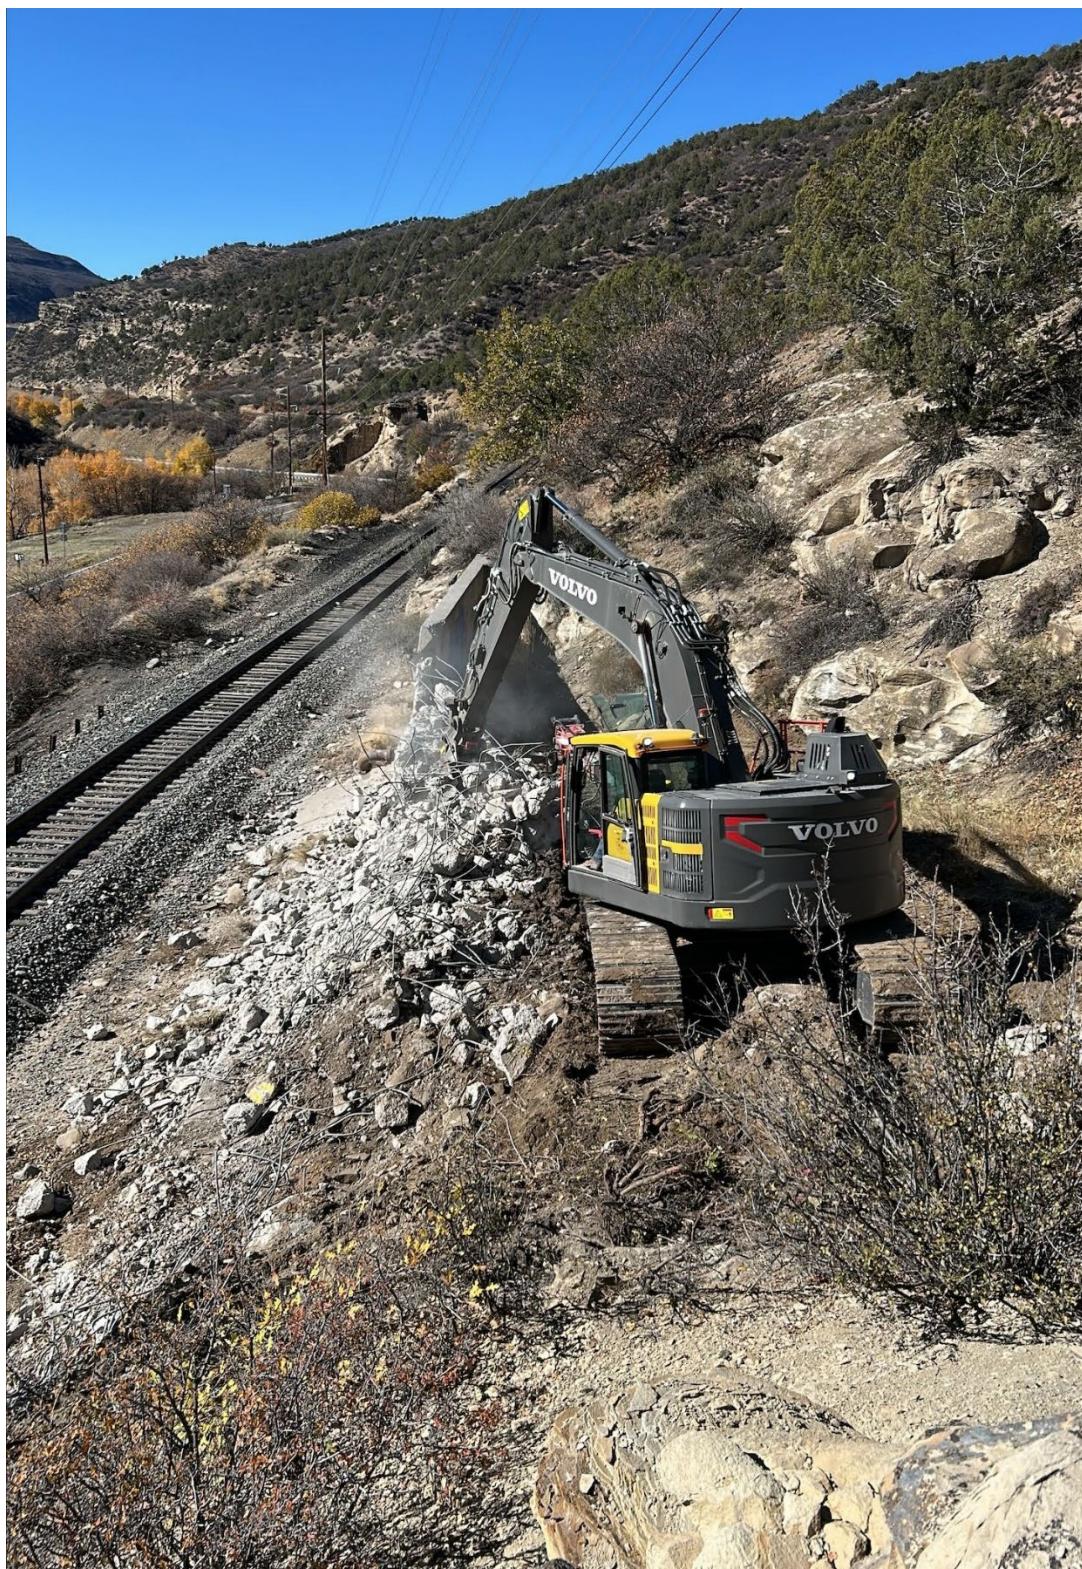
*Figure 17: Demolition of Pond C embankment*

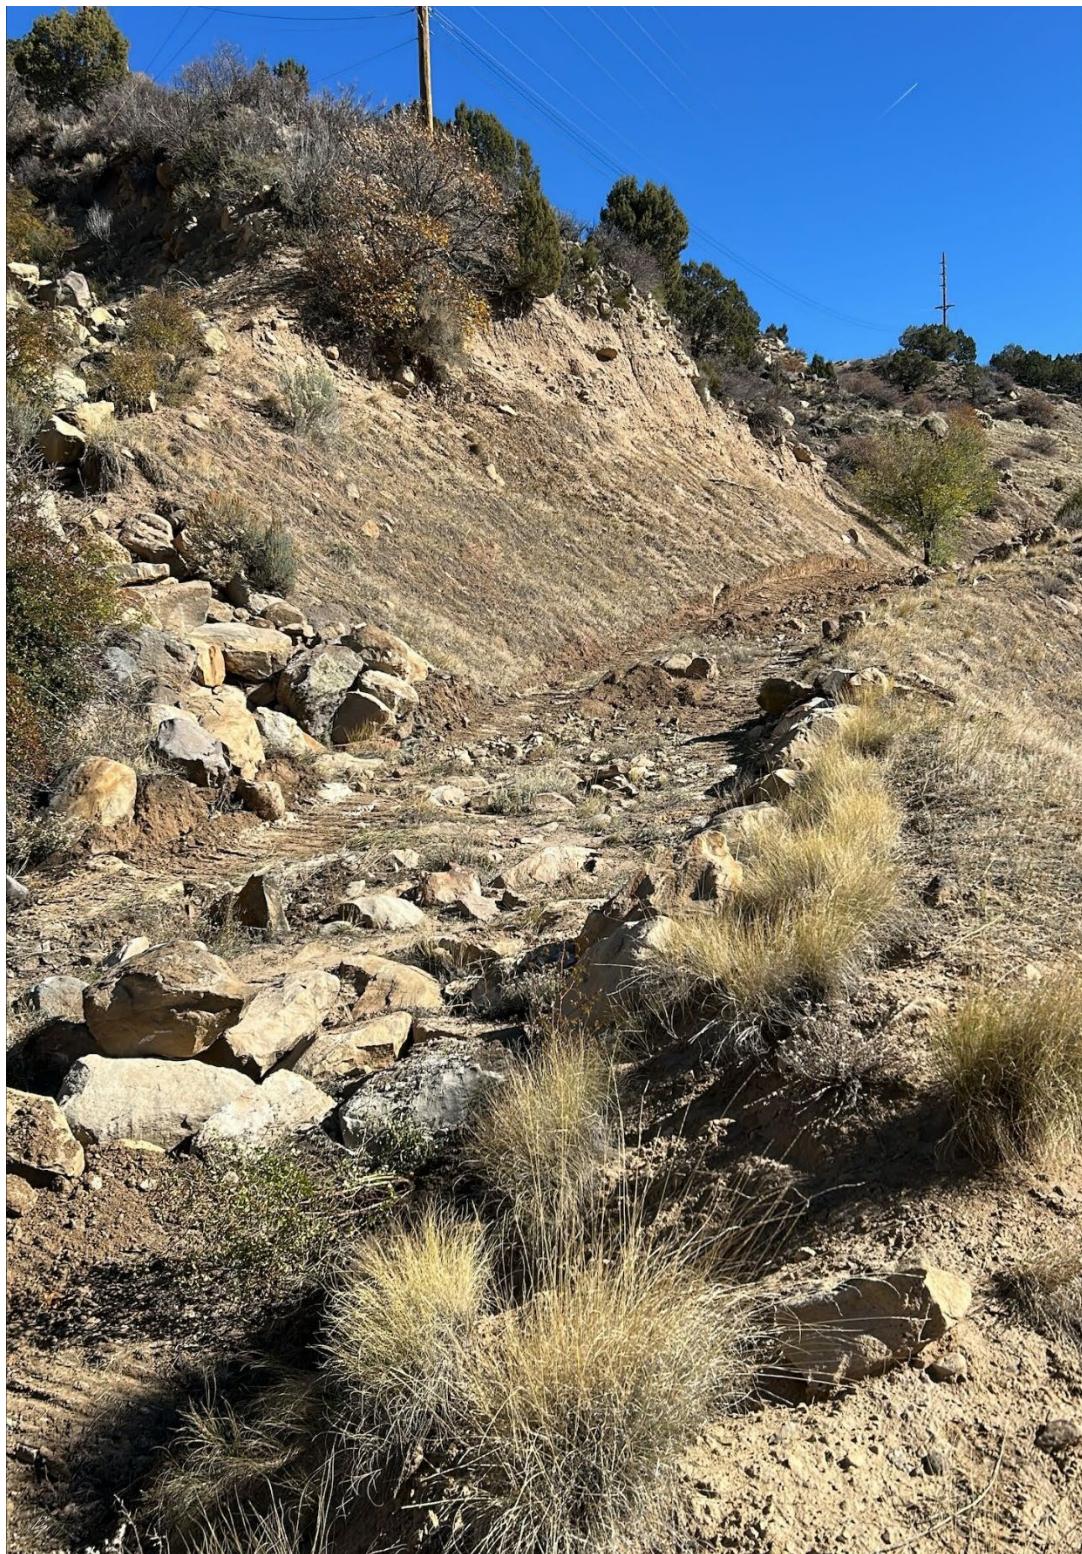
*Figure 18: Access road to Pond C*
