## C1981022, Elk Creek Mine, October Inspection Report

<b>Permit Number:</b> C-1981-022 <b>Mine Name:</b> Elk Creek Mine <b>Operator:</b> Oxbow Mining, LLC <b>Operator Address:</b> Mr Doug Smith 3737 Hwy 133 P. O. Box 535 Somerset, CO 81434	<b>County:</b> Delta, Gunnison <b>Operation Type:</b> Underground <b>Permit Status:</b> Active <b>Ownership:</b> Private
	<b>Operator Representative Present:</b>  Doug Smith
<b>Operator Representative Signature: (Field Issuance Only)</b>

<b>Inspection Start Date:</b> October 30, 2025 <b>Inspection Start Time:</b> 09:30 <b>Inspection End Date:</b> <b>Inspection End Time:</b>	<b>Inspection Type:</b> Coal Partial Inspection <b>Inspection Reason:</b> Normal I&E Program <b>Weather:</b> Clear
<b>Joint Inspection Agency:</b>  None	<b>Joint Inspection Contacts:</b>
<b>Post Inspection Agency:</b>  None	<b>Post Inspection Contacts:</b>
<b>Inspector(s):</b>  Leigh Simmons	<b>Inspector's Signature:</b>

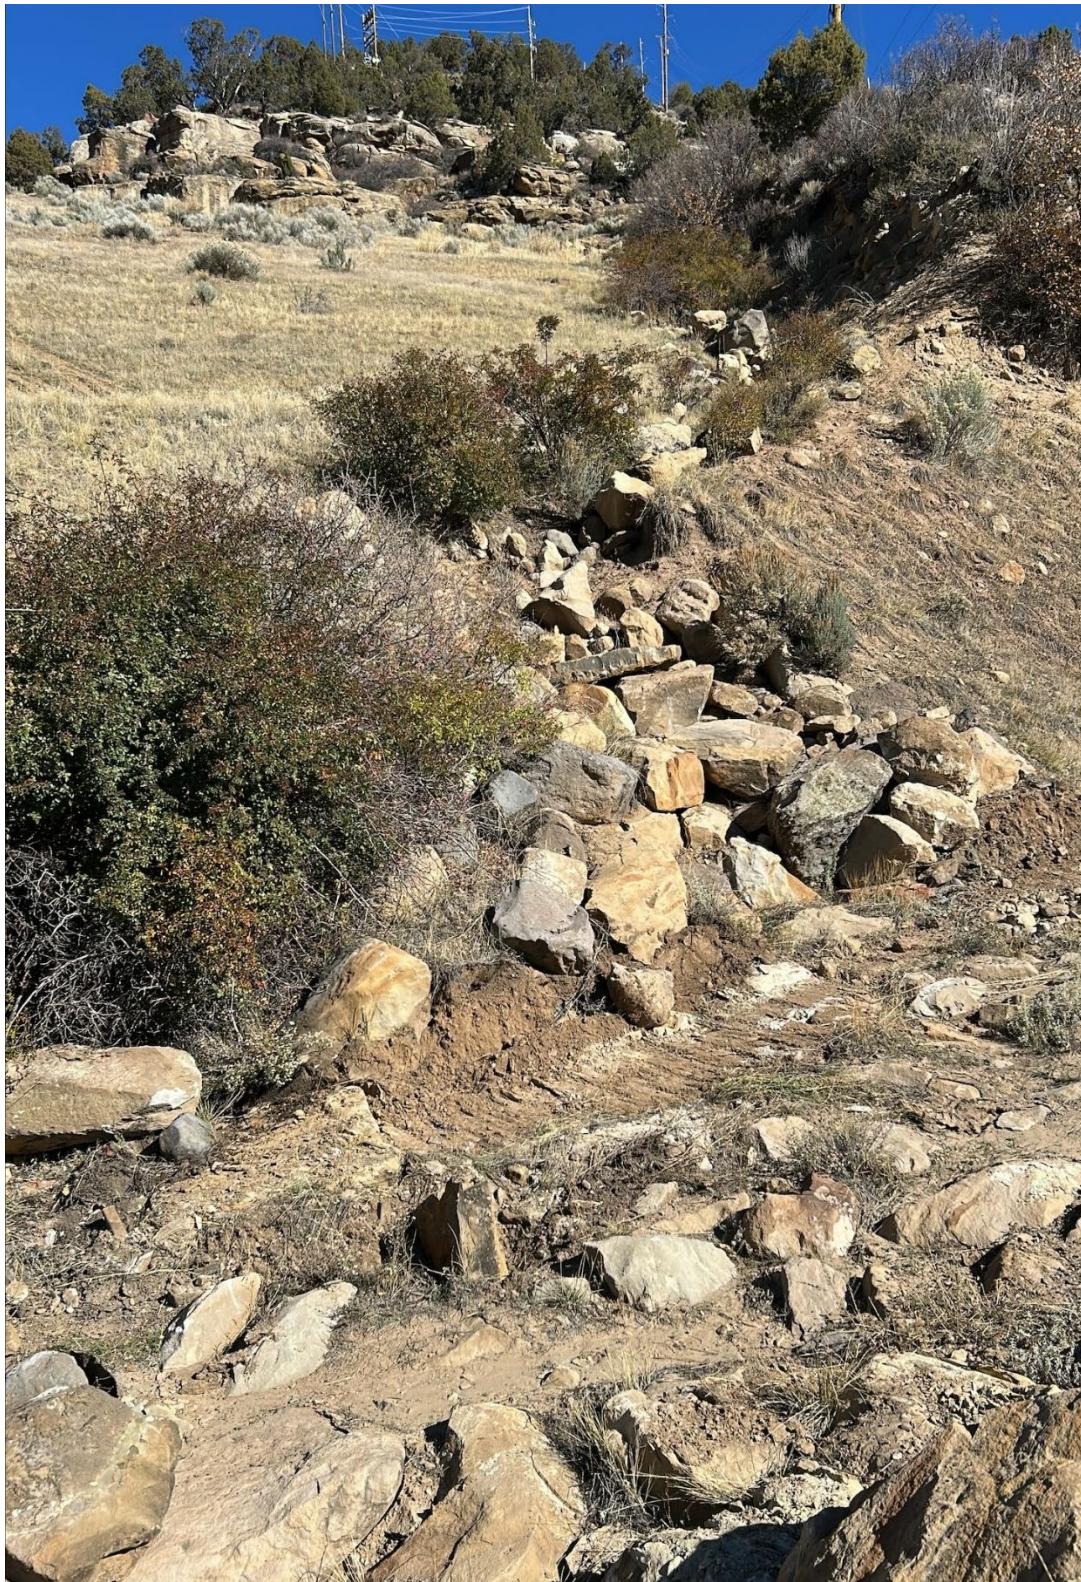
*Figure 19: Access across West Valley Fill drain*

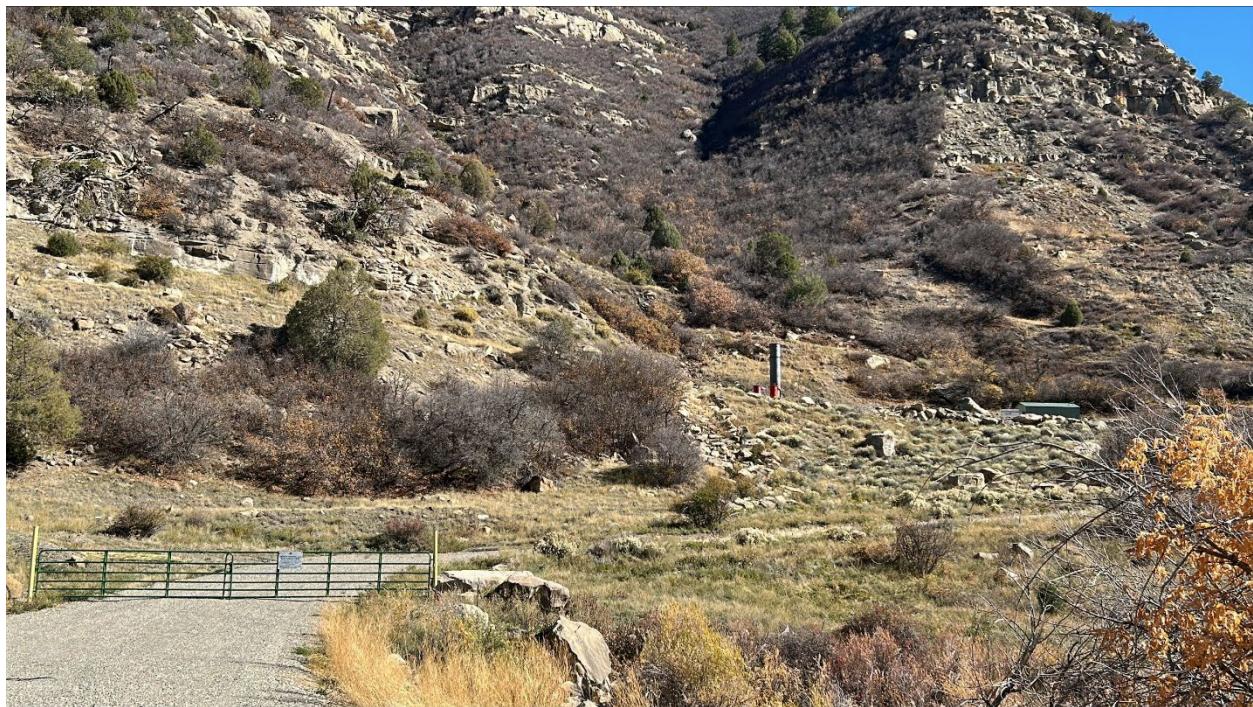
The methane facility in Hubbard Creek was not operating and was secure behind a locked gate.

*Figure 20: Hubbard Creek methane facility*
