STATE OF
COLORADO

Inspection Report

Permit Number: C-1981-018 Mine Name: Deserado Mine Operator: Blue Mountain Energy, Inc Operator Address: Mr Kurtis Blunt 3607 County Road 65 Rangely, CO, 81648	County: Moffat, Rio Blanco Operation Type: Underground Permit Status: Active Ownership: Private
	Operator Representative Present: Kurt Blunt
Operator Representative Signature: (Field Issuance Only) NA

Inspection Start Date: November 5, 2025 Inspection Start Time: 09:30 Inspection End Date: November 5, 2025 Inspection End Time: 12:00	Inspection Type: Coal Partial Inspection Inspection Reason: Normal I&E Program Weather: Clear	
Joint Inspection Agency: None	Joint Inspection Contacts: NA	
Post Inspection Agency: None	Post Inspection Contacts: NA	
Inspector(s): Todd Jesse	Inspector's Signature: 	Signature Date: 11/5/2025

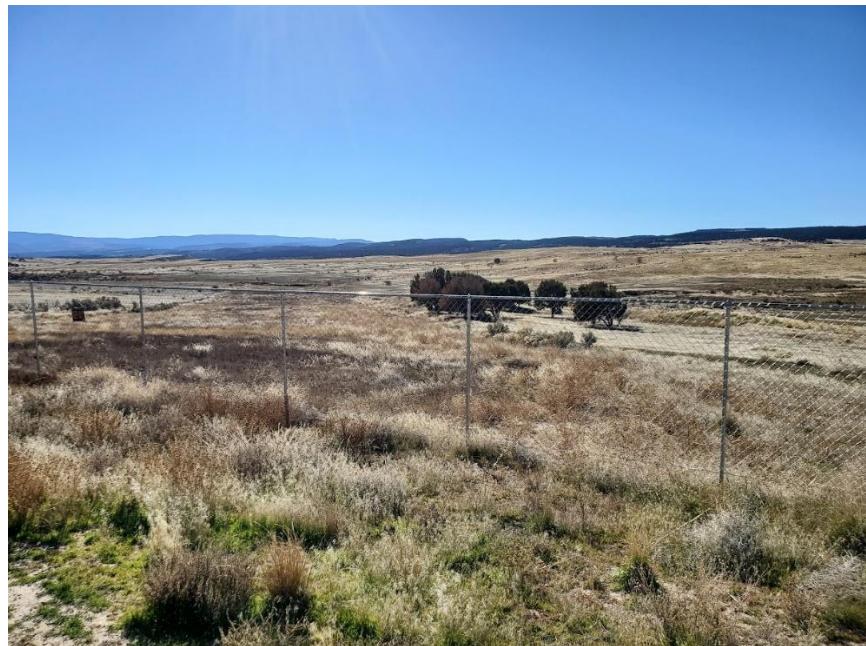
The Halandras Landfill has been backfilled and graded to approximate original contour. No topsoil has been spread on the site. The topsoil pile that remains next to the landfill appears to be of sufficient size to complete reclamation. Volunteer vegetation has grown on the site (Photo 1).

Photo 1: View to the south of the Halandras Landfill

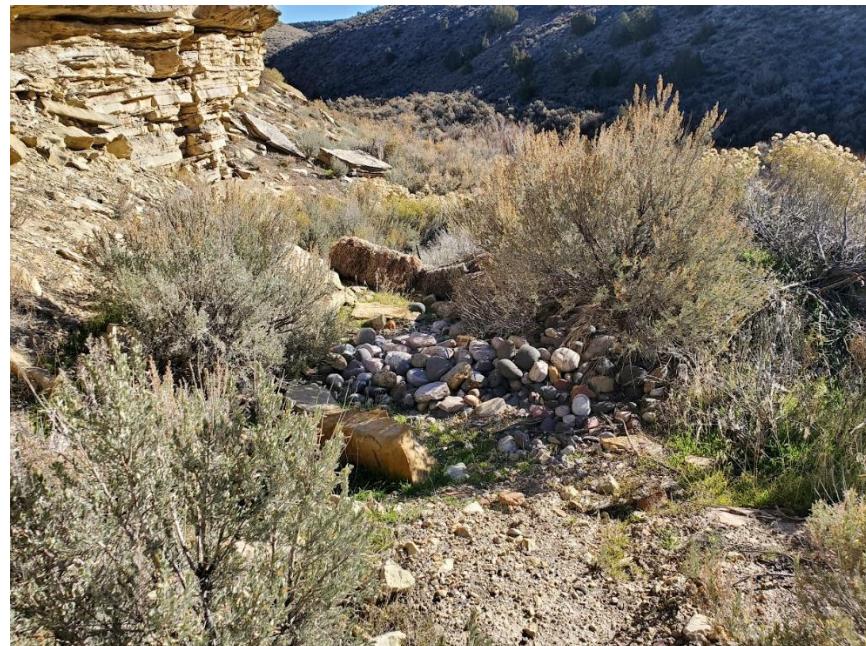
The explosives storage area for the Deserado Mine is located at the southern end of the main facilities area. The storage consists of a pad with a storage bunker for the explosives. The cut and fill slope of the pad was stable with no erosional features. Runoff from the pad is directed to an outlet at the southern end of the pad and passes down a channel through straw bales (Photo 2). The bales appear to be in good condition and functioning as designed

Photo 2: View to the east of the bales in the drainage for the explosives pad.

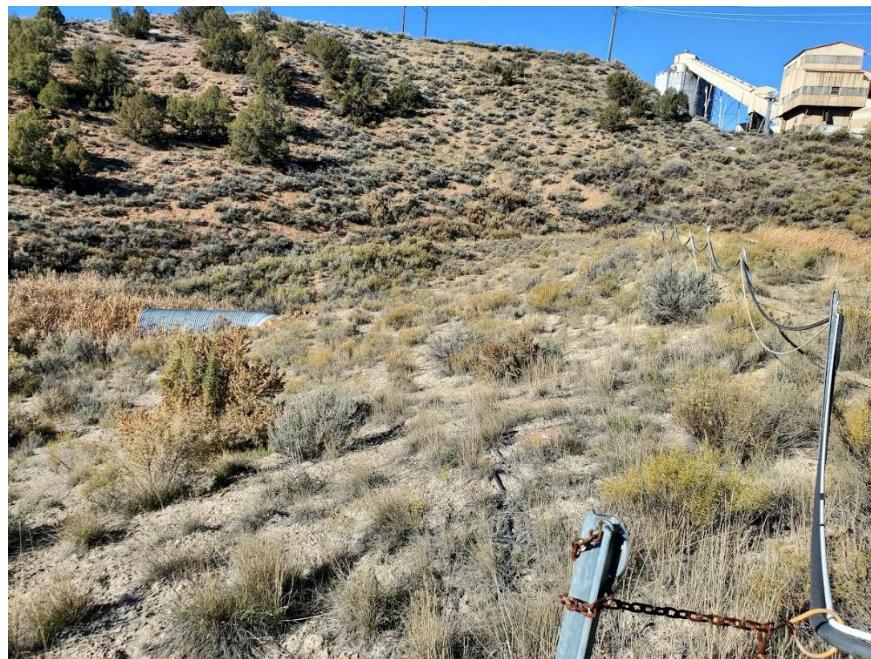
There are three ponds located in the main facilities area: the DP-1 Pond, the PP-1 Pond and the PP-2 Pond. The DP-1 Pond is located on the southern part of the lower facilities bench. DP-1 collects all runoff from the from the three facilities benches. The outlet structure was clear of debris and the pond was discharging at the time of inspection. The embankments appear stable with well-established vegetative cover (Photo 3). The emergency spillway has minor amounts of vegetation but still appears to be able to convey water and is well armored. There were no erosional concerns identified. The PP-1 Pond is located on the middle bench of the facilities area near the prep plant. The pond held water below the discharge level (Photo 4). There were no erosion or stability issues identified in the PP-1 Pond. The PP-2 Pond is located on the upper facilities bench. The outlet structure was in good condition with no vegetation obscuring the outlet (Photo 5). No erosion or stability issues were identified on the PP-2 Pond. Water diversion ditches throughout the main facilities area were unobstructed and stable.

Photo 3: View to the west of embankment of the DP-1 Pond.

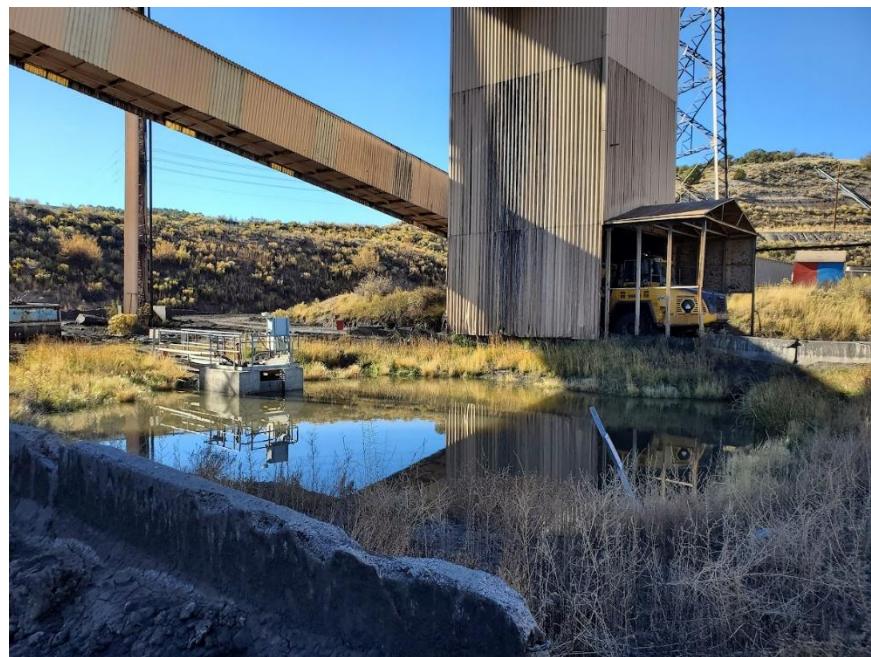
Photo 4: View to the southwest of PP-1 Pond.

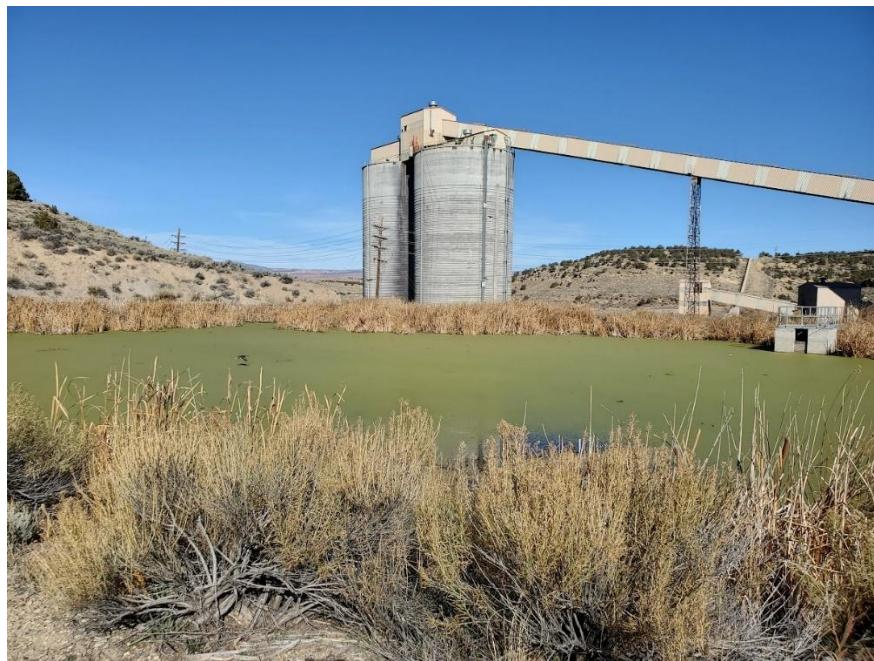
Photo 5: View to the northwest of the PP-2 Pond outlet.

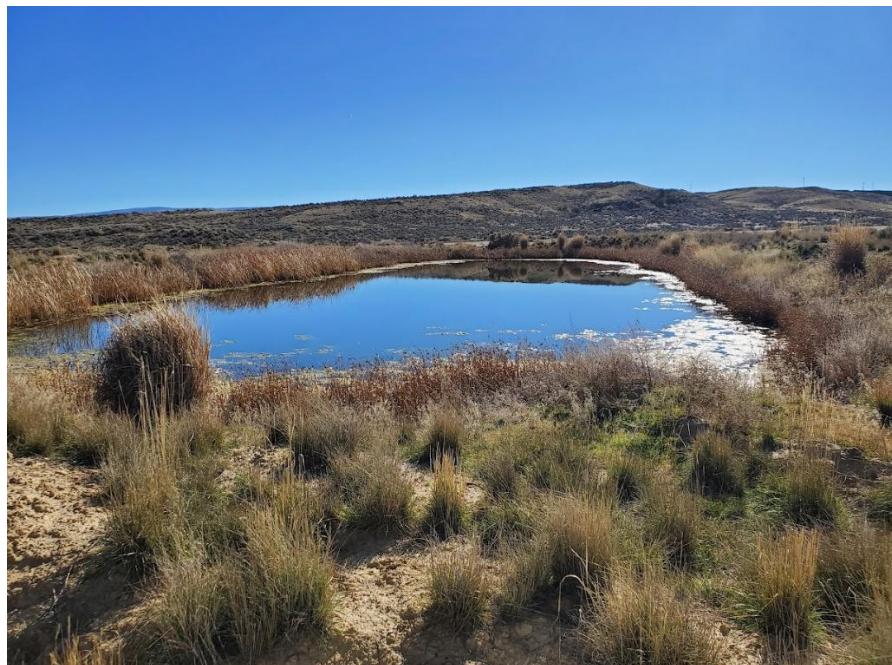
The B Seam Dewatering System No. 1 was active during the inspection. Cells were impounding water. The cells were stable with no erosional or other stability features noted. There was well established vegetation on the embankments of the cells (Photo 6).

Photo 6: View to the east of the Last Chance Pond – part of the B Seam Dewatering System No. 1.

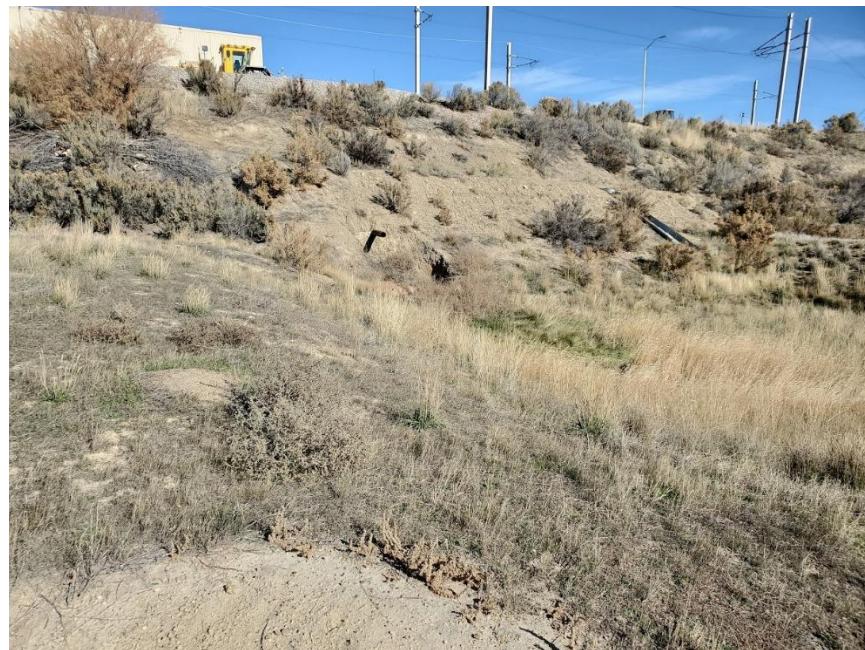
The RS-1 Sump and the RR-1 Pond are located at the south side of the Rail Loadout. The RS-1 Sump was dry. There were no indications of erosion around the sump. The RR-1 Pond was dry. The embankments of the pond seem stable. The erosion feature on the northern embankment that has been noted in previous inspection reports does not appear to have grown in size (Photo 7). The Rail Loadout Storage South Ditch has vegetation debris but does not appear obstructed and is able to convey water.

Photo 7: View to the north of erosion scar on rail pond. Had not enlarged.

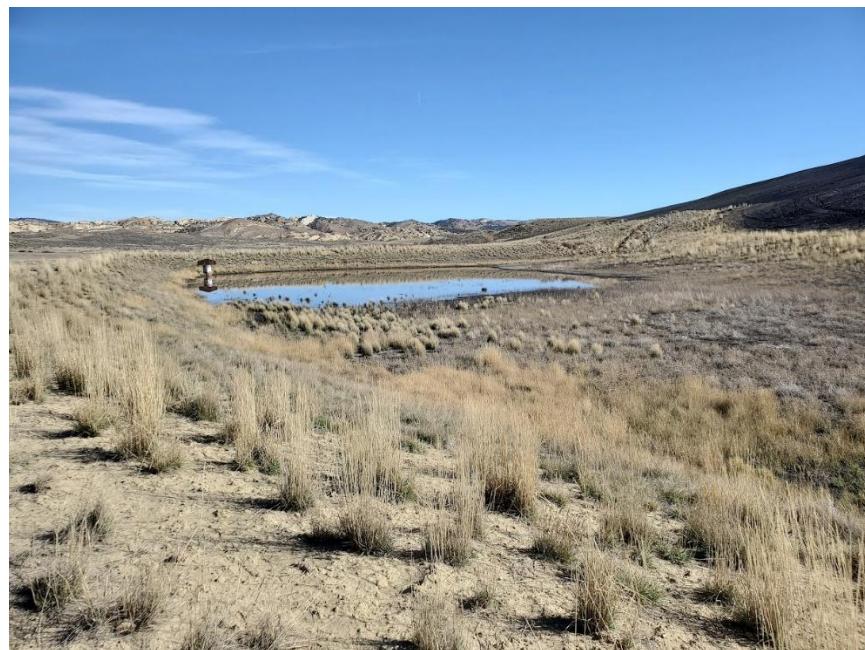
Two ponds are located at the northern base of Refuse Pile RP-2/3/4. The RP -2/3 Pond is located on the pile's northeast corner and was not inspected. The RP-4 Pond is located at the northwest base of the pile. The pond was holding water during the inspection (Photo 8). The outlet for the RP-4 Pond is capped with a trash rack. The outlet was clear of debris. Animal burrows were in the embankments of the RP-4 Pond and were filled during the inspection. Channels above the pond appear free of obstruction and able to convey water.

Photo 8: View to the east of water in RP-4 Pond

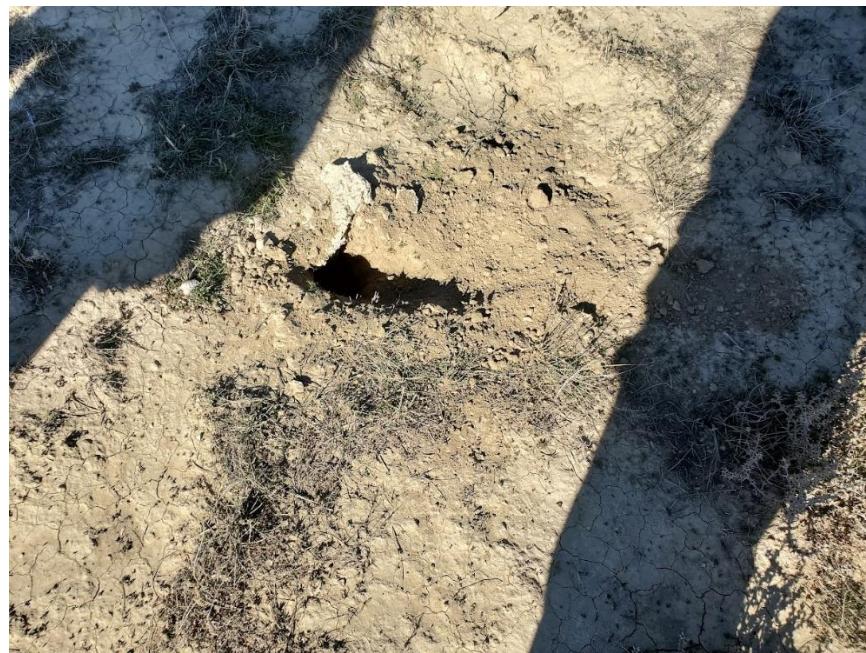
Pond RP-5 is located at the northern base of the RP-5a Refuse Pile. The pond was dry at the time of the inspection. The embankments of the ponds were vegetated, but numerous burrows were discovered (Photo 9). These burrows were filled during the inspection. The outlet was clear of obstructions.

Photo 9: View to the north of animal burrow on the RP-5 Pond embankment.

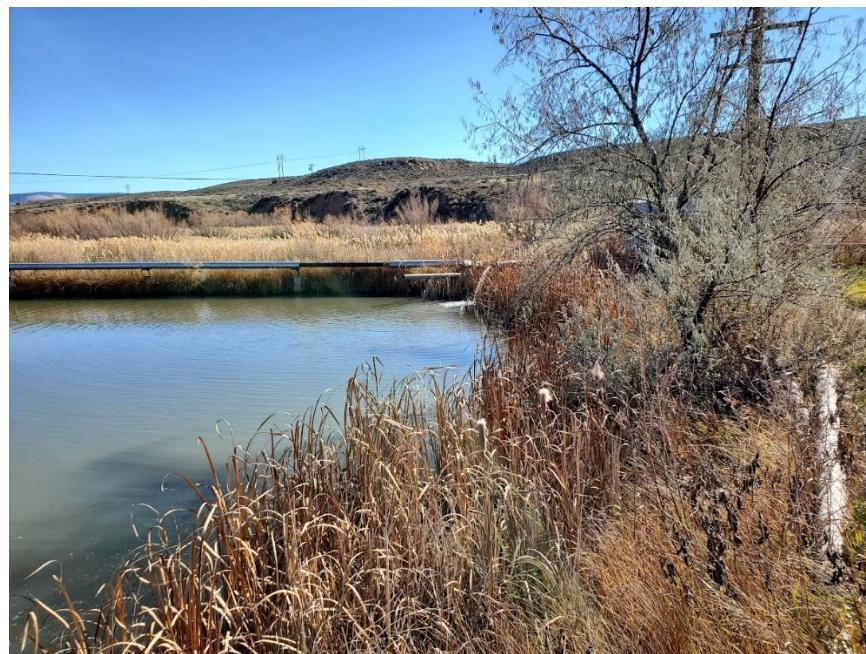
The Raw Water Lagoon is in the southeastern portion of the permit boundary off CR-65 and adjacent to the White River. There was no evidence of erosion or instability along pond embankments. The pipeline that moves water

from the river into the pond was in good condition (Photo 10). The pump that delivers water from the pond to the facilities area was free of obstructions/debris time of the inspection.

Photo 10: View to the east of inlet to Raw Water Lagoon.

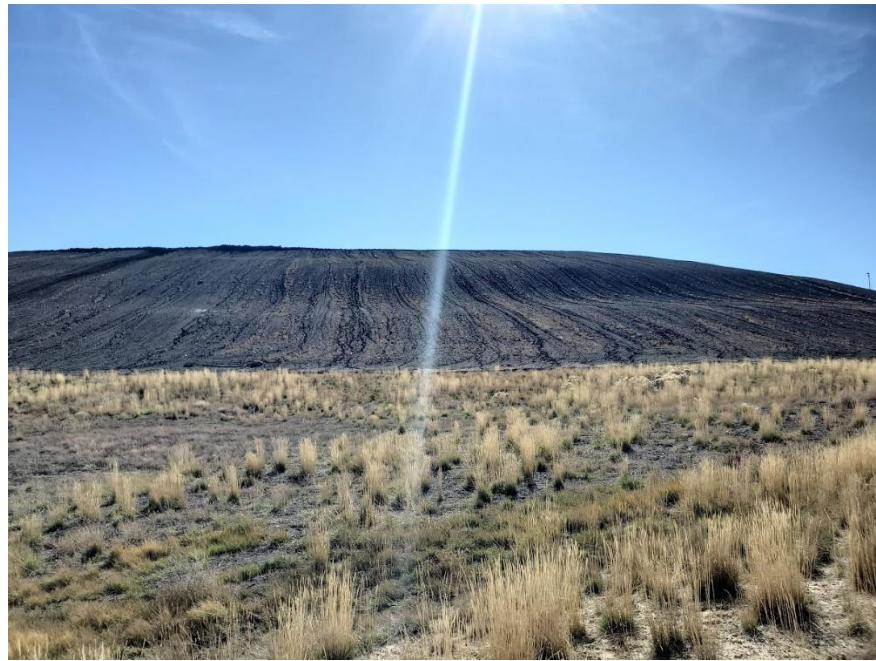
The RP-2/3/4 pile was stable. The operator graded the slopes of the stack to remove erosional rills the spring. Small rills have since reappeared in the slopes of the stack (Photo 11). However, the rills are not significant in size and do not appear to compromise the stability of the slope.

Photo 11: View to the south of rills on the RP-2/3/4 Pile

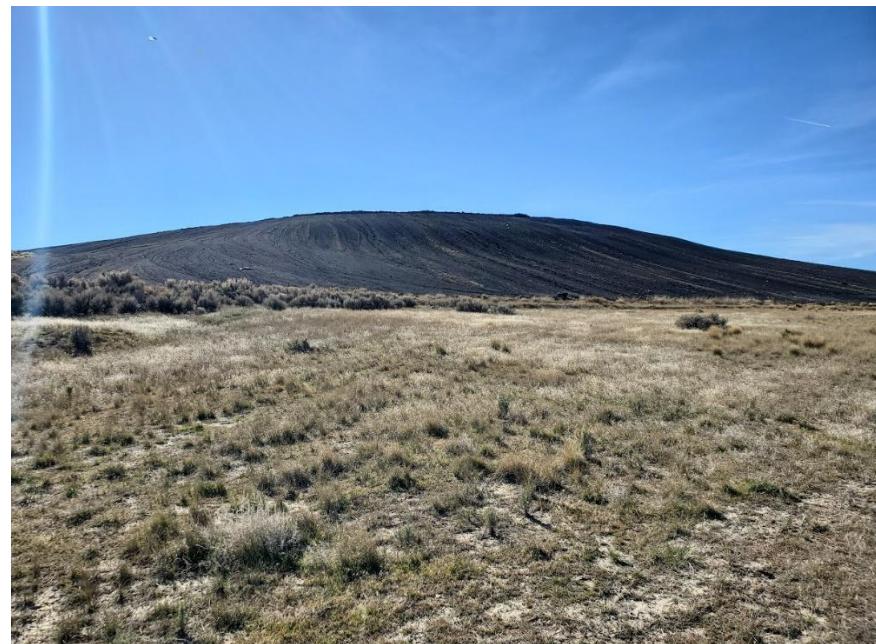
The RP-5a pile appeared stable during the inspection. Similar to the RP-2/3/4 pile, minor rills have appeared on the slopes of the pile since the operator graded in spring (Photo 12). The rills are not significant in size and do not appear to compromise the stability of the slope.

Photo 12: View to the south of rills on the RP-5a Pile.

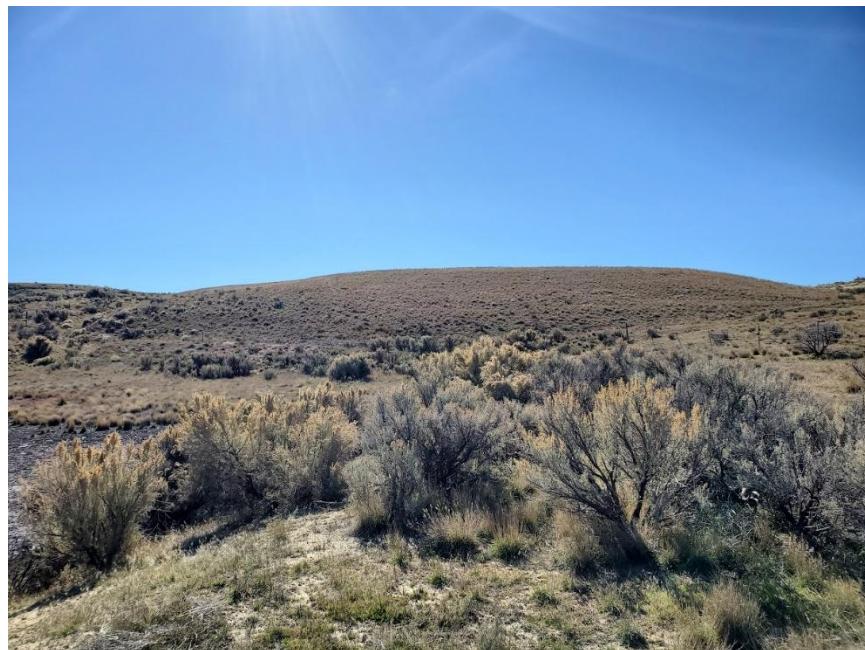
The RP-1 refuse pile has been reclaimed for several years. Vegetation is well established and protects the pile (Photo 13). No indications of instability of erosion were observed. The perimeter ditches appear stable with no erosion concerns.

Photo 13: View to the south of reclaimed RP-1 Stack

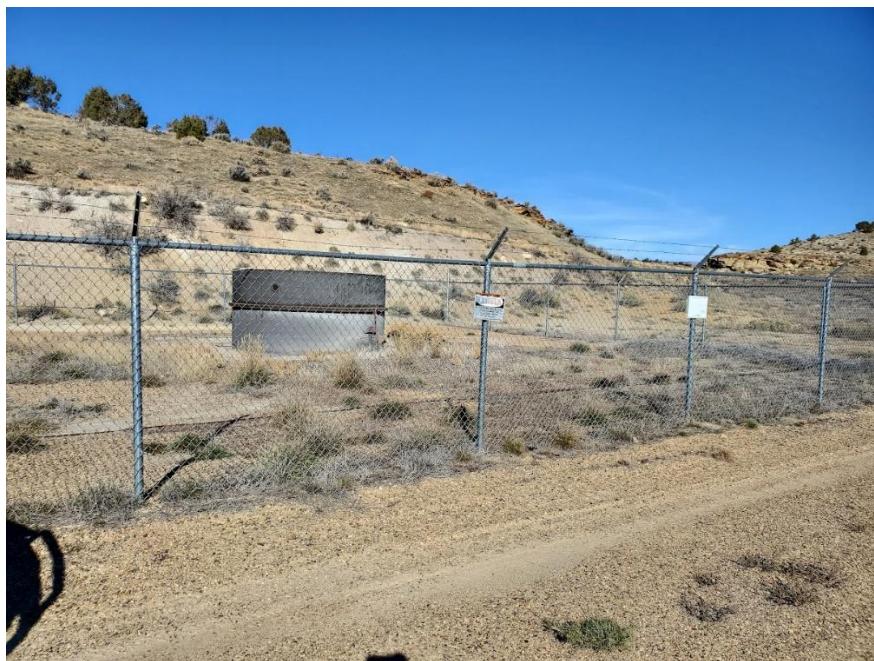
The B Seam Vent Shaft #1 is located north of the main facilities off of the haul road. The pad was stable with no erosional features. The fencing around the shaft to prevent unauthorized entry was in good condition (Photo 14)

Photo 14: View to the northwest of B Vent Shaft

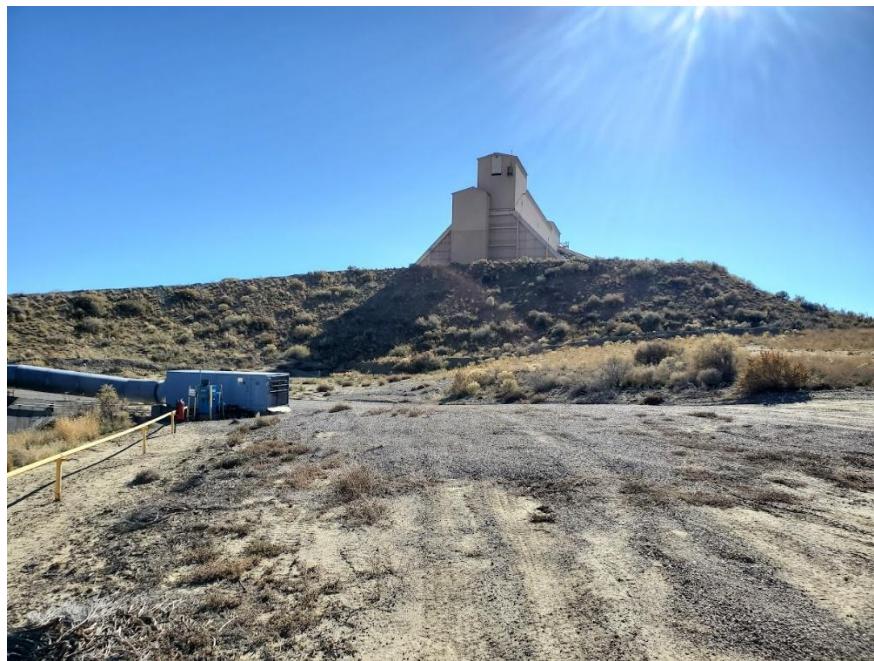
The Slot Storage Facility is located just to the south of the rail loadout. The pad that surrounds the Slot Storage is in good condition with a berm to control erosion. There were no erosional features noted on the embankments below the slot storage building (Photo 15).

Photo 15: View to the south of Slot Storage Facility

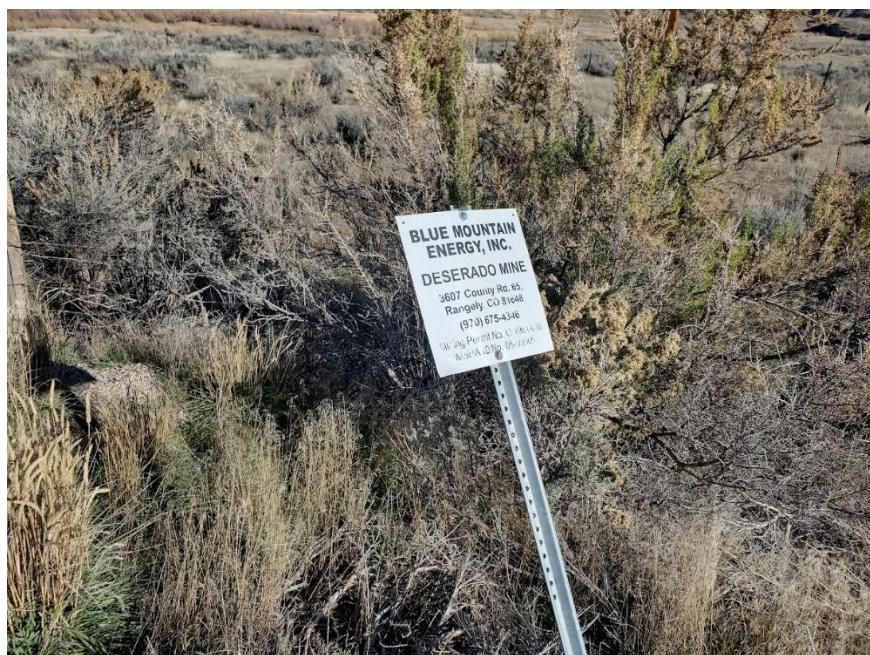
A mine identification sign was observed to be posted on the right-hand side of CR-65 as the county road enters the permit boundary. The sign was placed in an unobstructed location and the text was easily legible. Information on the sign contained the mine permit number, permittee name and contact information (Photo 16).

Photo 16: View to the west of mine ID sign at permit boundary.

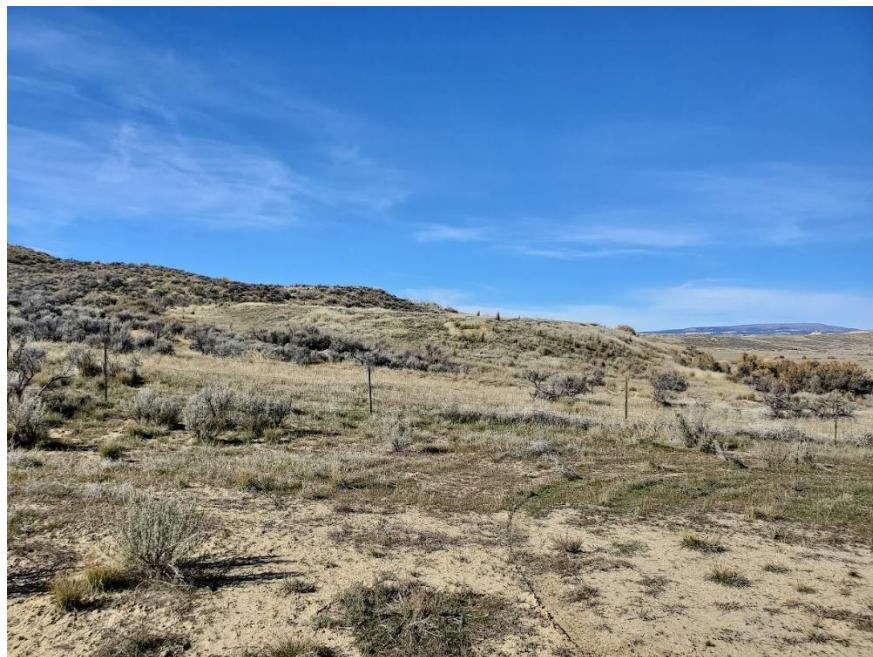
Topsoil stockpiles are located throughout the mine site. Topsoil stockpiles observed during this inspection include the facilities, B-Vent Shaft #1, rail loop stockpiles and the RA 2 stockpile (Photo 17) near the refuse pile. The stockpiles were protected by vegetation and showed no indications of erosion or instability. Topsoil piles that were observed had topsoil markers at the top of the pile. The markers are T-posts covered with pieces of white PVC. The markers were placed in visible locations and easy to spot. The facilities topsoil stockpile has armored channels that direct water. Channels are in good condition and show no signs of erosion.

Photo 17: View to the west of the RA2 topsoil stockpile.
