**MINERALS PROGRAM INSPECTION REPORT**  
**PHONE: (303) 866-3567**

| <b>MINE NAME:</b><br>C-JD-5 | <b>MINE/PROSPECTING ID#:</b><br>M-1977-248 | <b>MINERAL:</b><br>Uranium and vanadium | <b>COUNTY:</b><br>Montrose |
| <b>INSPECTION TYPE:</b><br>Monitoring | <b>WEATHER:</b><br>Clear | <b>INSP. DATE:</b><br>October 27, 2025 | <b>INSP. TIME:</b><br>14:00 |

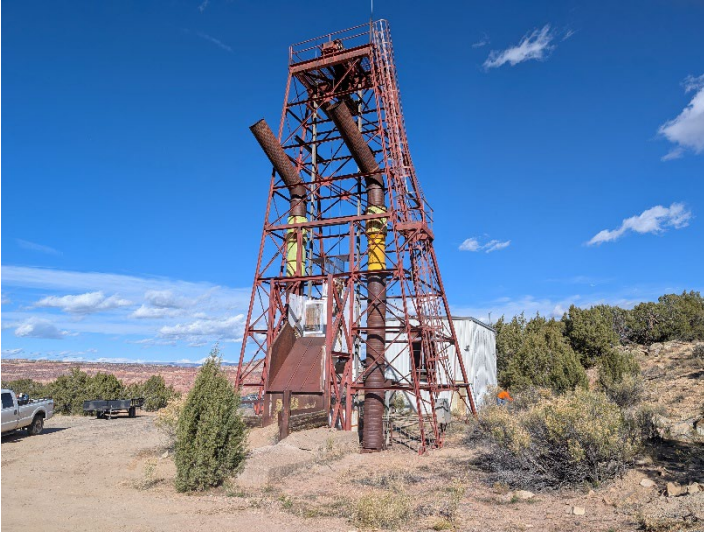
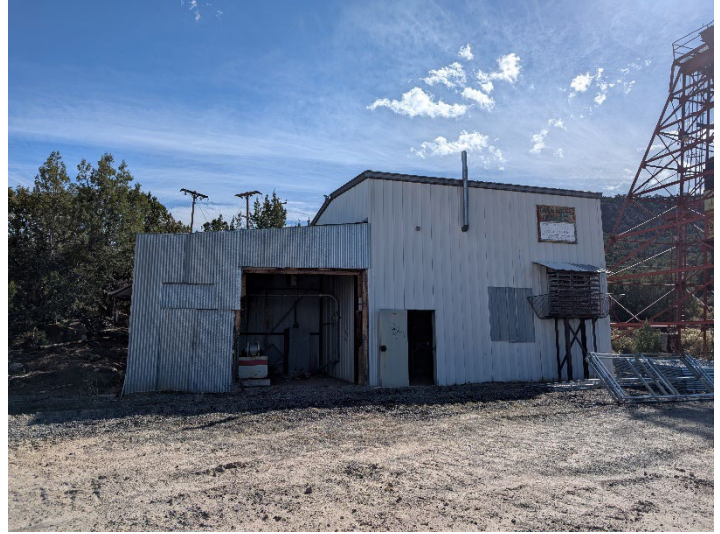
The head frame and hoist/compressor house structures remain on site. TR3 proposed securing these structures within fencing. Fencing materials were located on site, however the fencing was not yet installed at the time of this inspection.

Head frame and hoist/compressor house structures remain on site

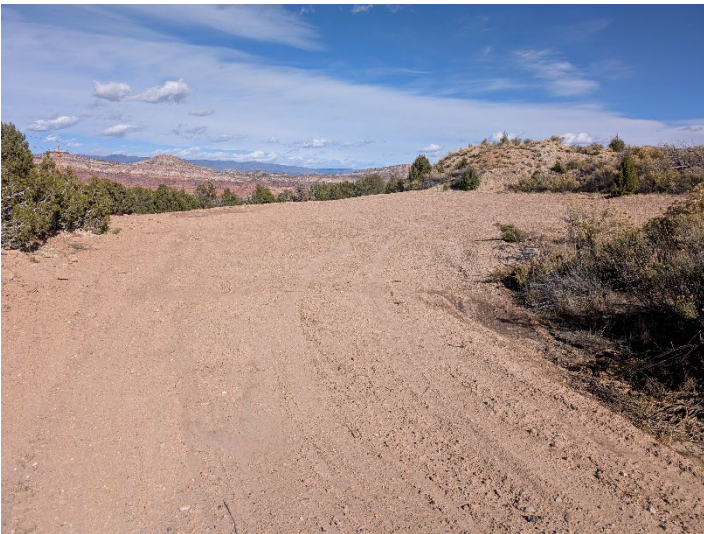
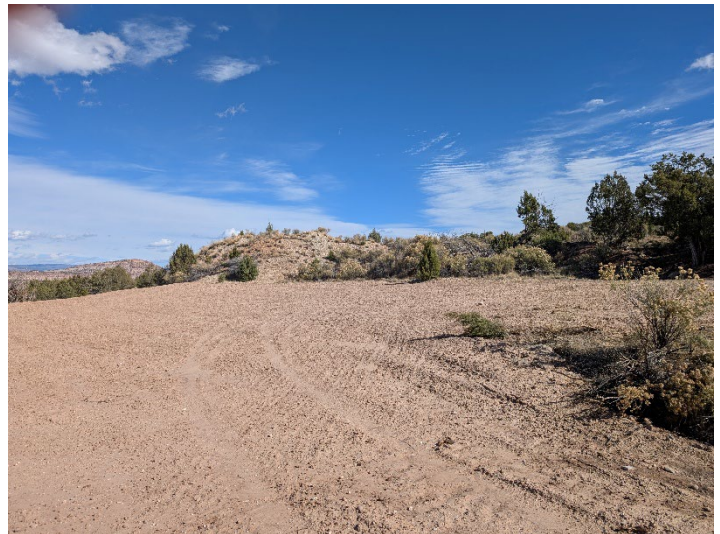
In the Ore Bin area and the Joe Dandy Decline area, the wood debris has been removed, and the areas have been regraded and covered with cover soil. The areas have not been reseeded yet.

Ore bin area – debris removed, area regraded

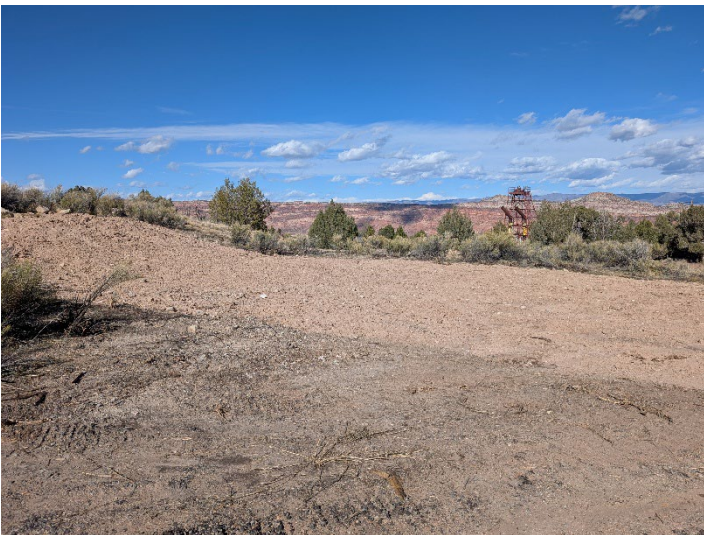
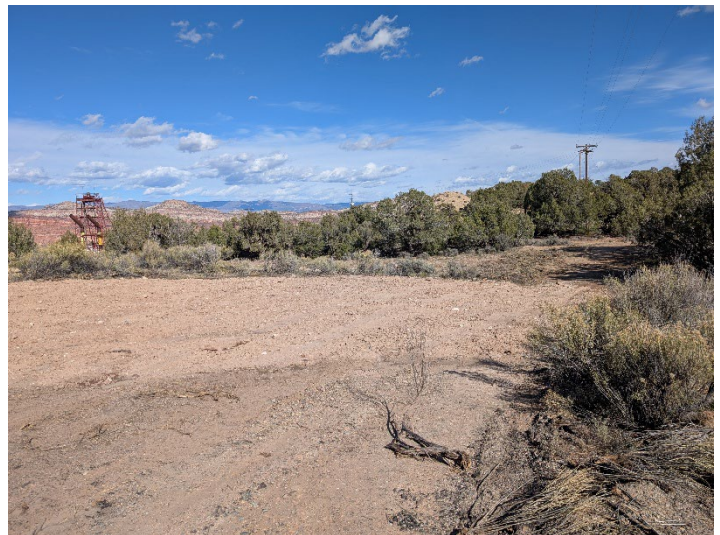
Joe Dandy Decline area – debris removed, area regraded

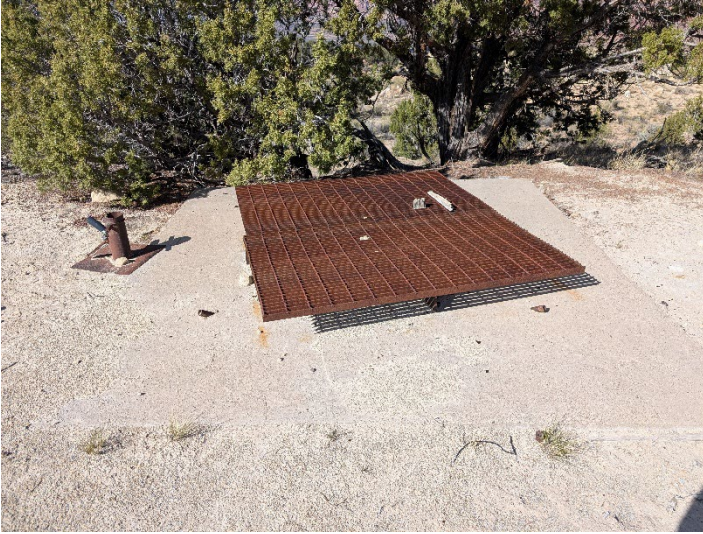
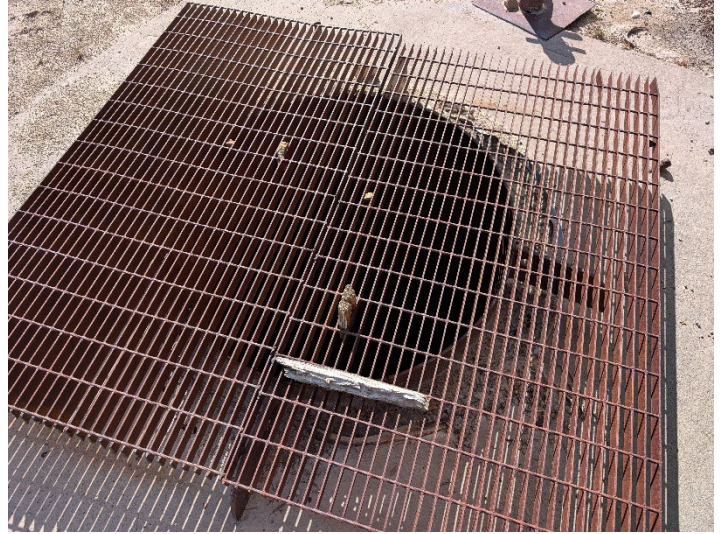
The vent shaft remains in place. The shaft is secured with steel grating welded to the shaft collar.

Vent shaft secured with steel grating welded to collar

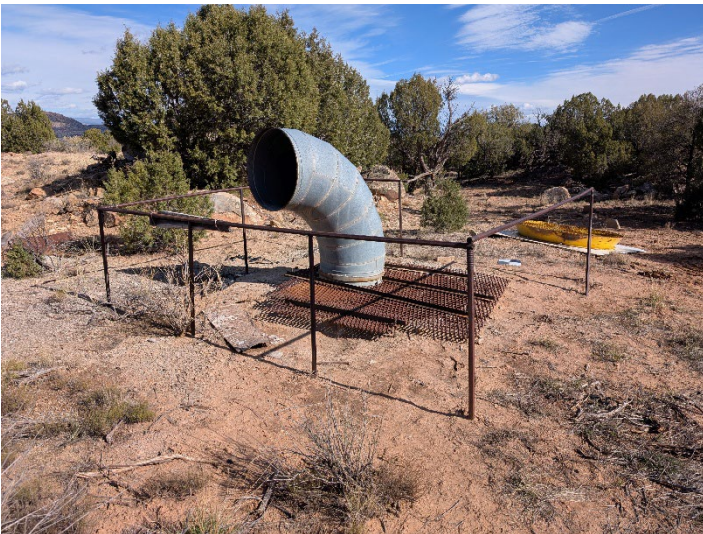
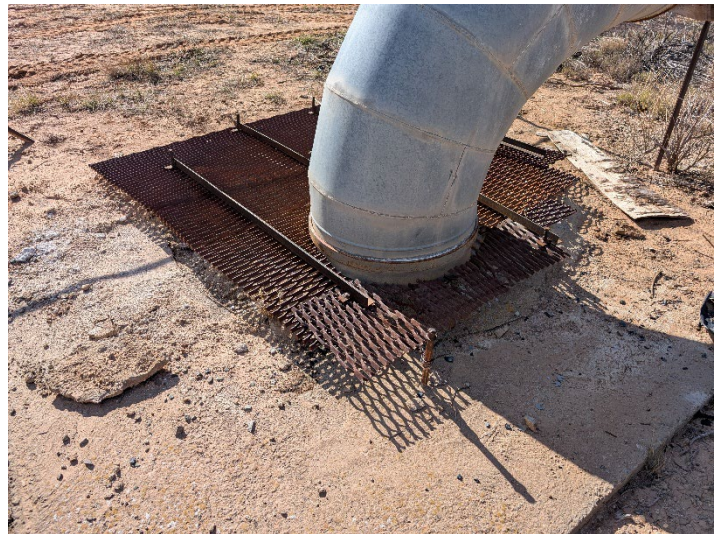
The vent fan and wood cribbing have been removed. The vent fan shaft had not yet been secured with grating welded to the collar.

Ventilation fan shaft – fan removed, shaft not yet secured
