### MINERALS PROGRAM INSPECTION REPORT

| <b>MINE NAME:</b><br>Bayfield Pit No. 1 | <b>MINE/PROSPECTING ID#:</b><br>M-1987-038 | <b>MINERAL:</b><br>Sand and gravel | <b>COUNTY:</b><br>La Plata |
| <b>INSPECTION TYPE:</b><br>Monitoring | <b>WEATHER:</b> Clear | <b>INSP. DATE:</b><br>October 28, 2025 | <b>INSP. TIME:</b><br>10:00 |

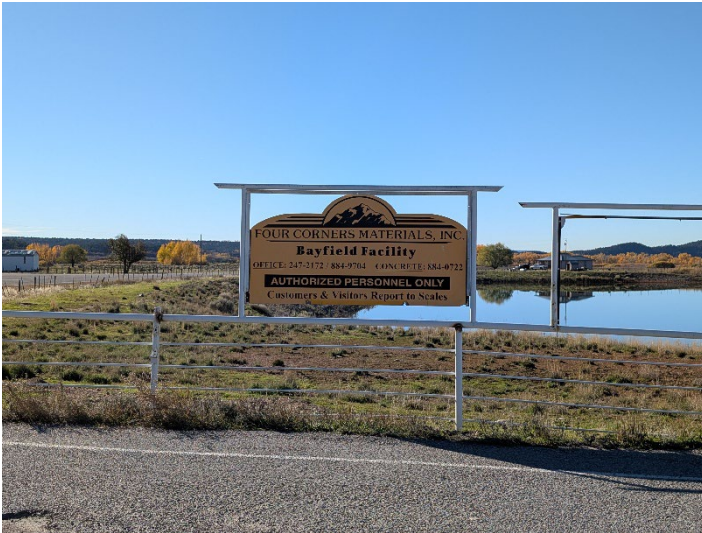
**PROBLEM:** The mine identification sign posted at the entrance of the mine site does not meet the requirements of Rule 3.12.1 (1), which states that the sign shall contain the permit number.

**Adequate mine identification signage was not noted at the entrance to the site. The sign posted at the entrance does not include the permit number. This was noted as a problem at the beginning of the report.**

Mine sign missing permit #

**CORRECTIVE ACTIONS:** The operator shall, at the entrance of the mine site, post a sign which shall be clearly visible from the access road with the following: the name of the operator, a statement that a reclamation permit for the operation has been issued by the Colorado Mined Land Reclamation Board; and the permit number. The operator shall submit photo documentation that a proper sign has been posted by the corrective action date.

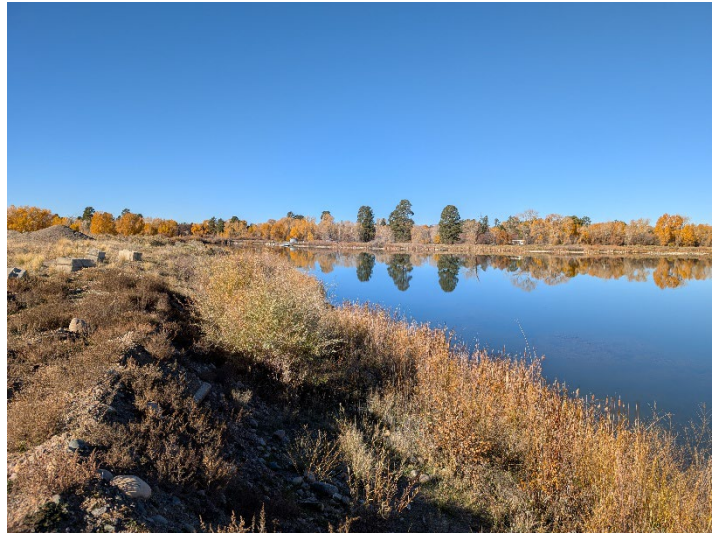
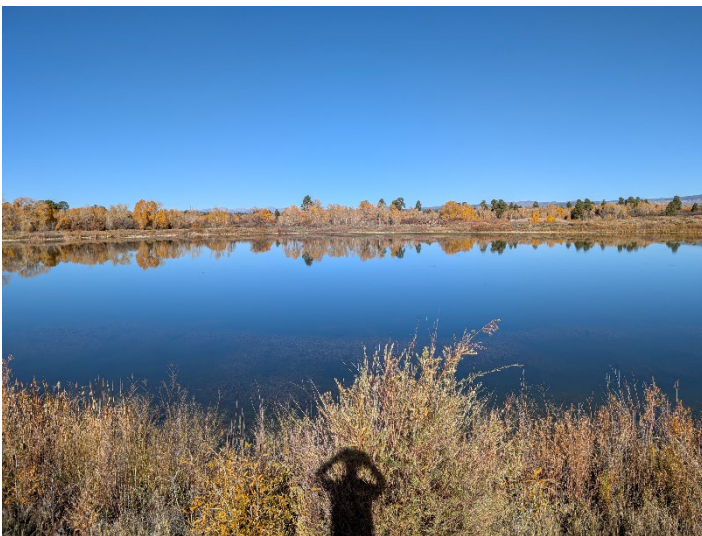
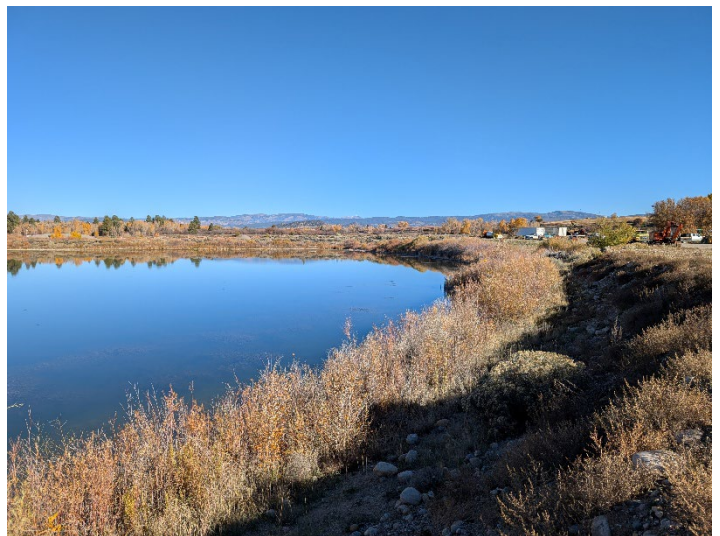
In the south part of the permit area there is a pond that covers approximately 23 acres. The pond banks are graded to approximately 2H:1V and appear stable. Vegetation is becoming well established on the slopes. No slope stability concerns were noted. No noxious weed infestations were noted.

South pond viewed from east side

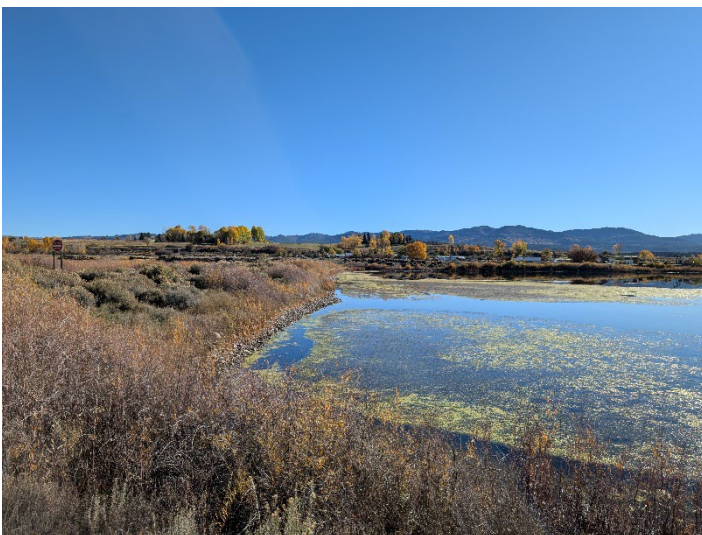
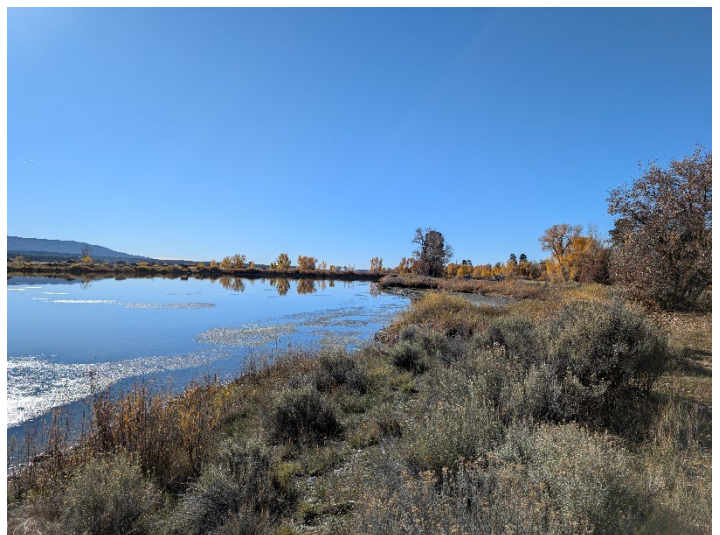
South pond viewed from NW side

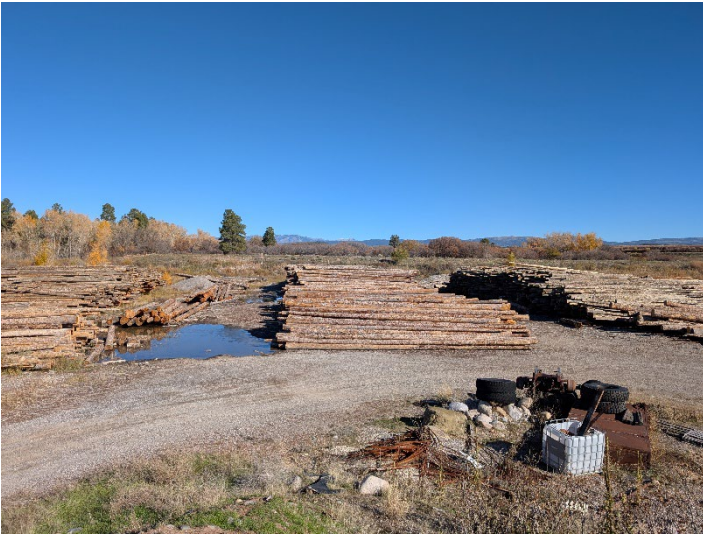
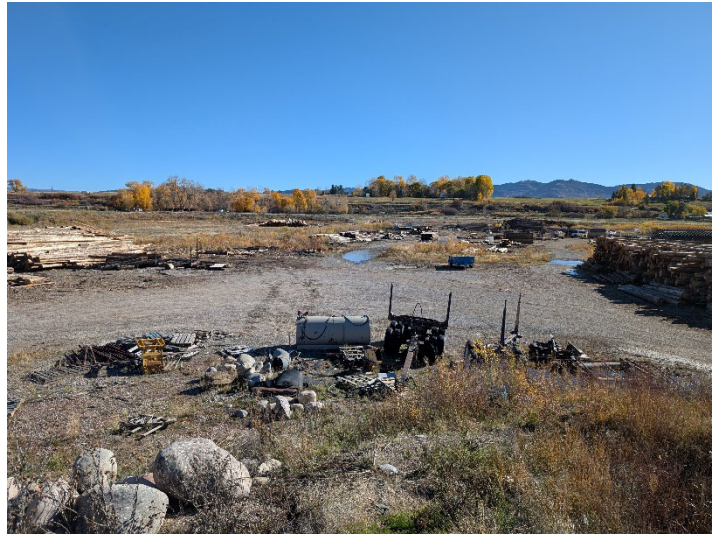
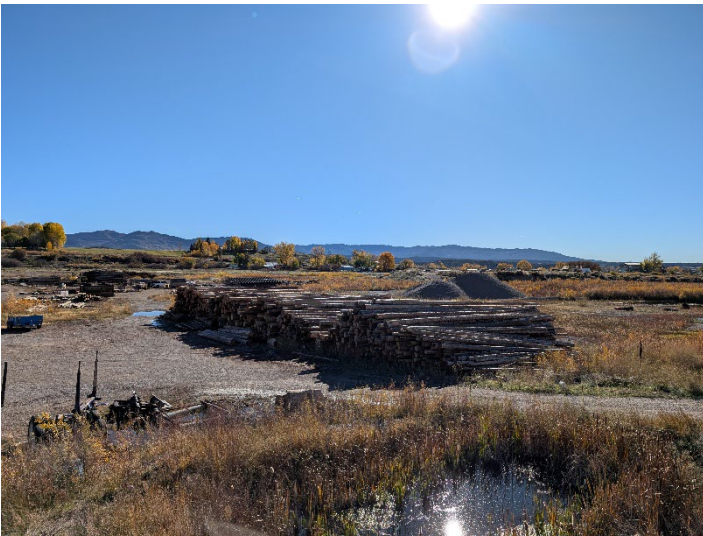
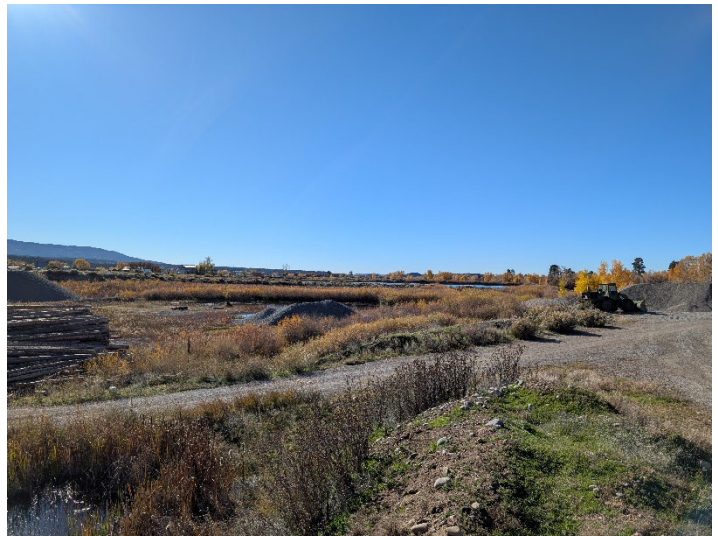
The north part of the permit area is currently in use by a logging operation. Logs and logging equipment are stored throughout the area. No stability or erosion concerns were noted here.

Logging operations in north part of permit area
