MINERALS PROGRAM INSPECTION REPORT
PHONE: (303) 866-3567

| MINE NAME: Hocker Gravel Pit | MINE/PROSPECTING ID#: M-2004-063 | MINERAL: Sand and gravel | COUNTY: La Plata |
| INSPECTION TYPE: Monitoring | WEATHER: Clear | INSP. DATE: October 28, 2025 | INSP. TIME: 11:00 |

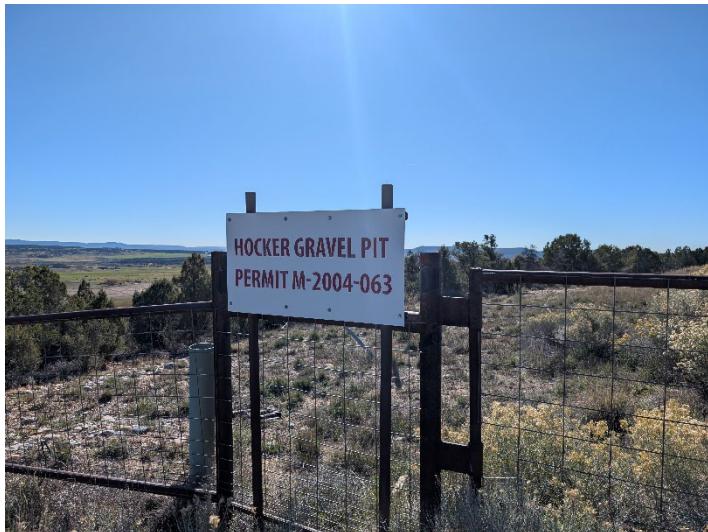
Adequate mine identification signage was noted at the entrance to the site.

Sign at site entrance

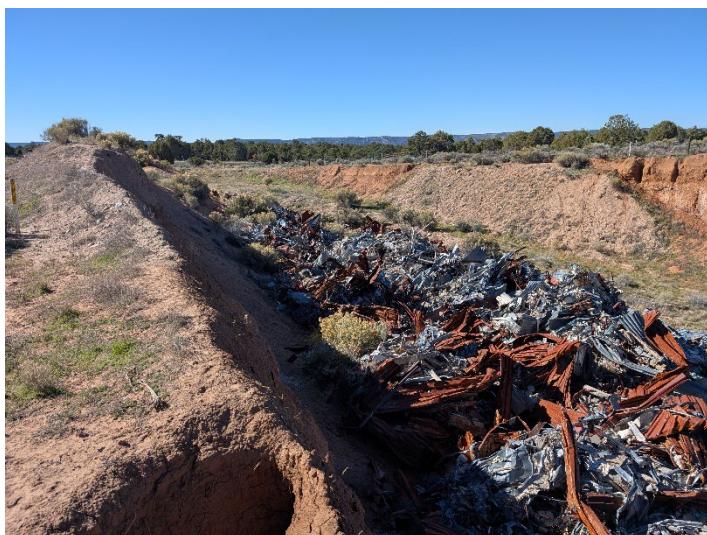
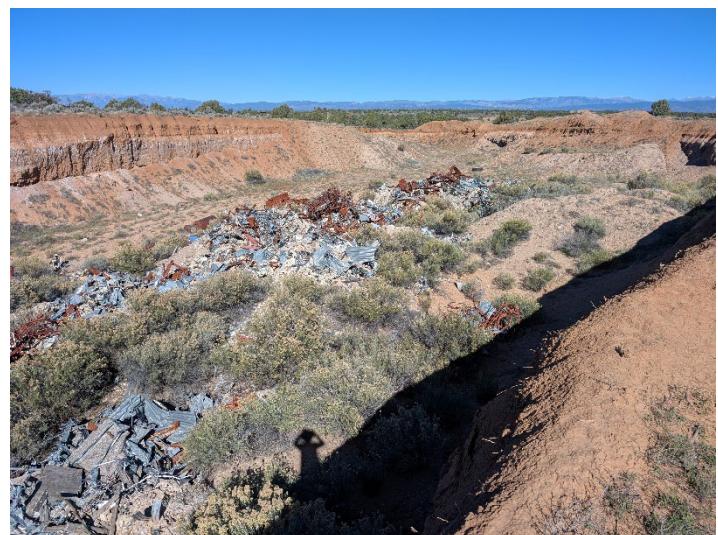
Construction debris approved for burial through TR1
