## Inspection Report for the Benson Brothers Pig Mesa Pit

**MINERALS PROGRAM INSPECTION REPORT**  
**PHONE: (303) 866-3567**

| <b>MINE NAME:</b><br>Benson Brothers Pig Mesa Pit | <b>MINE/PROSPECTING ID#:</b><br>M-2004-084 | <b>MINERAL:</b><br>Sand and gravel | <b>COUNTY:</b><br>Delta |

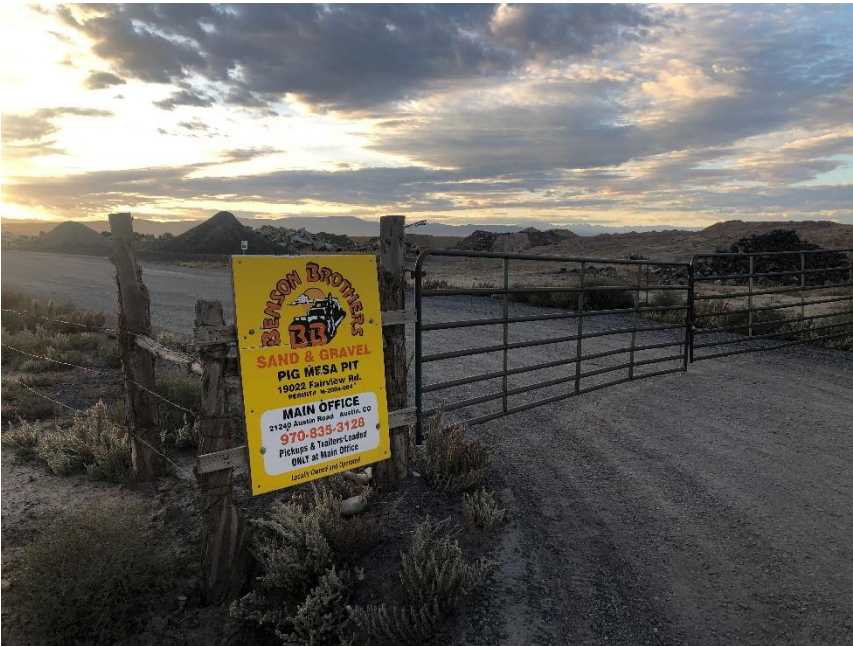
**PROBLEM #1:** The mine identification sign at the entrance of the site does not include all of the necessary information per Rule 3.1.12(1).

The entrance sign was clearly visible at the entrance to the pit. The entrance sign was large enough, however, per Rule 3.1.12(1), the sign must include a statement that a reclamation permit for the operation has been issued by the Colorado Mined Land Reclamation Board . This is cited as a problem in this report (see Problem #1). The approved affected boundary was well marked with fences (as required by Rule 3.1.12(2)), except for the south side of the site, where the operation has extended their pit beyond the approved southern permit boundary.

Photo 1. Entrance sign lacking reference to MLRB

**CORRECTIVE ACTIONS:** The operator shall, at the entrance of the mine site, post a sign which shall be clearly visible from the access road with the following: the name of the operator, the operation name, a statement that a reclamation permit for the operation has been issued by the Colorado Mined Land Reclamation Board, and the permit number. The operator shall submit photo documentation that a proper sign has been posted by the corrective action date.

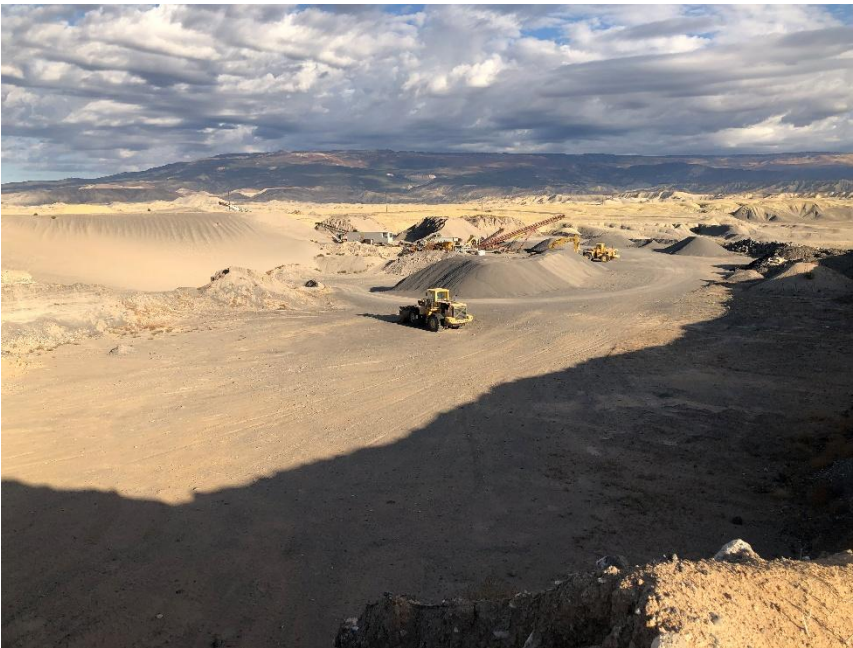
Photo 2. Processing area and stockpiles

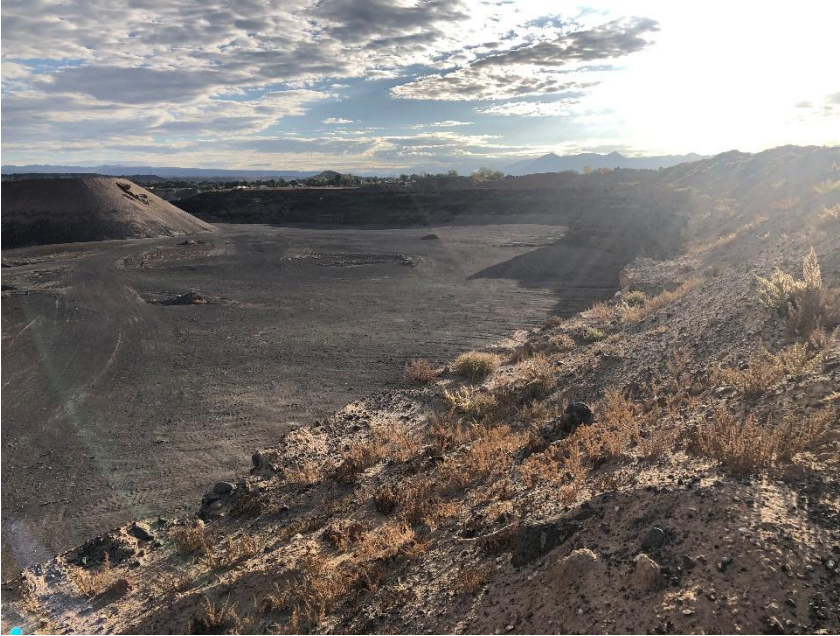
**POSSIBLE VIOLATION #1:** Approximately 4.5 acres of land has been affected outside of the approved permit boundary. This is a possible violation at this time pursuant to C.R.S. 34-32.5-109(1) for failure to first obtain from the Board or Office a reclamation permit prior to engaging in a new mining operation.

A portion of the Benson Brothers pit has been extended south into the permit area for the Pig Mesa Pit operated by Delta County (M-1978-168). According to aerial imagery in Google Earth, this encroachment started sometime between August 2019 and April 2023. The imagery also indicates that the Benson Brothers pit extends approximately 4.5 acres and approximately 120 feet beyond the approved southern permit boundary. Although Benson Brothers has an agreement with the County to mine in this area, there was no amendment to the mine permit to increase the acreage of the affected land, per Rule 1.1(6). The Division considers any offsite affected land that exceeds two acres in size to be substantial, and to therefore fall into the category of operating without a permit. Accordingly, a Possible Violation is cited in this report (see Possible Violation #1) for failure to first obtain from the Board or Office a reclamation permit prior to engaging in a new mining operation.

**Photo 3. Portion of pit that is beyond the permit boundary, looking east**

**CORRECTIVE ACTIONS:** By the corrective action due date, the operator shall submit an Amendment application, with the required \$2,229 fee, to incorporate the offsite affected lands into the permit. This Amendment should include any additional revisions to permit exhibits, as required by the Division in this inspection report (see Possible Violation #2 and Problem #3). If the Amendment is not received by the corrective action due date, the Division will issue a "Reason to Believe a Violation Exists and Notice of Board Hearing" letter for the possible violation, and a hearing before the Mined Land Reclamation Board (MLRB) will be scheduled for consideration of this matter.

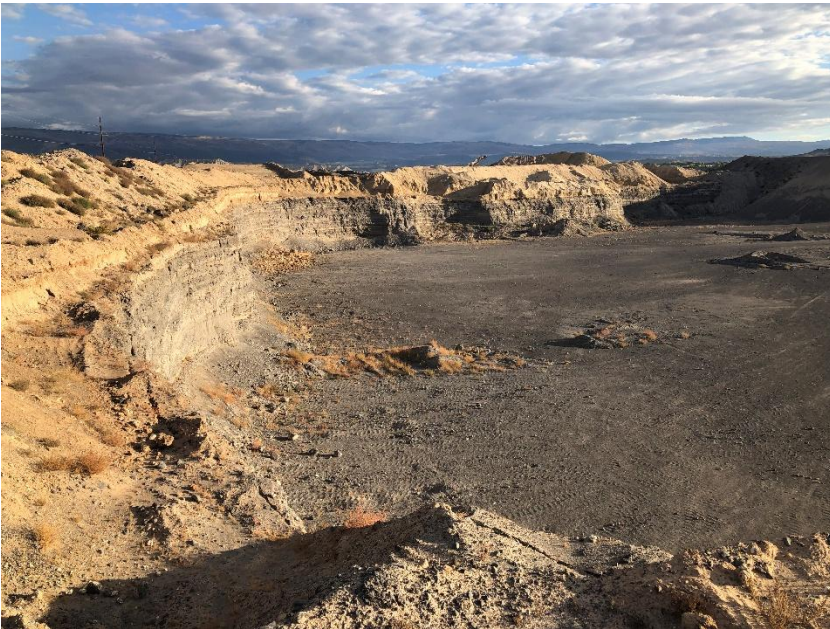
**Photo 4. Portion of pit that is beyond the permit boundary, looking north**

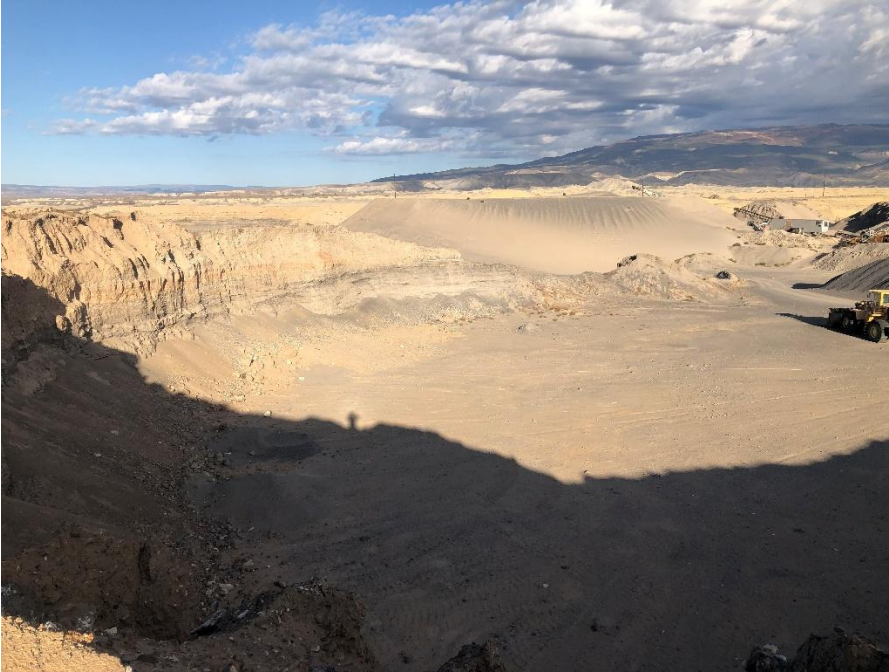
**Photo 5. Smaller pit on eastern portion of mine, looking west**

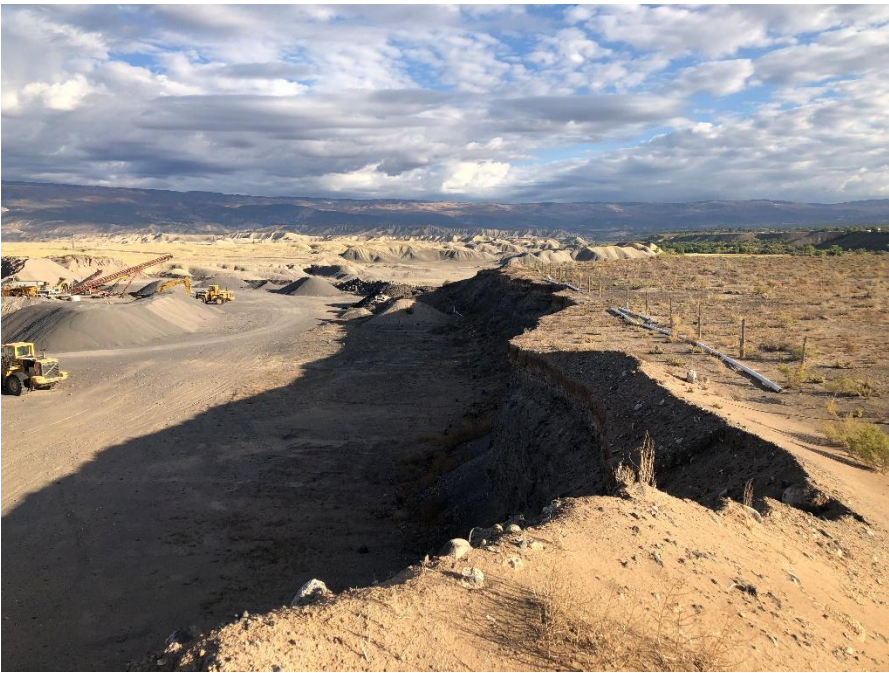
**Photo 6. Smaller pit on eastern portion of mine, looking north**

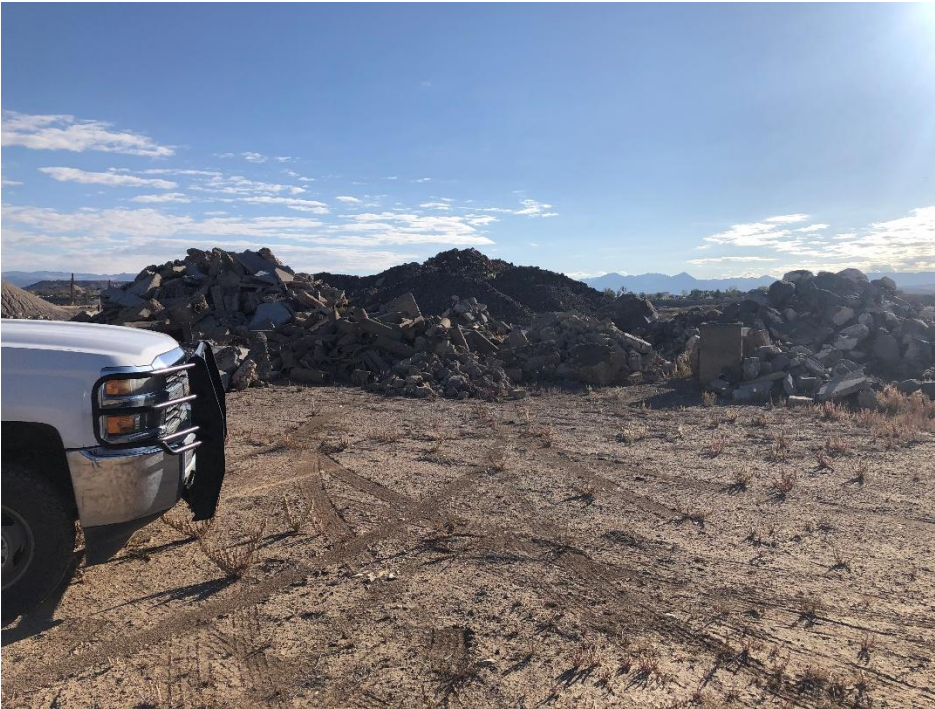
**Photo 7. Concrete rubble stored near entrance**

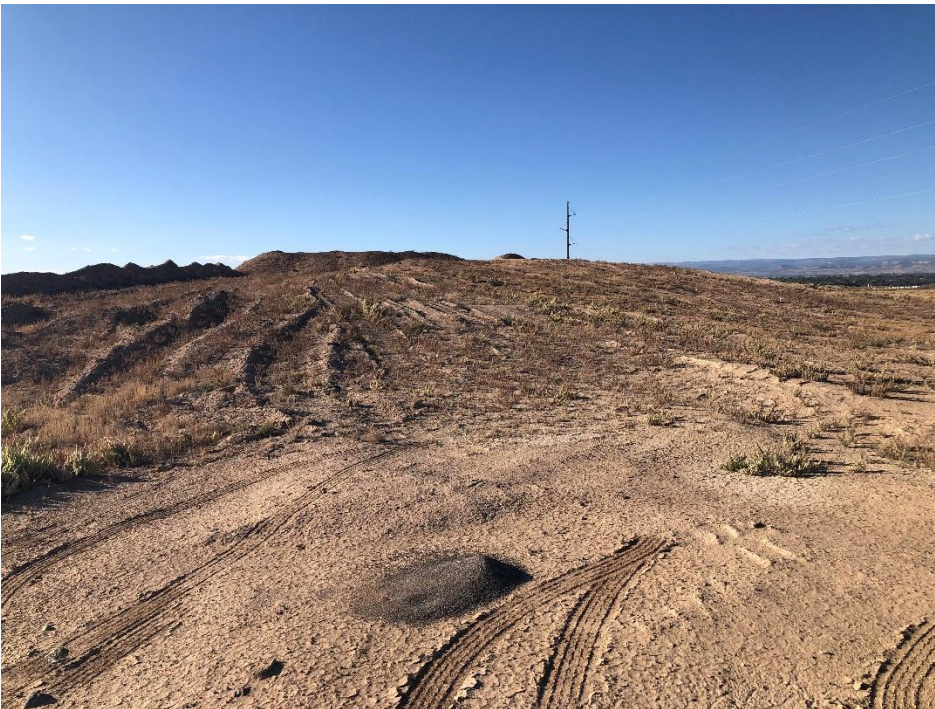
**Photo 8. Topsoil stockpile with some vegetation (erosion BMPs are recommended)**

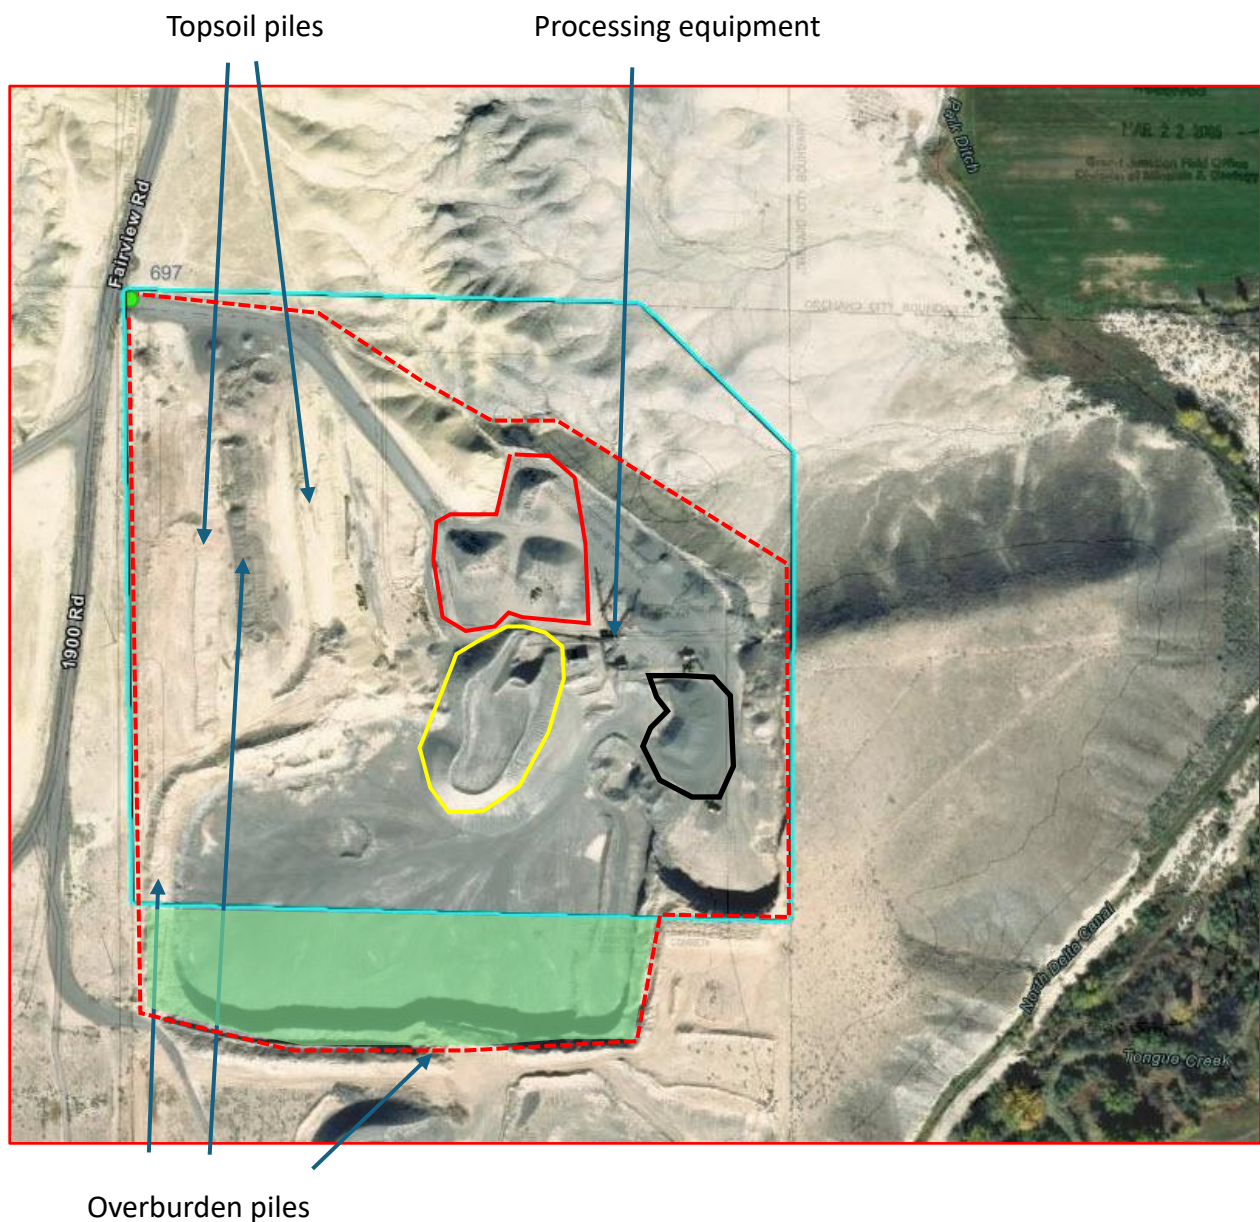
# **Map of Prominent Features at Benson Brothers Pig Mesa Pit**

*Green shaded area is disturbance beyond the permit area*
