Bowie #1 inspection report

Permit Number: C-1981-038 Mine Name: Bowie No. 1 Mine Operator: Bowie Resources, LLC Operator Address: Mr. Art Etter P.O. Box 1488 Paonia, CO 81428	County: Delta Operation Type: Underground Permit Status: Active Ownership: Private
	Operator Representative Present: None
Operator Representative Signature: (Field Issuance Only)

INSPECTION INFORMATION

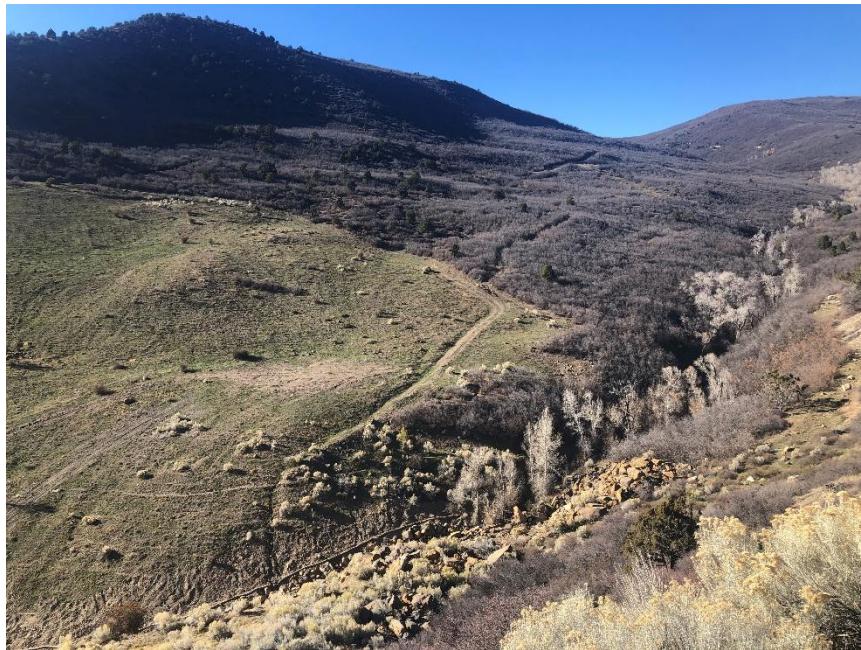
West Mine – road along northern side of main portion

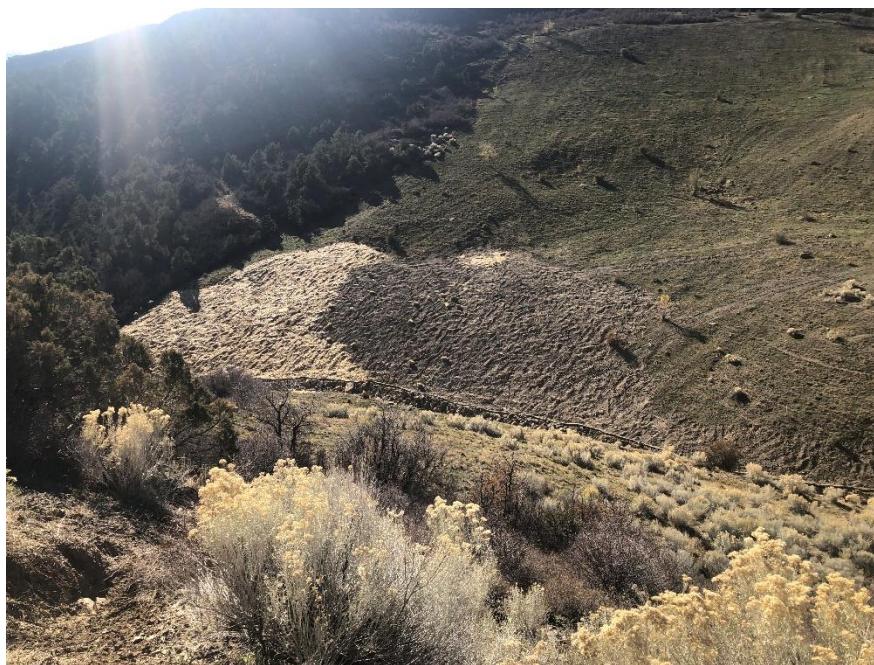
No mining activities were being conducted at this site. At the West Mine, BRL has removed the large culvert and ponds and seeded (per BRL staff seen at Bowie No. 2 Mine), and reclamation activities, namely spreading hay, were ongoing.

West Mine – straw on portion of reclamation

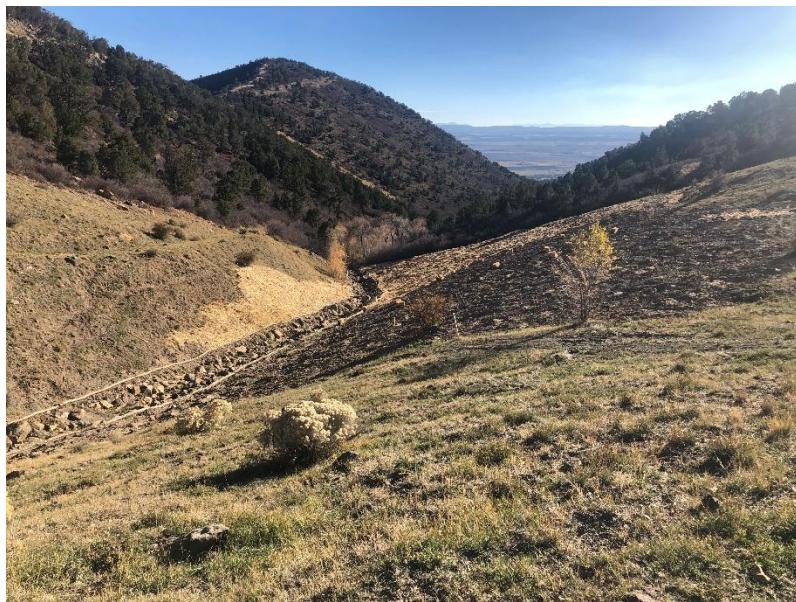
East Roatcap Creek at the West Mine appears stable. Per mud on the road to the West Mine (near the reclaimed fan area), the area had seen some rainfall in recent days, but the creek was not flowing during the inspection.

West Mine – reclaimed creek

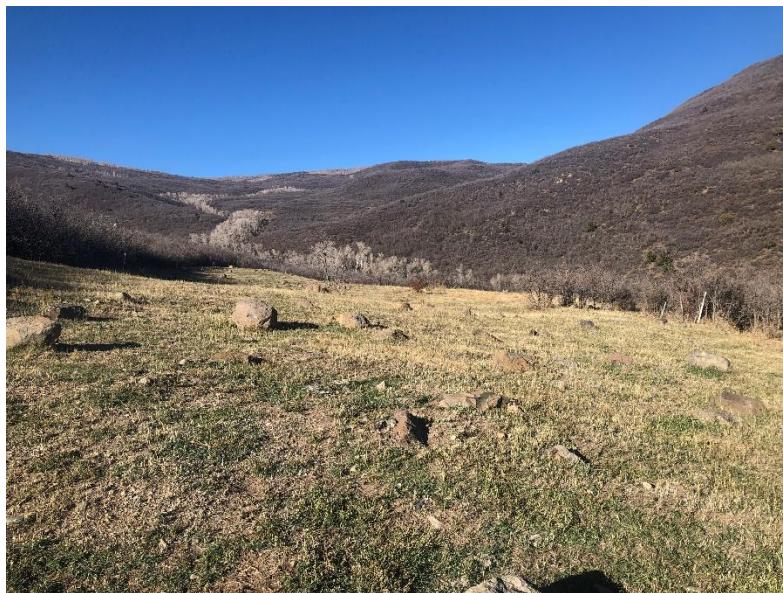
No erosion was seen in the previously reclaimed areas of the West Mine, including the reclaimed fan area.

West Mine – reclaimed fan area

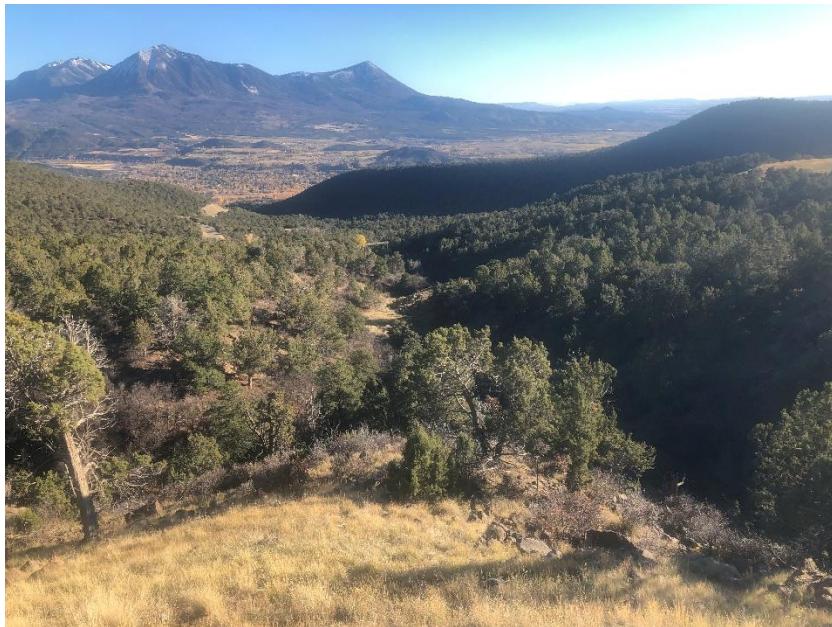
No problems were identified with the reclamation at Ponds 1, 2, 3, and 4 at the East Mine.

East Mine – looking down at reclaimed Ponds 3 and 4

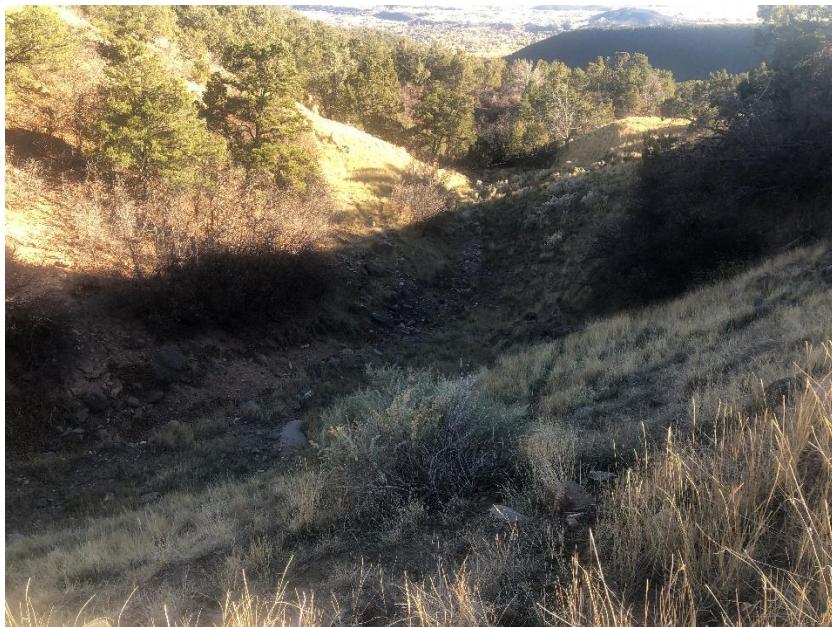
East Mine – looking down at reclaimed Pond 2

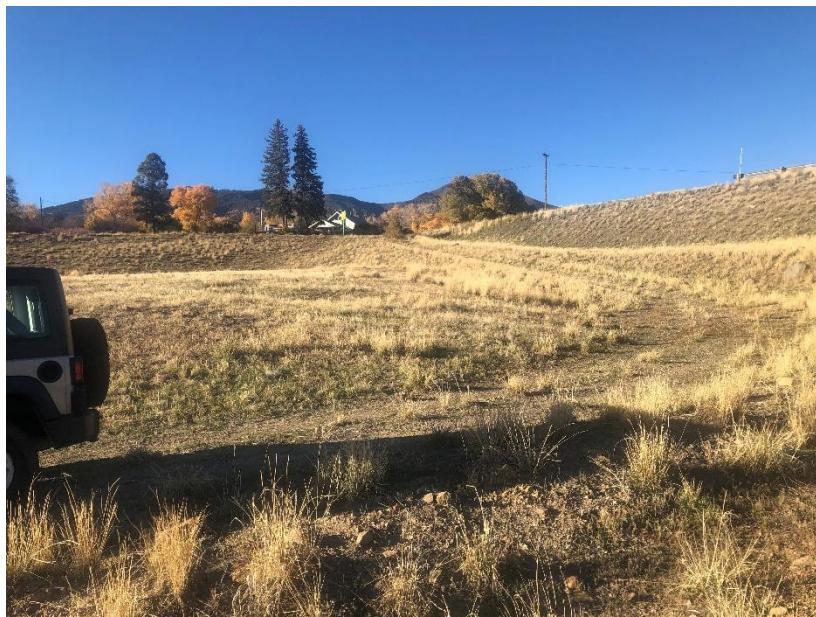
Cheat grass was prevalent at the coal storage area by the highway (as noted in past inspection reports). No other weed problems were observed at any of the locations that were inspected.

Coal storage by highway, looking up toward highway

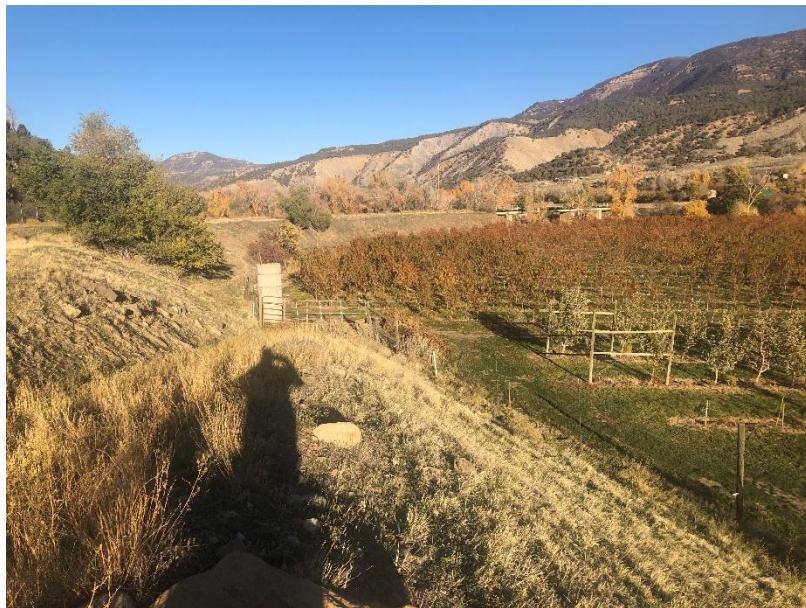
No erosion was seen at the storage area by the highway or the loadout, including the steep slope between the loadout and the orchard below. The trestle across the river appears stable.

Loadout, looking toward bridge
