## MINERALS PROGRAM INSPECTION REPORT

| <b>MINE NAME:</b><br>High Flume Gravel Pit | <b>MINE/PROSPECTING ID#:</b><br>M-1990-093 | <b>MINERAL:</b><br>Gravel | <b>COUNTY:</b><br>La Plata |
| <b>INSPECTION TYPE:</b><br>Monitoring | <b>WEATHER:</b><br>Clear | <b>INSP. DATE:</b><br>October 28, 2025 | <b>INSP. TIME:</b><br>14:15 |

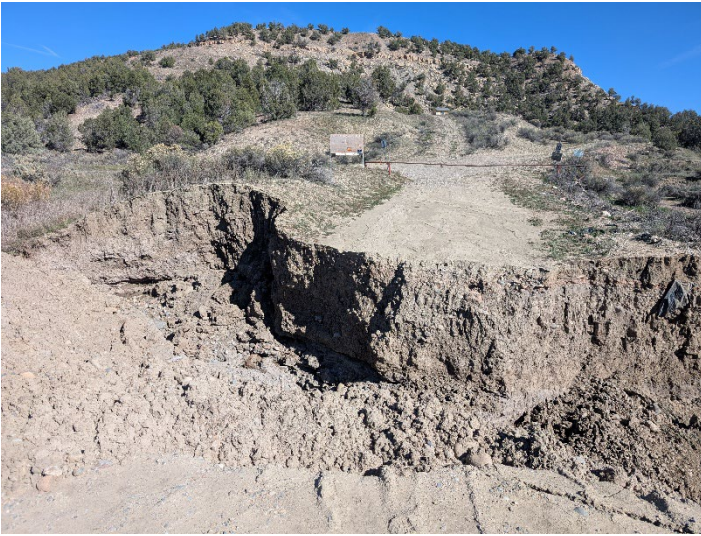
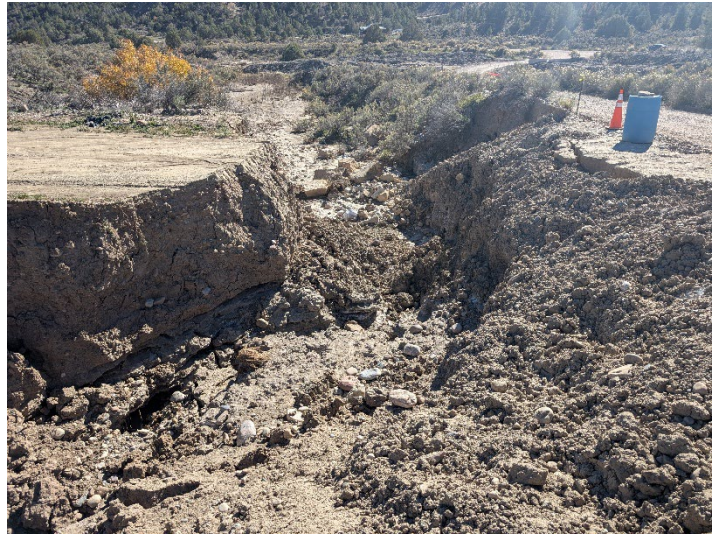
The access road, where it meets High Flume Road at the property boundary, has washed out and vehicular access to the site is not currently possible. However, the access road beyond the entrance gate has been graded since the Division's last inspection. Only minor rilling was noted on the access road beyond the entrance gate.

Access road washed out at property entrance

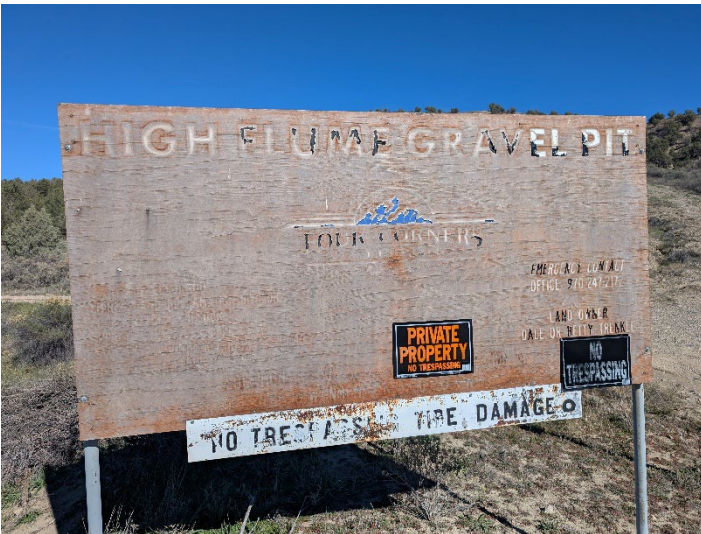
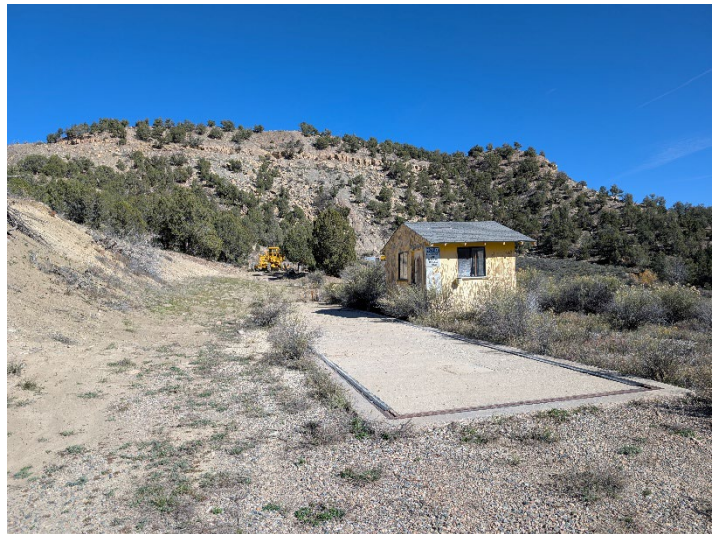
A dilapidated mine identification sign was noted at the entrance to the site. The permit boundary is not marked.

Dilapidated mine sign

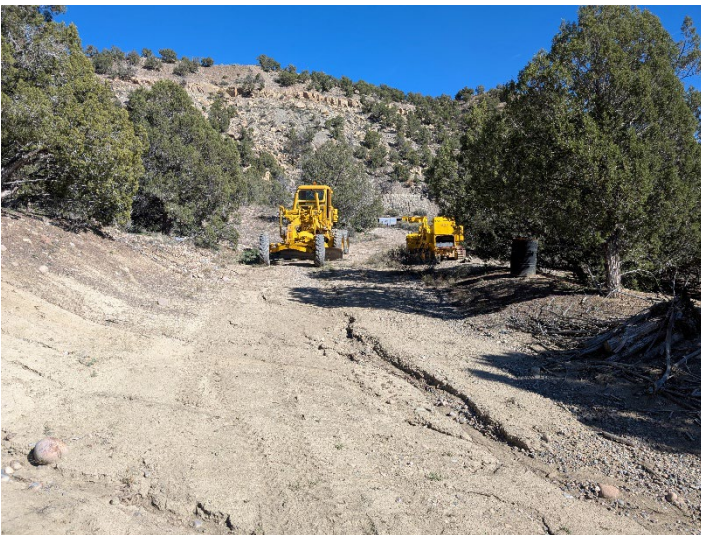
The scale and scale house remain on site. An old grader and small dozer were located near the scalehouse. It was not apparent whether these pieces of equipment would be operational or not. Several other pieces of dilapidated mining equipment and debris were stored at the first switchback above the scalehouse.

Scale and scalehouse

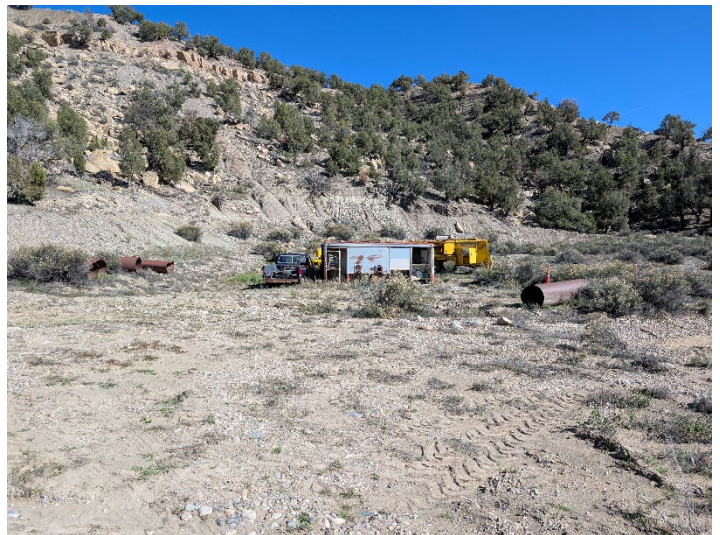
Equipment near scalehouse

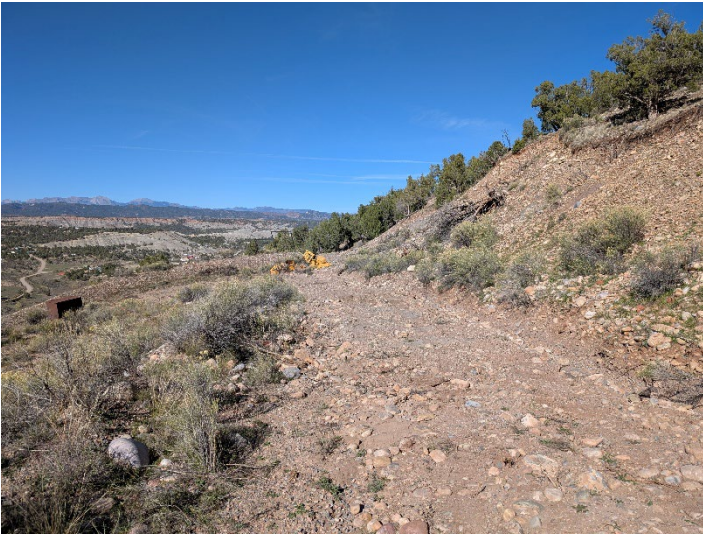
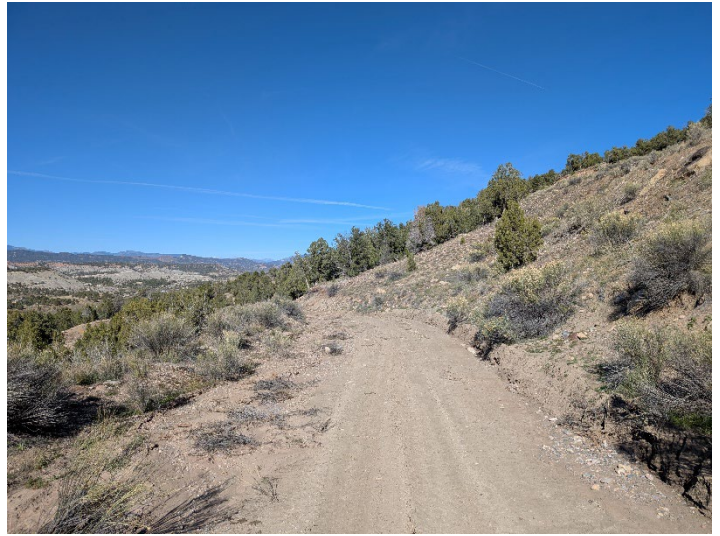
Access road above scalehouse

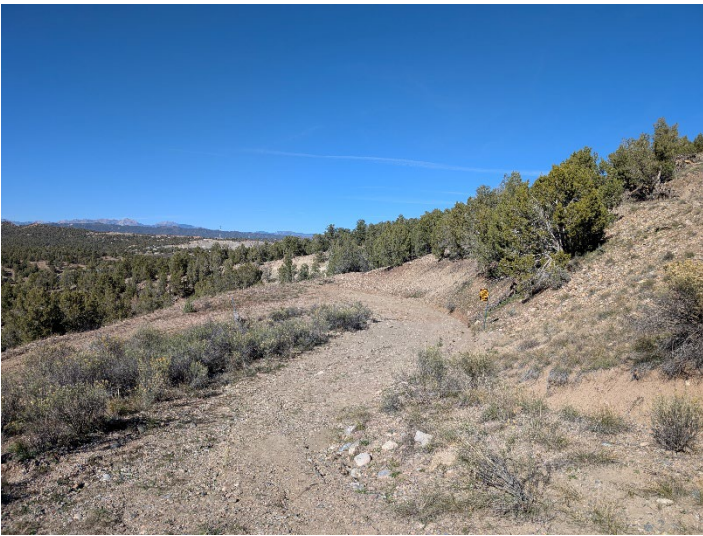
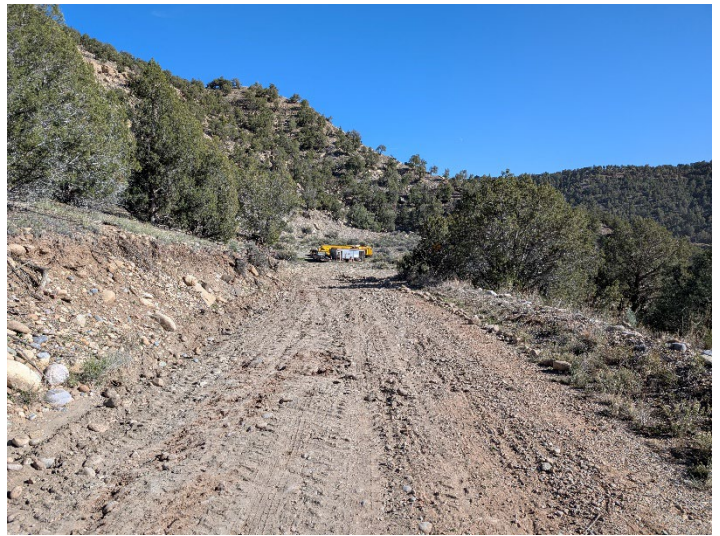
Access road above scalehouse

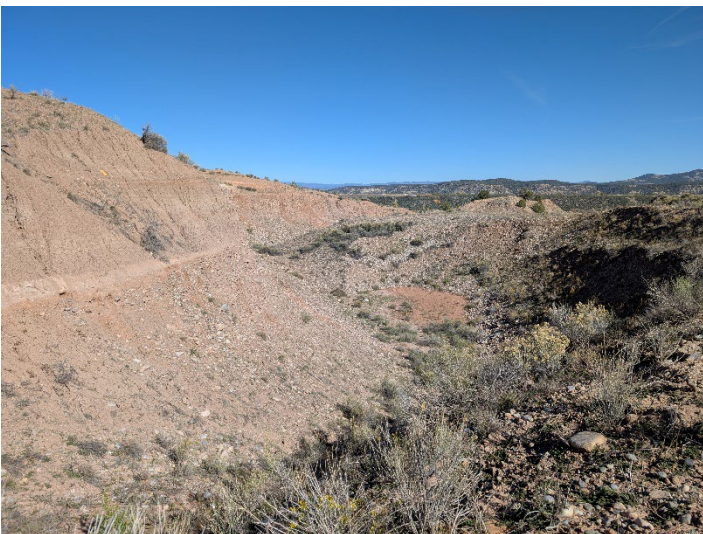
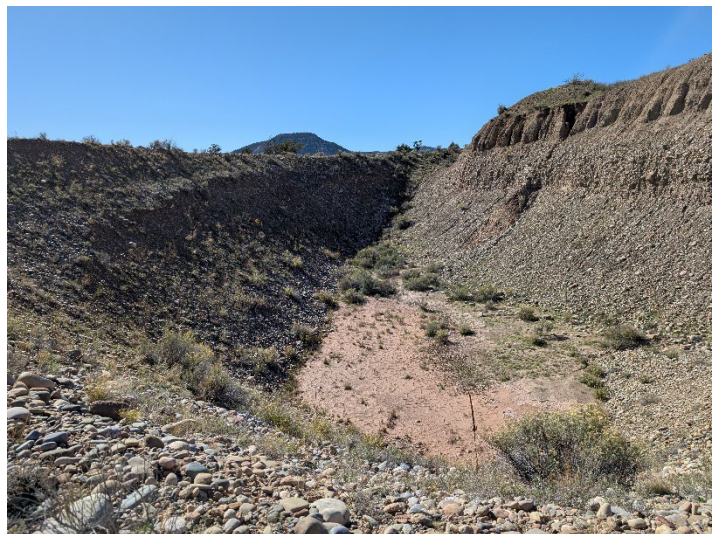
**PROBLEM:** Reclamation has not commenced at the site. Rule 3.1.3 states that all reclamation shall be carried to completion by the operator with all reasonable diligence within 5 years of the operator notifying the Division of final reclamation. The operator notified the Division of final reclamation on March 6, 2023.

The un-reclaimed pit area at the top of the mesa covers approximately 2 acres. The pit is approximately 40 feet in depth where once near vertical highwalls have sloughed to approximately 1H:1V. The pit daylights on the east side. There were no stockpiles observed on the bench area outside the pit.

Open pit

**CORRECTIVE ACTIONS:** Notify the Division, in writing, of the Operator's proposed schedule for completing reclamation at the site. Reclamation shall be completed by March 6, 2028.

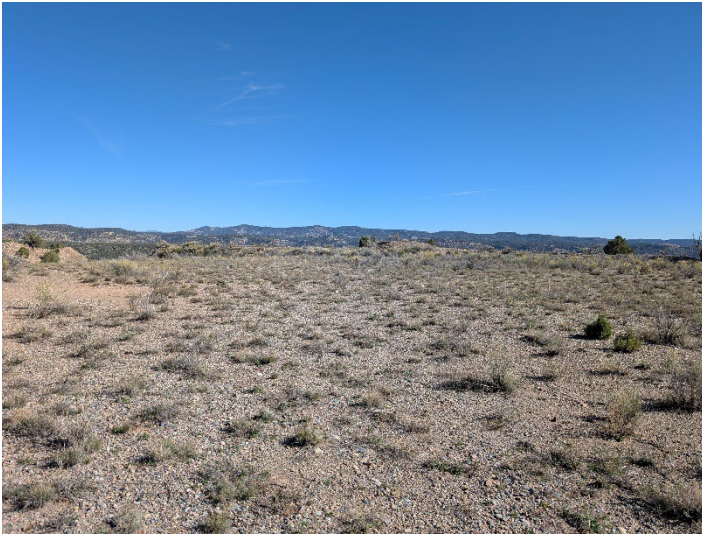
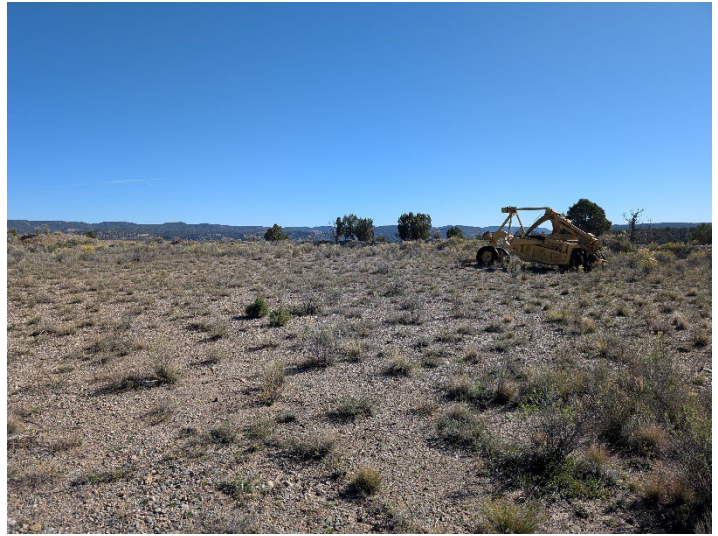
Bench area on south side of pit
