MINERALS PROGRAM INSPECTION REPORT
PHONE: (303) 866-3567

MINE NAME: Crossfire Bonds Gravel Pit	MINE/PROSPECTING ID#: M-2015-001	MINERAL: Gravel and sand	COUNTY: La Plata
INSPECTION TYPE: Monitoring	WEATHER: Clear	INSP. DATE: October 28, 2025	INSP. TIME: 13:30
OPERATOR: Crossfire Aggregate Services LLC	OPERATOR REPRESENTATIVE: Brian Abeln	TYPE OF OPERATION: 112c - Construction Regular Operation

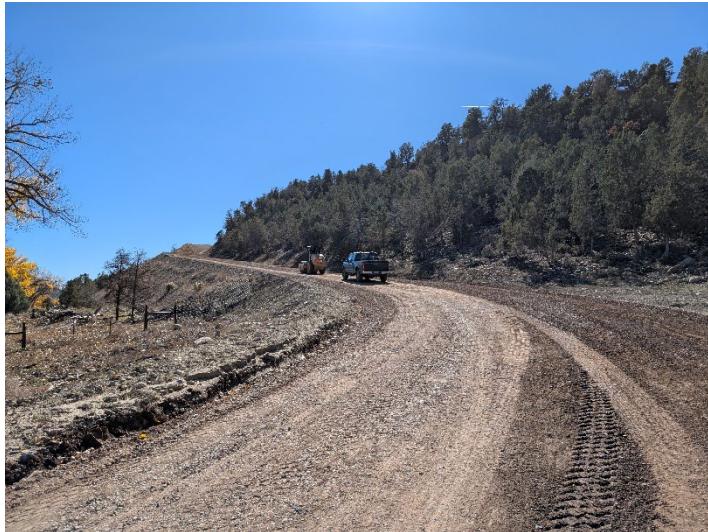
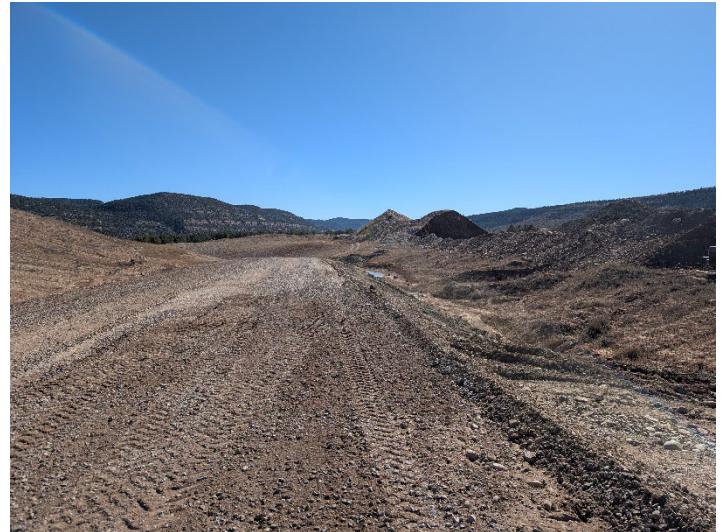
The access road has been constructed and was in good condition. The currently disturbed pit area has been cleared and grubbed. Mining is just beginning at the site. Topsoil has not been cleared from the whole disturbed area just yet. A highwall has not been created yet. A crusher was operating in the Phase 1 area during this inspection. Several piles of stockpiled gravel were located in this area.

Access road to site

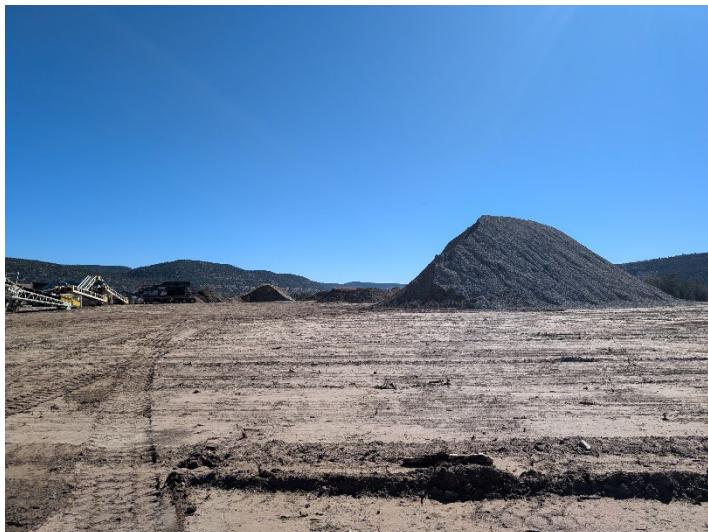
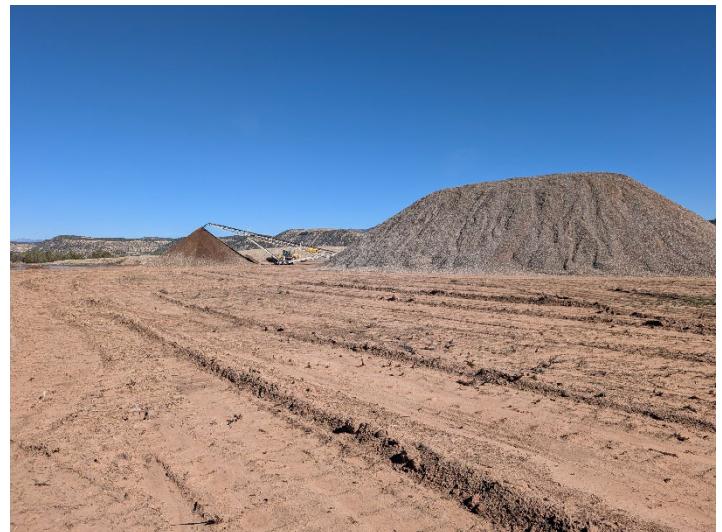
Current mining in Phase 1 area. Topsoil not yet cleared.

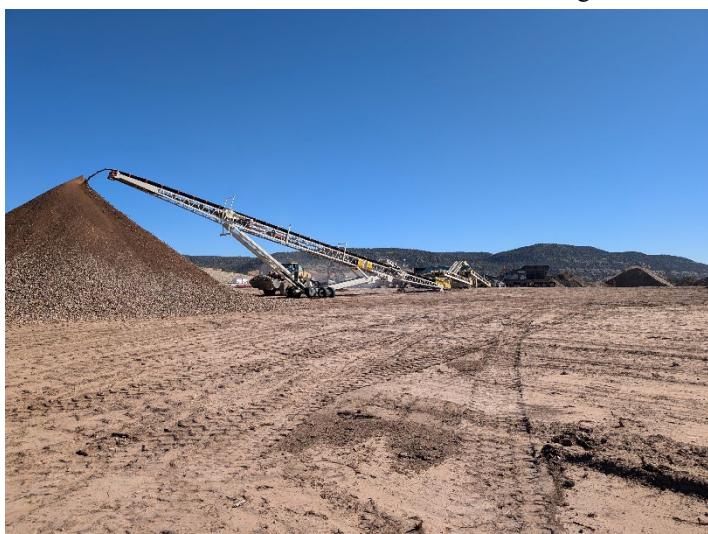
Crushing in Phase 1 area

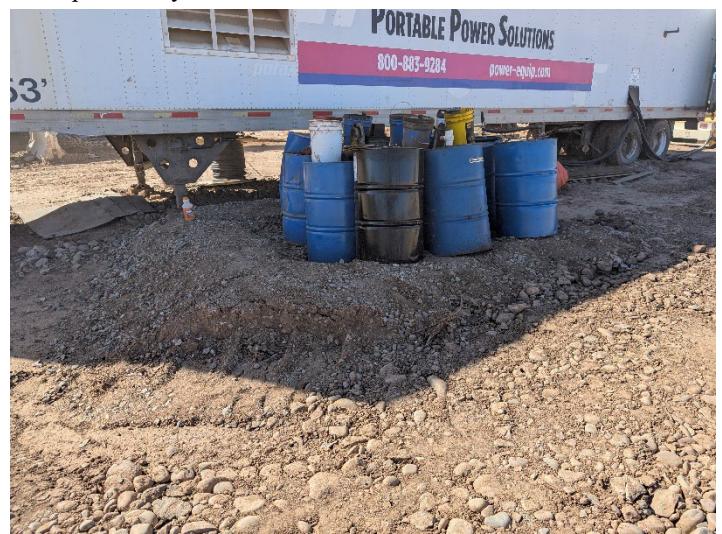
PROBLEM/POSSIBLE VIOLATION: Problem: Improper storage and containment of fuels and/or other hazardous materials was present on site.

Fuels and oils observed on site were not stored in adequate secondary containment structures. The oil barrels near the generator trailer were not in secondary containment. The fuel tank (blue tank near the scale house) was not in secondary containment. This was noted as Problem at the beginning of this report.

Oil barrels lacking secondary containment

CORRECTIVE ACTIONS: All storage tanks, petroleum and any hazardous materials on site for any period shall have appropriate secondary containment. The site will also have to comply with all applicable SPCC requirements. Please supply photo documentation that any fuel or hazardous materials containers are stored properly - including applicable secondary containment structures by the corrective action date. Note that secondary containment structures shall consist of impermeable containment which could contain all contents of the tanks and various containers (when full) plus 10% of the total capacity. The operator may also provide photo documentation that all containers have been removed from the site on or before the corrective action date.

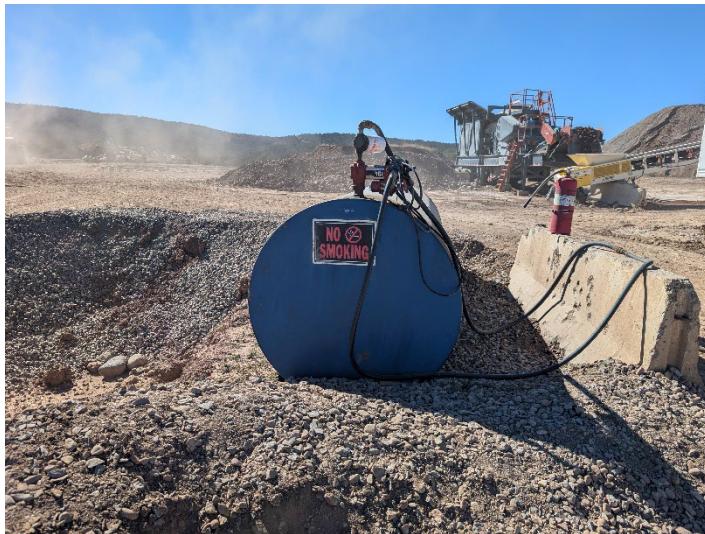
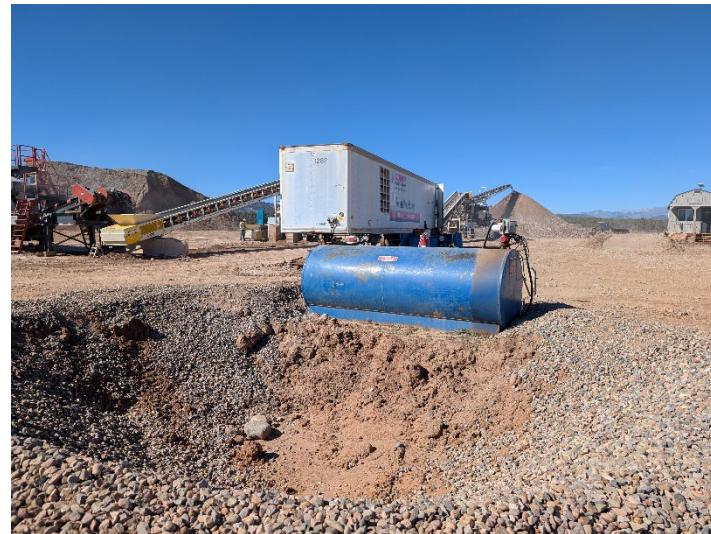
Fuel tank lacking secondary containment
