**MINERALS PROGRAM INSPECTION REPORT**  
**PHONE: (303) 866-3567**

| <b>MINE NAME:</b><br>Lariat Pit | <b>MINE/PROSPECTING ID#:</b><br>M-1977-251 | <b>MINERAL:</b><br>Clay (general) | <b>COUNTY:</b><br>Jefferson |
| <b>INSPECTION TYPE:</b><br>Monitoring | <b>WEATHER:</b> Clear | <b>INSP. DATE:</b><br>October 31, 2025 | <b>INSP. TIME:</b><br>10:00 |

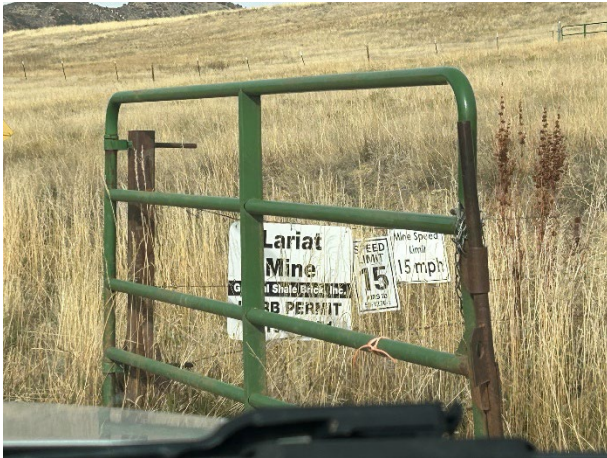
All boundary markers able to be easily observed were present and in good condition. The posted mine sign was present at the site entrance and in good condition. The operator is currently up to date with annual report submittals, with the anniversary date being set on March 4<sup>th</sup>.

Photo 1: Posted mine ID sign.

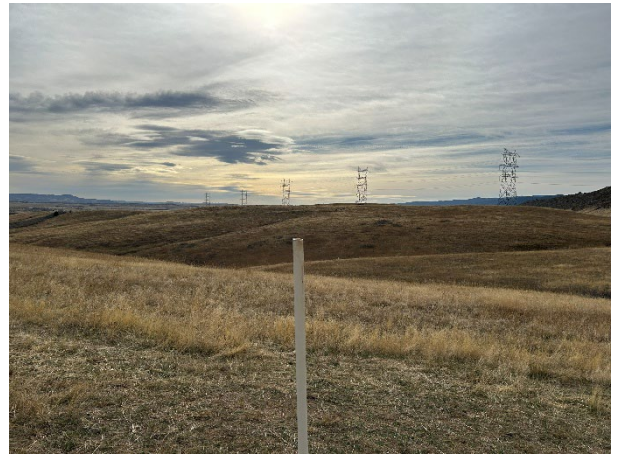
Photo 2: Example site boundary marker, located near lower stockpiles.

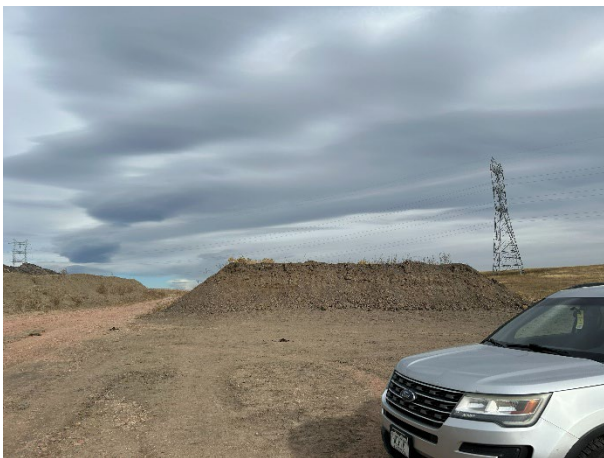
This site is currently approved to operate intermittently, and as of this inspection no mining activity has occurred in over a year. As is standard practice by this operator, mining is typically completed in "campaigns", and material is stockpiled and taken from as needed for brick production. A significant portion of the site has not been impacted by mining due to this practice.

Photo 3: Example product stockpile.

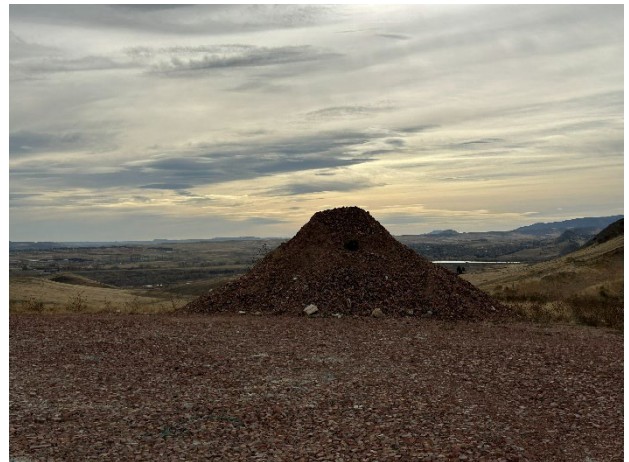
Photo 4: Decomposed brick stockpile.

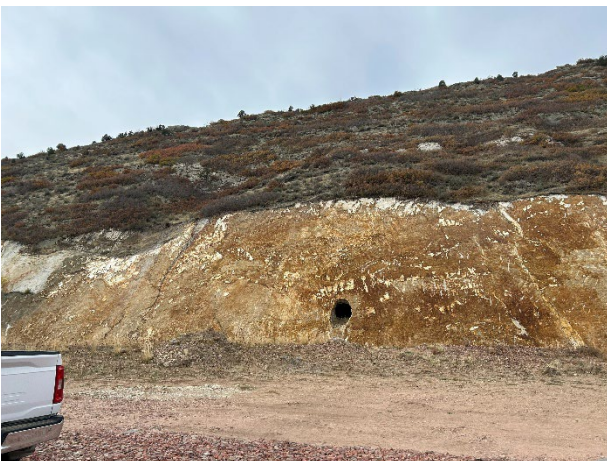
Photo 5: Mine highwall with old mine portal.
