STATE OF  
COLORADO

## Inspection reports

<b>Permit Number:</b> C-1992-081 <b>Mine Name:</b> Hayden Gulch Loadout <b>Operator:</b> Hayden Gulch Terminal, LLC <b>Operator Address:</b> Ms. Miranda Kawcak 29515 Routt County Road 27 Oak Creek, CO 80467	<b>County:</b> Routt <b>Operation Type:</b> Loadout <b>Permit Status:</b> Active <b>Ownership:</b> Private
	<b>Operator Representative Present:</b> N/a
<b>Operator Representative Signature: (Field Issuance Only)</b>

<b>Inspection Start Date:</b> November 5, 2025 <b>Inspection Start Time:</b> 15:30 <b>Inspection End Date:</b> November 5, 2025 <b>Inspection End Time:</b> 16:00	<b>Inspection Type:</b> Coal Partial Inspection <b>Inspection Reason:</b> Normal I&E Program <b>Weather:</b> Clear
<b>Joint Inspection Agency:</b> None	<b>Joint Inspection Contacts:</b>
<b>Post Inspection Agency:</b> None	<b>Post Inspection Contacts:</b>
<b>Inspector(s):</b> Brock Bowles	<b>Inspector's Signature:</b>

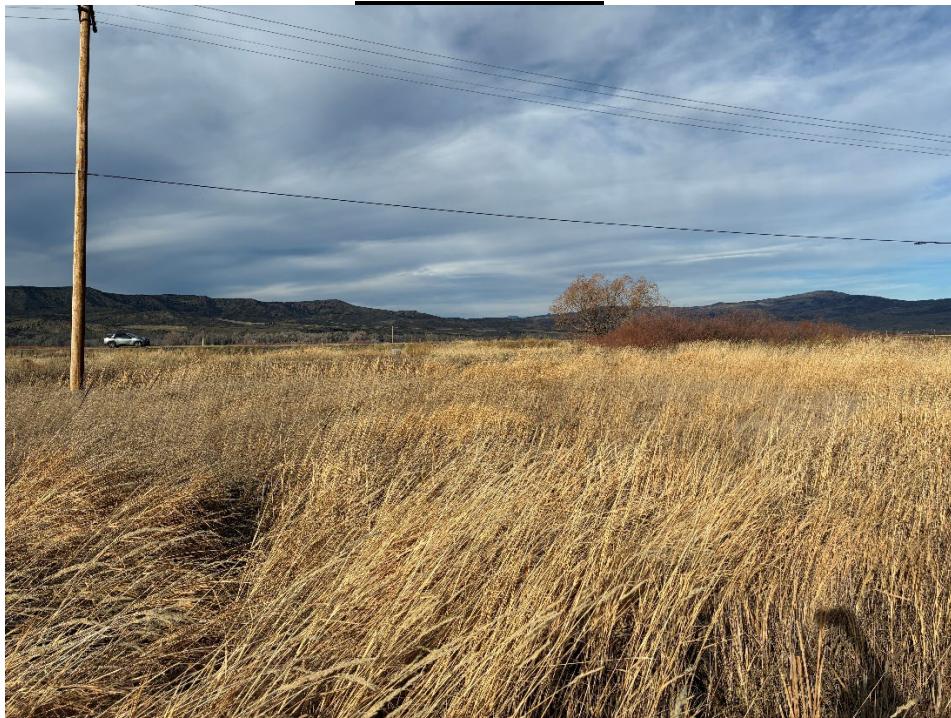
The lower areas on the southern side that were saturated earlier in the season were dry during this inspection (photo 1). The ditches did not contain water either.

Photo 1- South of Hwy 40 facing north. The dormant vegetation of the area saturated in the spring

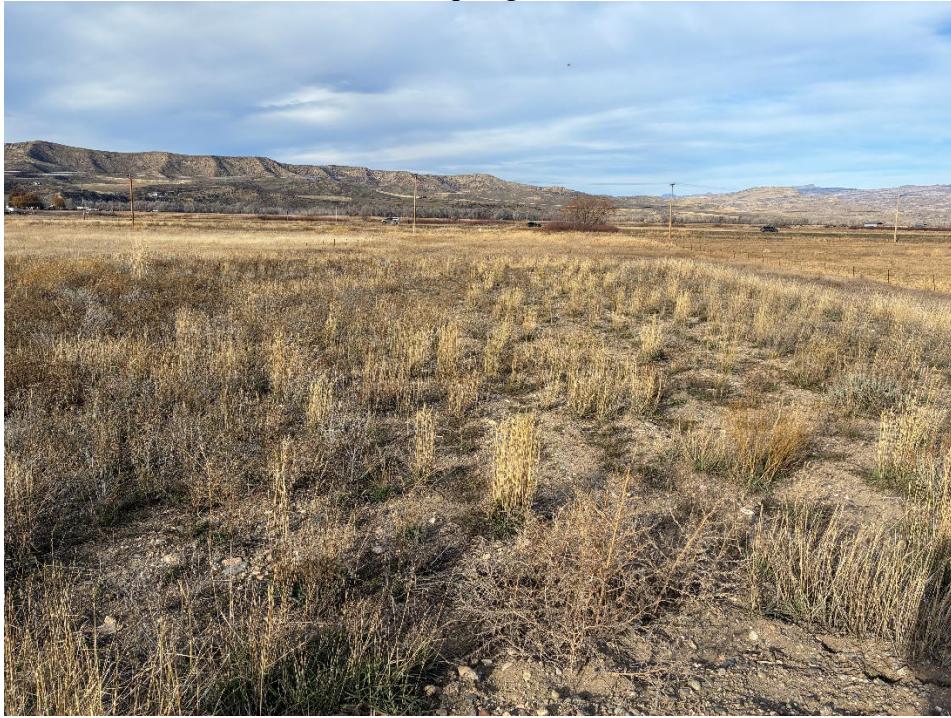
No erosion features were noted and the soil appears to be stable (photo 2).

Photo 2- The upland area south of Hwy 40 appears to be stable.
