C1980007, West Elk Mine, November Inspection Report

Permit Number: C-1980-007 Mine Name: West Elk Mine Operator: Mountain Coal Company, LLC Operator Address: Jessica Wilczek 5174 Highway 133 Somerset, CO 81434	County: Delta, Gunnison Operation Type: Underground Permit Status: Active Ownership: Private
	Operator Representative Present: N/A
Operator Representative Signature: (Field Issuance Only)

Inspection Start Date: November 18, 2025 Inspection Start Time: 11:00 Inspection End Date: Inspection End Time:	Inspection Type: Aerial Inspection Inspection Reason: Normal I&E Program Weather: Clear
Joint Inspection Agency: None	Joint Inspection Contacts:
Post Inspection Agency: None	Post Inspection Contacts:
Inspector(s): Leigh Simmons Brock Bowles	Inspector's Signature:

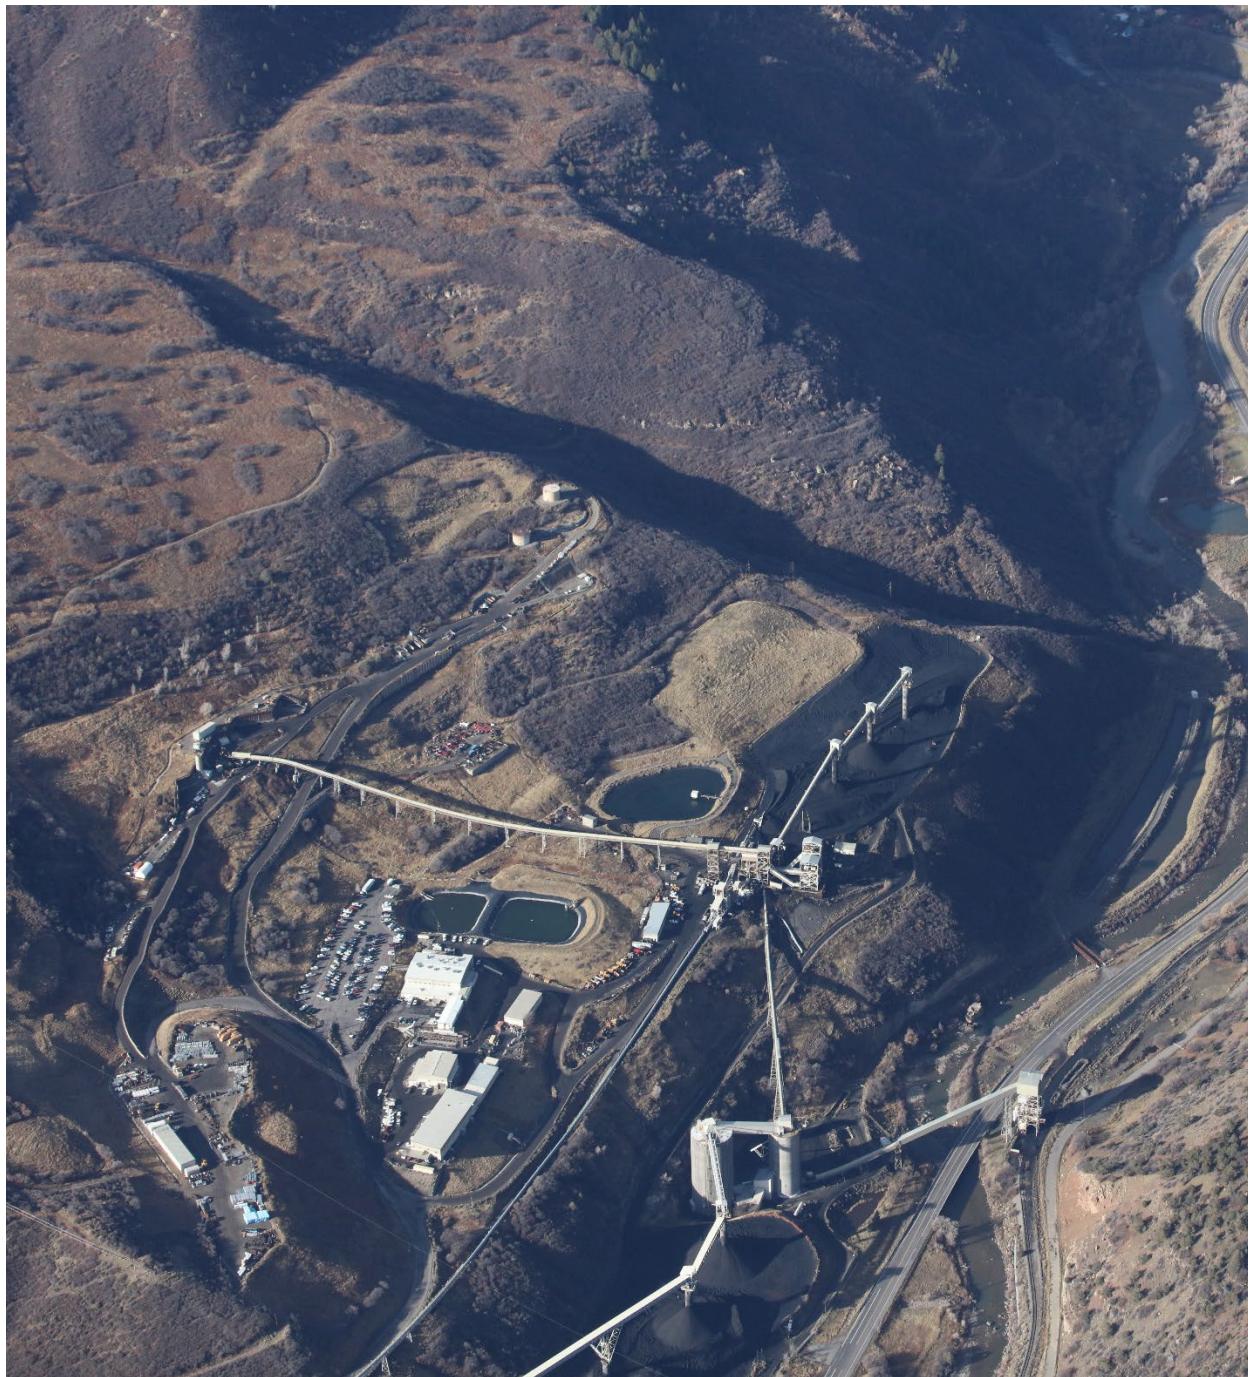
Figure 1: Overview of main facilities (west)

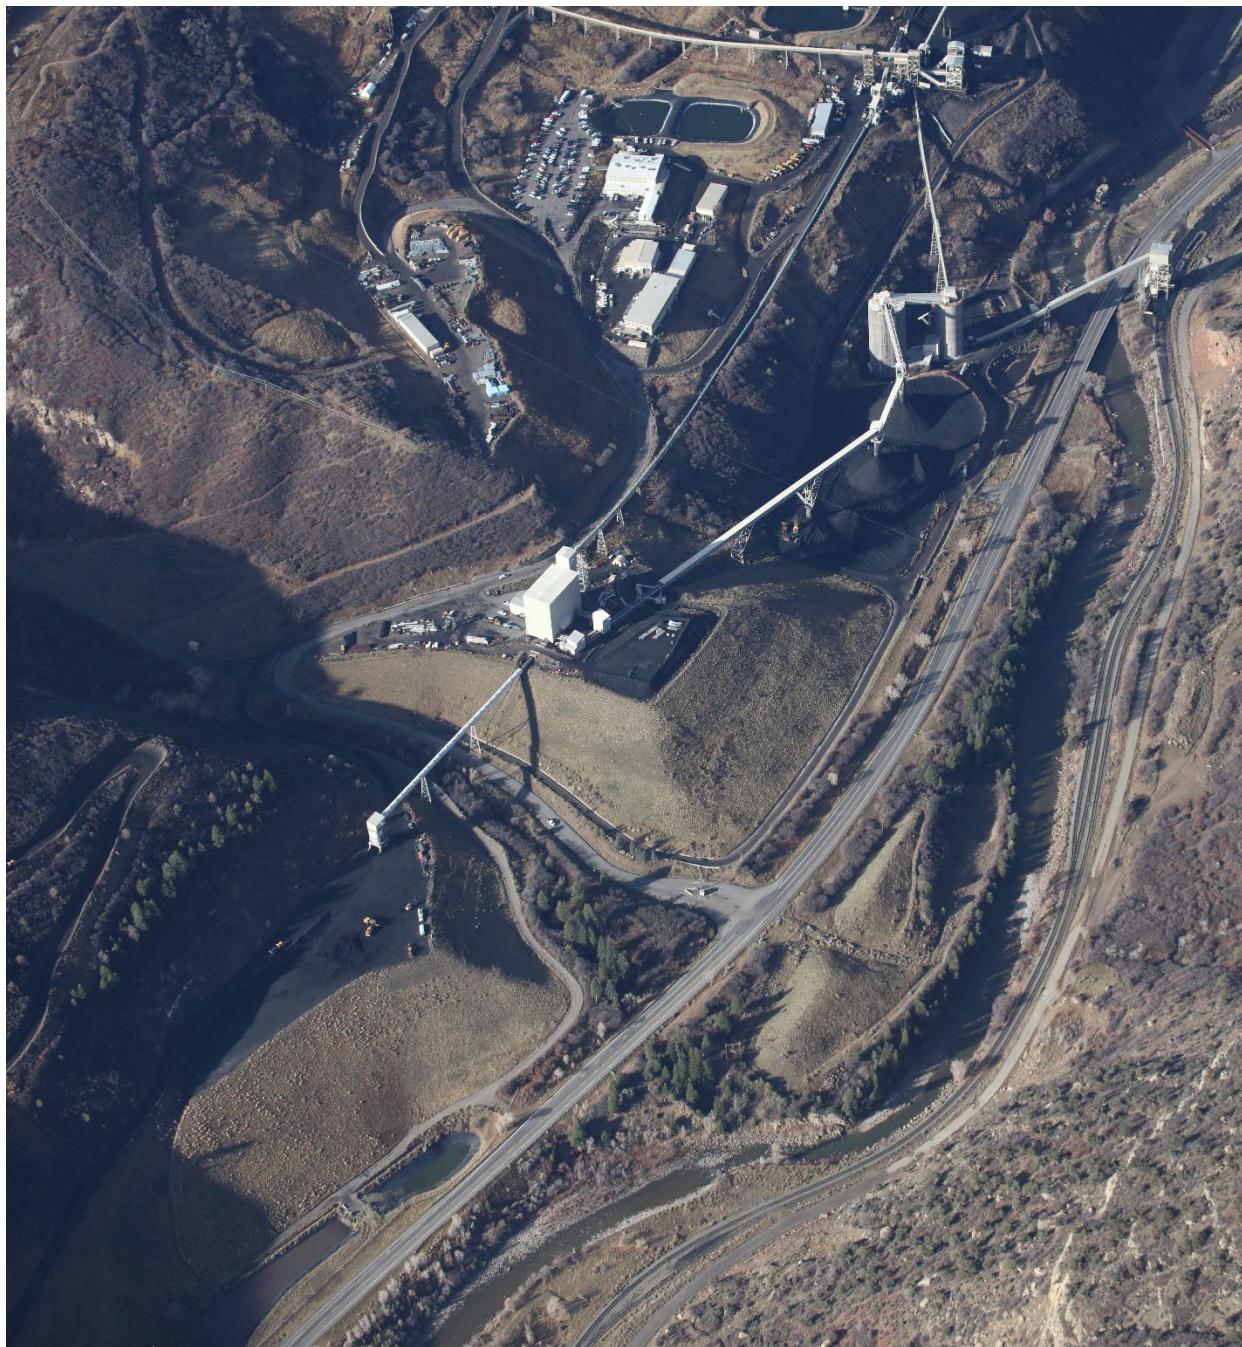
Figure 2: Overview of main facilities (east)

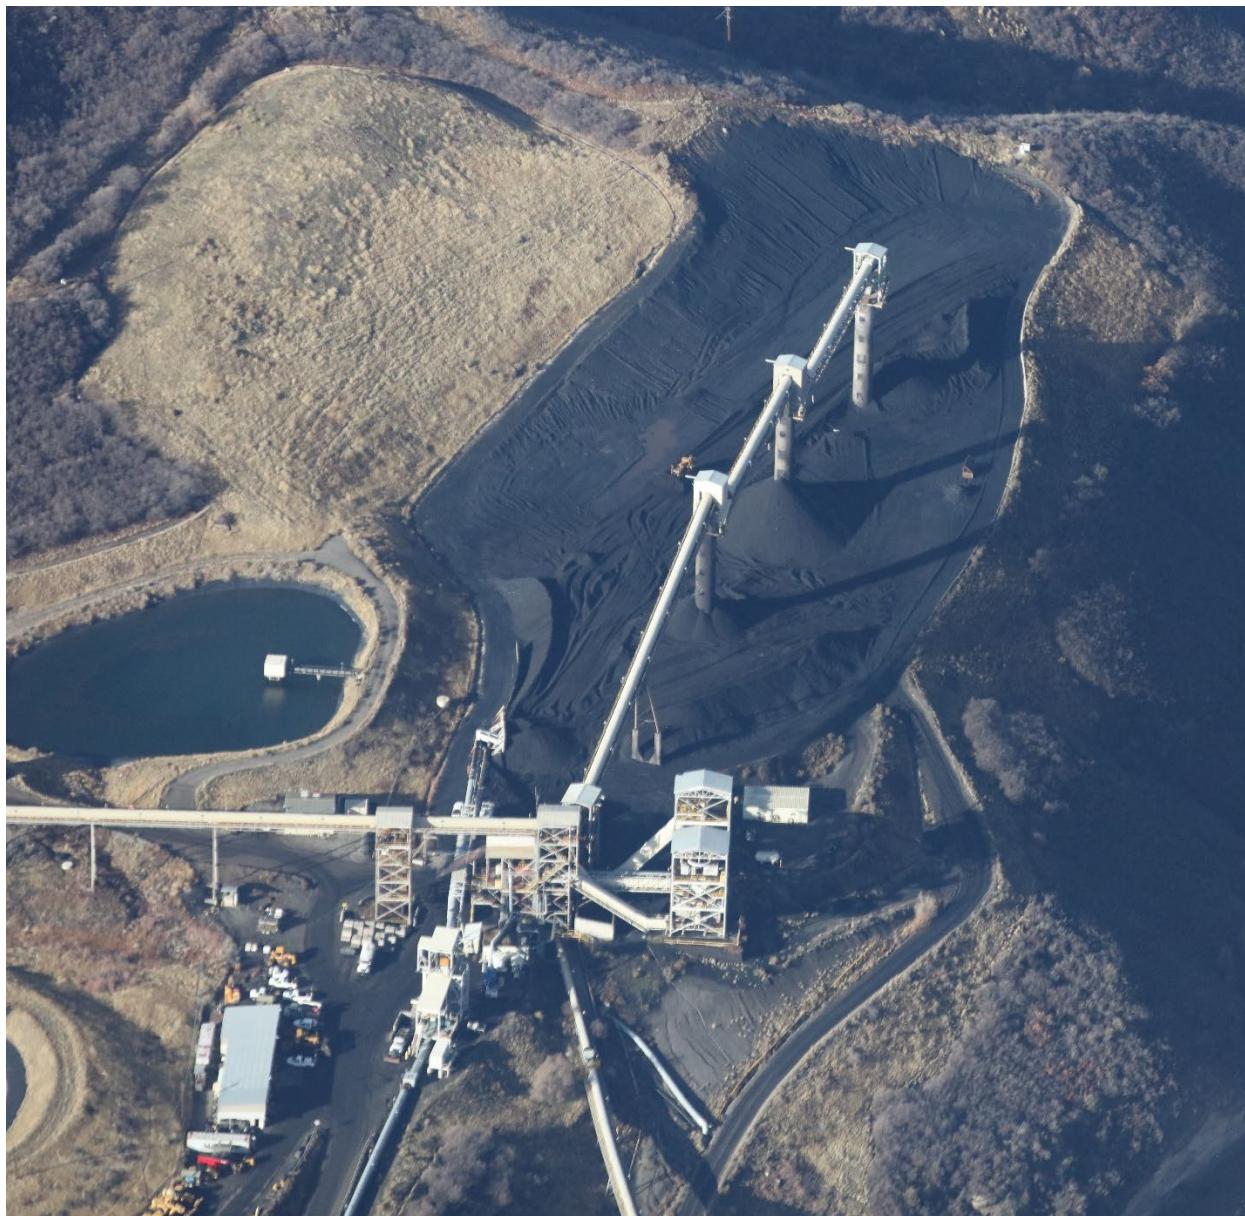
The volume of material on the run-of-mine coal stockpile had been drawn down, including the fines at stack tube 3.

Figure 3: Run-of-mine coal stockpile

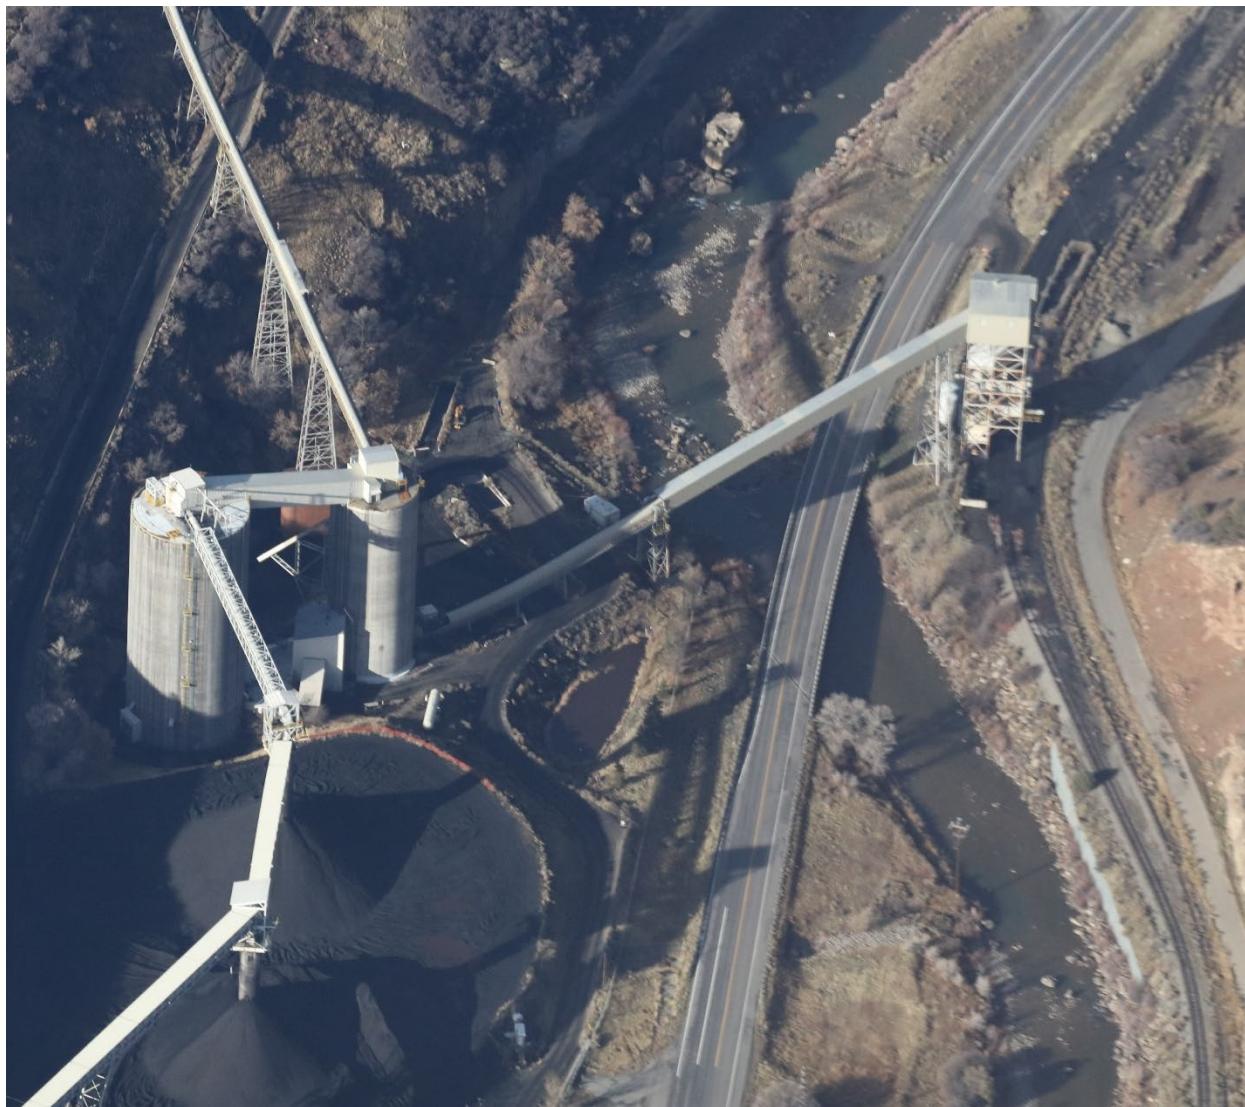
Figure 4: Silos, clean coal stockpile and train loadout

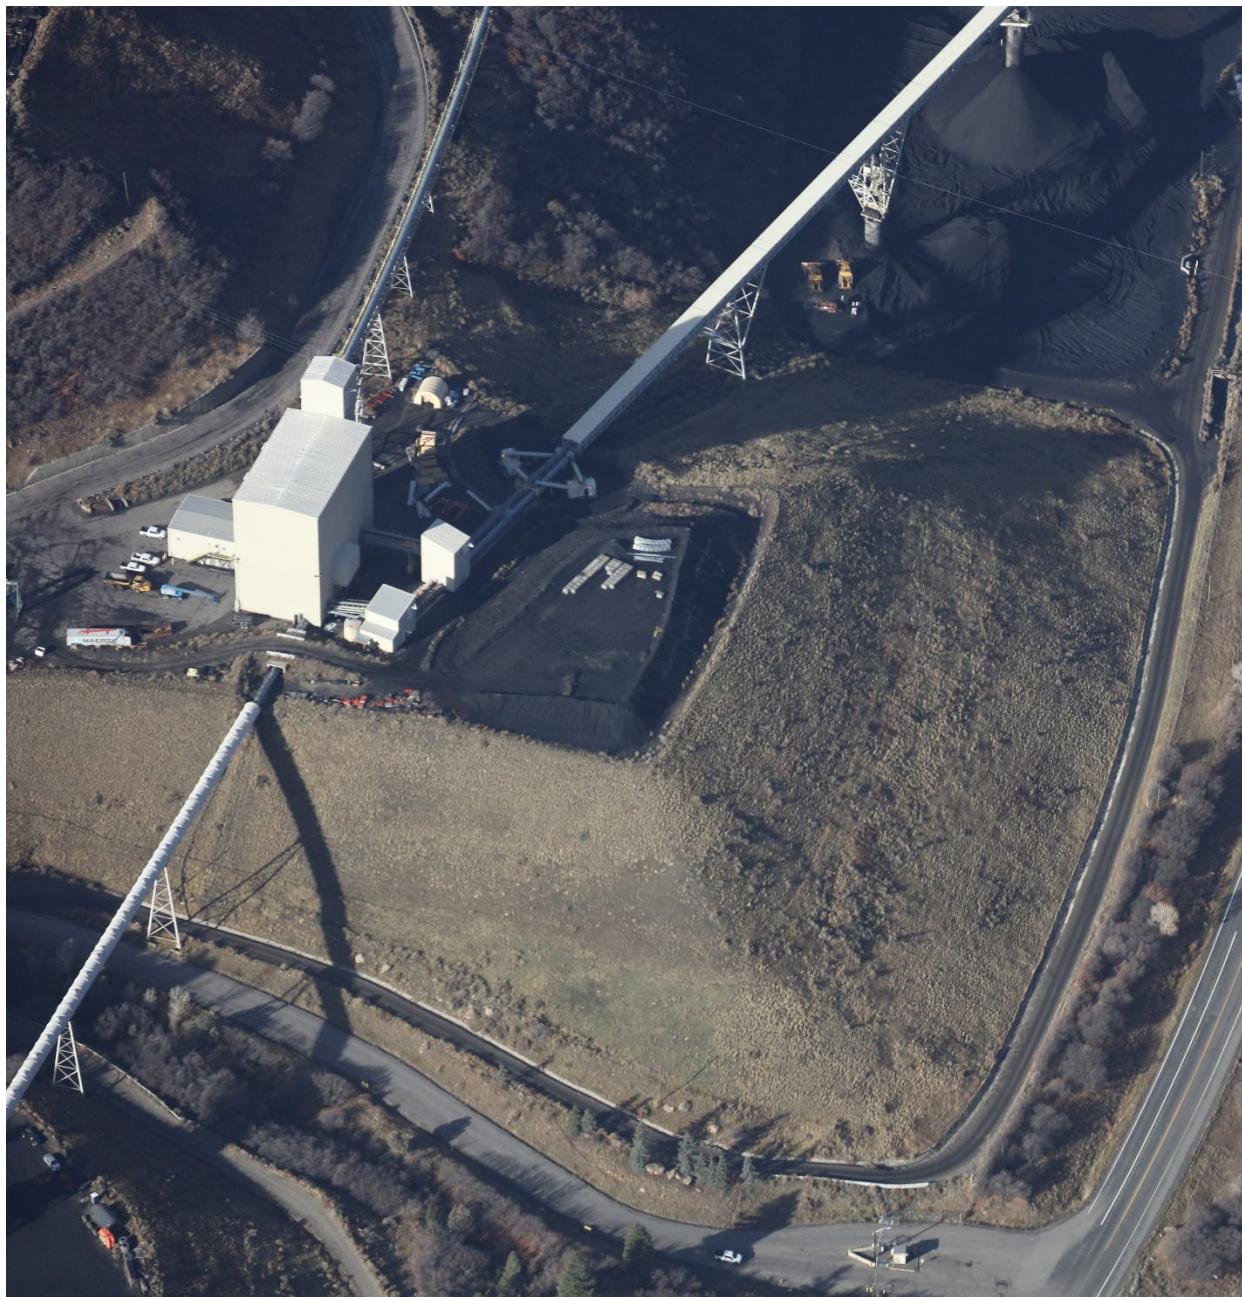
Material on top of the LRP appeared to have been graded. This should be reported in the quarterly waste pile report.

Figure 5: Prep plant and LRP

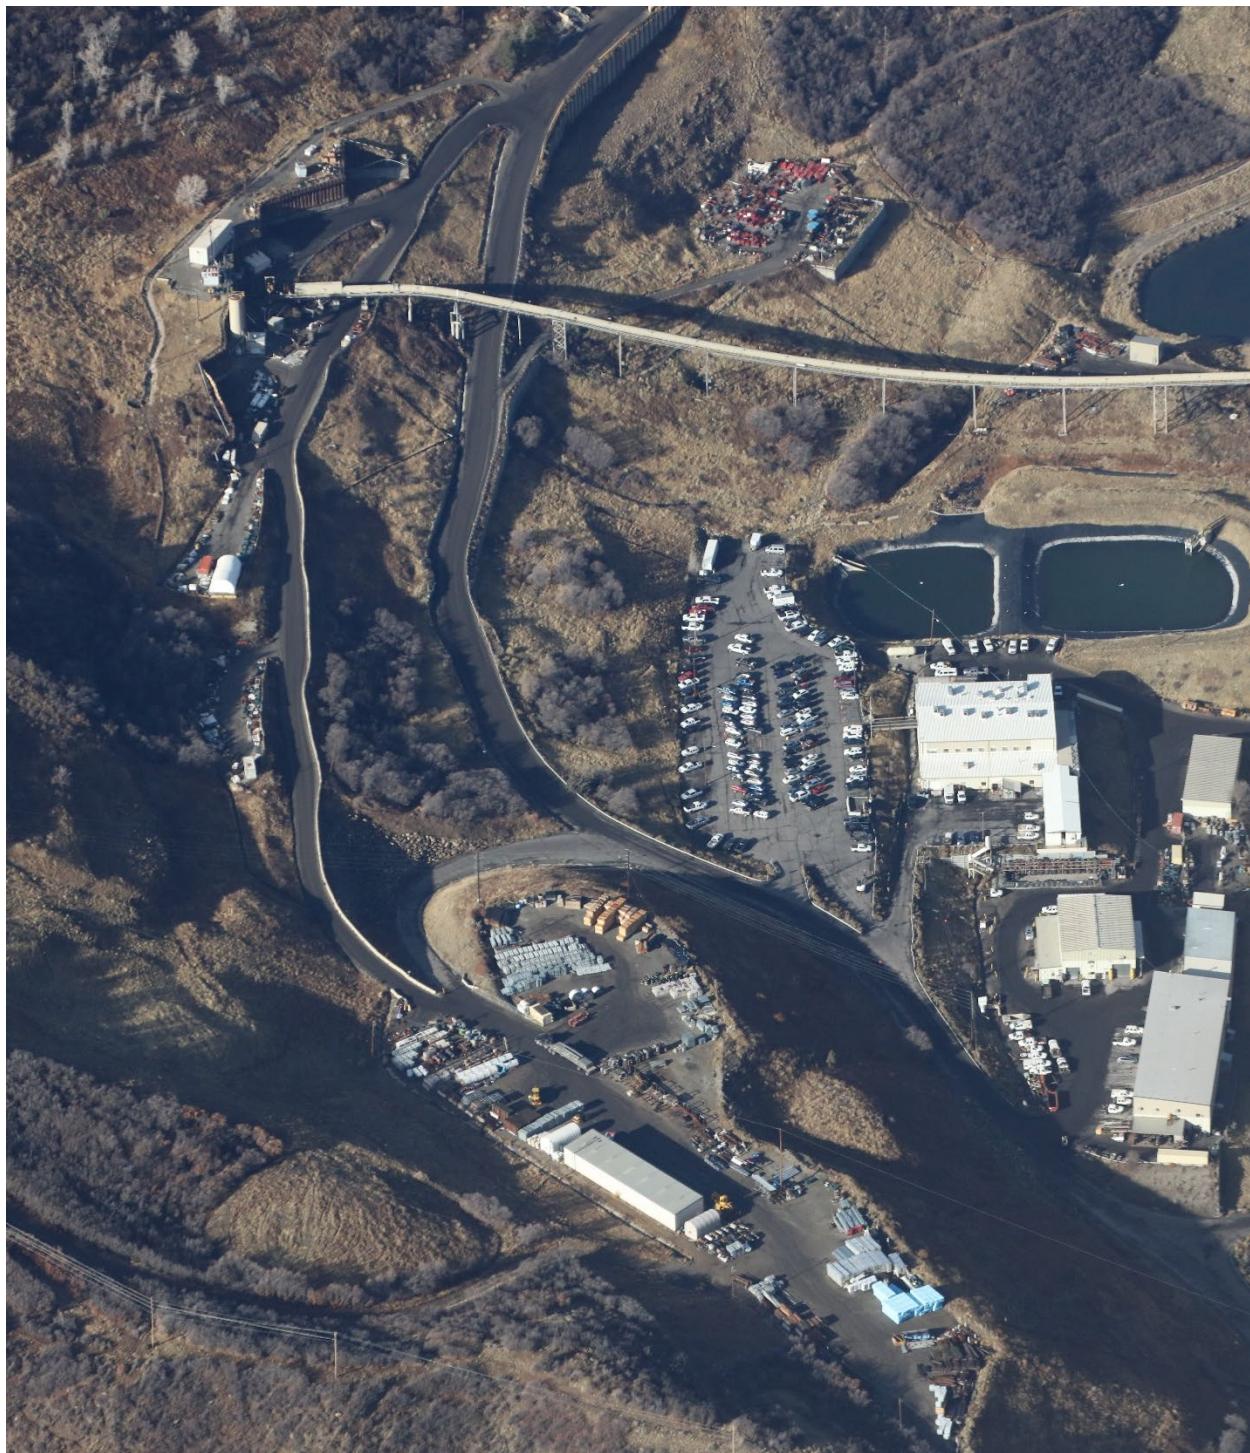
Figure 6 Office and shop buildings, FW ponds, MSB, C1 conveyor and portal

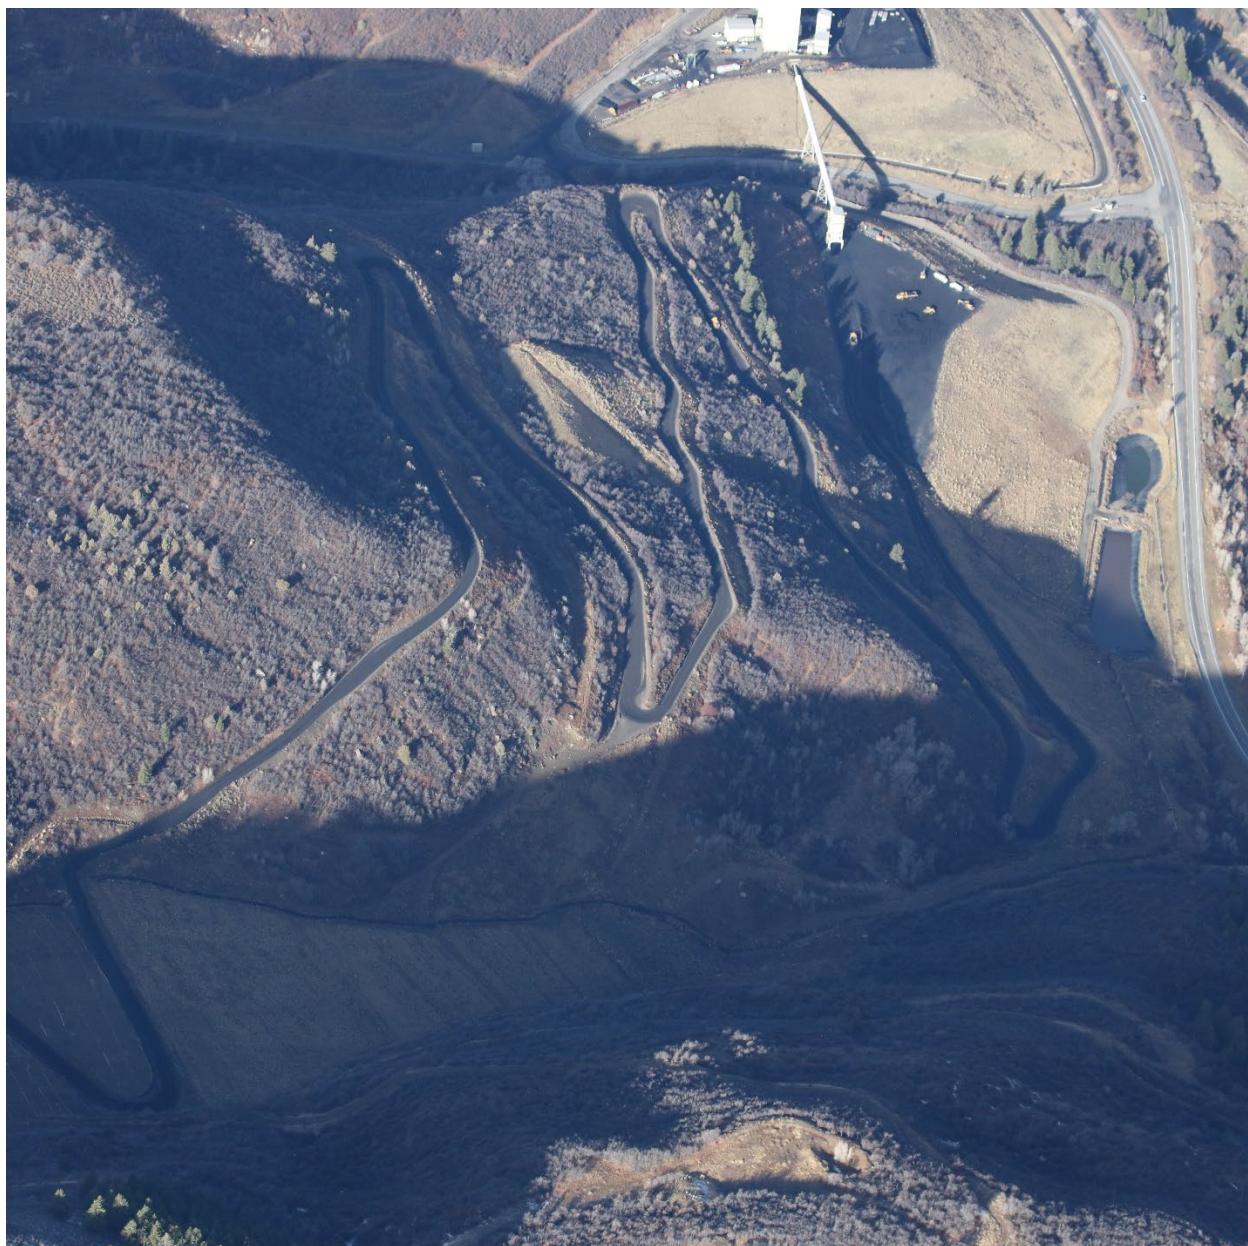
Figure 7: RPE and RPEE haul road

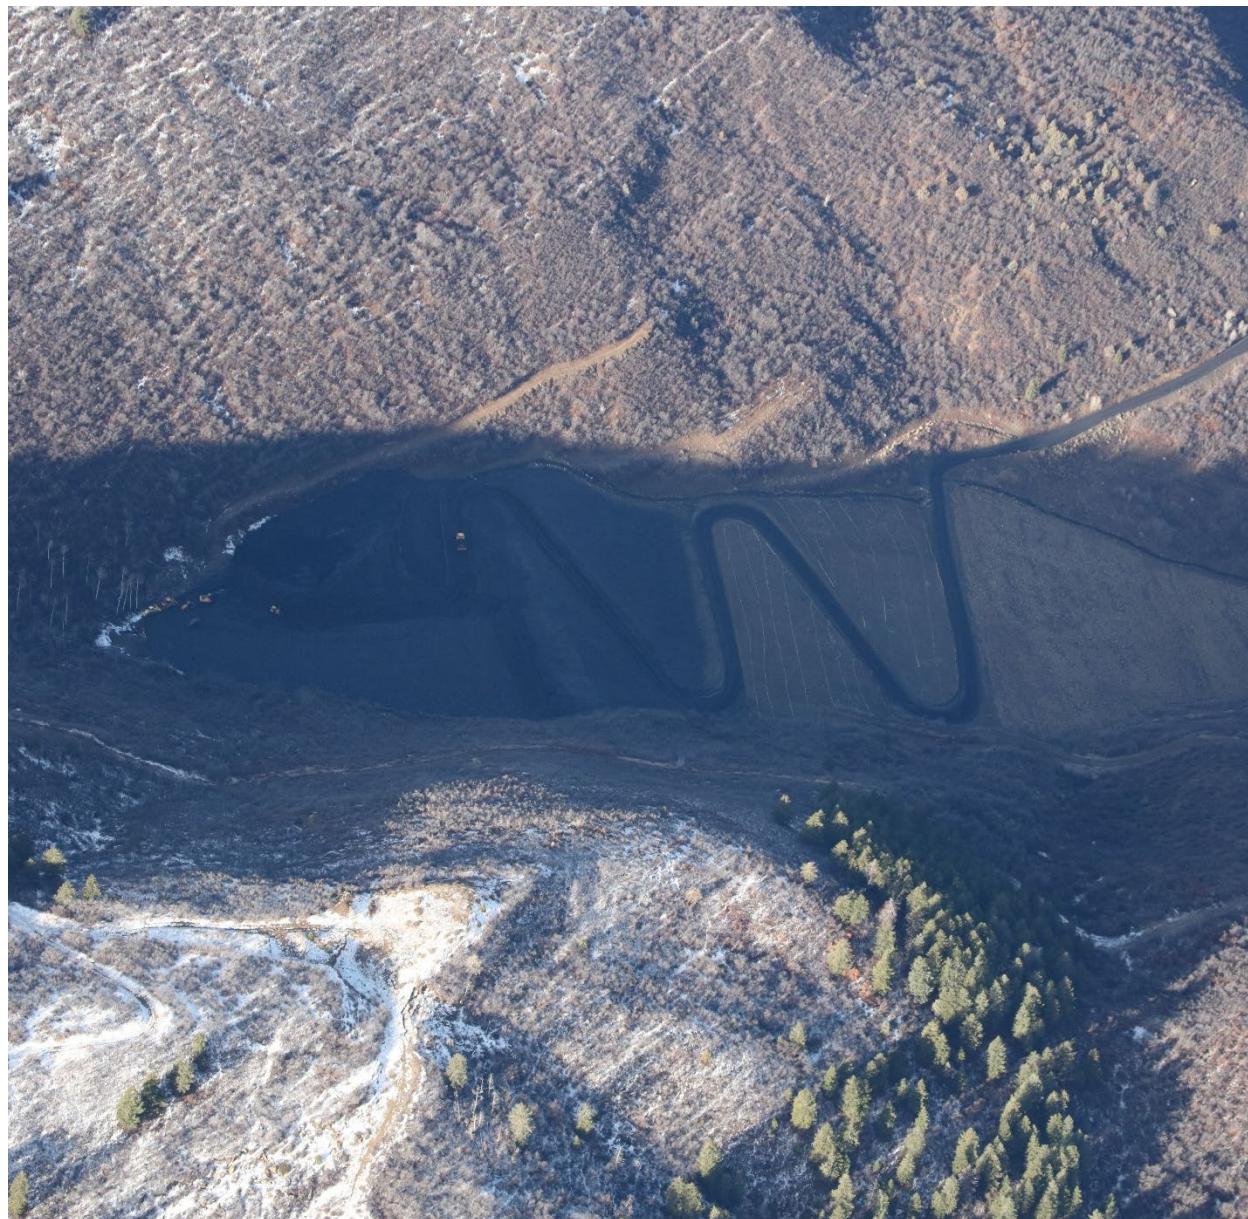
The images show haul trucks traveling to and from the RPEE, suggesting that processing waste was being transported.

Figure 8: RPEE

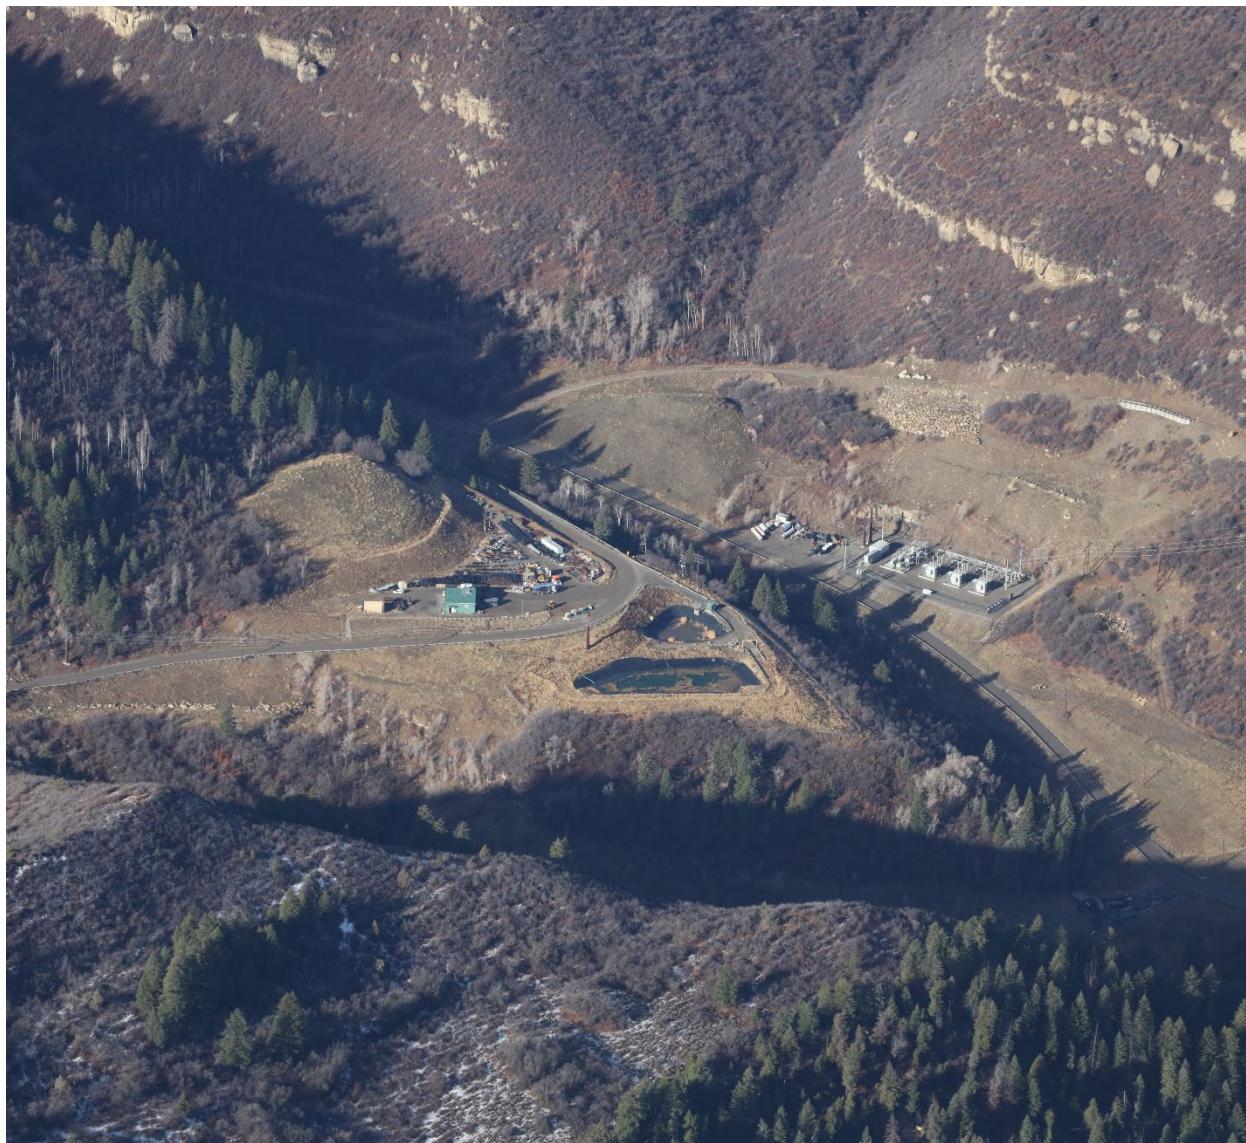
Figure 9: Sylvester Gulch Mine Water Pumping Facility

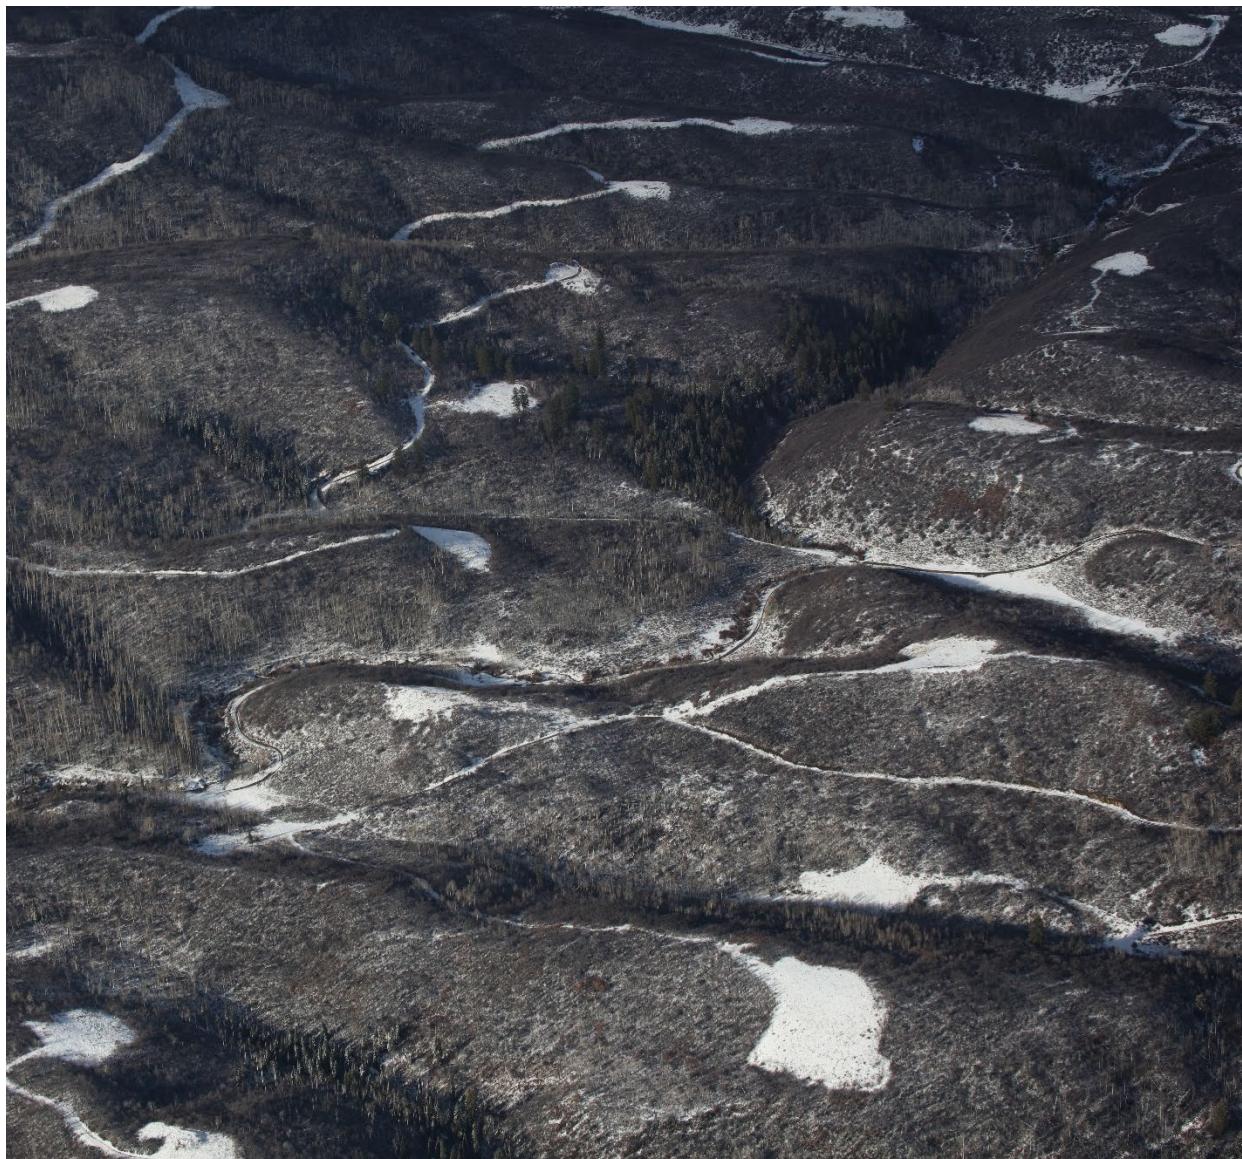
Figure 10: MVB pads and roads

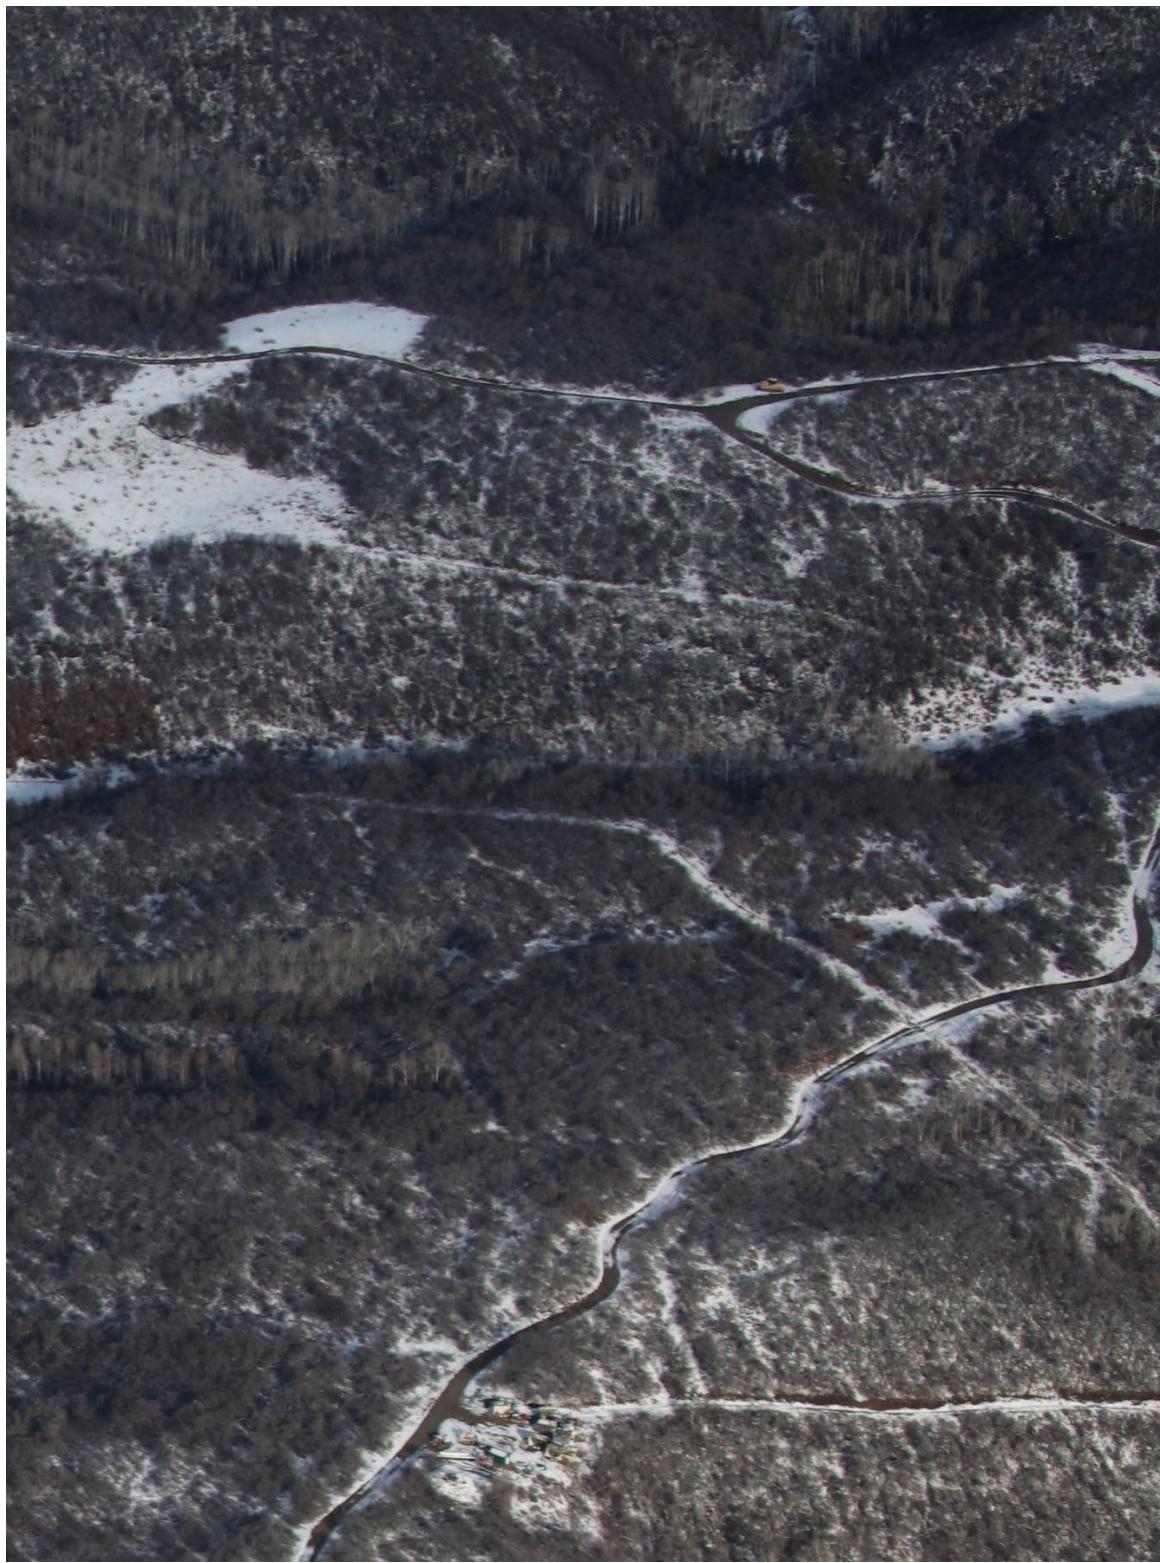
Equipment had been mobilized to begin construction of recently permitted B-seam MVB pads.

Figure 11: Dozer and excavator staged on USFS road
