Keenesburg inspection report

PERMIT INFORMATION

Permit Number: C-1981-028 Mine Name: Keenesburg Strip Mine Operator: Coors Energy Company Operator Address: Mr. Ben Moline P.O. Box 4030 Golden, CO 80402	County: Weld Operation Type: Surface Permit Status: Permanent Cessation Ownership: Private
	Operator Representative Present: None
Operator Representative Signature: (Field Issuance Only)

Inspection Start Date: November 21, 2025 Inspection Start Time: 13:00 Inspection End Date: November 21, 2025 Inspection End Time: 14:00	Inspection Type: Coal Partial Inspection Inspection Reason: Normal I&E Program Weather: Cloudy
Joint Inspection Agency: None	Joint Inspection Contacts:
Post Inspection Agency: None	Post Inspection Contacts:
Inspector(s): Robert Zuber, P.E.	Inspector's Signature:

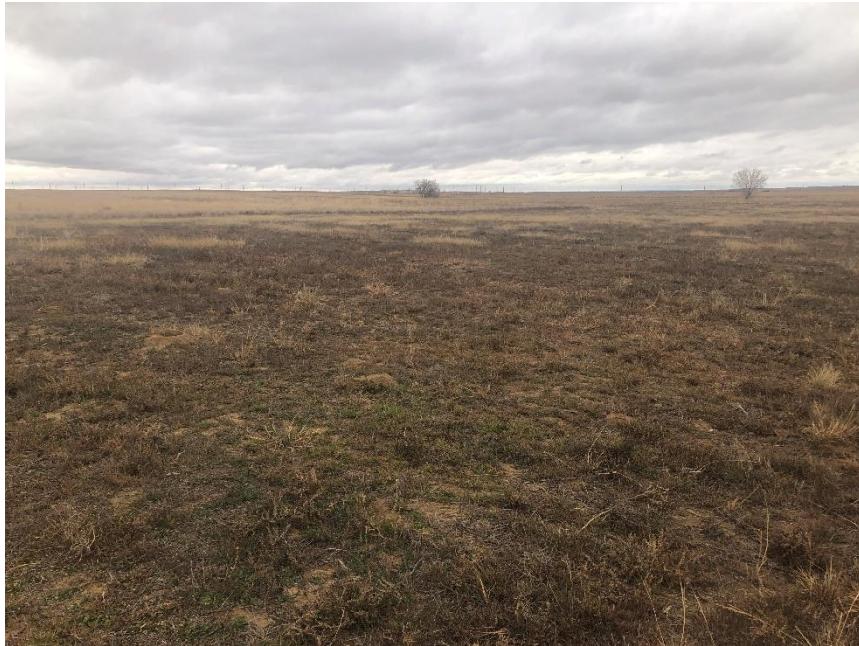
No Coors Energy Company (CEC) representative was present at the inspection. Based on correspondence with CEC before the inspection, they plan to interseed a portion of Area 25 (approximately one-third of it) and a small portion of Area 36 in December 2025. As noted in past Division reports, many areas, including Area 25, were mowed in 2025.

Other than cheat grass, no State-listed noxious weeds were identified. Many Russian thistle plants, a nuisance species, were seen along the north boundary and near Sediment Pond 2.

West side of Area 25 with many Russian thistle plants and recently mowed

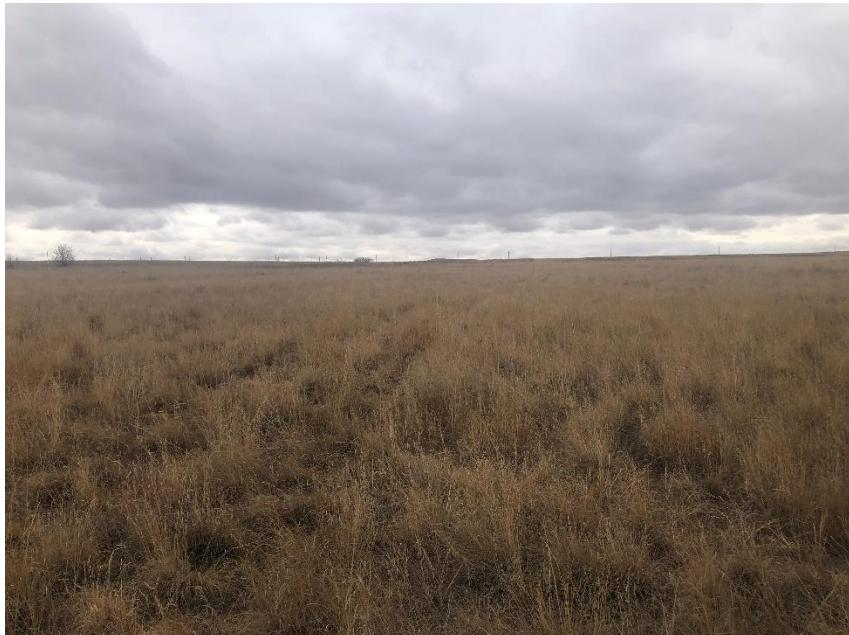
Good grass cover on the east side of Area 33

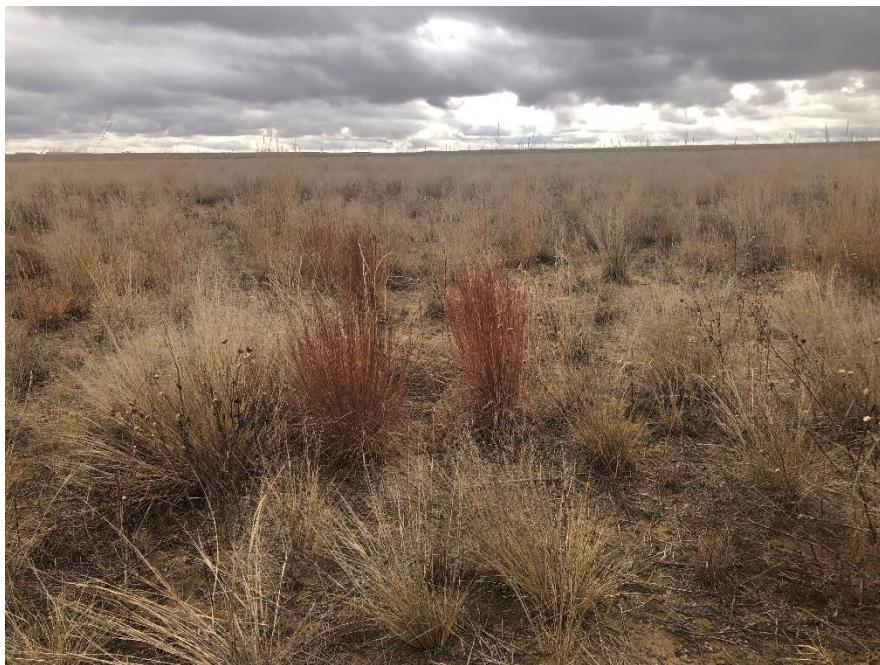
Good grass cover in middle of Area 36

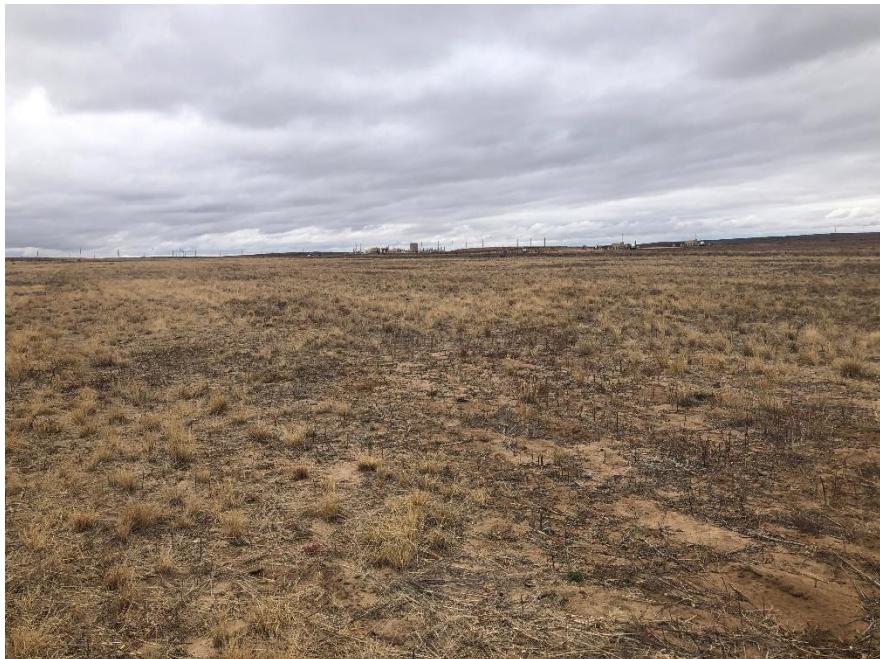
Area 37, recently mowed

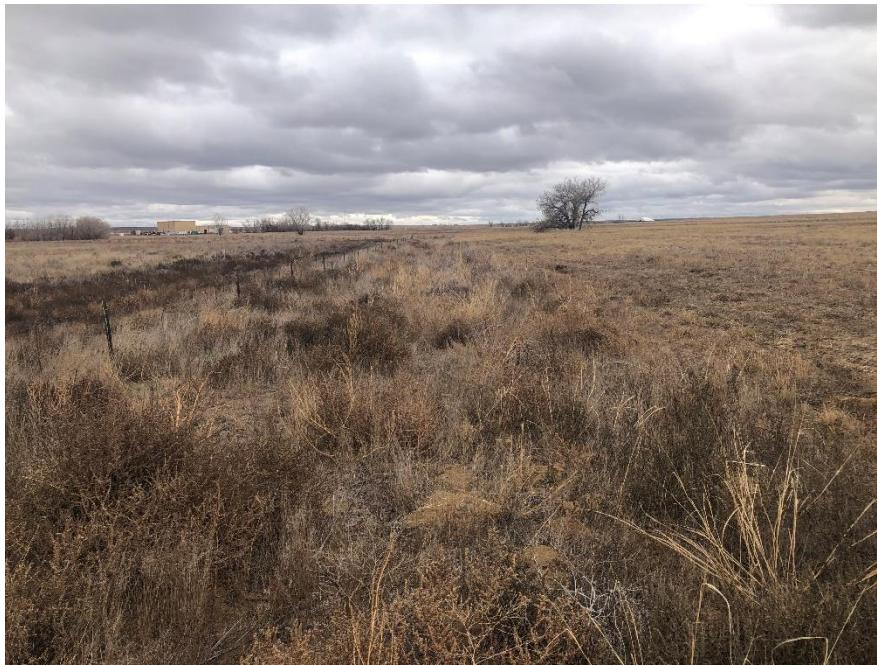
The ditch along the north boundary, which directs runoff to Sediment Pond 2, appears to be functioning well.

North boundary with good cover but many Russian thistle plants (looking southeast)

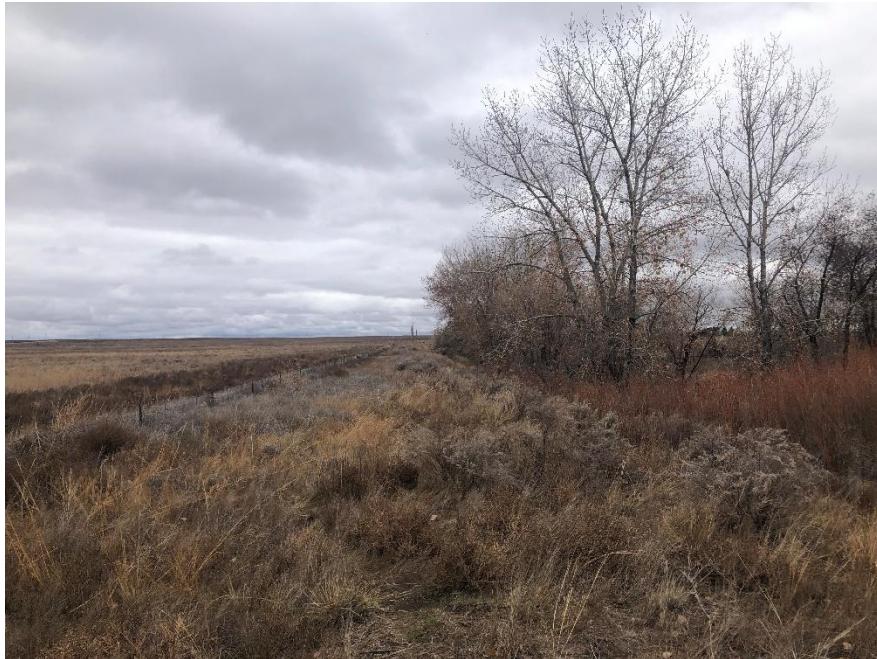
Area below Sediment Pond 2

Sediment Pond 2 and the Dugout Pond contained no visible water; both ponds have large amounts of vegetation on their bottoms. Neither was discharging during the inspection, and there were no signs that the ponds had discharged recently. No problems were observed.

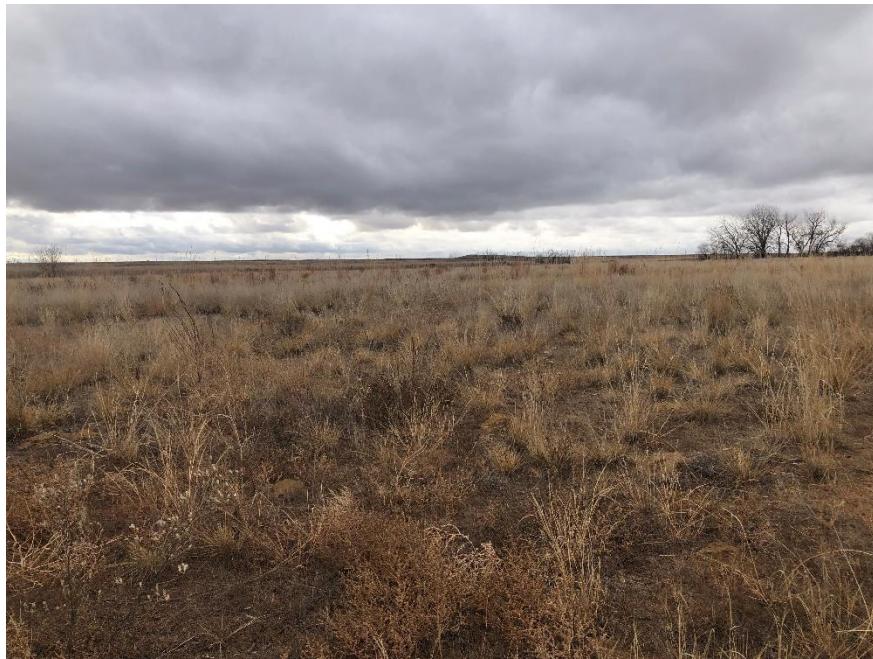
Area 38 with good cover (looking west from fence)

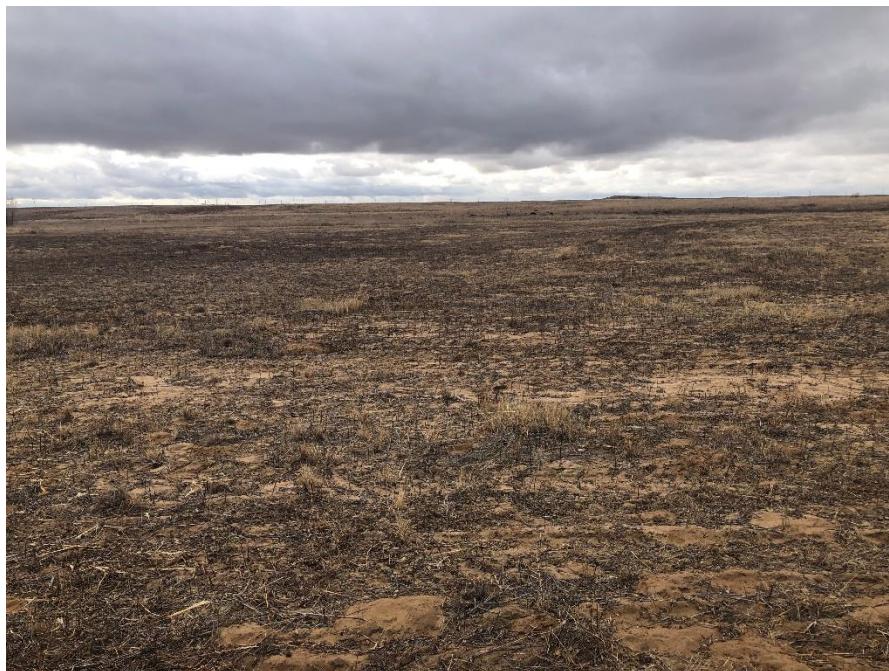
Area 34, mowed (looking west from fence)
