MINERALS PROGRAM INSPECTION REPORT
PHONE: (303) 866-3567

MINE NAME: Wedding Bell Project (Rim Rock Area)	MINE/PROSPECTING ID#: P-2021-010	MINERAL: Unknown commodity	COUNTY: Montrose
INSPECTION TYPE: Surety Release Inspection	WEATHER: Clear	INSP. DATE: October 22, 2025	INSP. TIME: 13:51
OPERATOR: Standard Minerals Inc.	OPERATOR REPRESENTATIVE: Tony Adkins	TYPE OF OPERATION: MP - Mineral Prospecting	
REASON FOR INSPECTION: Surety Release Requested	BOND CALCULATION TYPE:	BOND AMOUNT: \$17,505.00	
DATE OF COMPLAINT: NA	POST INSP. CONTACTS: None	JOINT INSP. AGENCY: None	
INSPECTOR(S): Lucas West	INSPECTOR'S SIGNATURE: 	SIGNATURE DATE: December 4, 2025

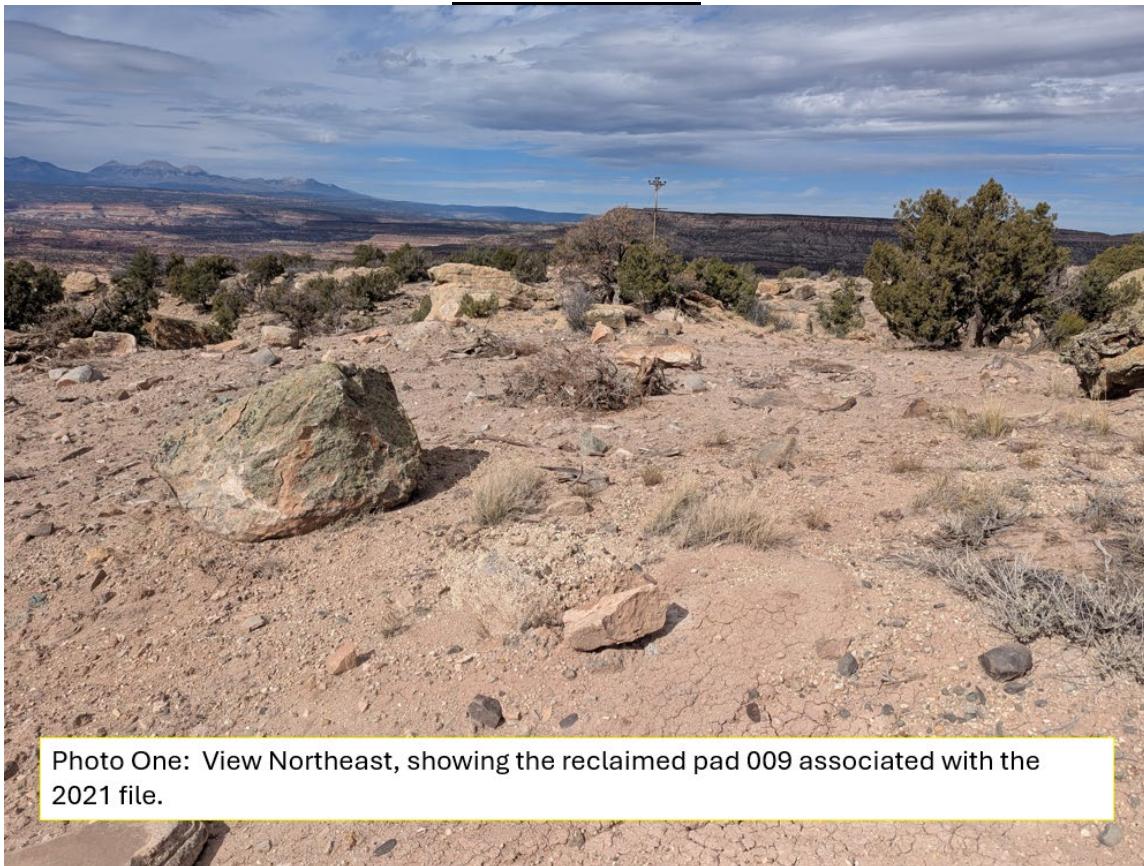
The original disturbances created under File No. P-2021-010 had previously been inspected and the reclamation had been deemed successful with the exception of vegetative cover on one pad. The Modification, conducted in 2024 added eight additional drill pads with a total of 9 holes drilled. The Division has received the proper drill hole abandonment forms for each hole that was drilled. All of the pads associated with the modification were observed and found to be in good condition. The earthwork was done in a manner that blended with the surrounding areas, no evidence of settling or excessive erosion was noted. The vegetative cover of the pads ranges depending on angle and aspect. The cover of all pads is as good as or better than adjacent undisturbed lands of similar angle and aspect. No state listed noxious weeds were noted on any of the pads. All observed pads have been spread with downed woody debris to help blend with the natural environment. Examples of the pads associated with P-2021-010 can be seen in Photos [One](#) and [Two](#). All short access roads that were constructed were found to be in similar condition to the pads.

Photo One: View Northeast, showing the reclaimed pad 009 associated with the 2021 file.

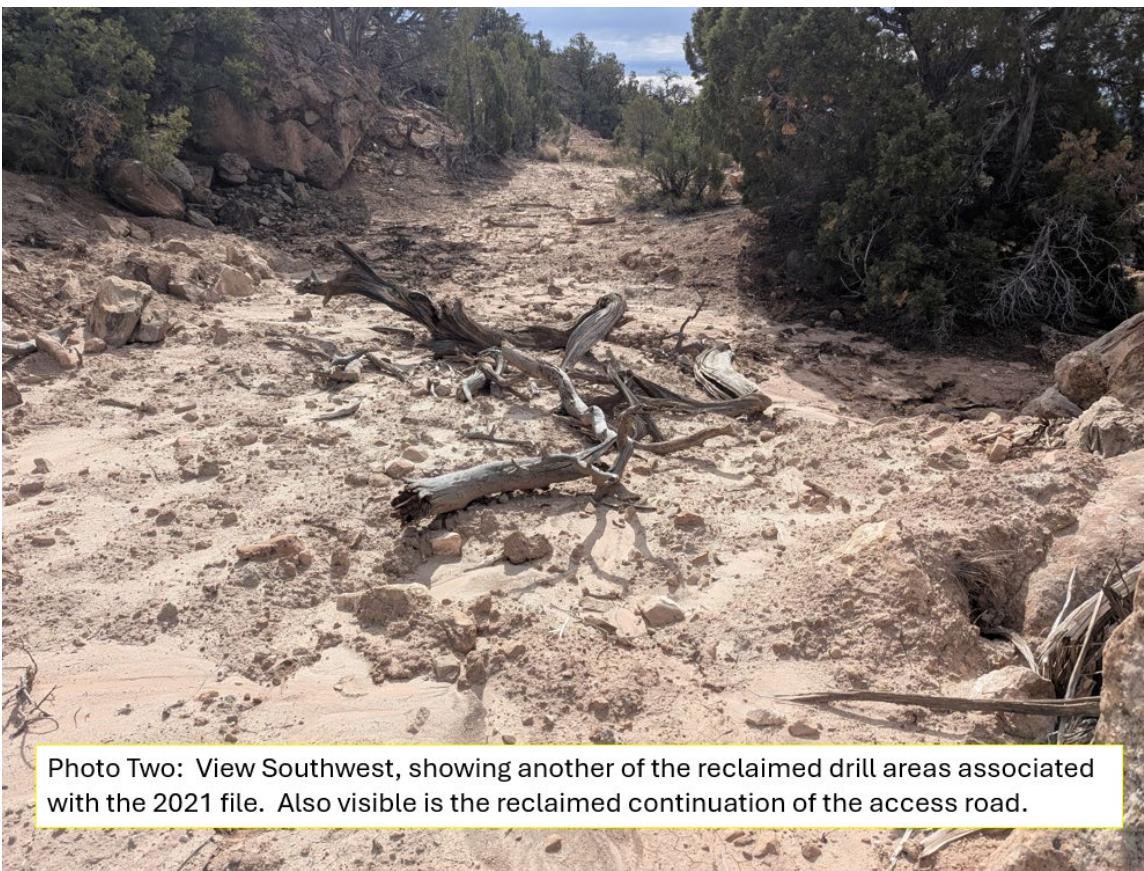
Photo Two: View Southwest, showing another of the reclaimed drill areas associated with the 2021 file. Also visible is the reclaimed continuation of the access road.

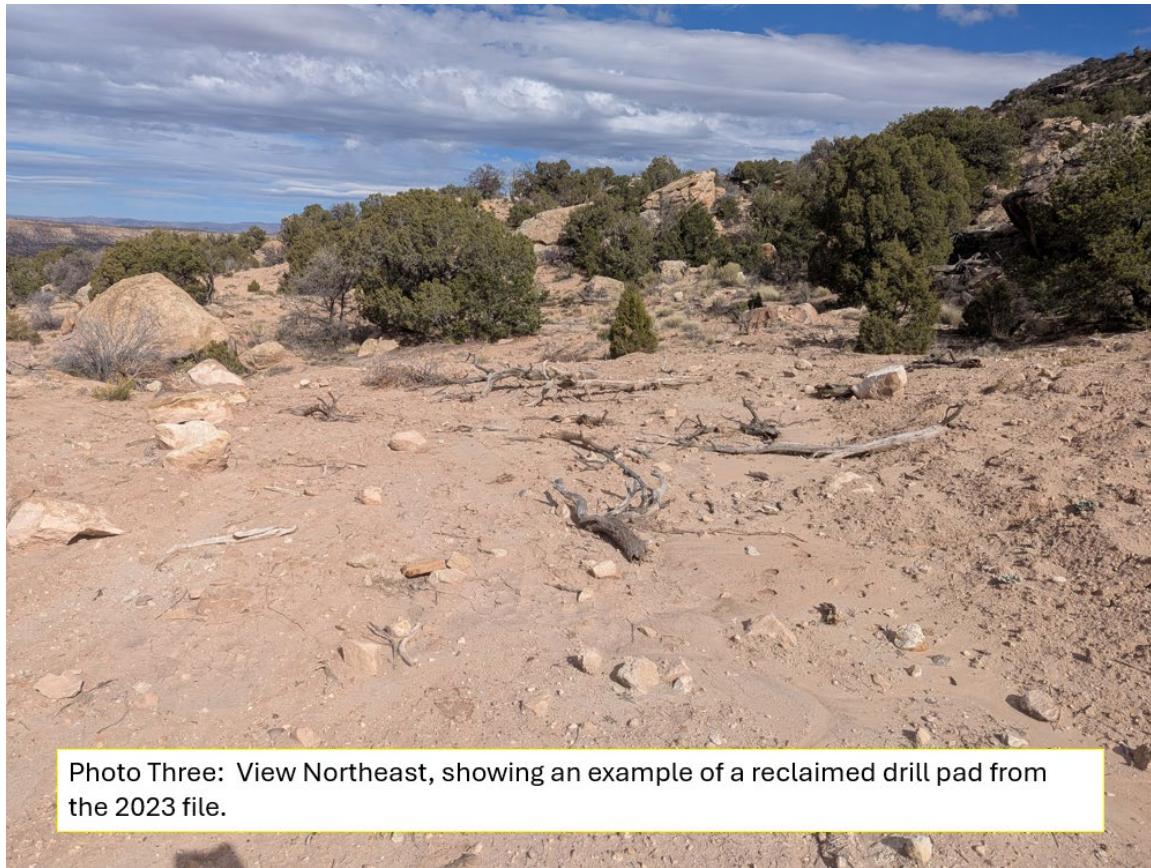
File No. P-2023-011 consisted of an additional eight drill pads with one hole per pad. Several of those holes were never drilled but the pads were constructed. For the holes that were drilled, the Division has received the proper drill hole abandonment reports. All pads were observed and found to be in good condition. The earthwork and grading appeared to be stable at the time of the inspection, and no evidence of settling or erosion was noted. Like the P-2021 sites, the vegetative cover ranged from sparse to more dense. Reclamation species were identified and no evidence of state listed noxious weeds were noted. The access roads that were built were found to be in similar condition to the pads themselves. All disturbed areas have been spread with downed woody debris to blend with adjacent undisturbed lands. Examples of the disturbances associated with the P-2023 file can be seen in Photos [Three](#) and [Four](#).
