MINERALS PROGRAM INSPECTION REPORT
PHONE: (303) 866-3567

MINE NAME: C-JD-5	MINE/PROSPECTING ID#: M-1977-248	MINERAL: Uranium and vanadium	COUNTY: Montrose
INSPECTION TYPE: Monitoring	WEATHER: Clear	INSP. DATE: November 13, 2025	INSP. TIME: 10:30
OPERATOR: Gold Eagle Mining, Inc.	OPERATOR REPRESENTATIVE: Carl Warren	TYPE OF OPERATION: 112d-1 - Designated Mining Operation	
REASON FOR INSPECTION: Normal I&E Program	BOND CALCULATION TYPE: None	BOND AMOUNT: \$100.00	
DATE OF COMPLAINT: NA	POST INSP. CONTACTS: None	JOINT INSP. AGENCY: None	
INSPECTOR(S): Dustin Czapla	INSPECTOR'S SIGNATURE:

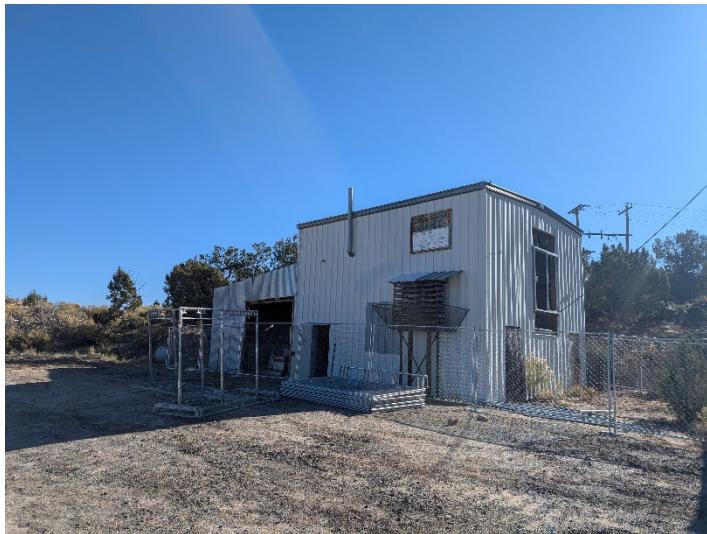
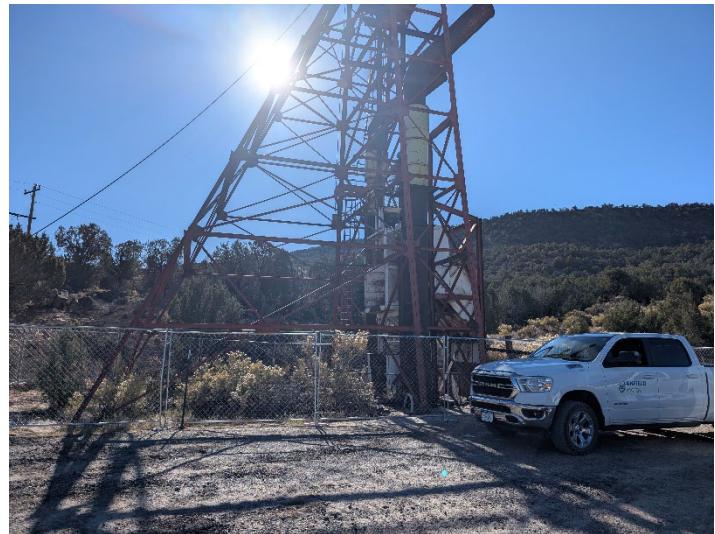
The head frame and hoist/compressor house structures remain on site. TR3 proposed securing these structures within fencing and locked gates. The operator has installed a temporary fence around the structures.

Head frame and hoist/compressor structures remain on site. Temporary fencing installed.

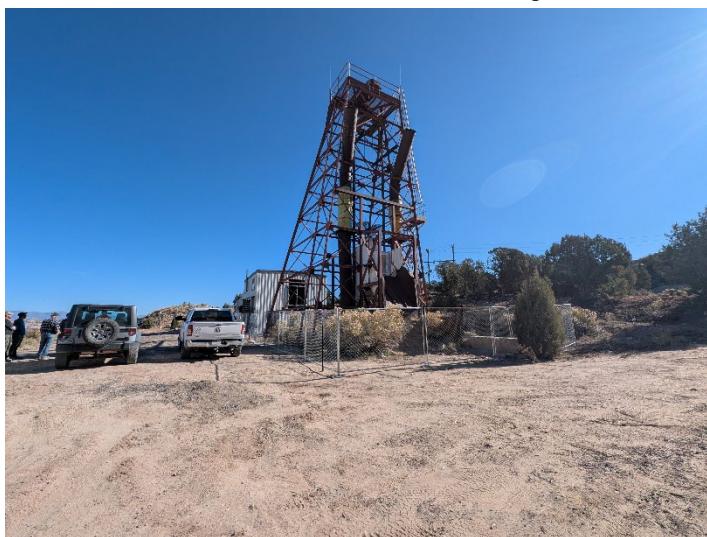
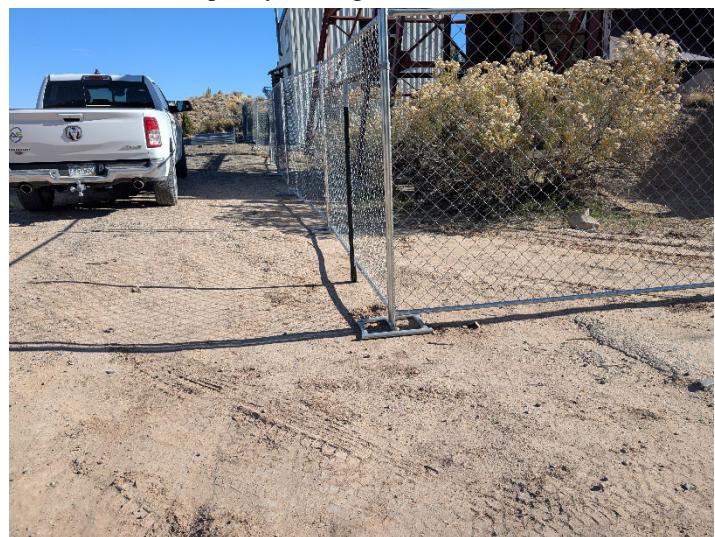
Head frame and hoist/compressor structures remain on site. Temporary fencing installed.

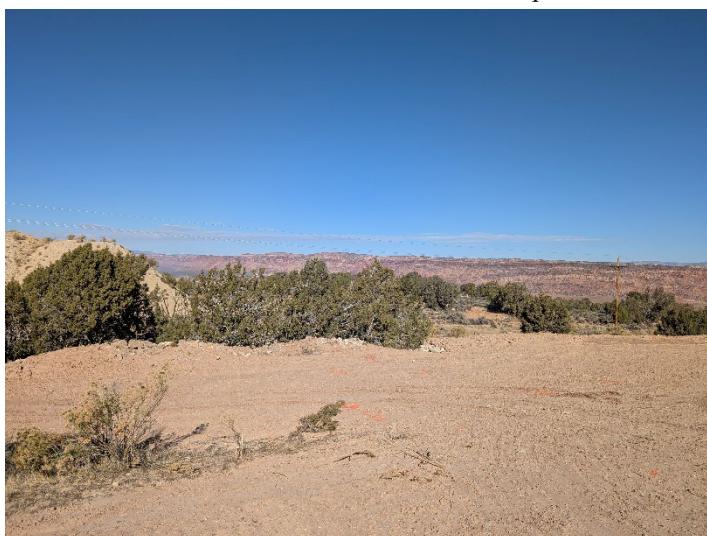
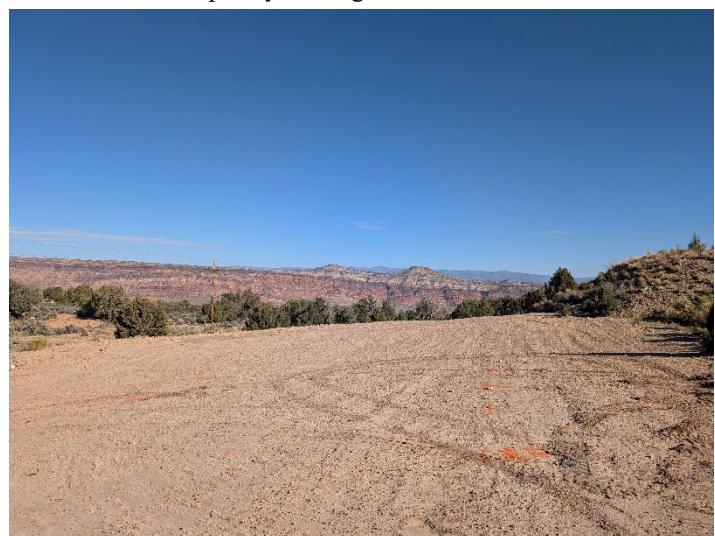
In the Ore Bin area and the Joe Dandy Decline area, the wood debris has been removed, and the areas have been regraded and covered with cover soil. The operator stated that these areas have been seeded.

Ore bin area – debris removed, area regraded, seeded

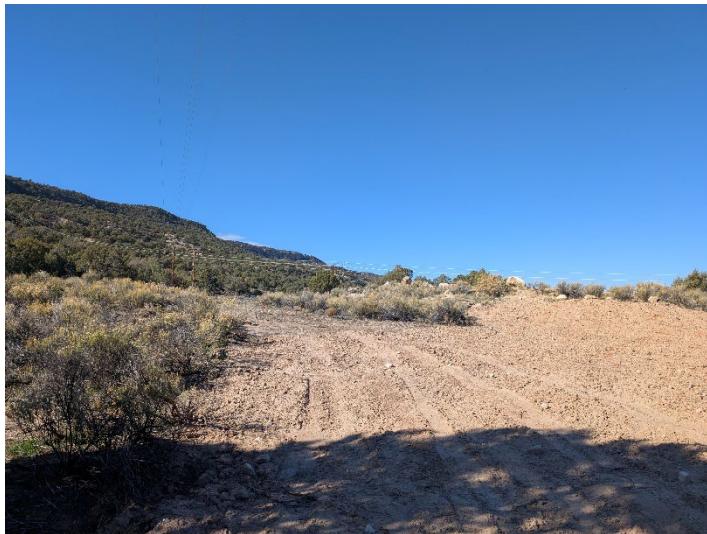
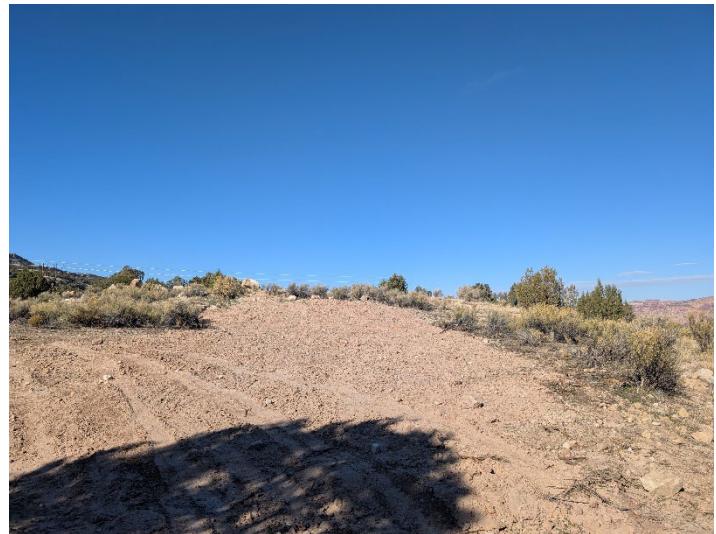
Joe Dandy Decline area – debris removed, area regraded, seeded

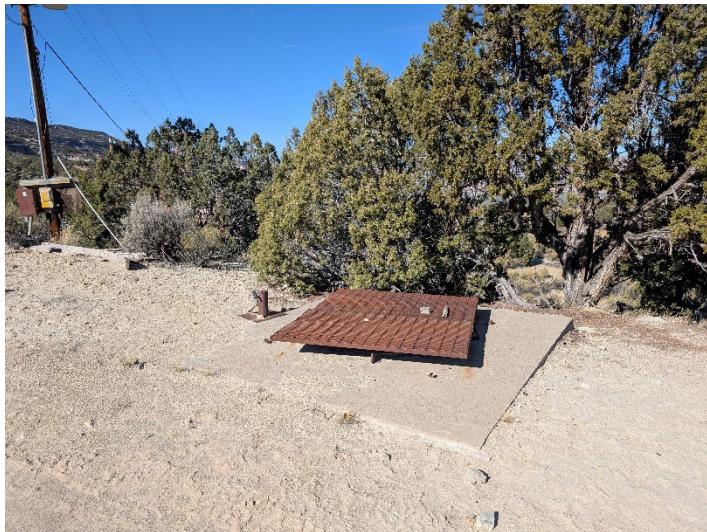
The vent shaft remains in place. The shaft is secured with steel grating welded to the shaft collar.

Vent shaft secured with steel grating welded to collar

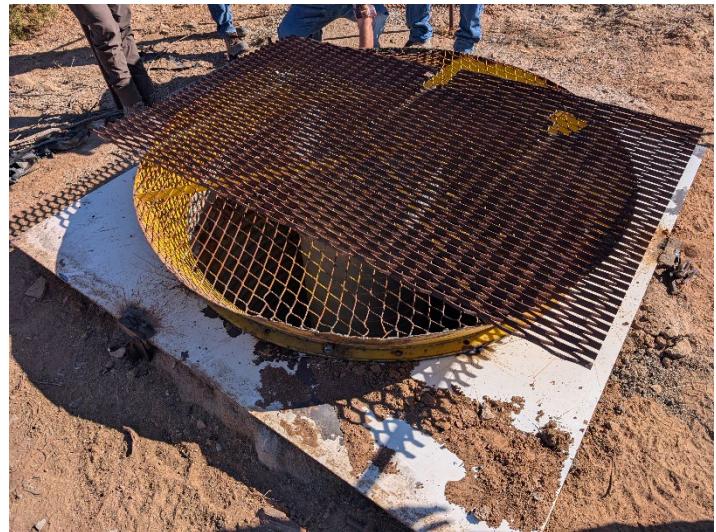
The vent fan and wood cribbing have been removed. The vent fan shaft has not yet been secured with grating welded to the collar.

Ventilation fan shaft – fan removed, shaft not yet secured with the appropriate grating
