Division of Reclamation,  
Mining and Safety

### PERMIT INFORMATION

<b>Permit Number:</b> C-1981-012 <b>Mine Name:</b> New Elk Mine <b>Operator:</b> New Elk Coal Company, LLC <b>Operator Address:</b> 12250 Highway 12 Weston, CO 81091	<b>County:</b> Las Animas <b>Operation Type:</b> Underground <b>Permit Status:</b> <b>Suspended</b> <b>Ownership:</b> Private
	<b>Operator Representative Present:</b>  Bill Massarotti
<b>Operator Representative Signature: (Field Issuance Only)</b>

<b>Inspection Start Date:</b> November 20, 2025 <b>Inspection Start Time:</b> 08:40 <b>Inspection End Date:</b> November 20, 2025 <b>Inspection End Time:</b> 09:54	<b>Inspection Type:</b> Coal Partial Inspection <b>Inspection Reason:</b> Normal I&E Program <b>Weather:</b> Cloudy
<b>Joint Inspection Agency:</b>  None	<b>Joint Inspection Contacts:</b>
<b>Post Inspection Agency:</b>  None	<b>Post Inspection Contacts:</b>
<b>Inspector(s):</b>  Amber M. Gibson	<b>Inspector's Signature:</b>

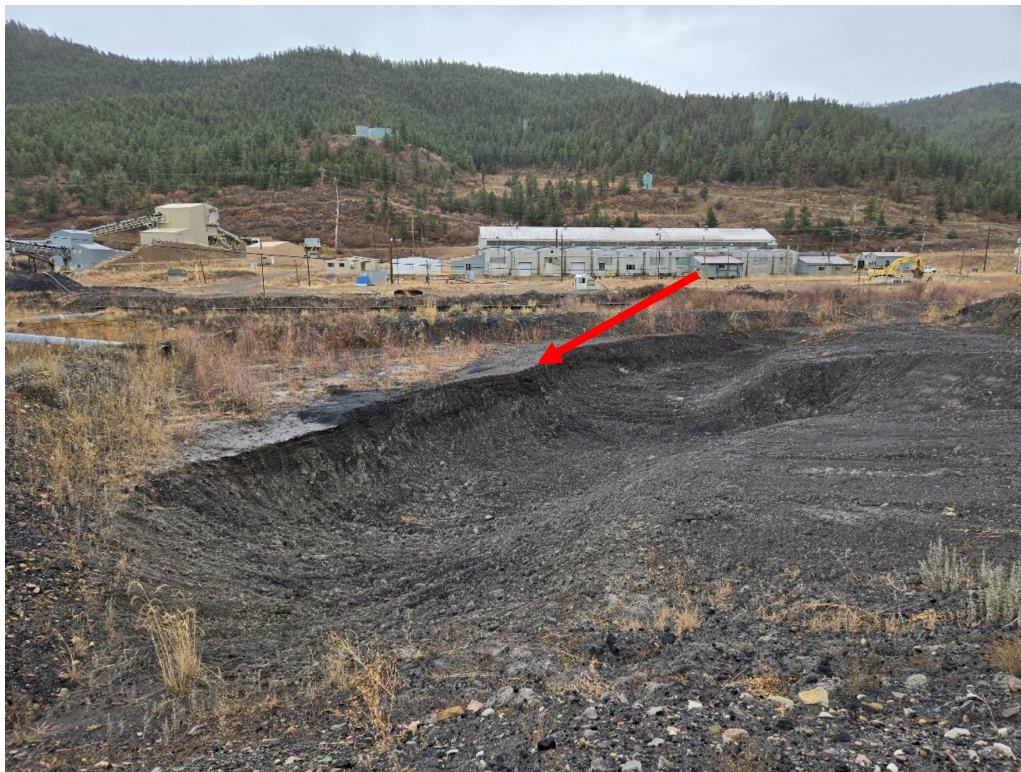
- The sediment basin and sediment drying area on the north and west sides of DWDA #2 were dry at the time of the inspection.
- The sediment basin at the east end of DWDA #2 held damp mud, but no standing water, at the time of the inspection.
- The inlet for culvert C13, located within the sediment basin for DWDA #2, was clear of obstructions.
- **The sediment basin** on the east side of DWDA #2 has been cleaned of sediment and has been deepened to increase capacity.

*Photo 1: Looking south at the excavated sediment basin on the east end of DWDA #2. The arrow points to the previous floor height of the sediment basin.*

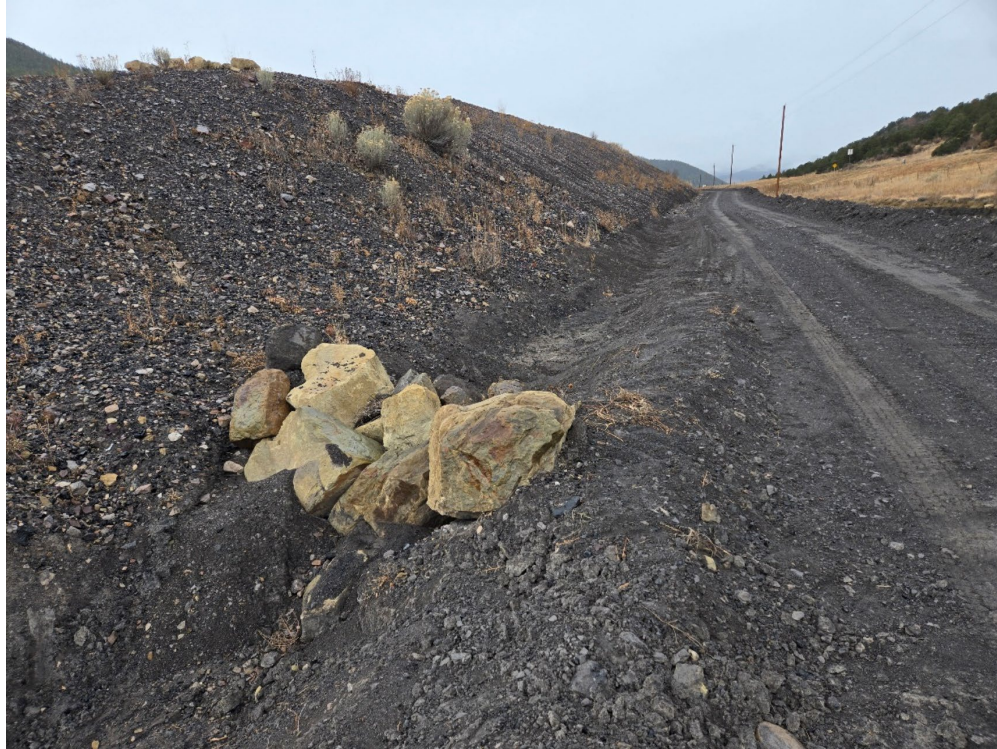
- **“OMI: (October 2024 report) The check dams along the north side of the sediment basin at DWDA #2 have filled with sediment. The Operator shall clean the check dams of sediment and ensure that the sediment control structures are functioning appropriately.”**  
**This has been resolved.** The check dams along the northeast side of DWDA #2 that serve as sediment controls for the sediment basin on the east side of this area have been cleaned of sediment, rebuilt, and stabilized.
- **“OMI: (July 2025 report) Ditch D12 on the north side of DWDA #2 has filled with sediment. The Operator shall remove this sediment and stabilize the ditch and road to ensure that the sediment control structures are functioning appropriately.”**  
**This has been resolved.** The Ditch D12 has been dug out and re-shaped to better aid in controlling stormwater runoff and sediment deposition.

*Photo 2: Looking west at Ditch D12 on the north side of DWDA #2. The check dams within D12 have been repaired.*

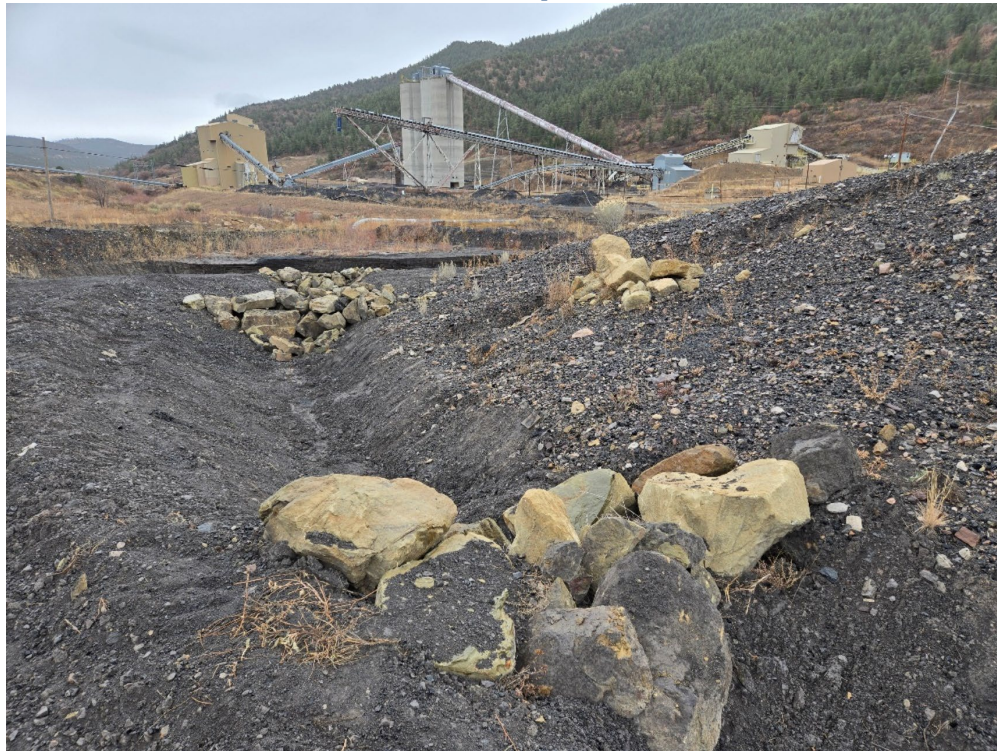
*Photo 3: Looking east at the cleaned and repaired check dams within D12 leading to the sediment basin on the east side of DWDA #2.*

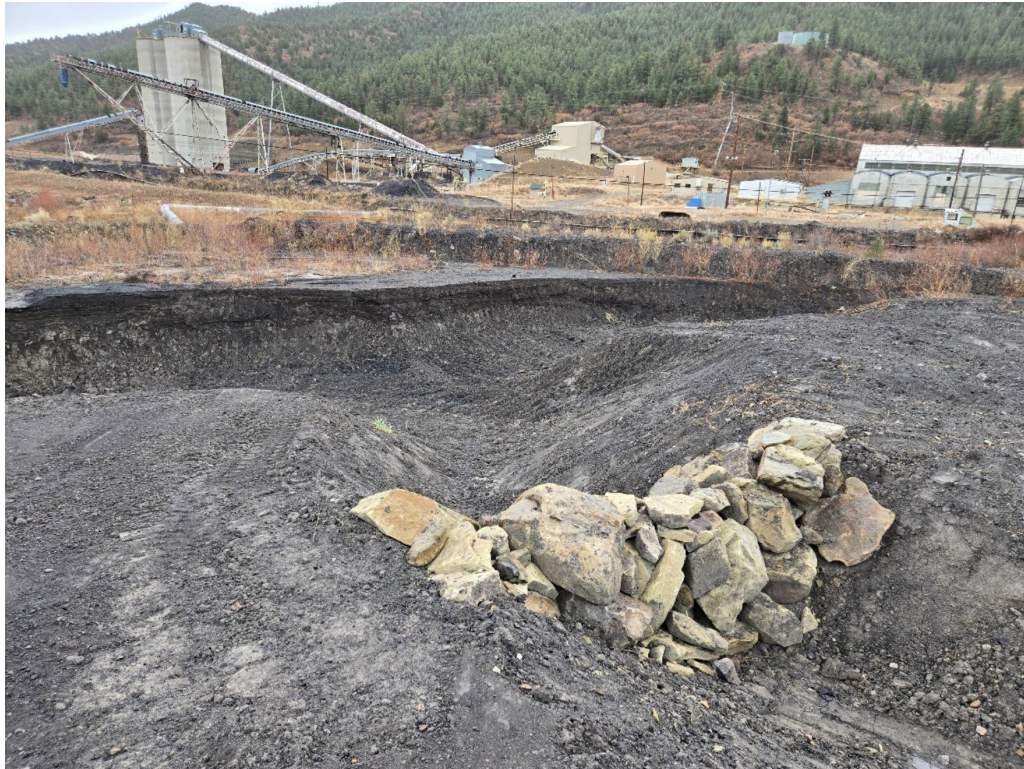
*Photo 4: Looking southeast at where D12 joins with the sediment basin.*

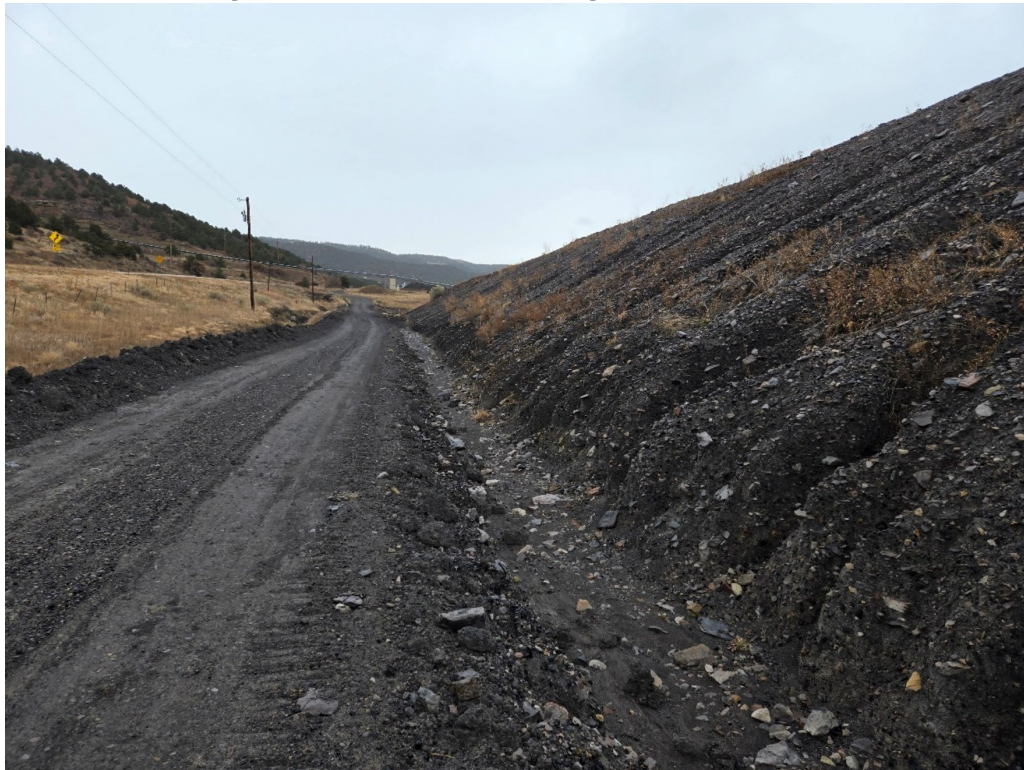
*Photo 5: Looking east along the cleaned-out ditch D12 on the north side of DWDA #2.*

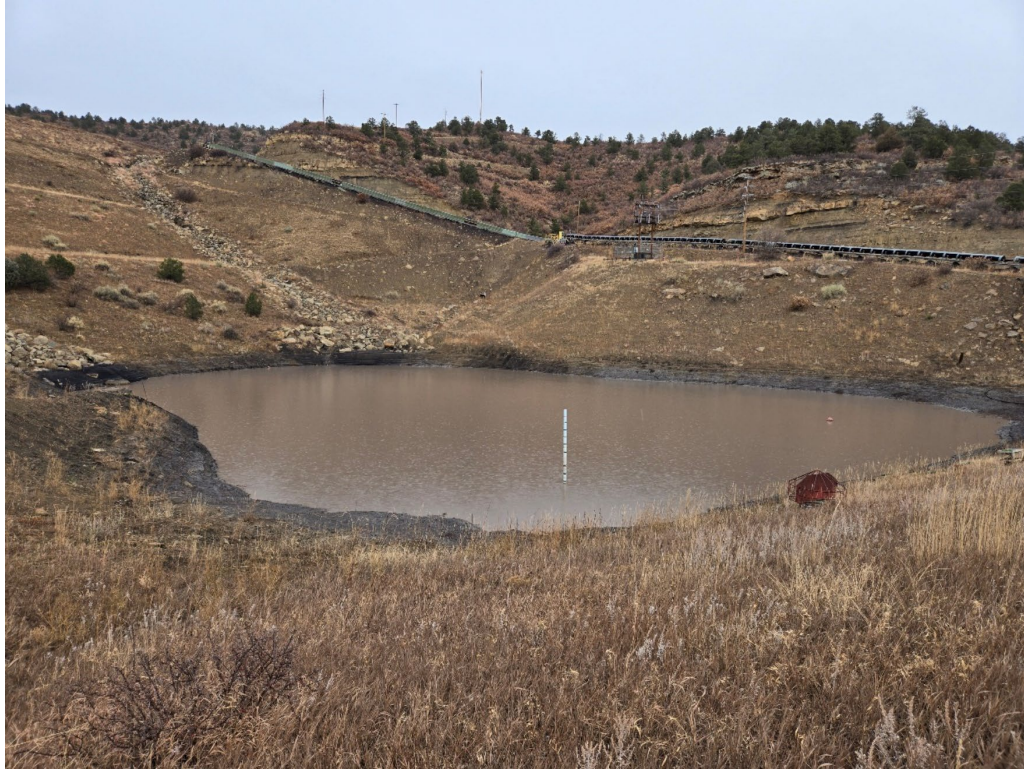
- Pond 08 –
  - The pond contained water at the time of the inspection and was below its capacity. Mr. Massarotti explained that the preferred maximum storage capacity of Pond 08 that would be maintained onsite had been exceeded. The pond levels had been below the primary spillway (decant) and emergency spillway levels, but Mr. Massarotti explained that the pond level would preferably be much lower while the site was operating (see Photo 7 below). The excess water was pumped to Ponds 006A and Pond 007A and was about two feet and two inches lower than the preferred maximum capacity line at the time of the inspection.

- The spillways appeared clear, and the banks were stable. Pond 08 was not discharging.
- Pond 006A –
  - The pond contained water at the time of the inspection. The water level was below capacity even though most of the water pumped from Pond 08 was placed in this pond.

*Photo 6: Looking northeast at Pond 08.*

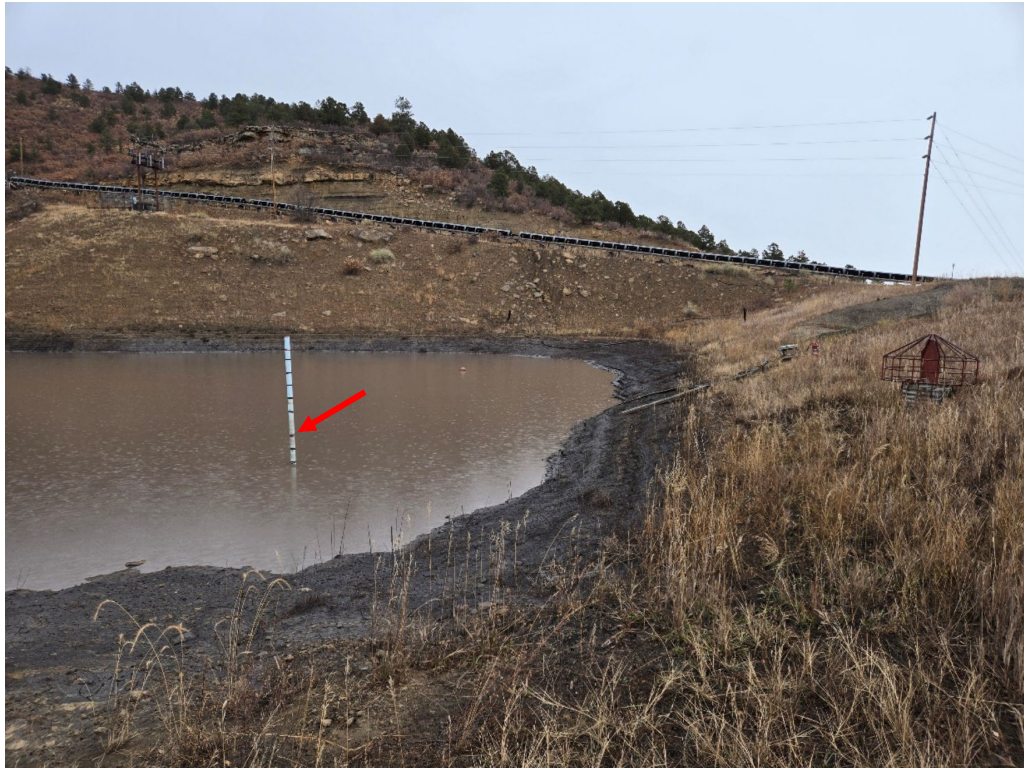
*Photo 7: Pumping the water to Ponds 6 and 7 lowered the water level by 4 or 5 feet in Pond 08. The arrow points to maximum capacity level maintained when the site was operating.*

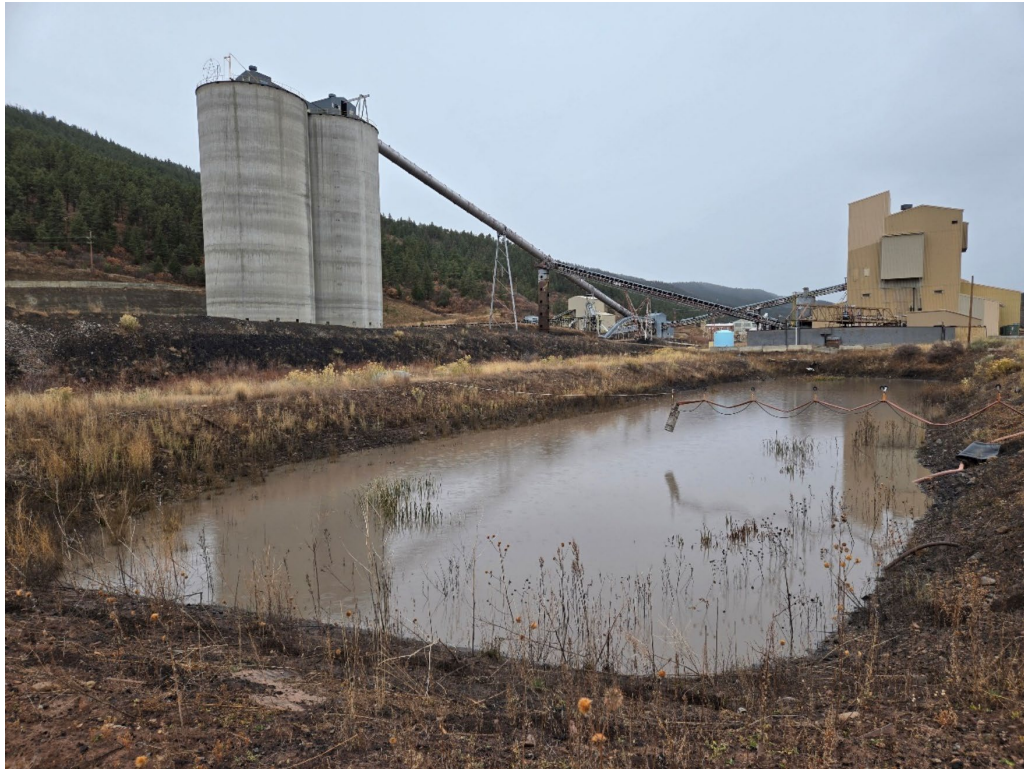
- The banks of the pond appeared to be stable.
- Pond 007A –
  - The water was lower than it had been at recent inspections at the time of the inspection and had plenty of capacity before reaching the blue marker on the white PVC pipe.

*Photo 8: Looking southwest at Pond 006A.*

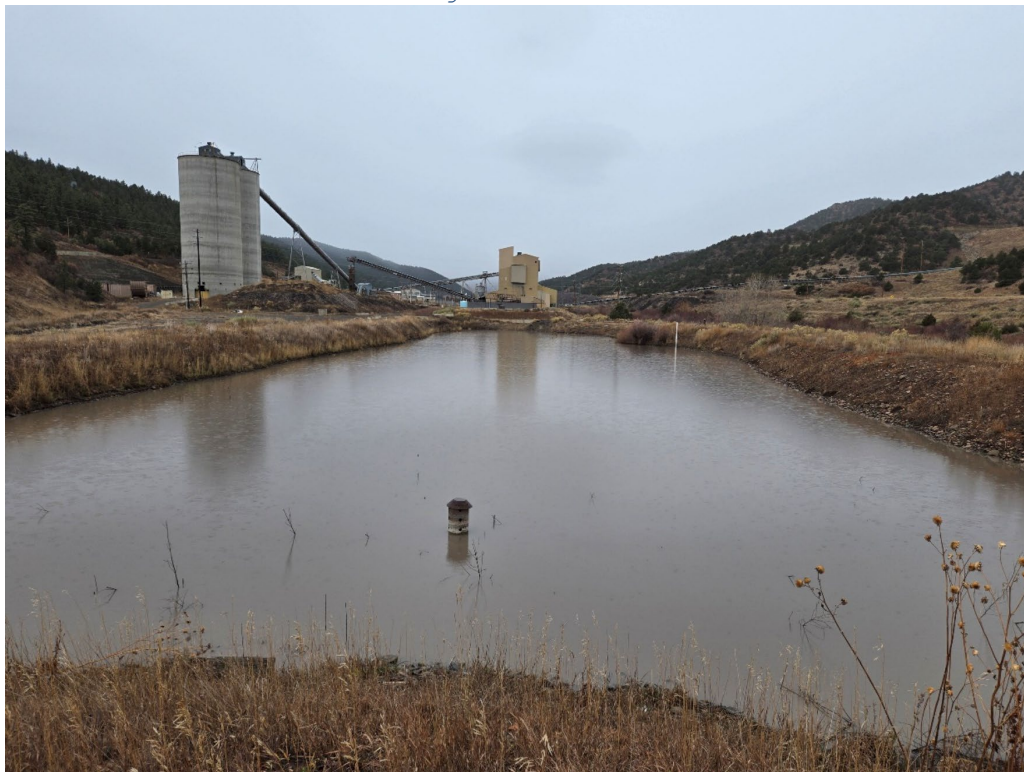
- The water level is below the top few holes of the principal spillway.
  - The pond was not discharging.
  - The banks appeared stable, and the emergency spillway was clear.

*Photo 9: Looking west across Pond 007A.*

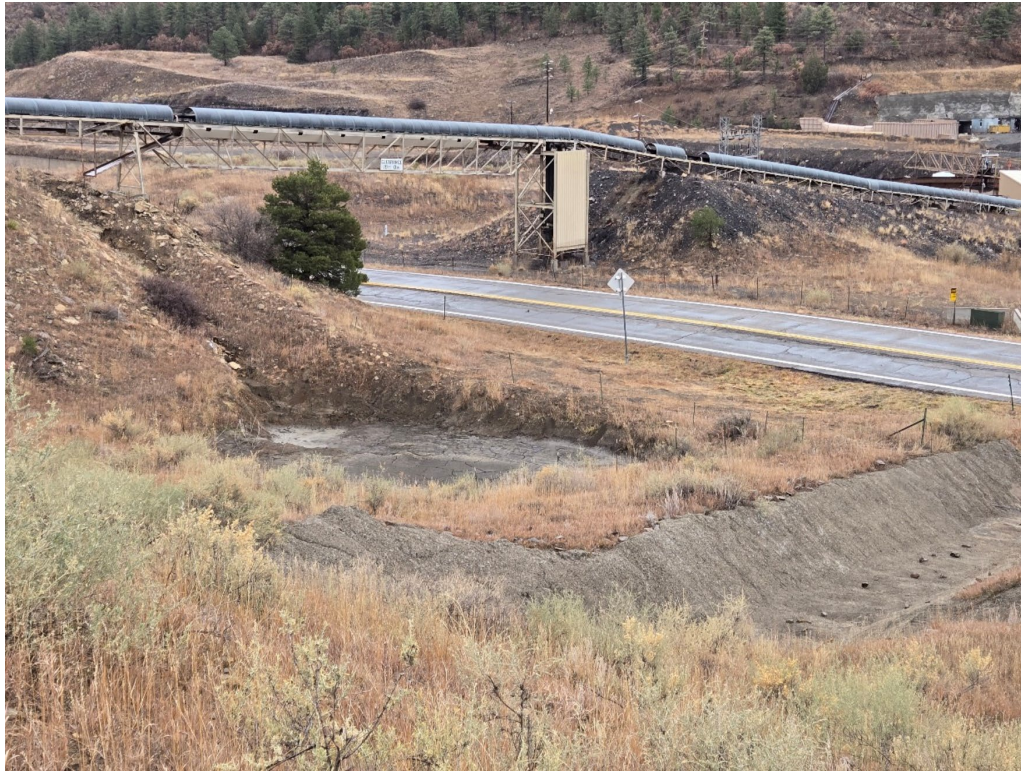
- Containment area #5 was mostly dry at the time of the inspection. The containment area had been below capacity, but water was nearing the top of the embankment. As part of the recent maintenance on site, the sediment that had accumulated in Containment Area #5 has been removed. The sediment load capacity has been increased and [this maintenance issue has been resolved](#).

*Photo 10: Looking southeast at Containment Area #5.*

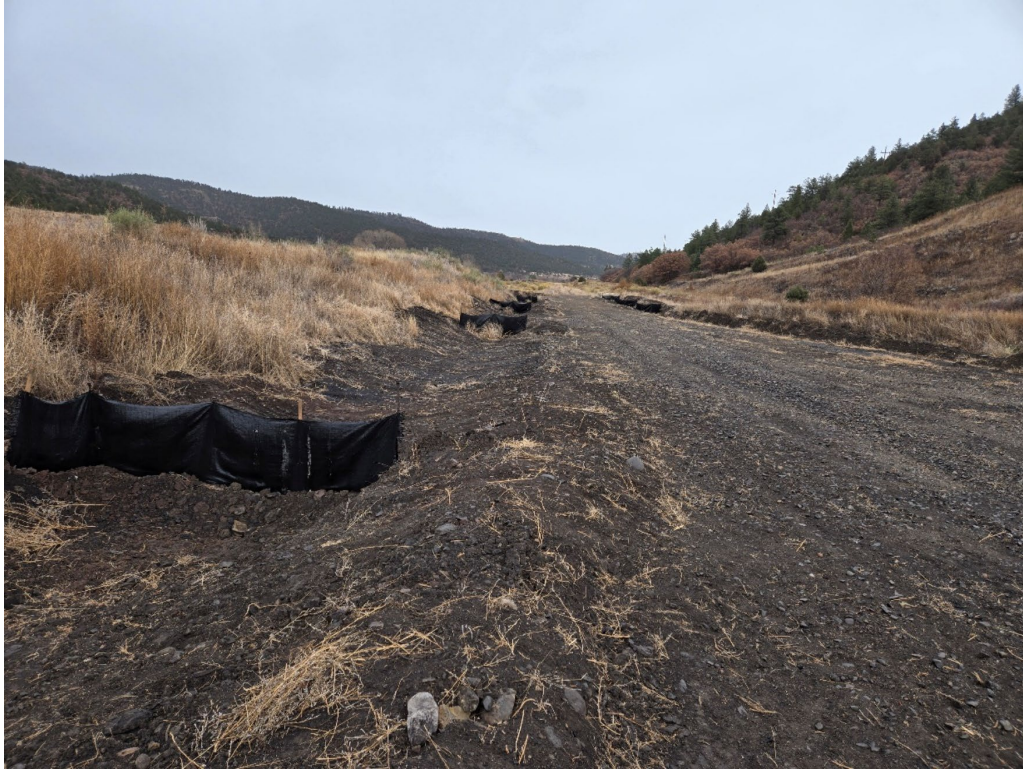
- **“OMI: (January 2024 report) The silt fences along the road in the S.A.E south of Pond 007 are damaged and need to be repaired.”**  
[This has been resolved](#). The debris caught in the previous fences was removed, and the silt fences along the road in the S.A.E south of Pond 007 have been both repaired and replaced. The silt fences appear to have been adequately installed and appear functional.
- *OMI: (March 2024 report) The silt fence on the western border of the S.A.E. on the top of the hill needs to be repaired.*

*Photo 11: Looking east at the silt fences in the S.A.E on the south side of Pond 007A on the northside of the access road.*

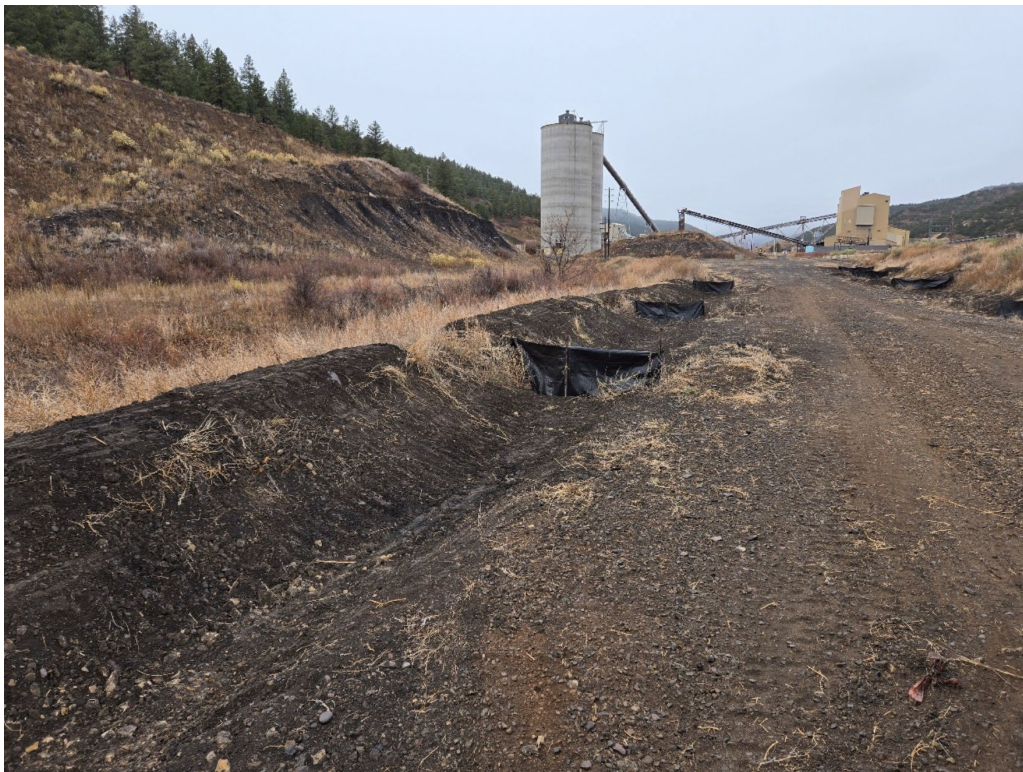
*Photo 12: Looking west at the silt fences in the S.A.E on the south side of Pond 007A on the*

*southside of the access road.*

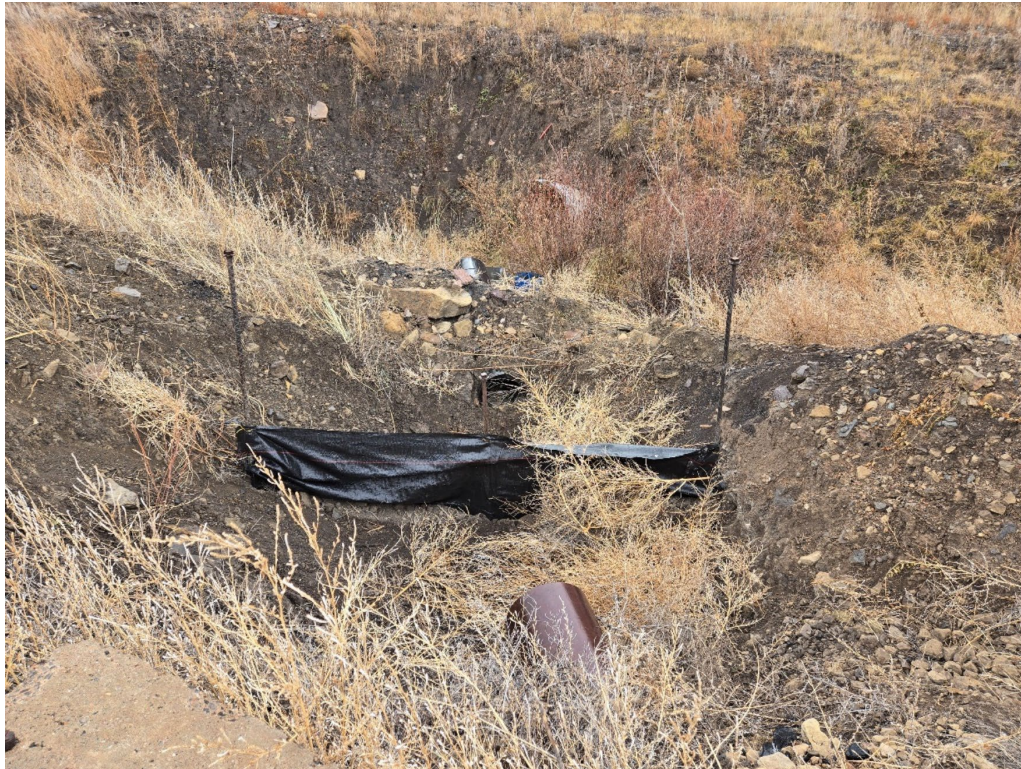
*Photo 13: Looking south at the repaired silt fence near culvert C90.*

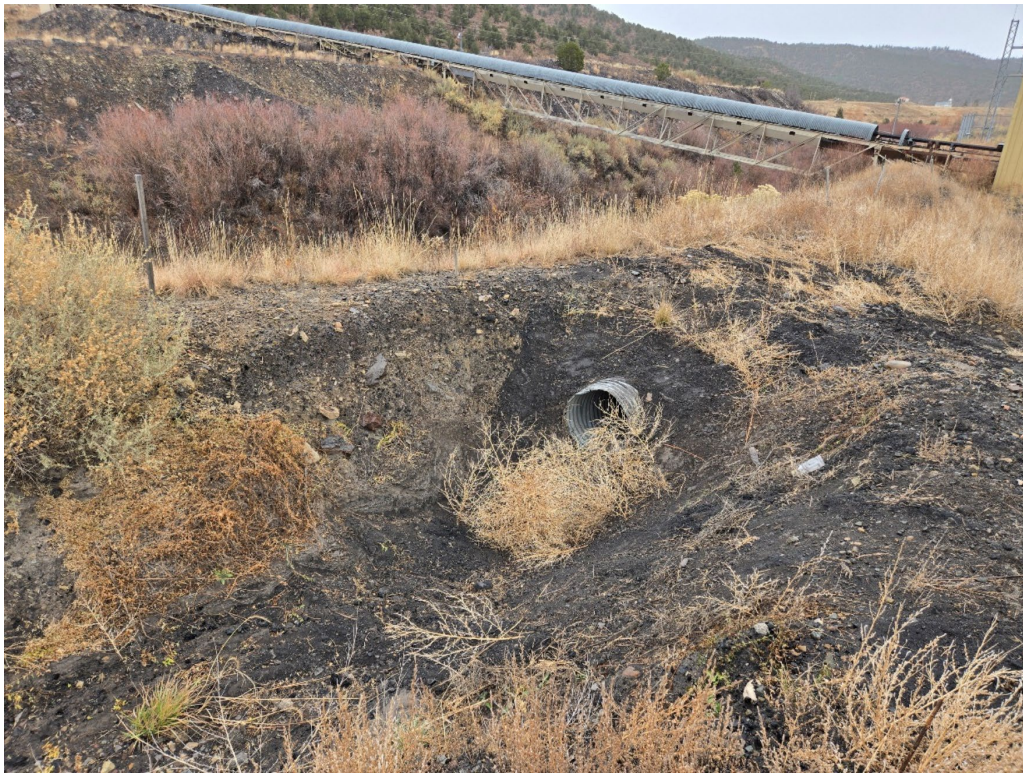
- **“OMI: (August 2025 report) Culvert C64, within Ditch D32, is blocked by vegetative debris. As a result, water has cut around the ditch and has deposited sediment within the raw coal storage area. No water appears to have overflowed on the north side, which leads to the river. **The Operator shall clear the debris from C64 and repair D32 to ensure that water from this ditch flows directly to Pond 007a as designed.**”**

**This has been resolved.** The vegetation directly in front and within C64 has been removed, ditch D32 has been cleaned out and repaired, and the erosion where water had overtopped the ditch has been filled in and stabilized.

*Photo 14: Looking northeast at where the erosion in ditch D34 was repaired and at the cleaned-out inlet side of C64.*

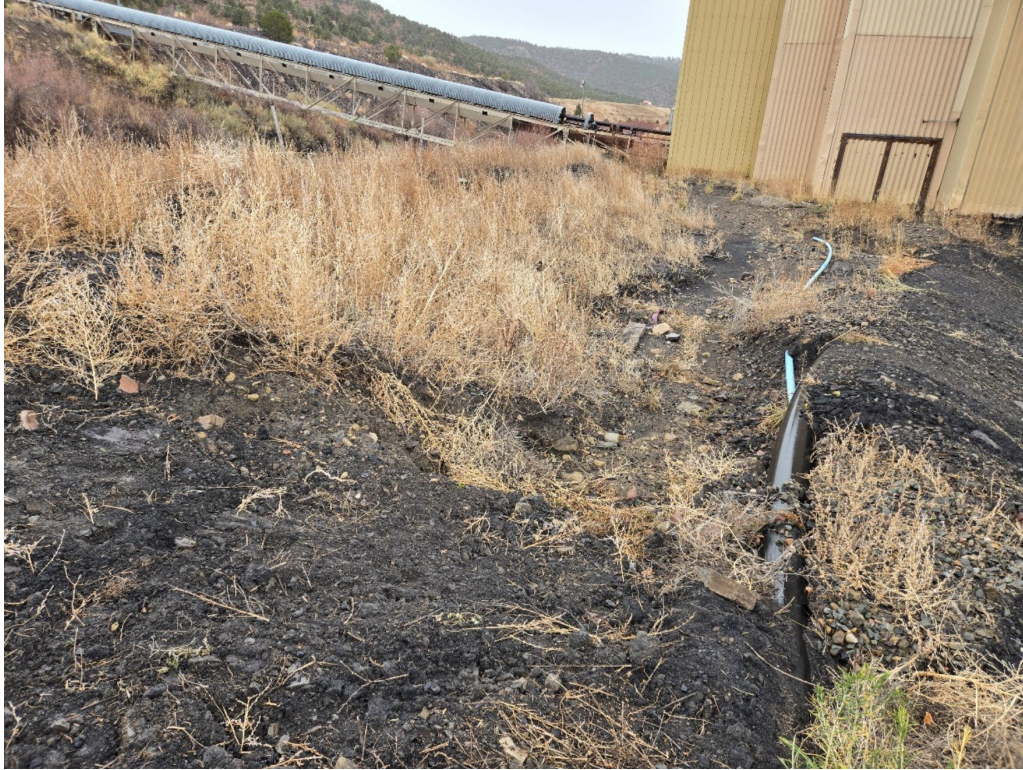
*Photo 15: Looking east at where the Operator built a berm on the Wash Plant side of D34.*

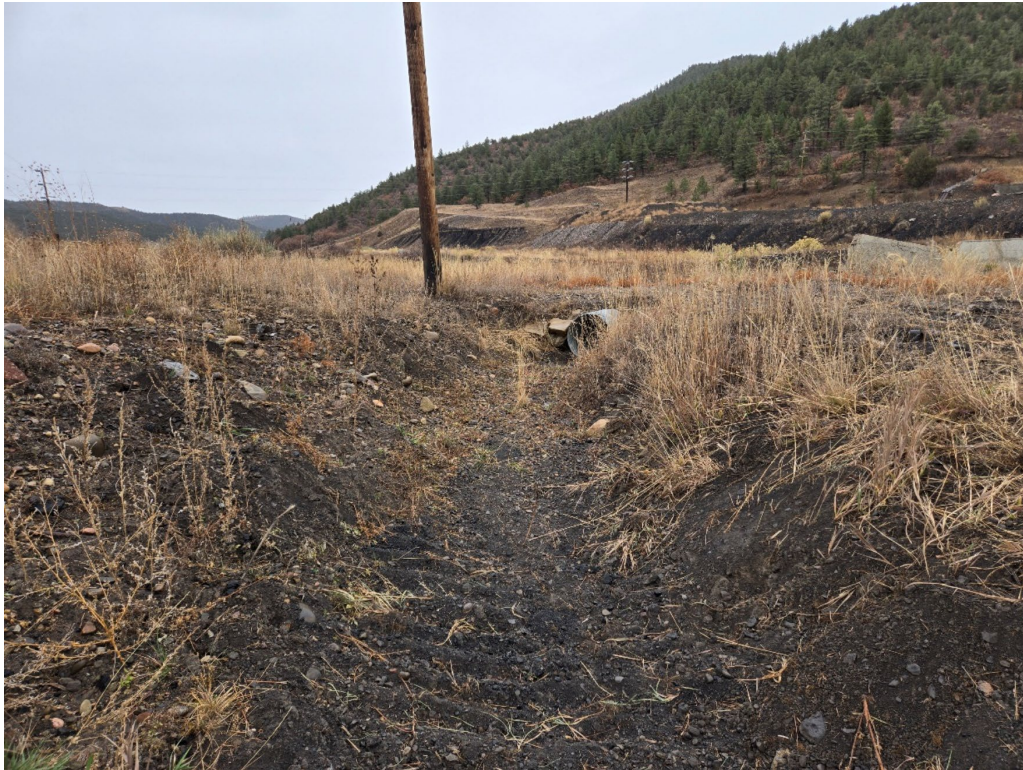
- **Ditches D32A and D32B**, on the east side of the outlet for C65 were cleaned, deepened, and re-stabilized. The outlet for culvert C65 and culvert C22 were also cleared of debris and sediment. With Mr. Massarotti’s help, we used a tape measure and estimated the dimensions of the cleared ditch to be 9’ wide by 2.5’ deep. The future Permittee will need to ensure ditch and culvert dimensions match the approved designs.

*Photo 16: Looking east at the cleaned and widened Ditch D32B and culvert C22.*

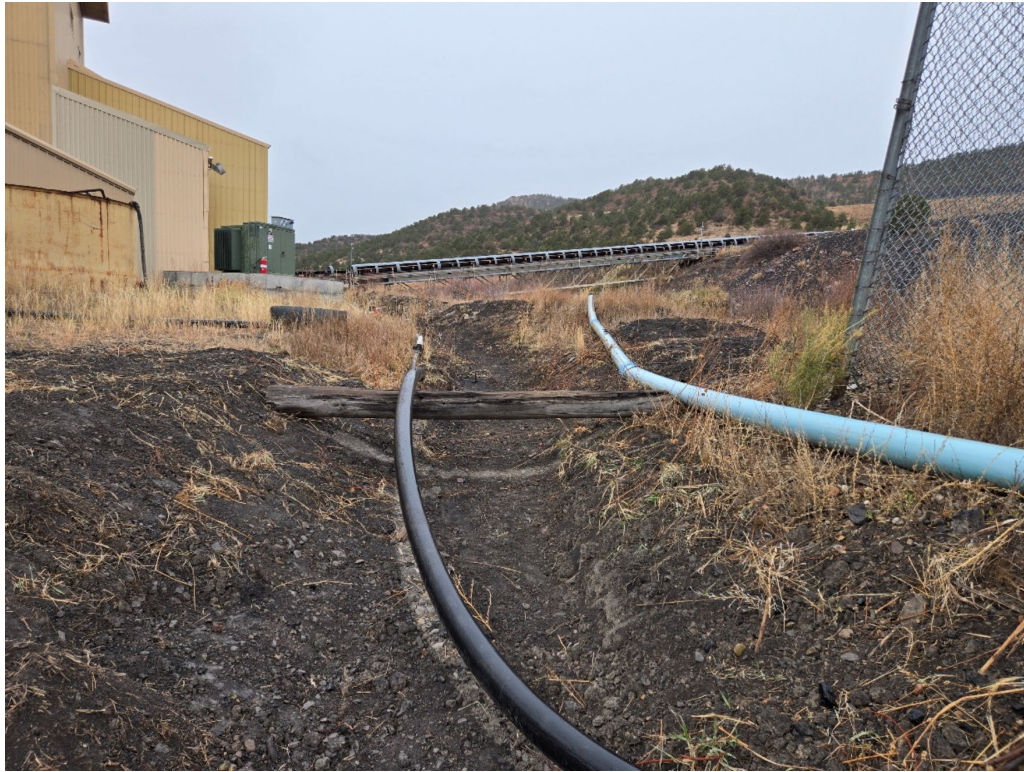
*Photo 17: Looking west at the cleaned and widened Ditches D32B and D32A.*

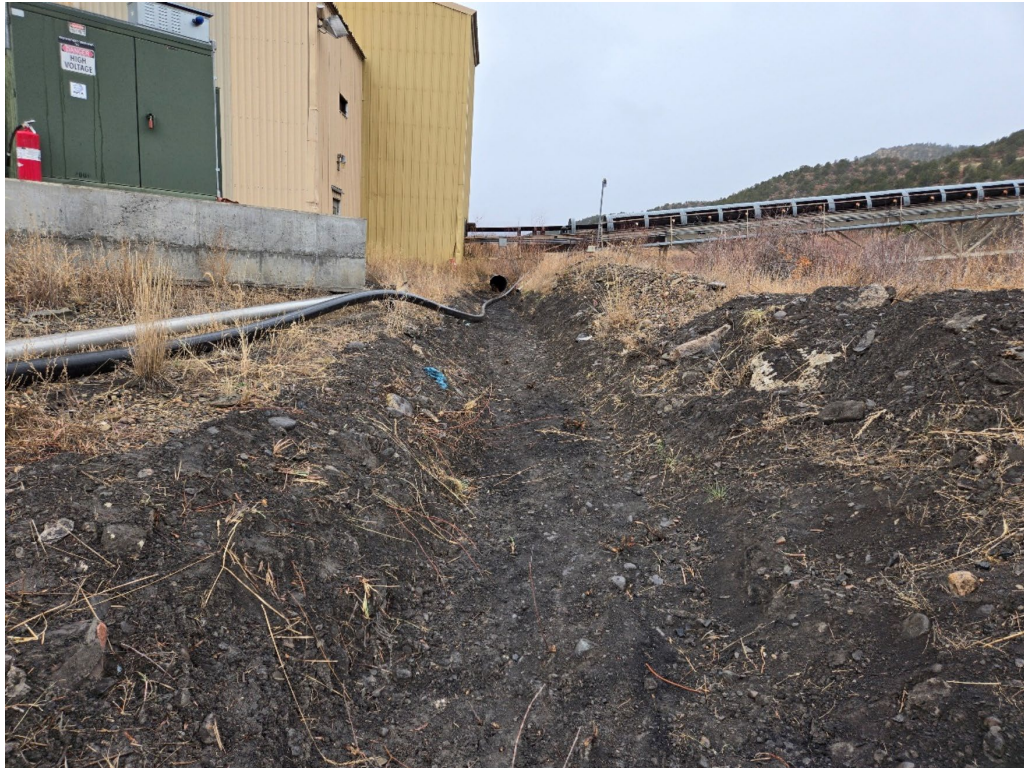
*Photo 18: Looking west at D32A and the outlet for C65.*

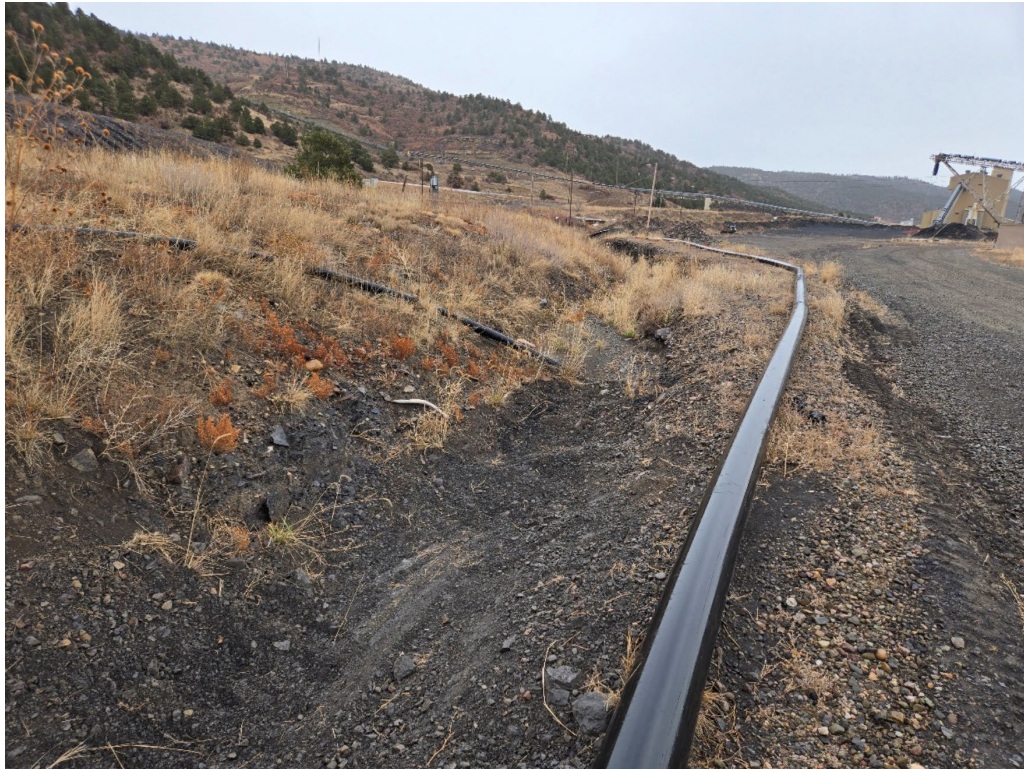
- **Ditch D15** was also cleaned and the ditch has been re-established.

*Photo 19: Looking east at the cleaned-out ditch D15.*

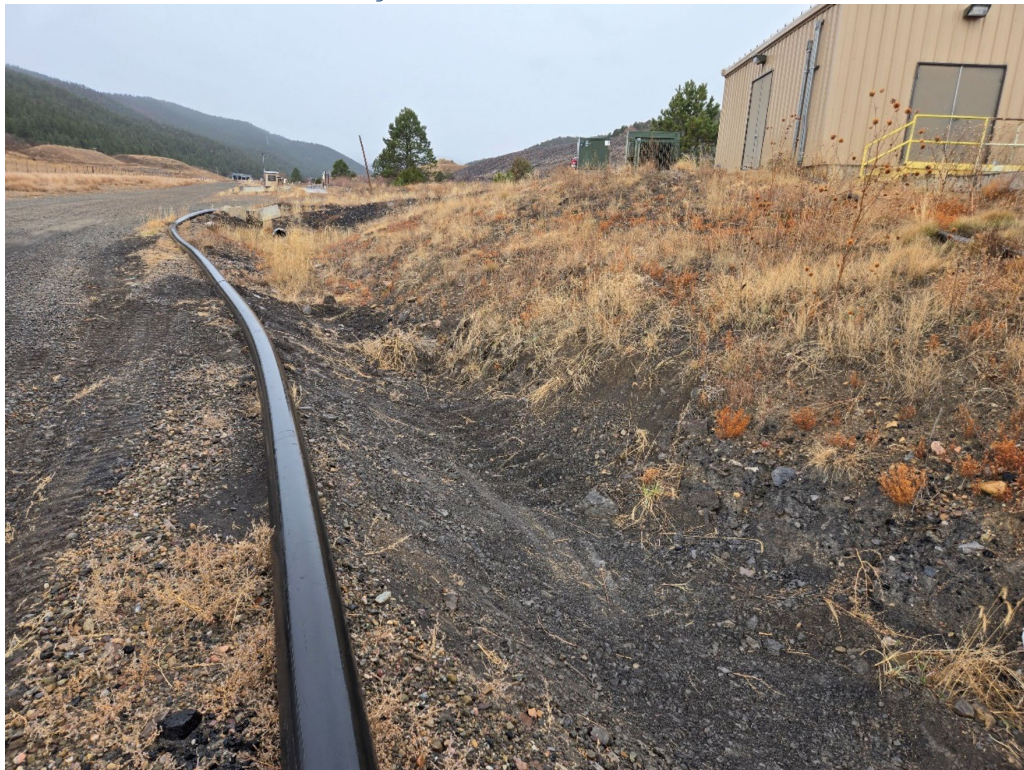
*Photo 20: Looking west at the cleaned-out ditch D15.*

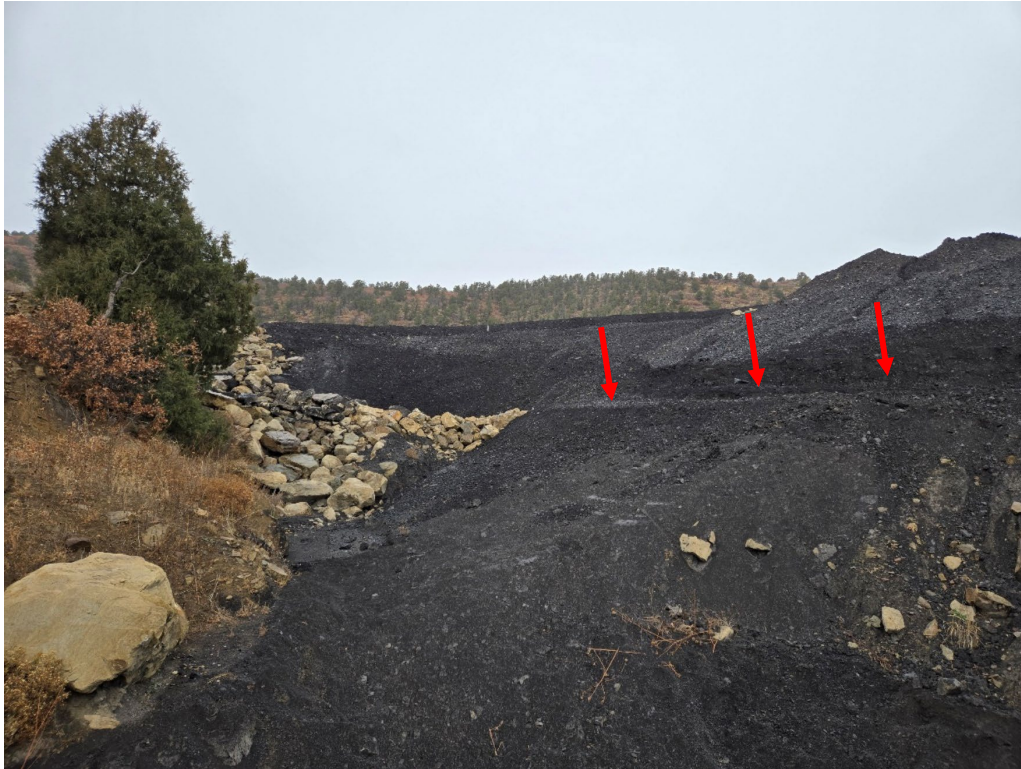
- The erosion on the northwest corner of the RDA before Culvert C81 has been filled in and repaired. To do so, the Operator constructed a small temporary road leading from the RDA haul road and cutting across the eroded slopes (see the yellow line on Figure 1).
- The Operator constructed a berm north of the ditch lining the top slope of the RDA to help slow sediment accumulation generated from run-off. The berm directs water towards the armoring in ditch D55.
- Ditch D55 has been restabilized and ditches have been cut that lead towards the armored channel to help slow sediment accumulation in this area.

*Photo 21: Looking northwest at the repaired erosion on the west side of the RDA. The arrow points to where the Operator created a temporary road to conduct maintenance in this area.*

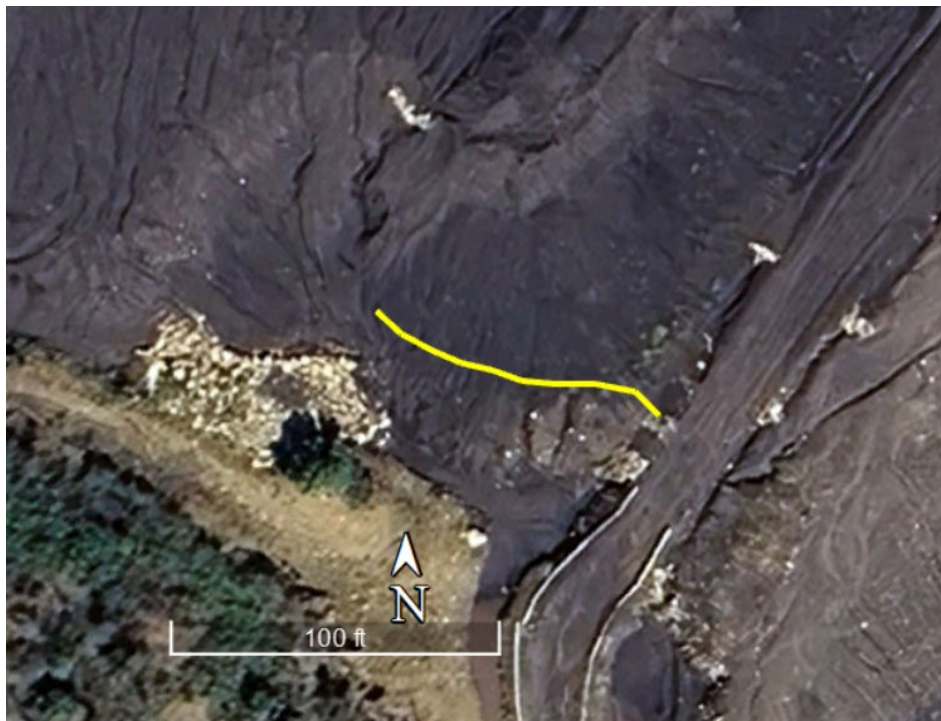
Figure 1: The aerial image above is sourced from Google Earth and is dated September 6, 2024. During the inspection, I used the Esri Field Maps mobile application while I walked along the temporary road to collect its location (see the yellow line on the image above).

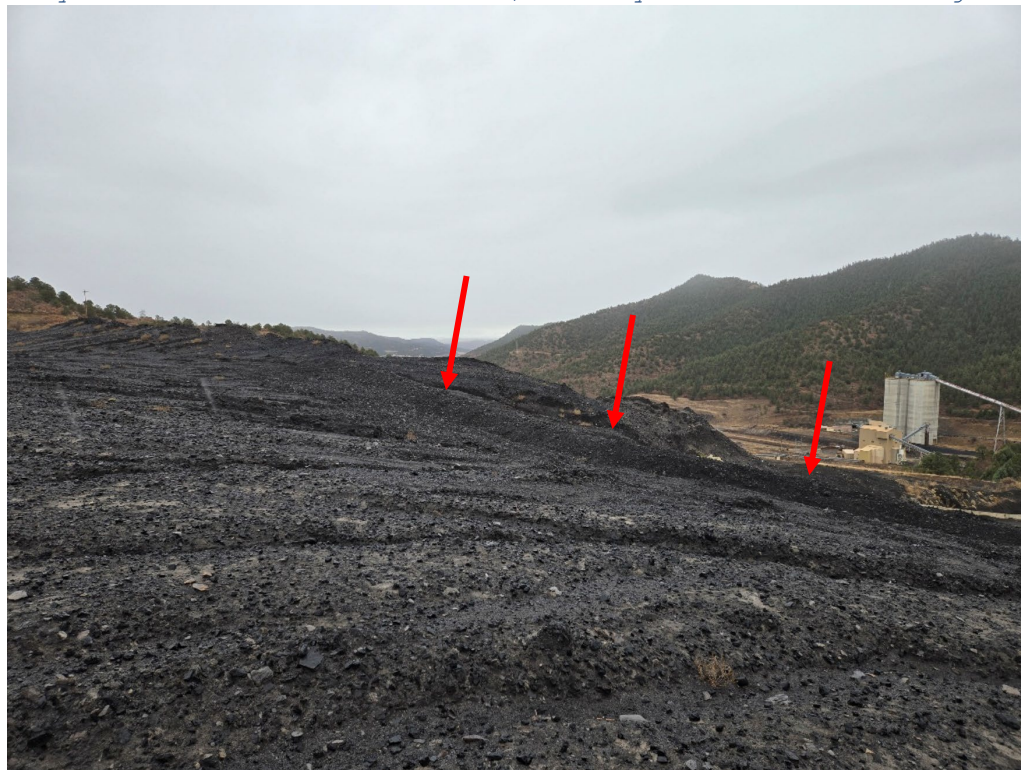
Photo 22: Standing on top of the RDA looking at the new berm along the top that will help divert stormwater runoff straight to the armored channel in Ditch D55.

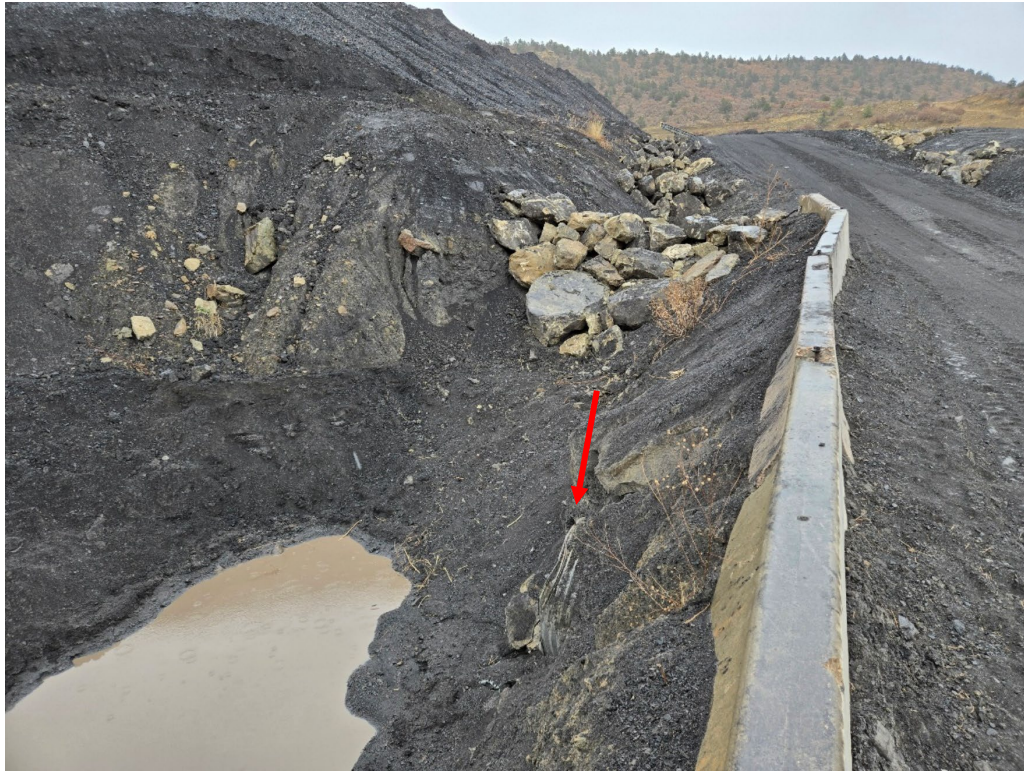
- The Operator flushed culvert C81 using a water truck and cleared the inlet and outlet side of the excess sediment. The unnamed ditch on the outlet side of C81 was excavated to remove sediment that had accumulated, and to increase the ditch's capacity. Mr. Massarotti stated that it was dug to a depth that he had seen when the site was operating and did not believe that the ditch has been deepened beyond its design. The new Permittee will be required to review approved design plans to ensure that if any maintenance work altered approved dimensions there will be a revised design submitted to the Division via a revision application.

*Photo 23: Looking east at the cleaned-out sediment sump in front of the C81 inlet (arrow).*

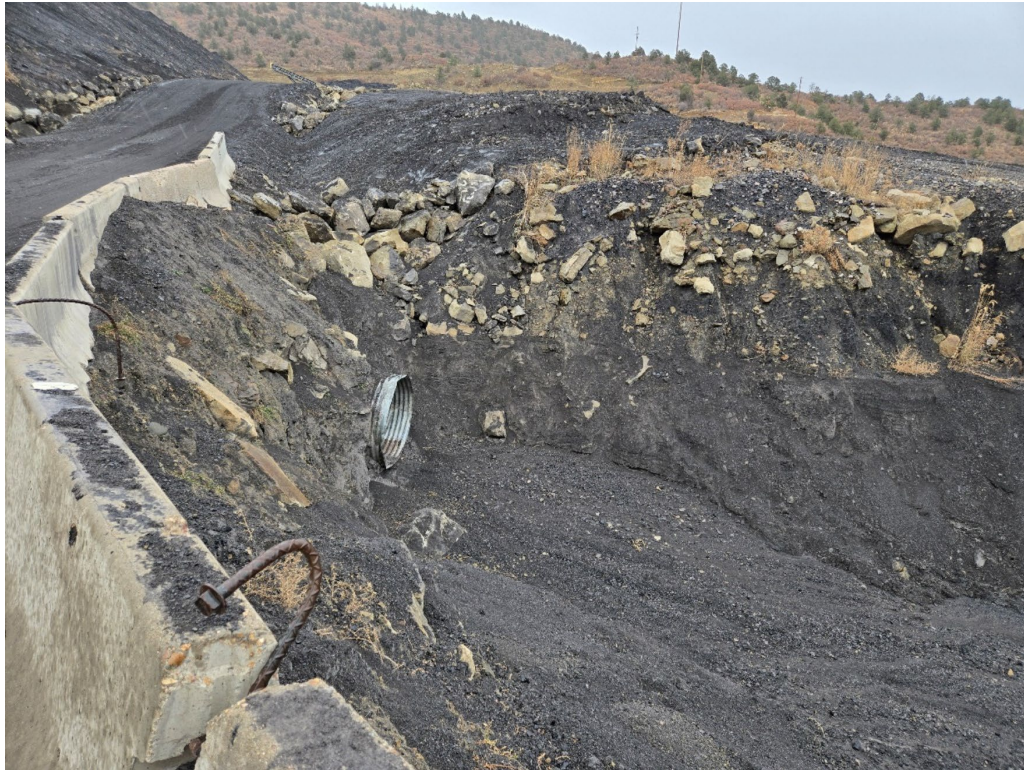
*Photo 24: Looking east at the cleaned-out sediment sump in front of the C81 outlet.*

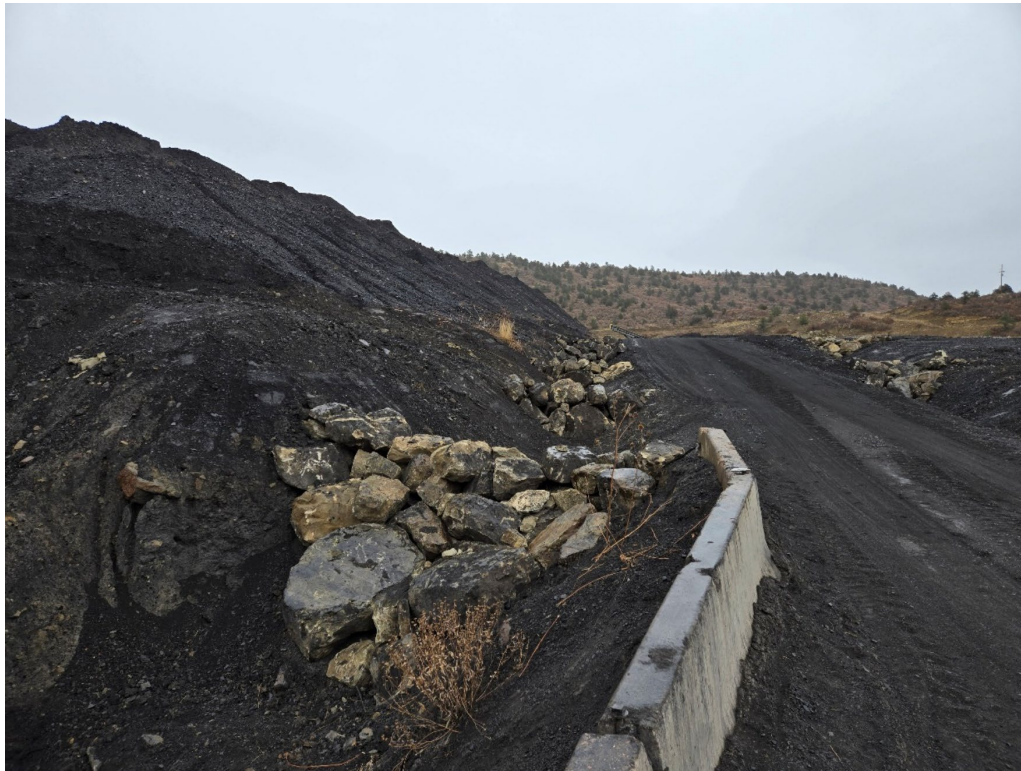
**This concern has been resolved.**
    - Sediment from the check dams that line the north and south side of the road leading to the top of the RDA has been removed and the check dams have been repaired and re-stabilized.

*Photo 25: Looking east at the repaired check dams on both sides of the RDA haul road.*
