Division of Reclamation,  
Mining and Safety

### PERMIT INFORMATION

<b>Permit Number:</b> C-1981-012 <b>Mine Name:</b> New Elk Mine <b>Operator:</b> New Elk Coal Company, LLC <b>Operator Address:</b> 12250 Highway 12 Weston, CO 81091	<b>County:</b> Las Animas <b>Operation Type:</b> Underground <b>Permit Status:</b> <b>Suspended</b> <b>Ownership:</b> Private
	<b>Operator Representative Present:</b>  Bill Massarotti
<b>Operator Representative Signature: (Field Issuance Only)</b>

<b>Inspection Start Date:</b> November 20, 2025 <b>Inspection Start Time:</b> 08:40 <b>Inspection End Date:</b> November 20, 2025 <b>Inspection End Time:</b> 09:54	<b>Inspection Type:</b> Coal Partial Inspection <b>Inspection Reason:</b> Normal I&E Program <b>Weather:</b> Cloudy
<b>Joint Inspection Agency:</b>  None	<b>Joint Inspection Contacts:</b>
<b>Post Inspection Agency:</b>  None	<b>Post Inspection Contacts:</b>
<b>Inspector(s):</b>  Amber M. Gibson	<b>Inspector's Signature:</b>

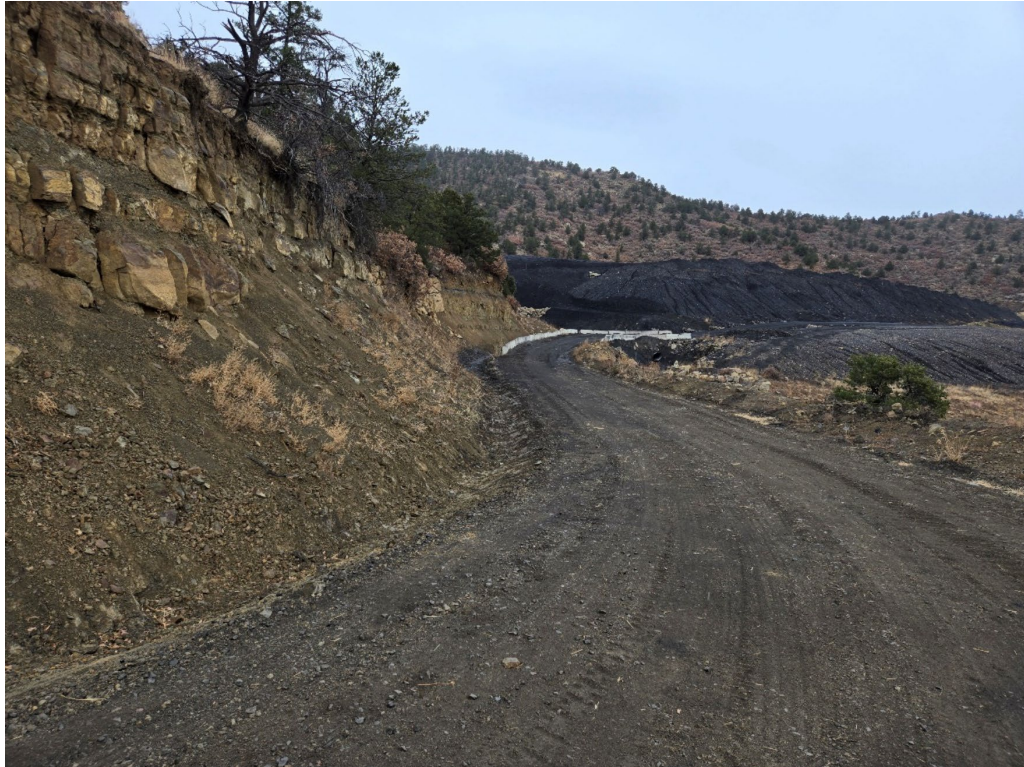
During this inspection, recently deposited fine-grained-grey sediment was observed on the haul road. It appears to have overtopped the ditch where the road bends and has spread towards the armored channel that leads to Pond 08. **The Operator shall remove excess sediment from this ditch to ensure areas offsite do not become impacted by sediment generated from stormwater or snowmelt run-off."**

- Sediment had been removed within this ditch (D56) and the ditch had been cleaned, sump areas had been cleaned, the road had been graded, and fallen rocks strewn along the road had been removed by the time of the inspection.

*Photo 26: Looking north at the cleaned-out Ditch D56 alongside the haul road, where fine grey sediment had previously been deposited onto the road.*

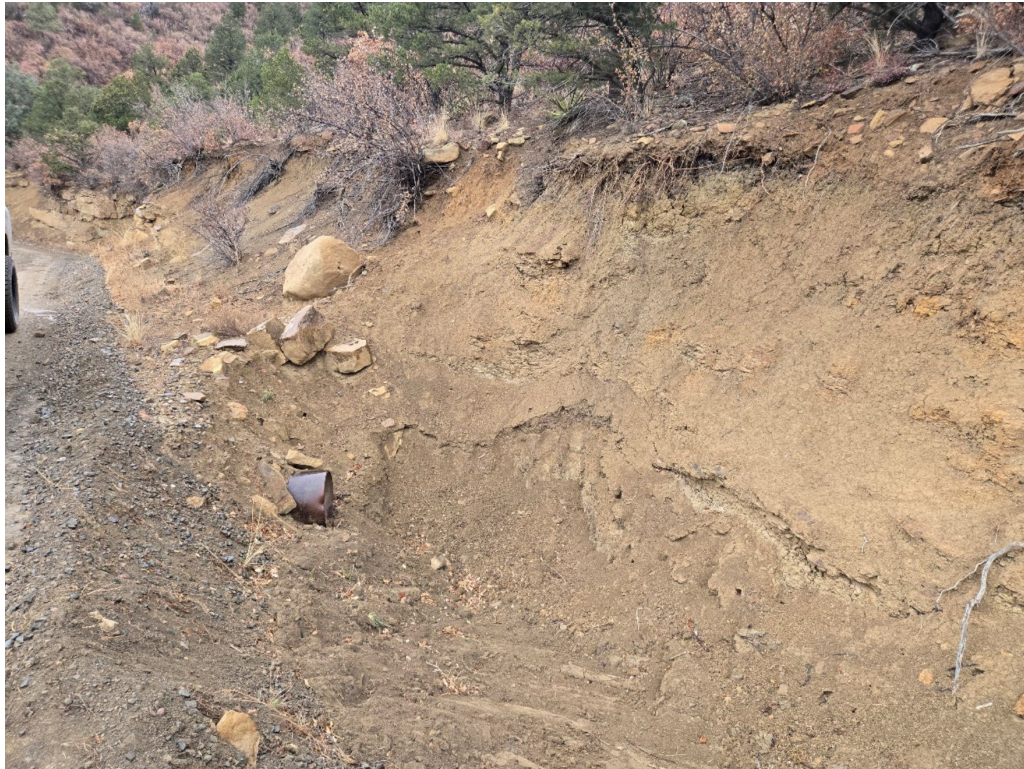
*Photo 27: Looking at one of the cleaned-out sediment sumps along the RDA haul road.*

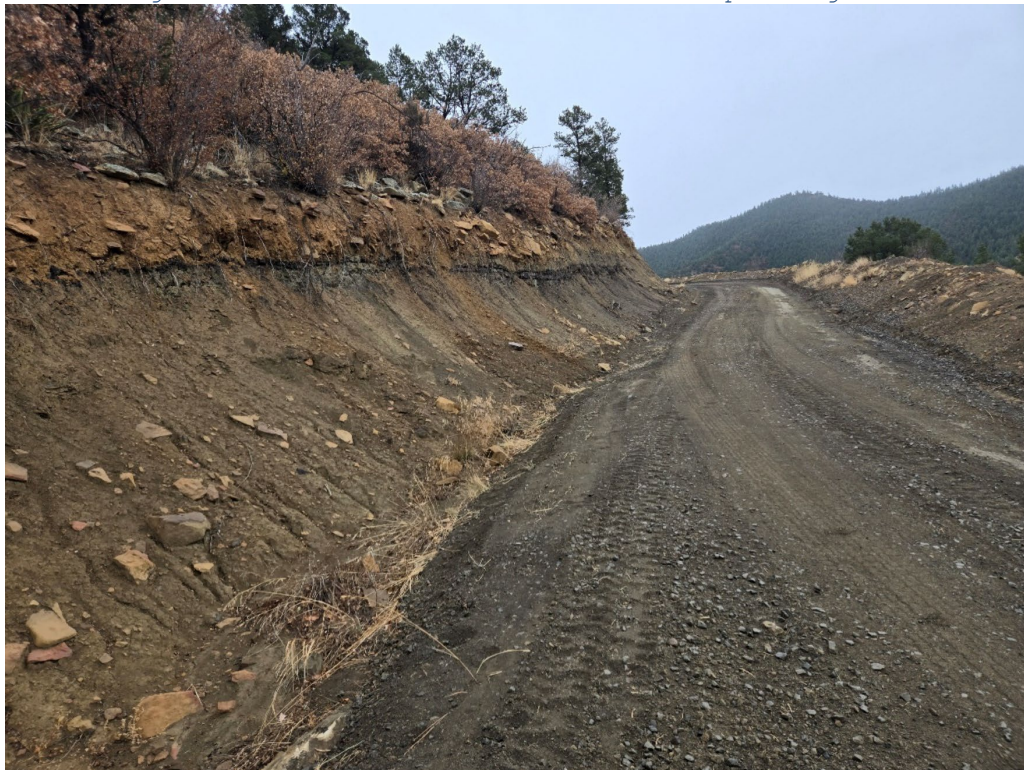
*Photo 28: Looking east along the regraded haul road where falling rocks have been removed and*

*ditch D57 has been cleaned of sediment.*

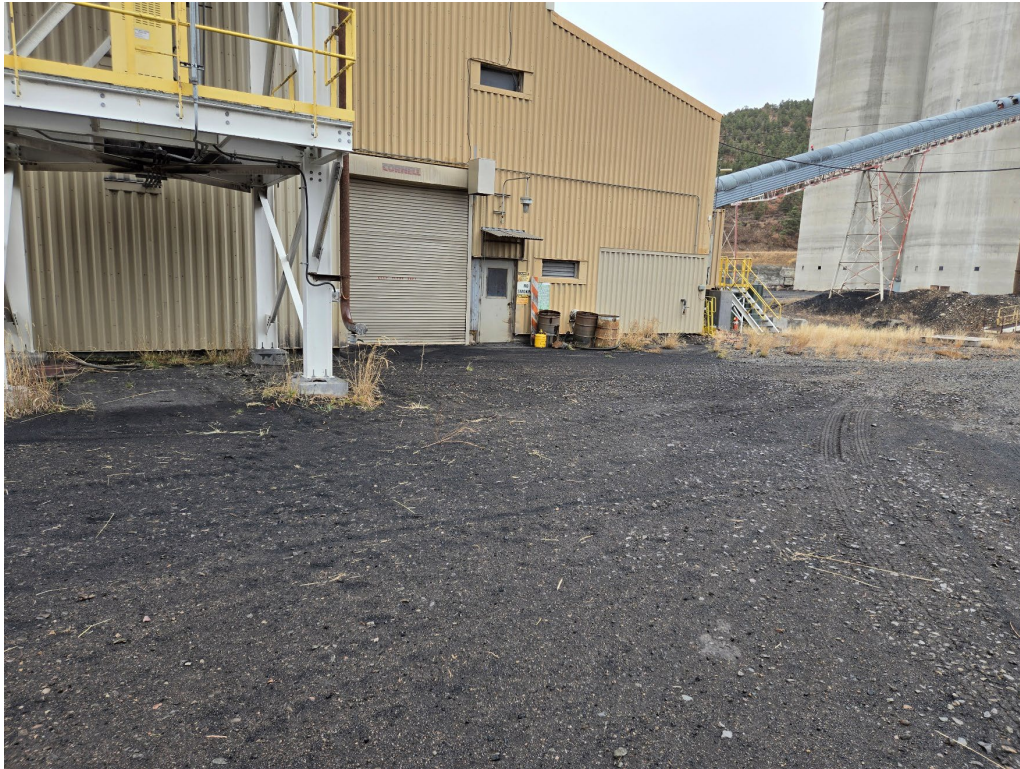
- **“OMI:** (October 2024 report) During the Division’s September 2024 inspection, a few barrels were observed along the west side of the wash plant building, within the raw coal storage area. One of the barrels had fallen over, and its liquid contents have spilled onto the ground next to the wash plant building. The Division believes the spilt material to be rusty stormwater. The Division observed the overturned barrel again during the October inspection and has not yet received confirmation that the spill has been cleaned. **The Operator shall provide evidence to the Division that the spill has been cleaned.”**

**This concern has been resolved.**
  - The tipped barrel has been erected, the barrels have been placed next to the wash plant, and the spill has been cleaned.

Photo 29: Area near Wash Plant where a barrel had spilled. The spill has been cleaned, and the barrels have been moved and placed against the building.
