## C1980007, West Elk Mine, December Inspection Report

### PERMIT INFORMATION

<b>Permit Number:</b> C-1980-007 <b>Mine Name:</b> West Elk Mine <b>Operator:</b> Mountain Coal Company, LLC <b>Operator Address:</b> Jessica Wilczek 5174 Highway 133 Somerset, CO 81434	<b>County:</b> Delta, Gunnison <b>Operation Type:</b> Underground <b>Permit Status:</b> Active <b>Ownership:</b> Private
	<b>Operator Representative Present:</b>  Josh Thompson
<b>Operator Representative Signature: (Field Issuance Only)</b>

<b>Inspection Start Date:</b> December 9, 2025 <b>Inspection Start Time:</b> 09:30 <b>Inspection End Date:</b> <b>Inspection End Time:</b>	<b>Inspection Type:</b> Coal Complete Inspection <b>Inspection Reason:</b> Normal I&E Program <b>Weather:</b> Clear
<b>Joint Inspection Agency:</b>  None	<b>Joint Inspection Contacts:</b>
<b>Post Inspection Agency:</b>  None	<b>Post Inspection Contacts:</b>
<b>Inspector(s):</b>  Leigh Simmons	<b>Inspector's Signature:</b>

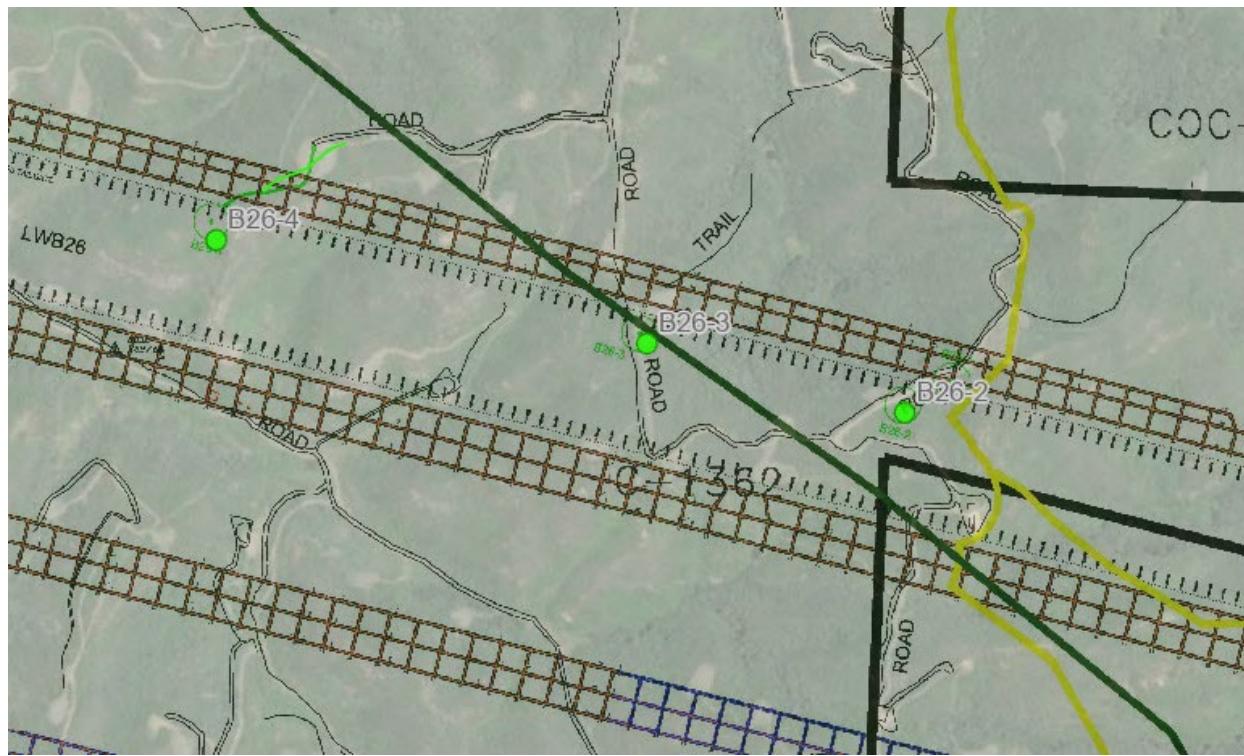
Three new MVB pads (B26-2, -3 and -4, permitted with TR-158) had been constructed by D and S Underground. Drilling of the first of two holes was in progress on the B26-2 pad; the drilling contractor was RACS. The pads were level with a berm around the edge, mud pits were also bermed. Topsoil had been stockpiled.

Figure 1: Screenshot of inspection map, showing GPS locations of three new pads (green points) overlaid on semi-transparent pad layout map approved with TR-158 and aerial image.

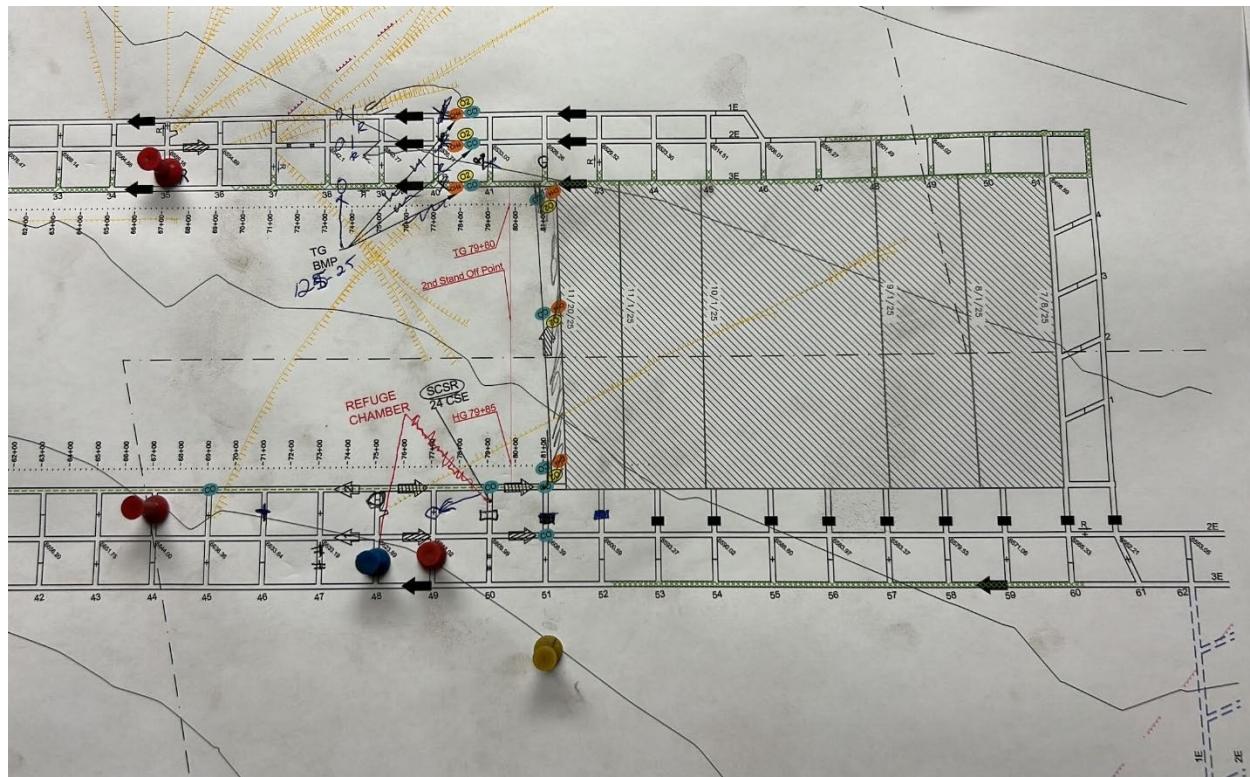
Longwall mining of the LWB26 panel was in progress at around cross cut 51 on the headgate.

Figure 3: Mine map, showing longwall progress in B26 panel

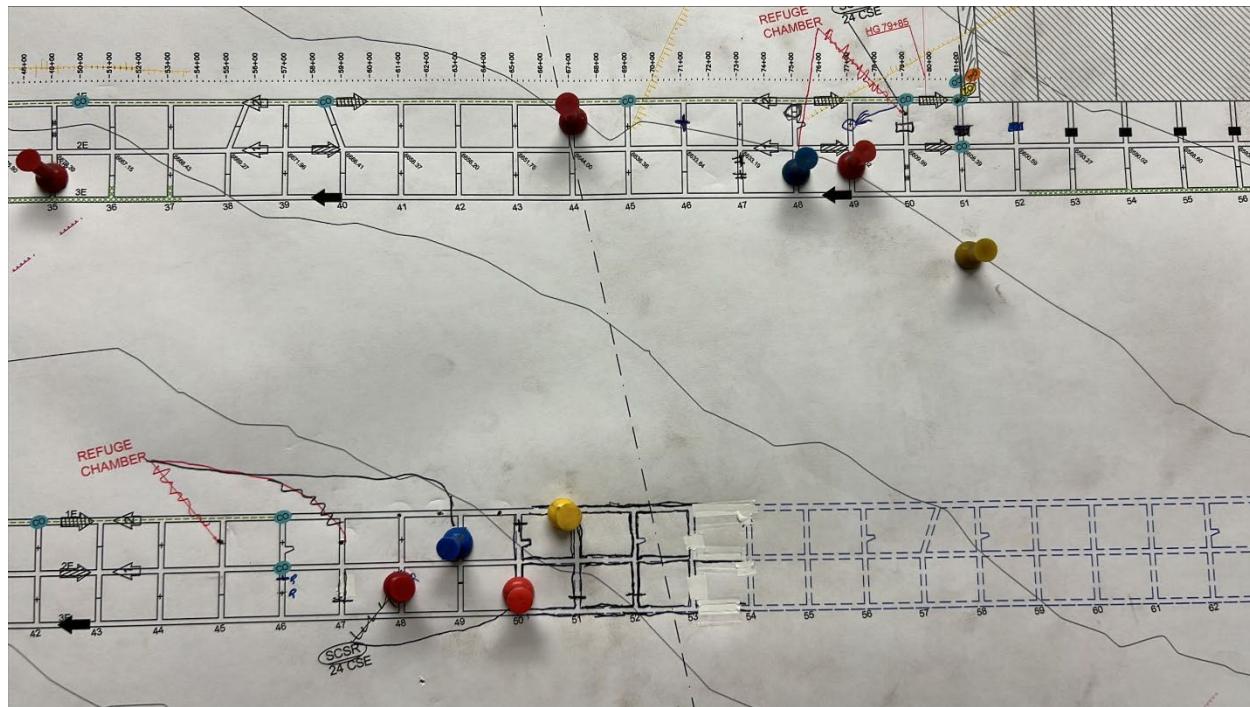
Development of the B27 headgate was in progress, at around cross cut 53.

Figure 4: Mine map showing development progress in B27 head gate

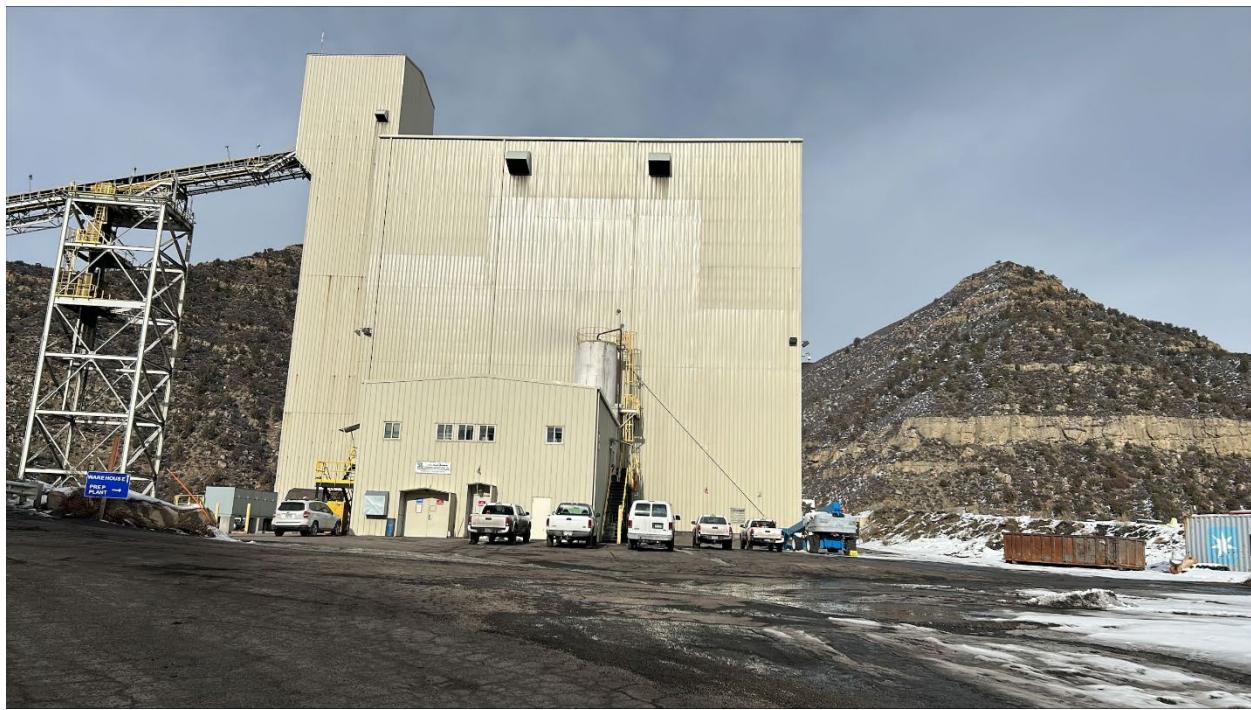
Siding had been replaced on the prep plant, so that the plant could resume operation. One more side of the building was expected to be re-sided at some point in the future, when weather and operational conditions are suitable.

Figure 5: Prep plant

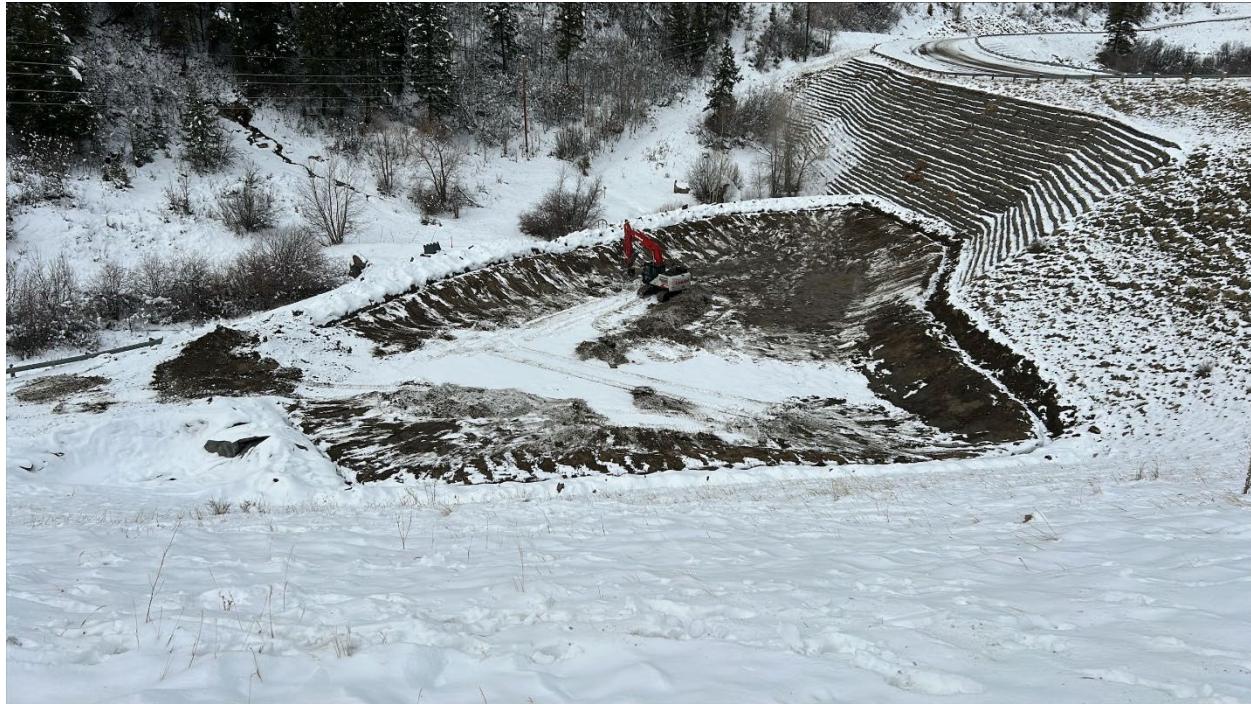
The damaged liner had been removed from the SG-1 pond, and work was in progress to clear accumulated snow from the pond. A new liner had been brought to the site and was expected to be installed the following day. MCC's intention was to use scraps from the new liner to patch holes in the RPE pond in the short term, until the full liner can be replaced.

Figure 6: SG-1 pond, being prepared for installation of new liner

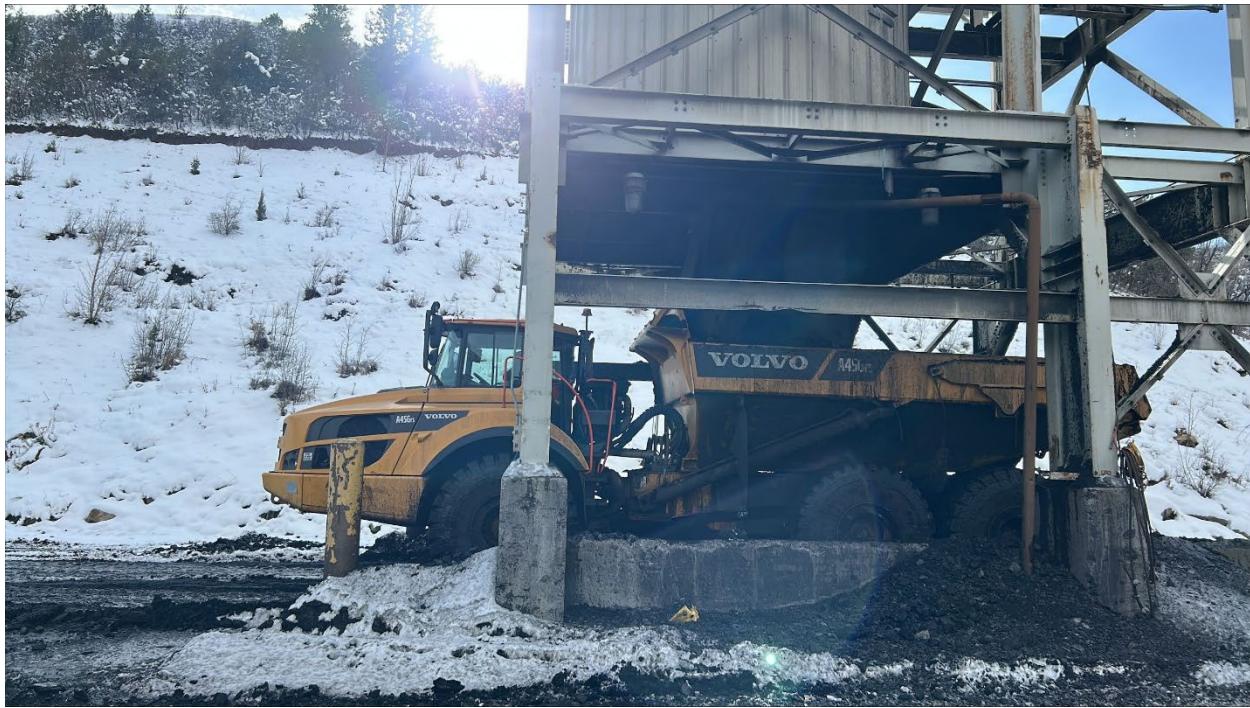
The prep plant was in operation at the time of the inspection. New processing waste was being temporarily placed on the RPE; no waste was being transported to the RPEE.

Figure 7: Processing waste being generated

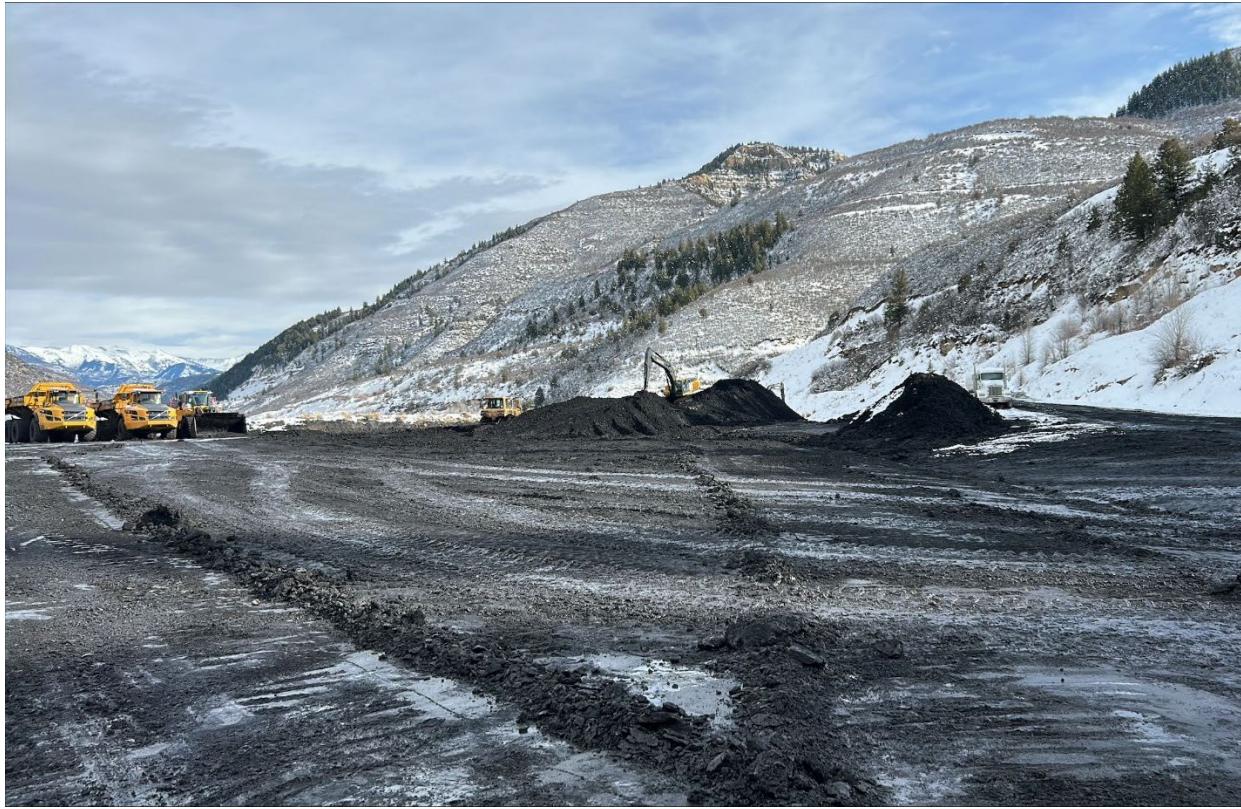
Figure 8: Processing waste being temporarily placed on RPE

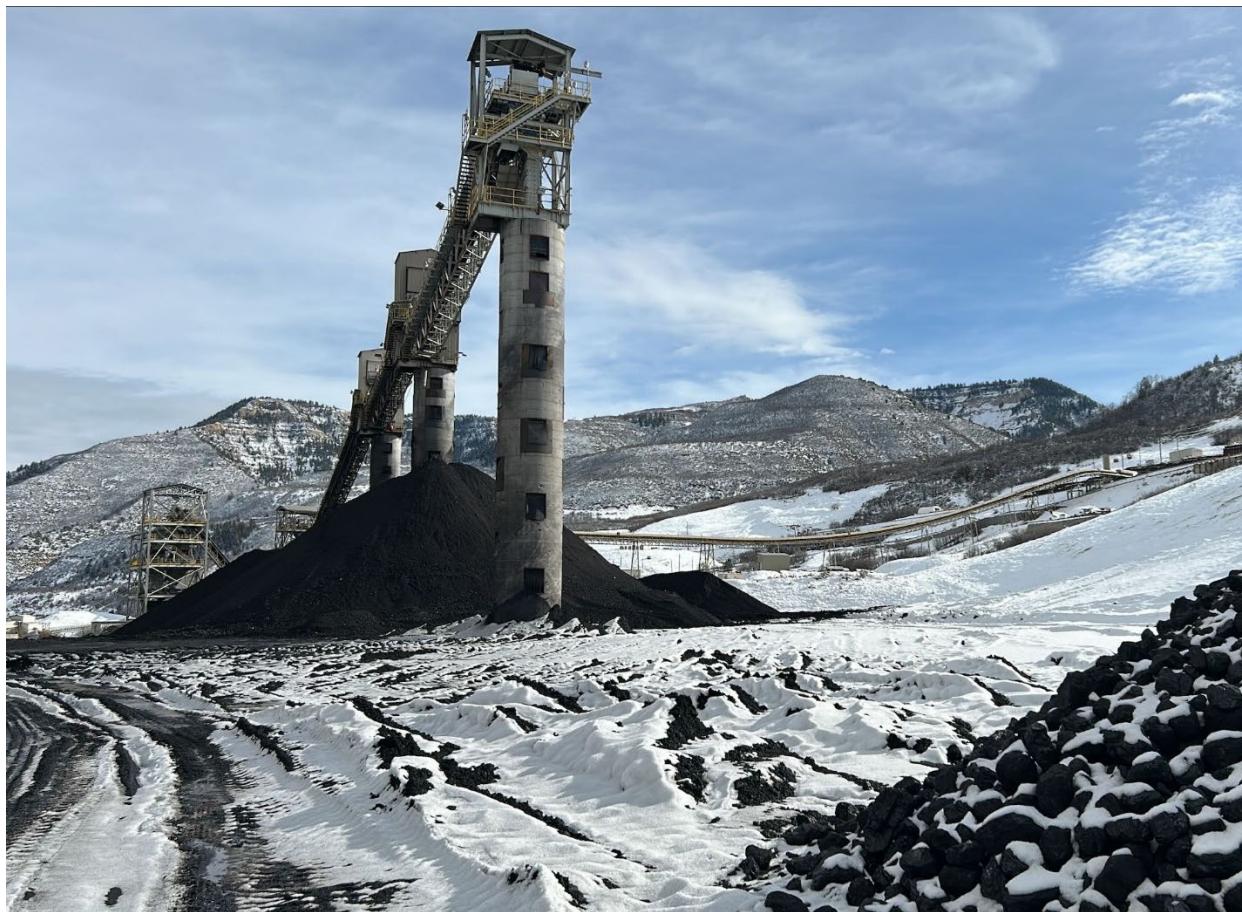
All fines that had been stockpiled at Stack Tube 5 on the Run-of-Mine coal stockpile pad had been removed. Fines placed on the LRP were still in place but would likely be removed in 2026.

Figure 9: Run-of-Mine coal stockpile pad from west, showing fines completely removed

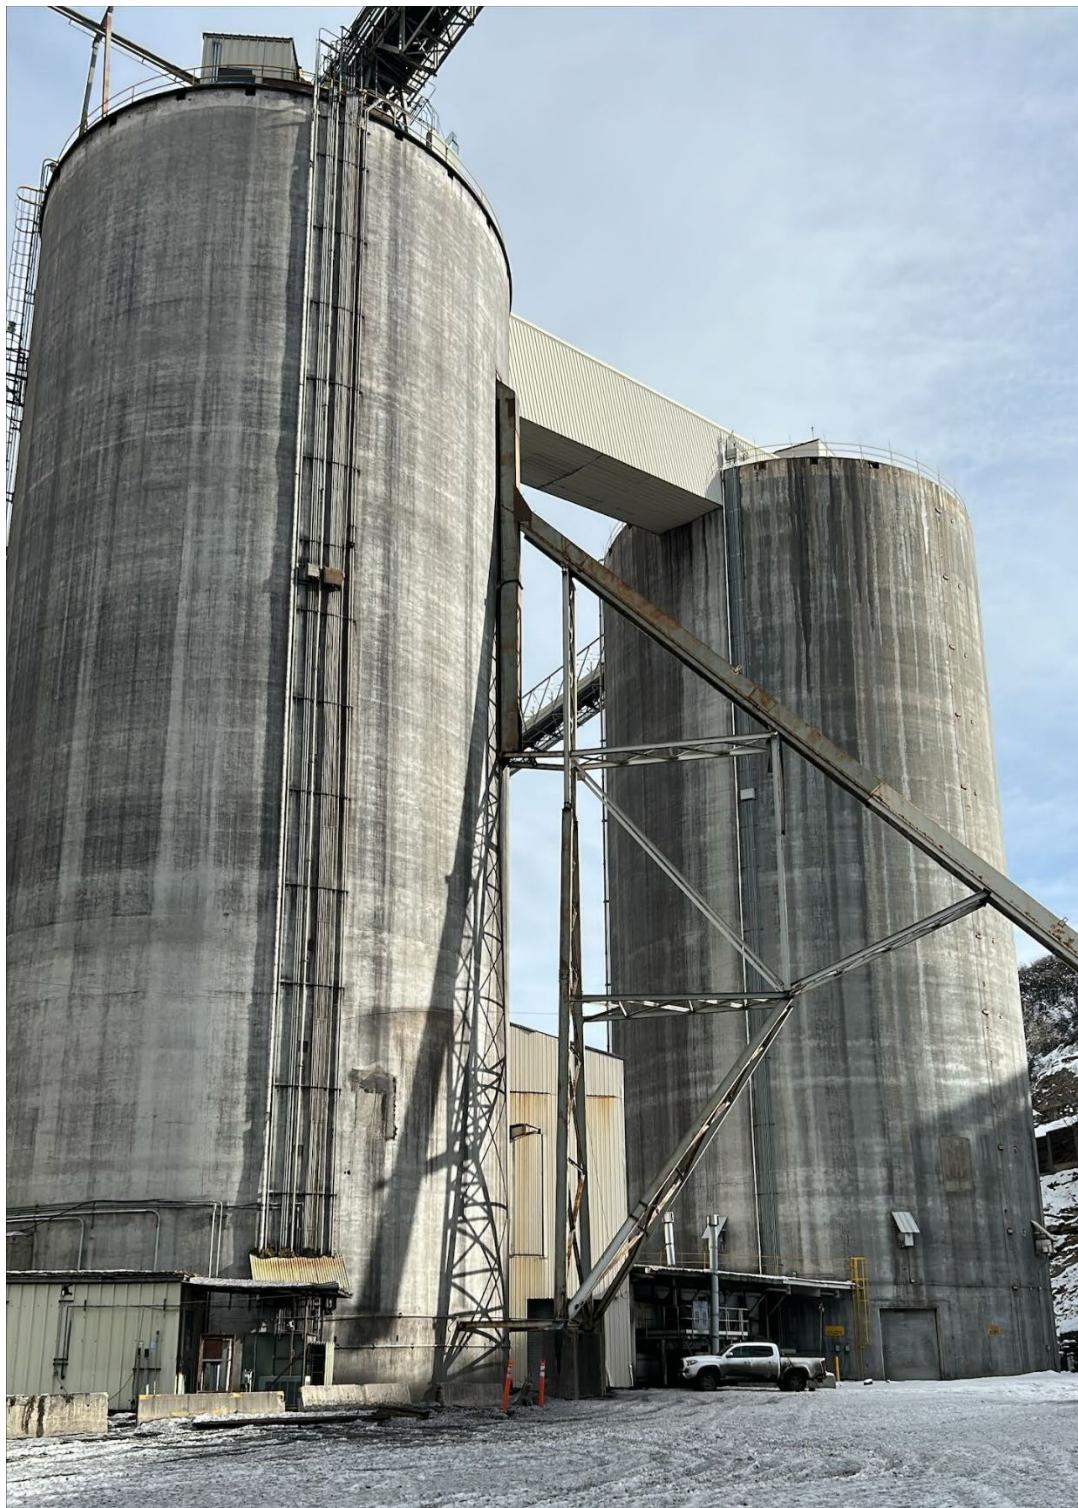
*Figure 10: No activity at silos*

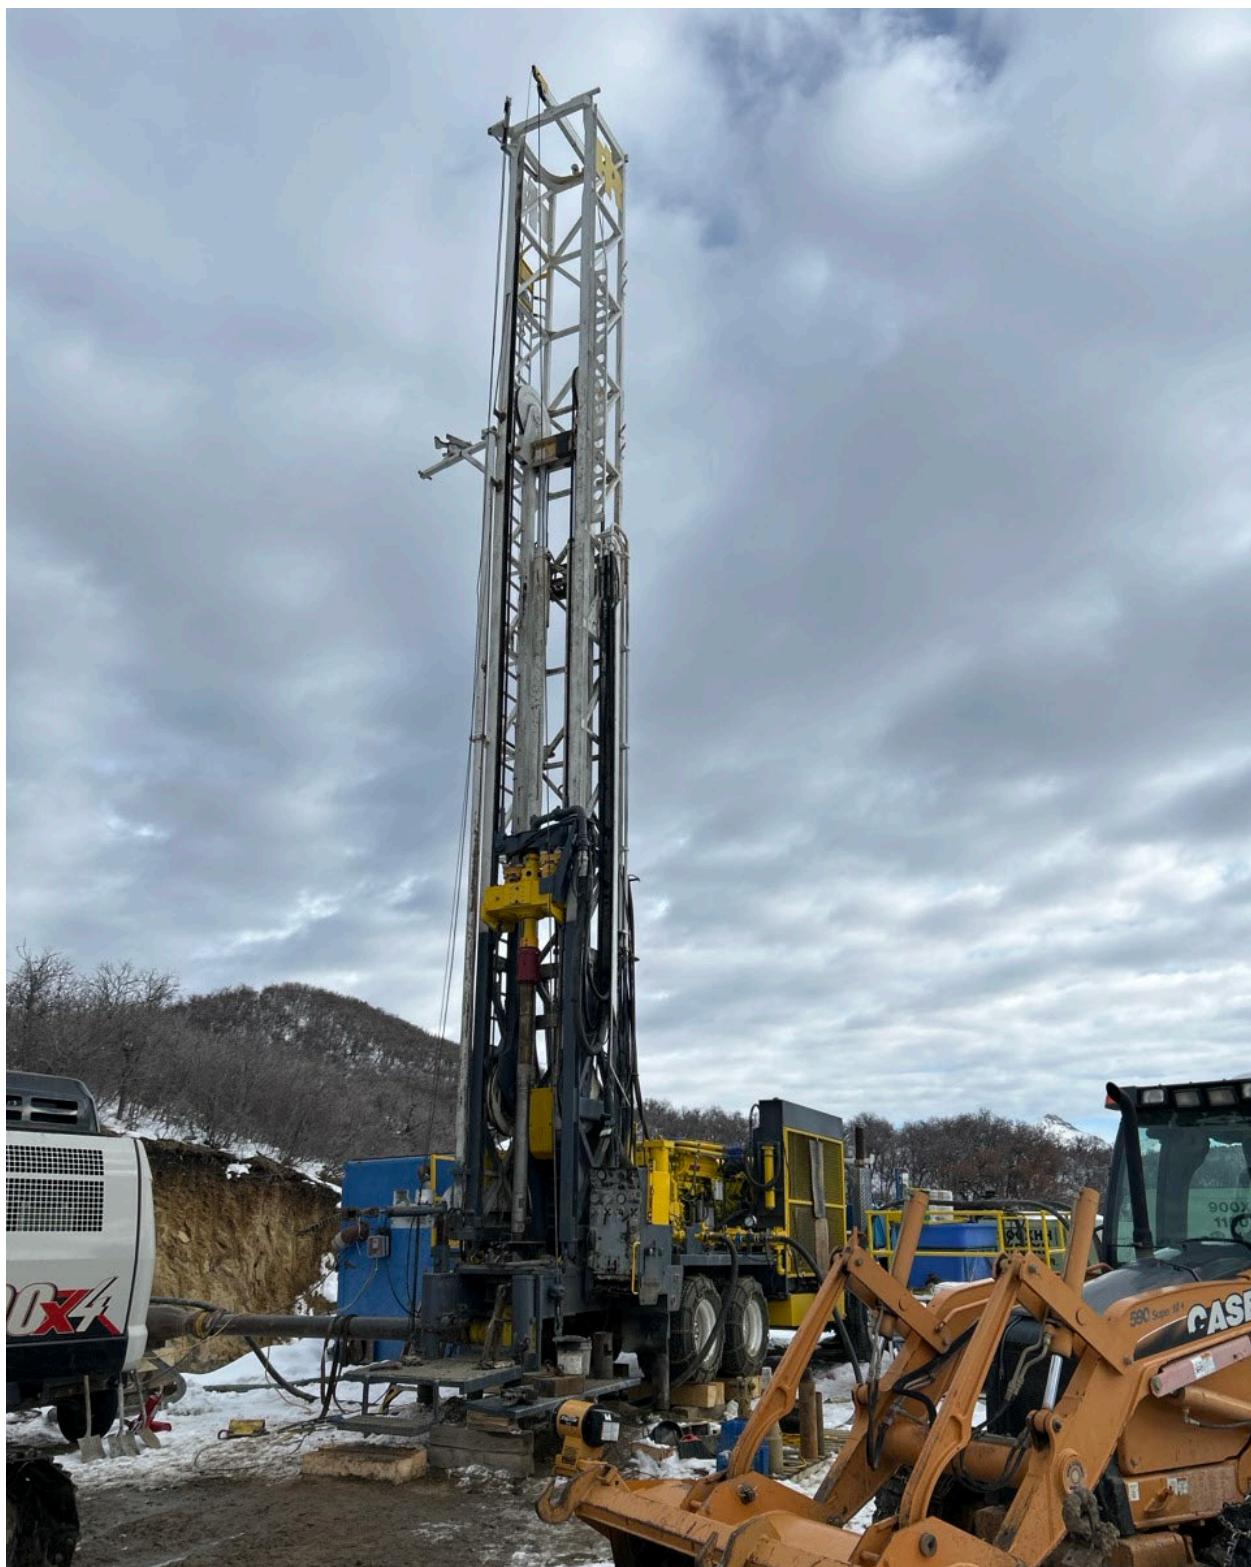
Figure 11: Drill rig on B26-2

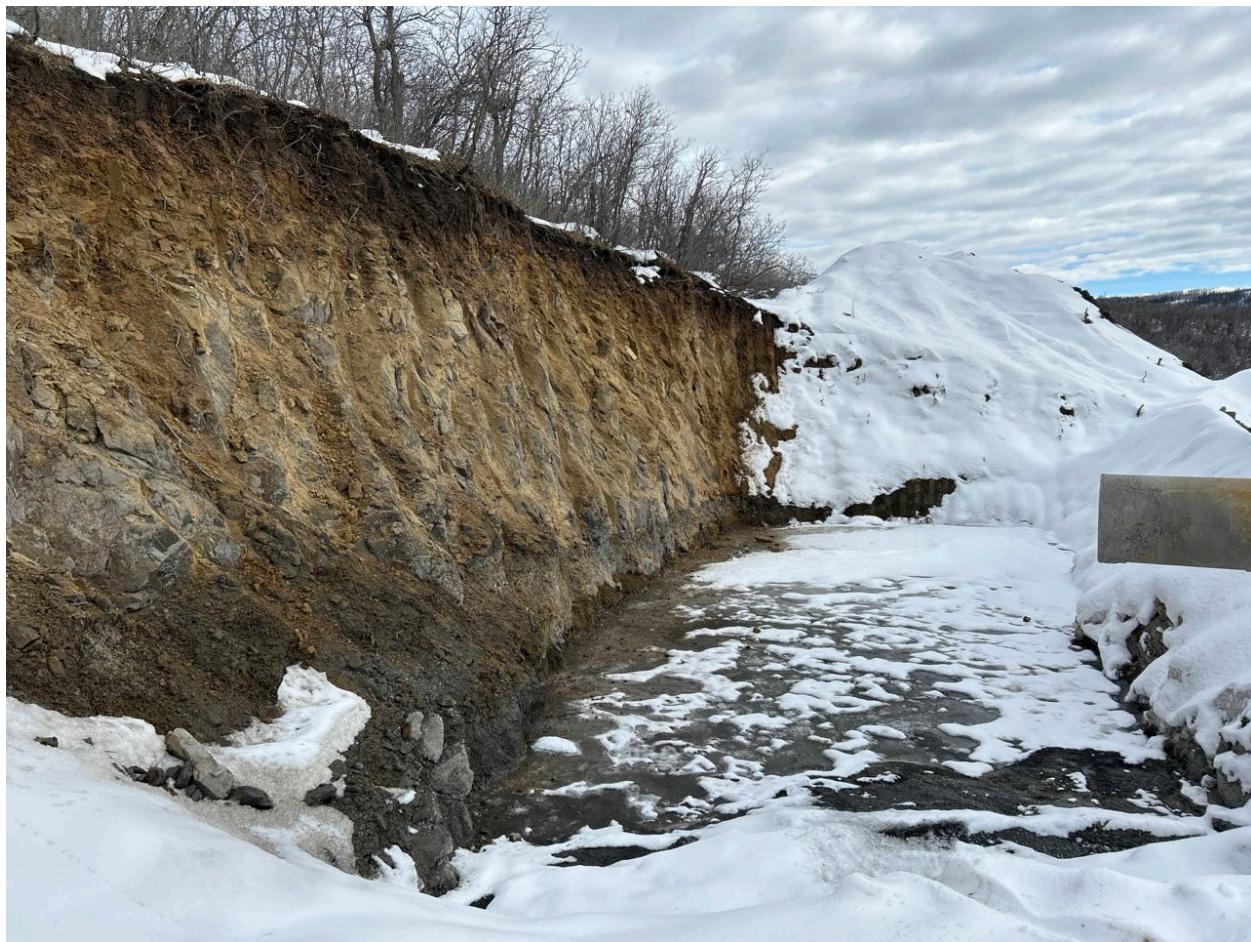
Figure 12: Mud pit on B26-2

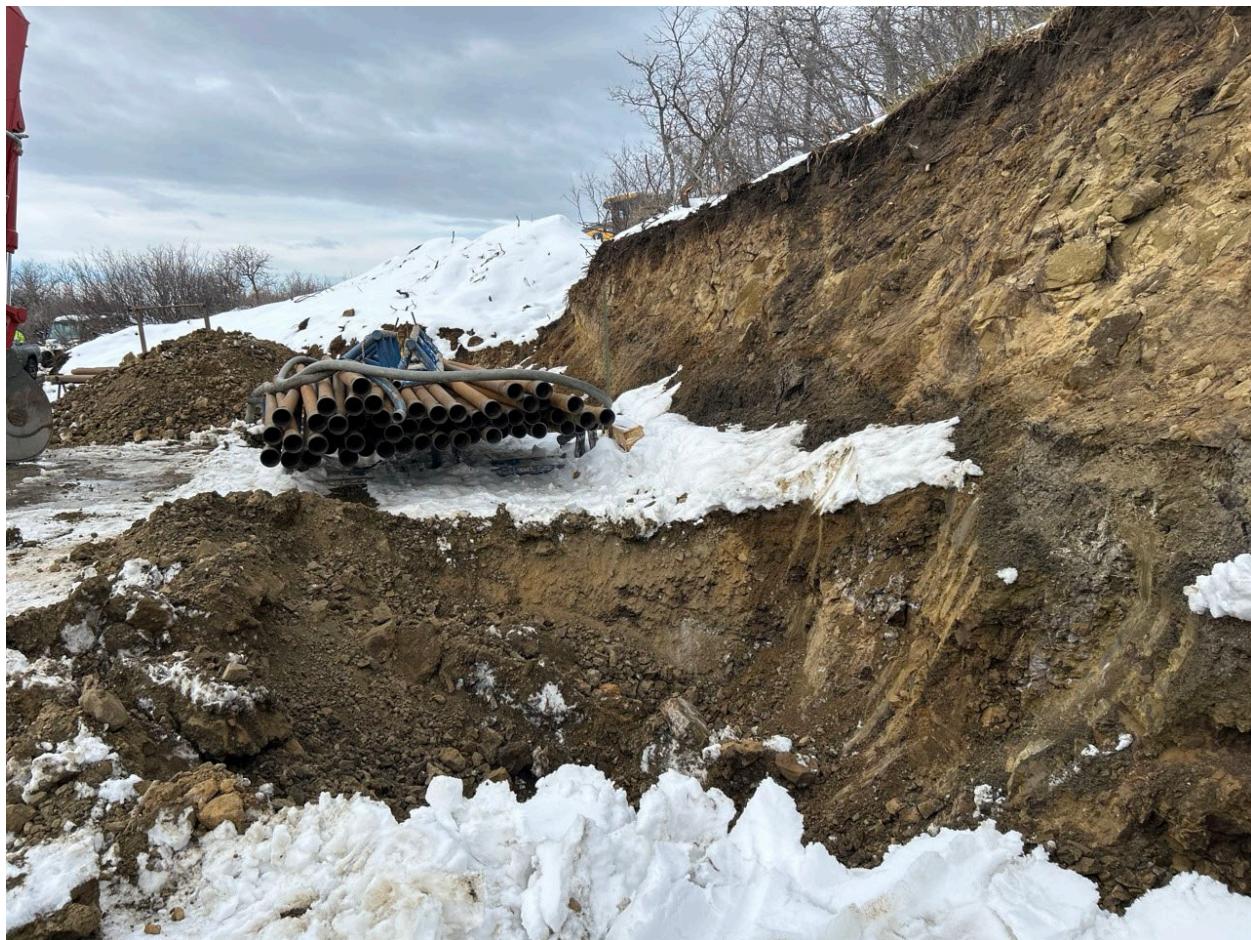
Figure 13: Second mud pit on B26-2 under construction

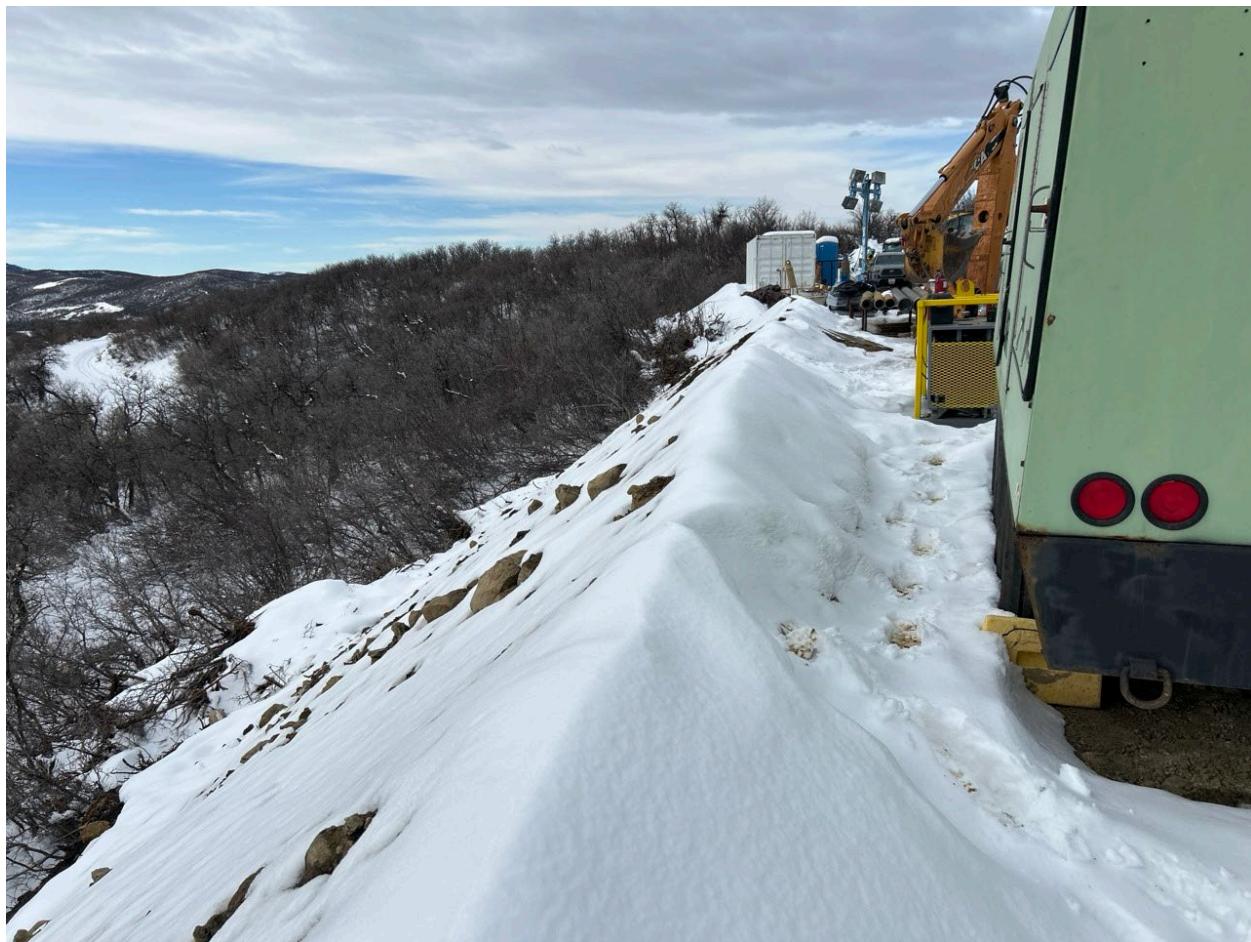
Figure 14: Berm on B26-2

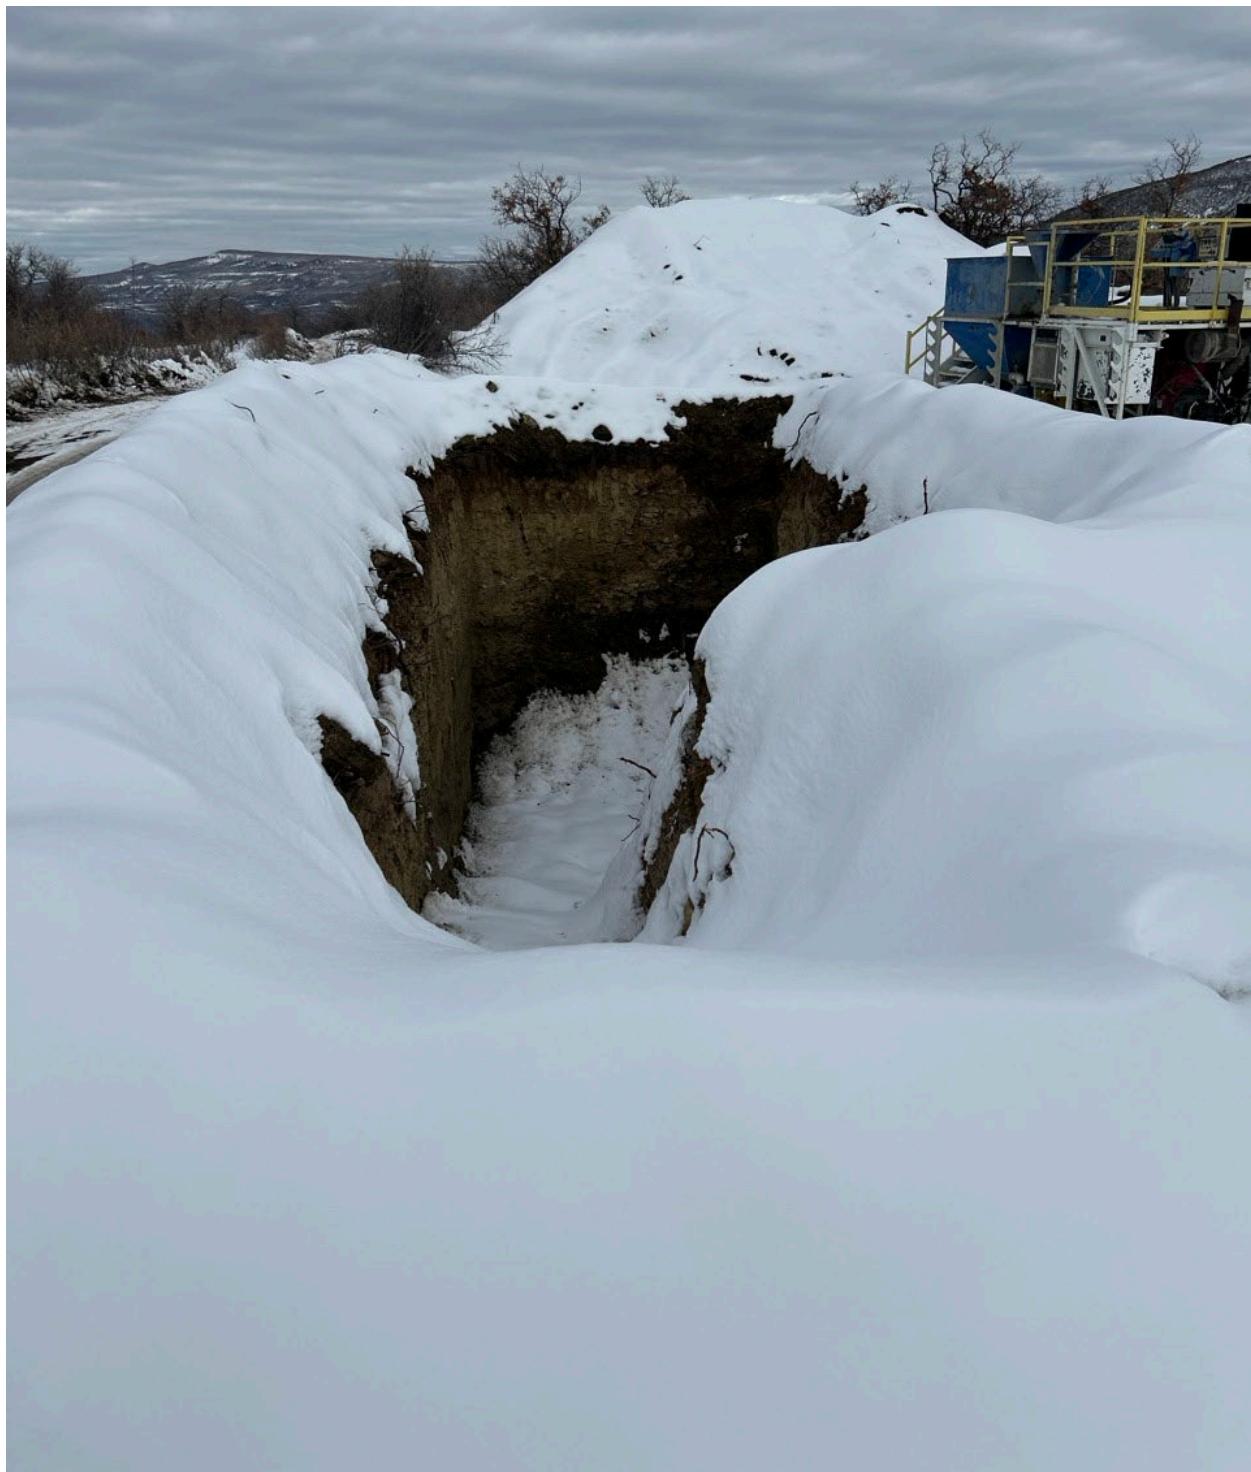
Figure 15: Mud pit on B26-3

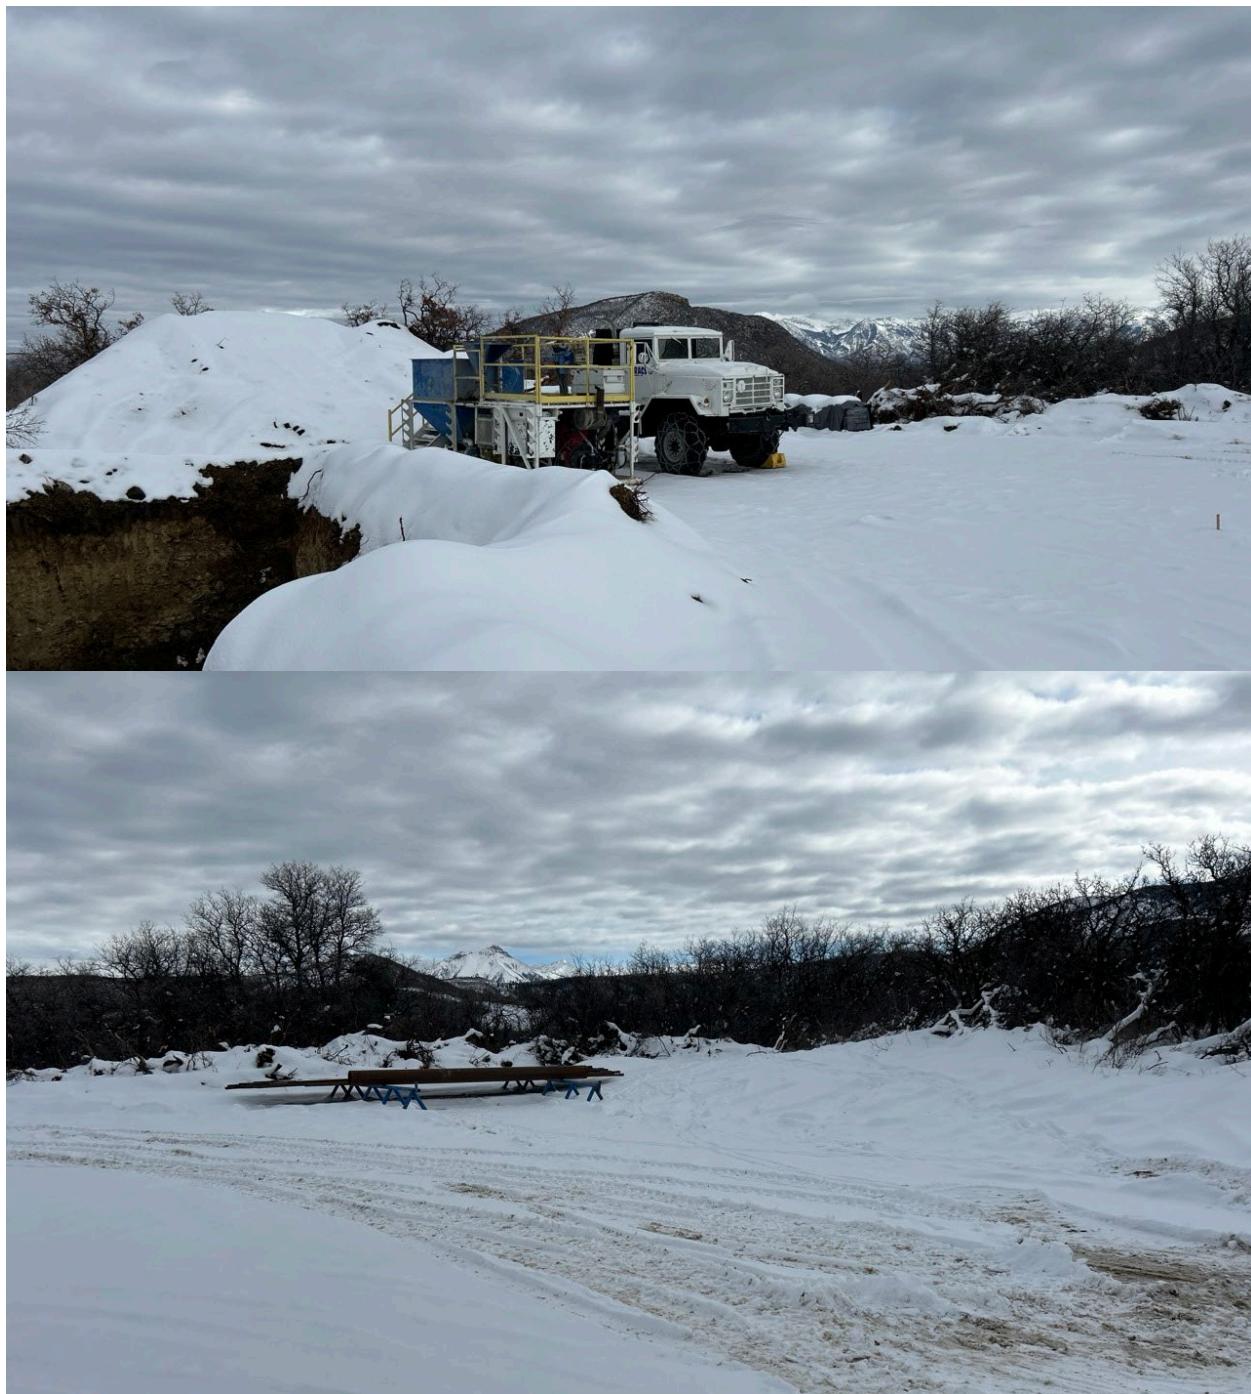
Figure 16: Drilling equipment and materials staged on B26-3

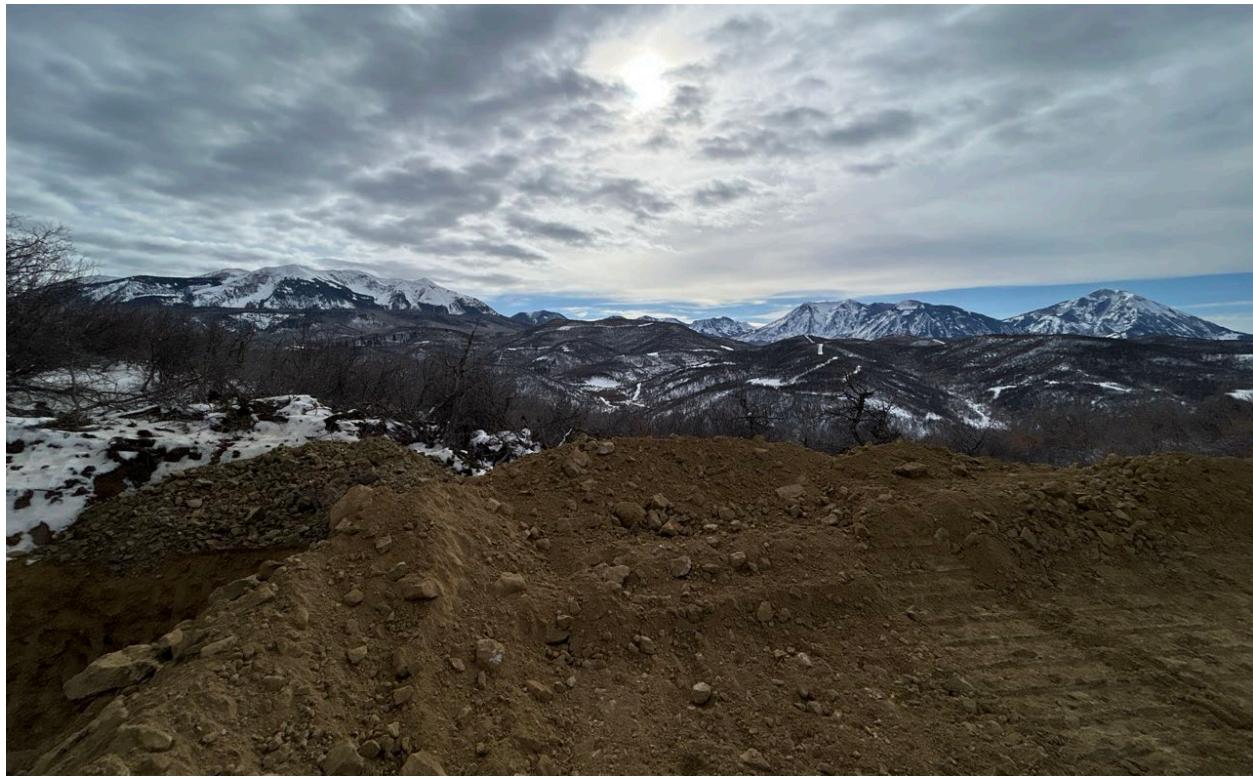
Figure 17: B26-4 pad newly constructed

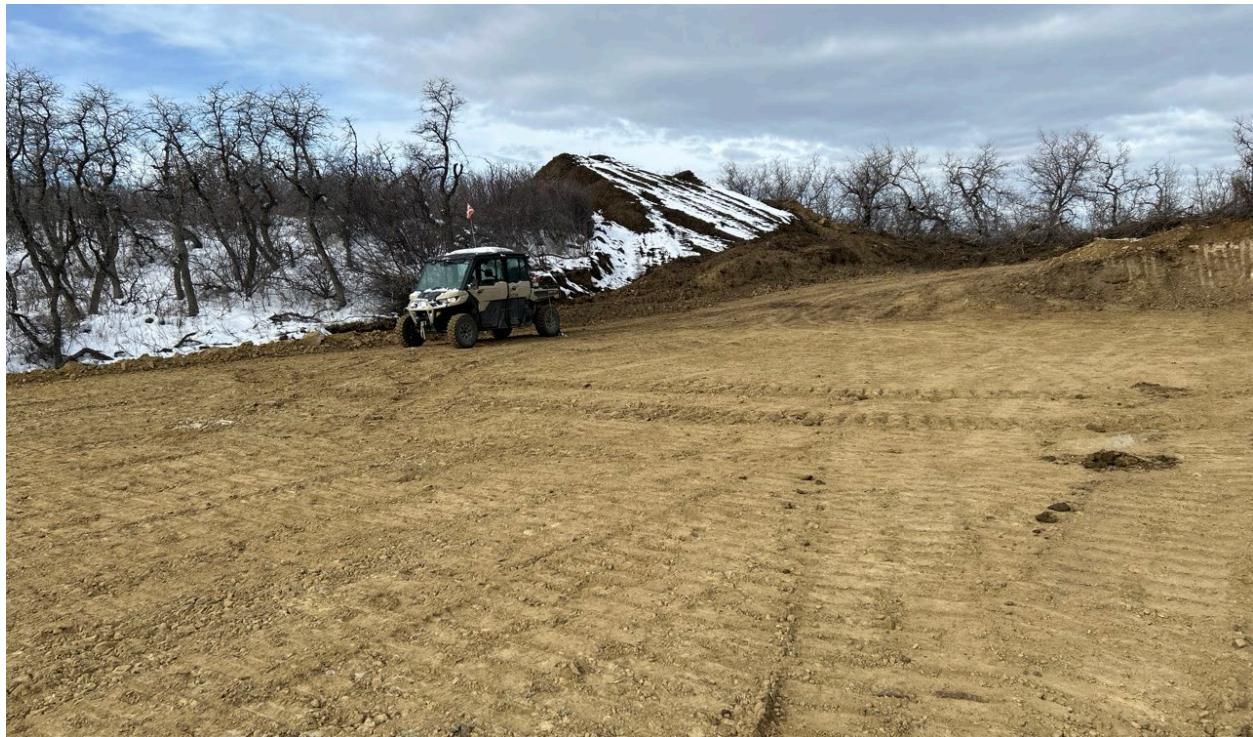
Figure 18: B26-4 pad leveled and compacted

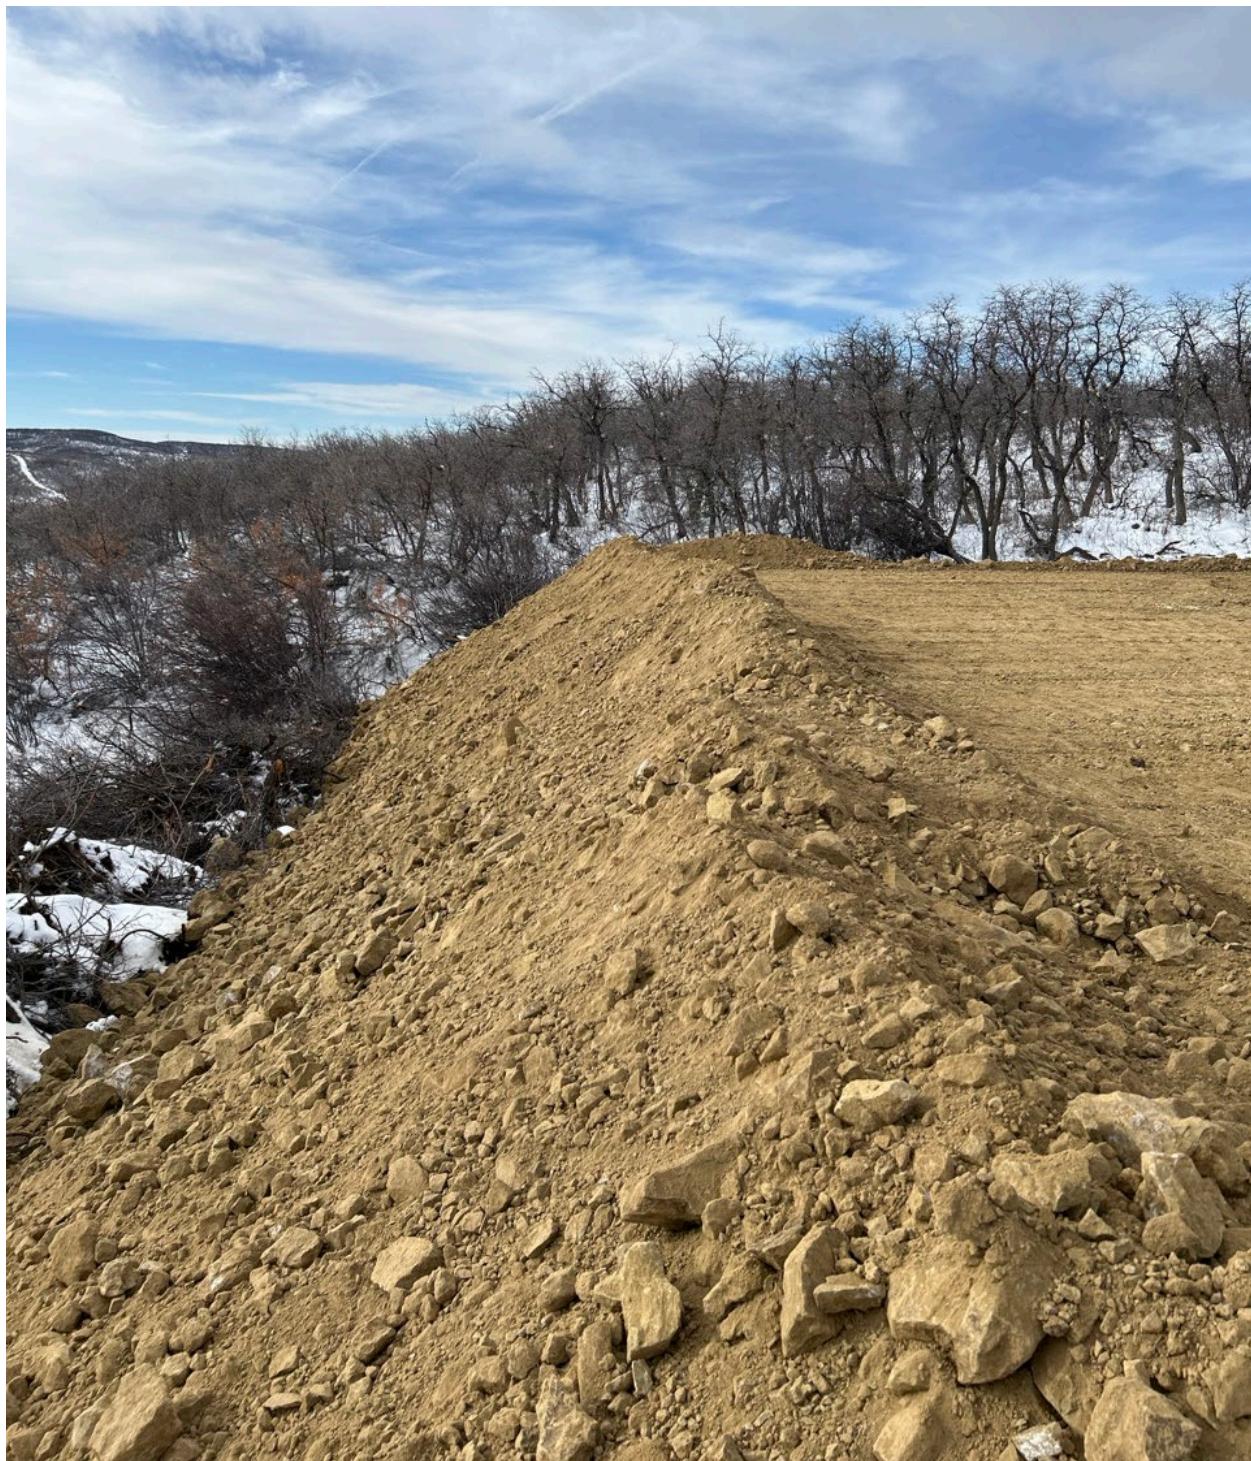
Figure 19: Berm on B26-4 pad
