## C1980007, West Elk Mine, December Inspection Report

### PERMIT INFORMATION

<b>Permit Number:</b> C-1980-007 <b>Mine Name:</b> West Elk Mine <b>Operator:</b> Mountain Coal Company, LLC <b>Operator Address:</b> Jessica Wilczek 5174 Highway 133 Somerset, CO 81434	<b>County:</b> Delta, Gunnison <b>Operation Type:</b> Underground <b>Permit Status:</b> Active <b>Ownership:</b> Private
	<b>Operator Representative Present:</b>  Josh Thompson
<b>Operator Representative Signature: (Field Issuance Only)</b>

<b>Inspection Start Date:</b> December 9, 2025 <b>Inspection Start Time:</b> 09:30 <b>Inspection End Date:</b> <b>Inspection End Time:</b>	<b>Inspection Type:</b> Coal Complete Inspection <b>Inspection Reason:</b> Normal I&E Program <b>Weather:</b> Clear
<b>Joint Inspection Agency:</b>  None	<b>Joint Inspection Contacts:</b>
<b>Post Inspection Agency:</b>  None	<b>Post Inspection Contacts:</b>
<b>Inspector(s):</b>  Leigh Simmons	<b>Inspector's Signature:</b>

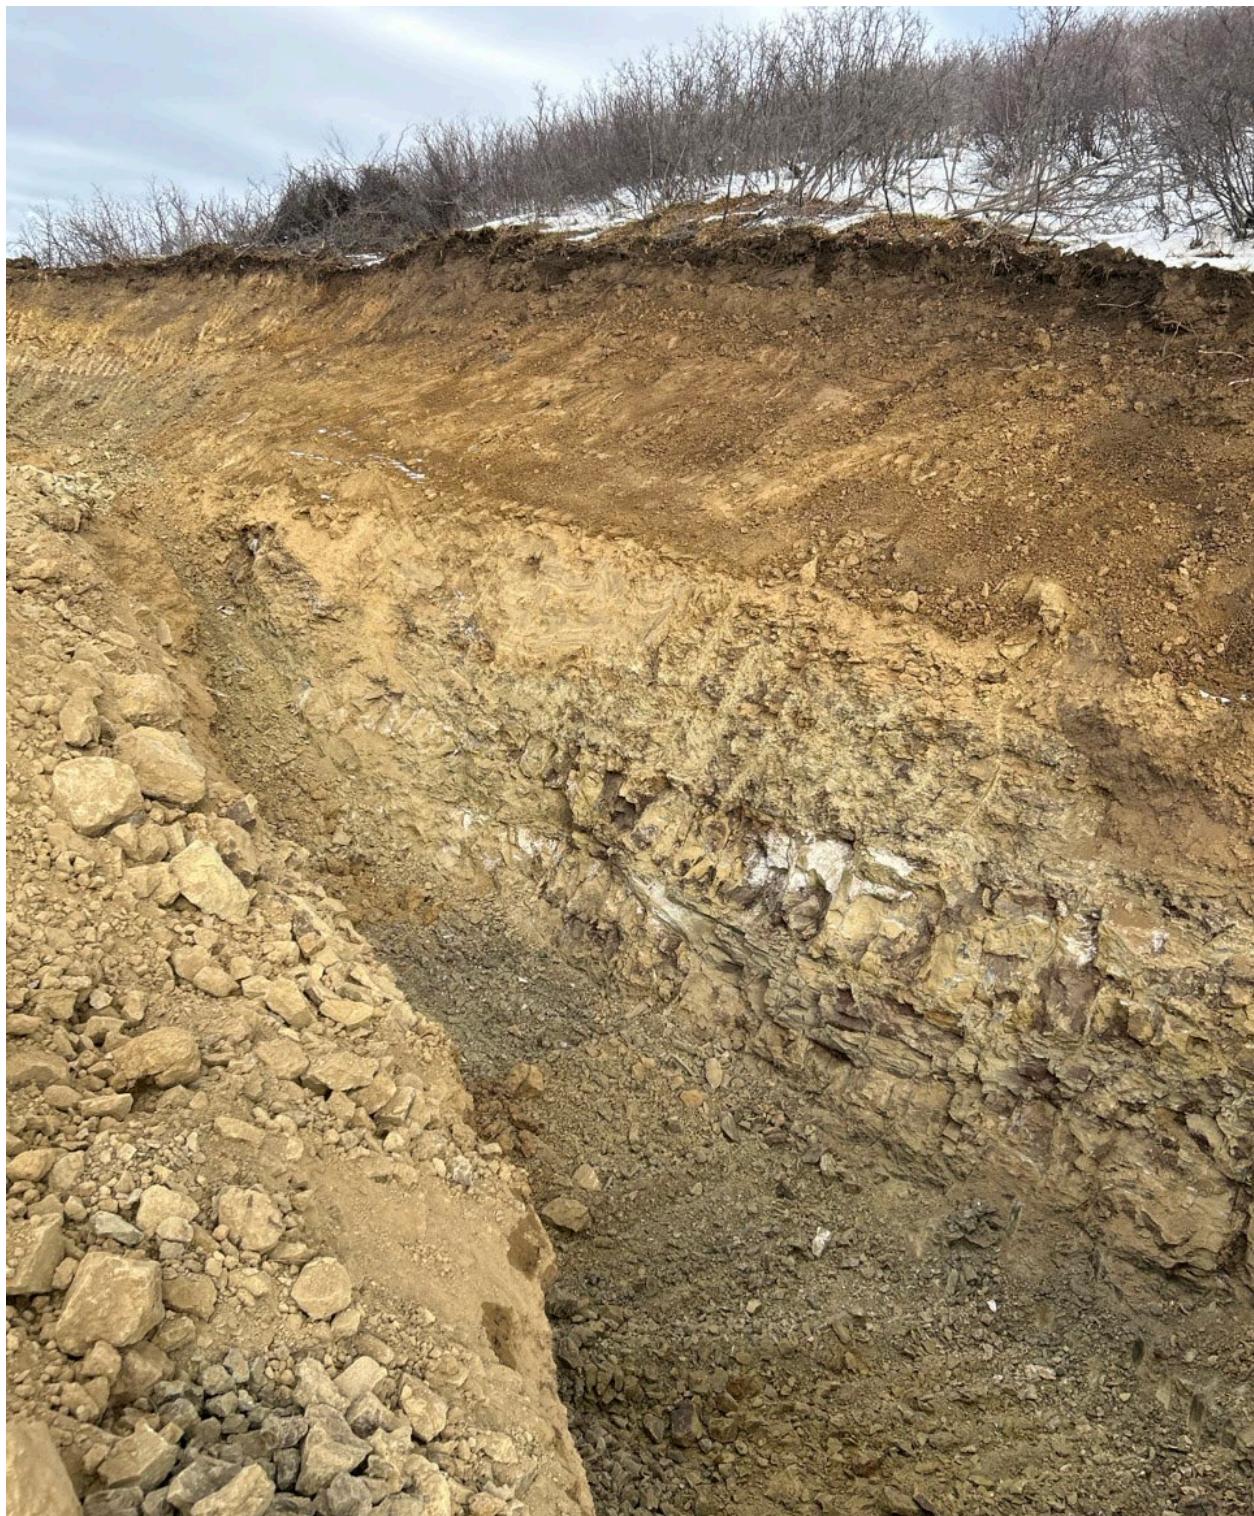
*Figure 20: Mud pit on B26-4 pad*
