MINERALS PROGRAM INSPECTION REPORT
PHONE: (303) 866-3567

MINE NAME: West Sunday	MINE/PROSPECTING ID#: M-1981-021	MINERAL: Uranium and vanadiu	COUNTY: San Miguel
INSPECTION TYPE: Multi Person Inspection	WEATHER: Clear	INSP. DATE: October 9, 2025	INSP. TIME: 11:38
OPERATOR: Pinon Ridge Mining LLC	OPERATOR REPRESENTATIVE: Mike Rutter	TYPE OF OPERATION: 112d-3 - Designated Mining Operation	
REASON FOR INSPECTION: Normal I&E Program	BOND CALCULATION TYPE:	BOND AMOUNT: \$126,940.00	
DATE OF COMPLAINT: NA	POST INSP. CONTACTS: None	JOINT INSP. AGENCY: None	
INSPECTOR(S): Lucas West	INSPECTOR'S SIGNATURE: 	SIGNATURE DATE: December 11, 2025

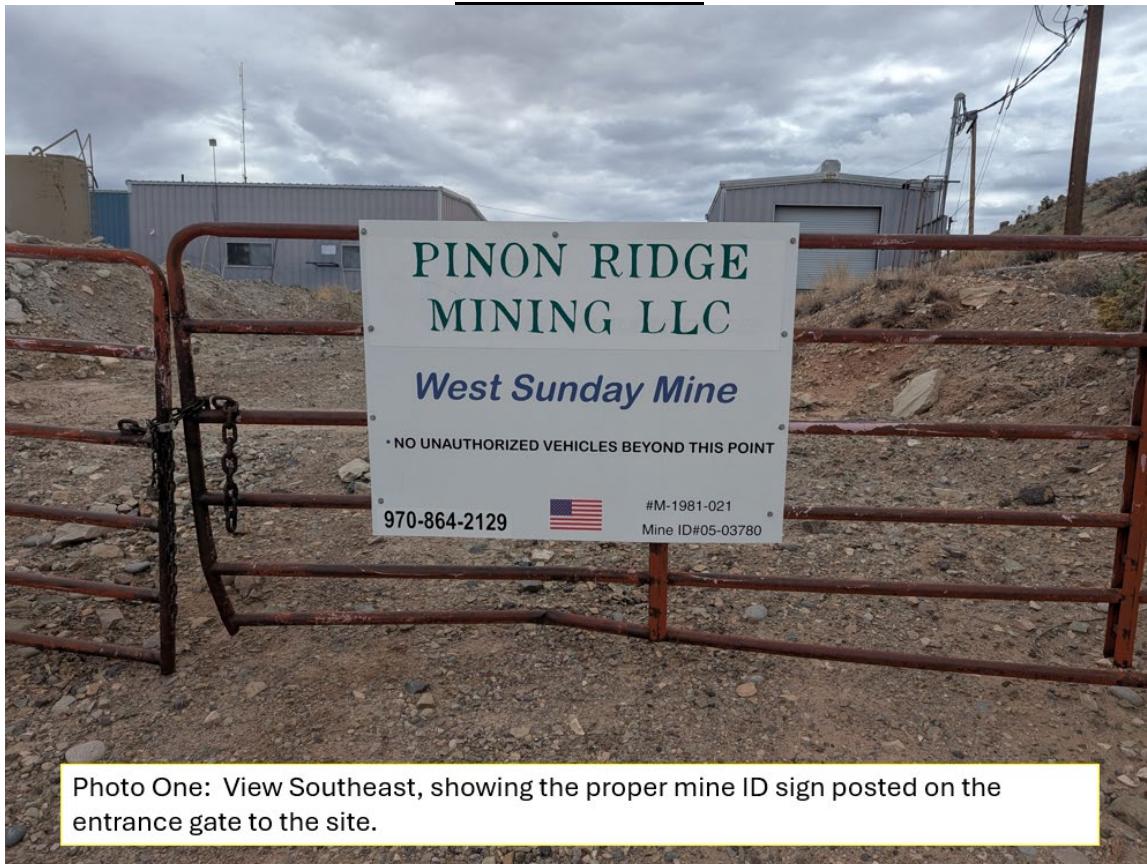
The permit ID sign was observed at the entrance to the site as seen in Photo One. The permit boundary markers were also observed. The remote vent shaft sites were not inspected at this time. Evidence that the diversion ditches and storm water control devices are functioning as designed was observed and no significant erosion was observed throughout the site. An example of the stormwater control structures can be seen in Photo Two. All work and shop appeared to be in good condition as seen in Photos Two and Three.

Photo One: View Southeast, showing the proper mine ID sign posted on the entrance gate to the site.

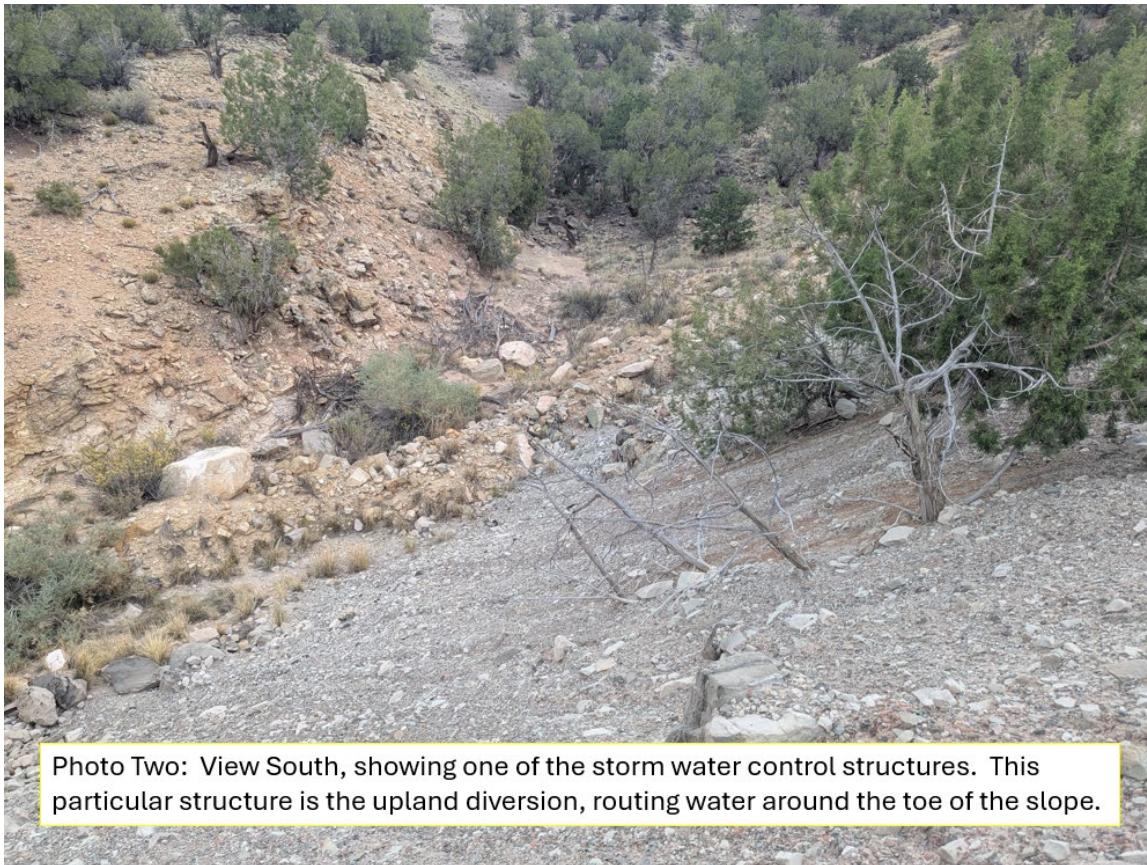
Photo Two: View South, showing one of the storm water control structures. This particular structure is the upland diversion, routing water around the toe of the slope.

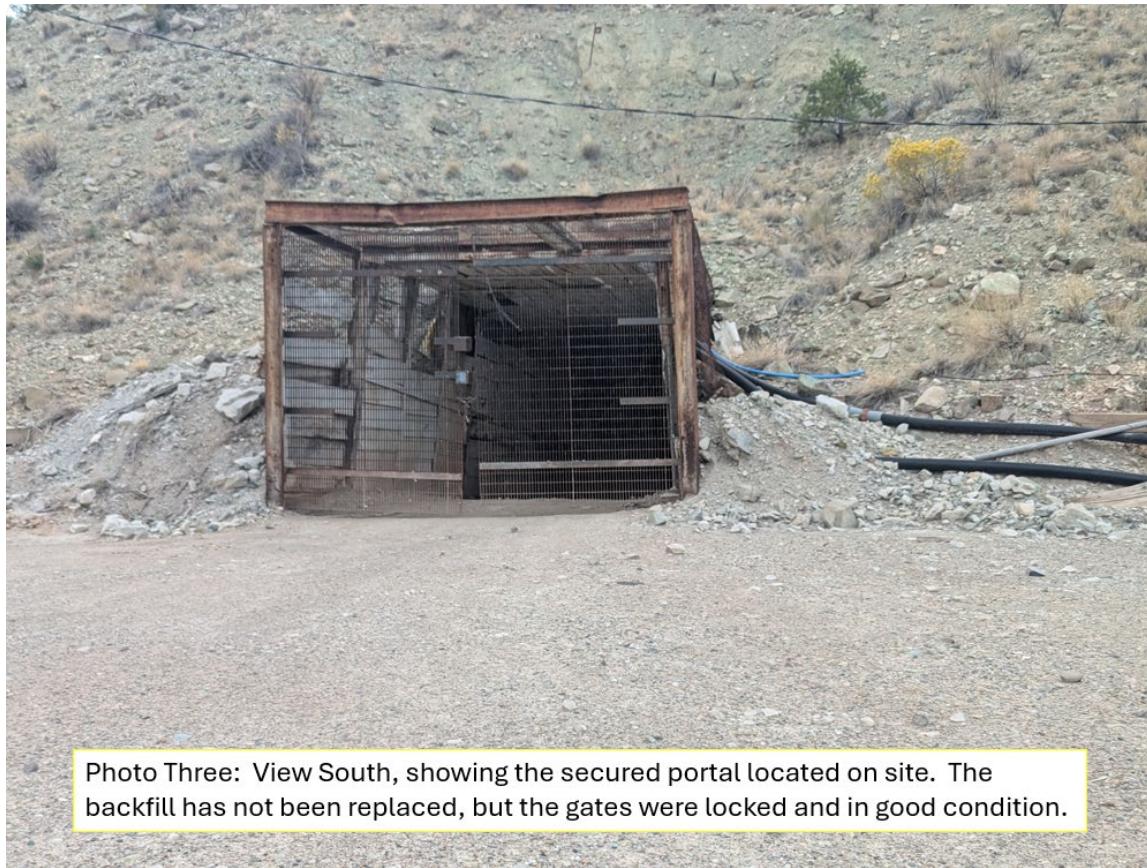
The portal located on site has been used as ventilation for the underground workings of the entire Sunday Complex however because operations were not active at the time of the inspection the gates were locked. The portal was secure and in good condition at the time of the inspection as seen in Photo Three. The main pad and work area was in good condition, evidence of weed management during the growing season was observed. The whole site exhibits positive drainage, and no erosional issues were observed at this time. Some areas around the perimeter of the pad area have begun to revegetate themselves with volunteer species. The pad showed no signs of settling or slumping during the inspection. A significant amount of newly generated development rock has been placed on the pad by underground equipment trammimg it to the surface. The small stockpiles all appeared to be stable and no issued were noted. An example of the development rock piles can be seen in Photo Four. The out slopes of the pad are also in good condition, appearing stable during the inspection and showing no signs of significant erosion. An example of the out slopes can be seen in Photo Five.

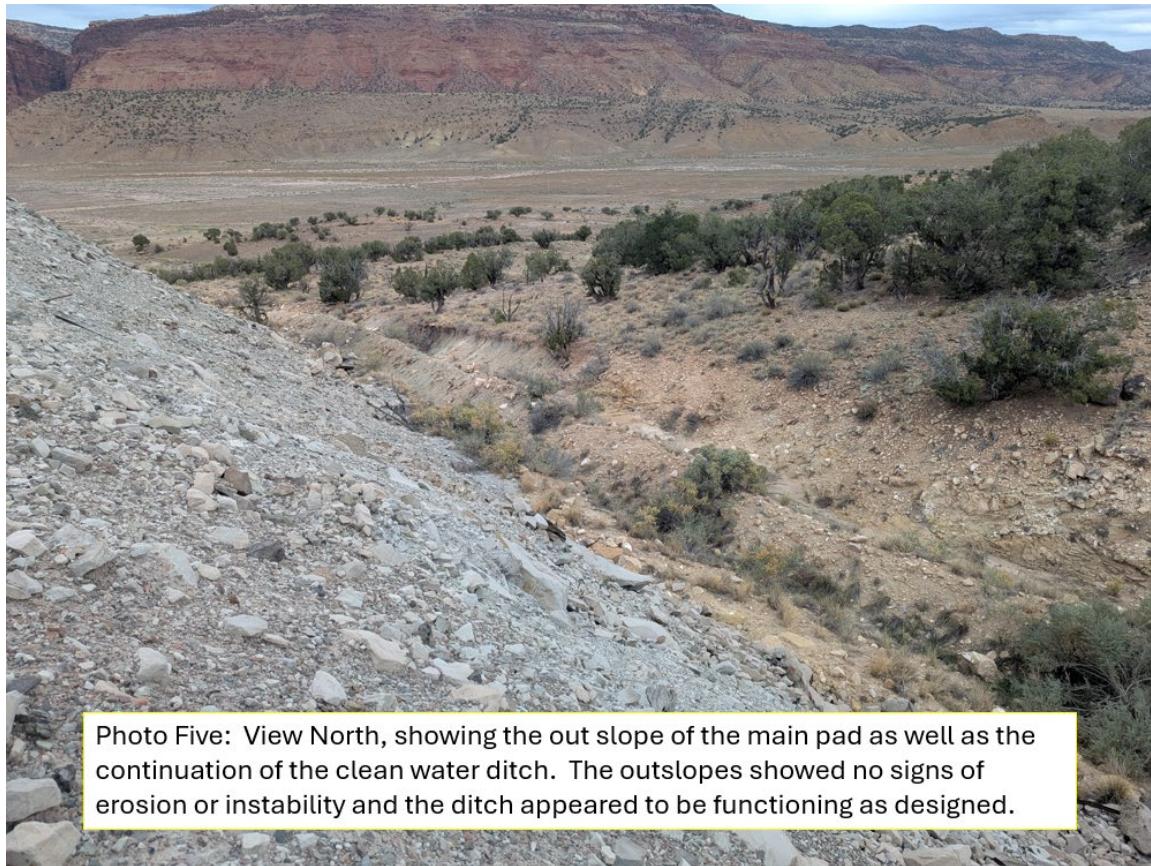
Photo Five: View North, showing the out slope of the main pad as well as the continuation of the clean water ditch. The outslopes showed no signs of erosion or instability and the ditch appeared to be functioning as designed.

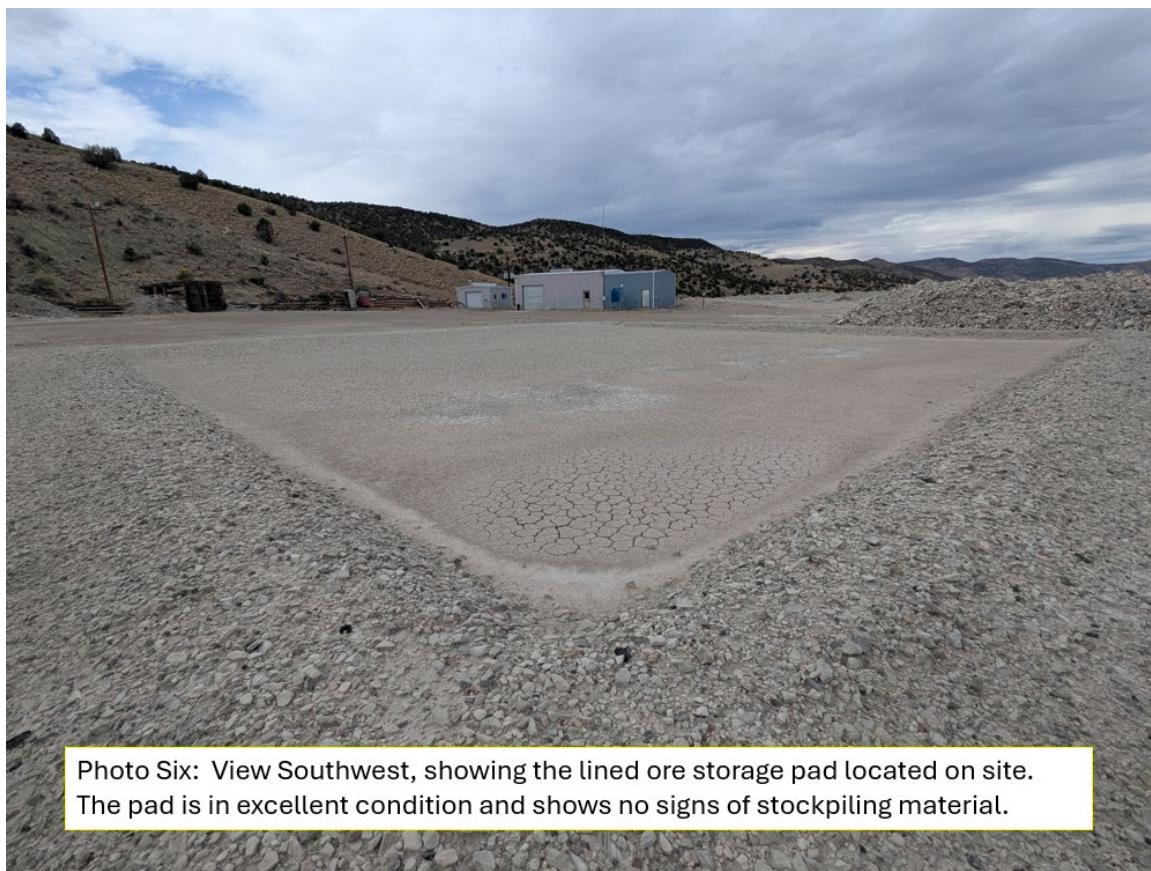
The lined Ore Pad was observed to be in good condition. The face of the pad shows no evidence of surface stockpiling and no observable impacts from precipitation was noted. The out slopes and berms of the pad appear stable. The pad can be seen in Photos Six. The shop and storage structures located on site were also found to be in good condition. No evidence of vandalism or attempted unauthorized entry was noted.

Photo Six: View Southwest, showing the lined ore storage pad located on site. The pad is in excellent condition and shows no signs of stockpiling material.
