PERMIT INFORMATION

Permit Number: C1981033 Mine Name: Bear Mine Operator: N/A Operator Address: N/A	County: Gunnison Operation Type: Underground Permit Status: Revoked Ownership: Private
	Operator Representative Present: N/A
Operator Representative Signature: (Field Issuance Only)

INSPECTION INFORMATION

Inspection Start Date: December 9, 2025 Inspection Start Time: 14:00 Inspection End Date: Inspection End Time:	Inspection Type: Coal Complete Inspection Inspection Reason: Normal I&E Program Weather: Clear
Joint Inspection Agency: None	Joint Inspection Contacts:
Post Inspection Agency: None	Post Inspection Contacts:
Inspector(s): Leigh Simmons	Inspector's Signature:

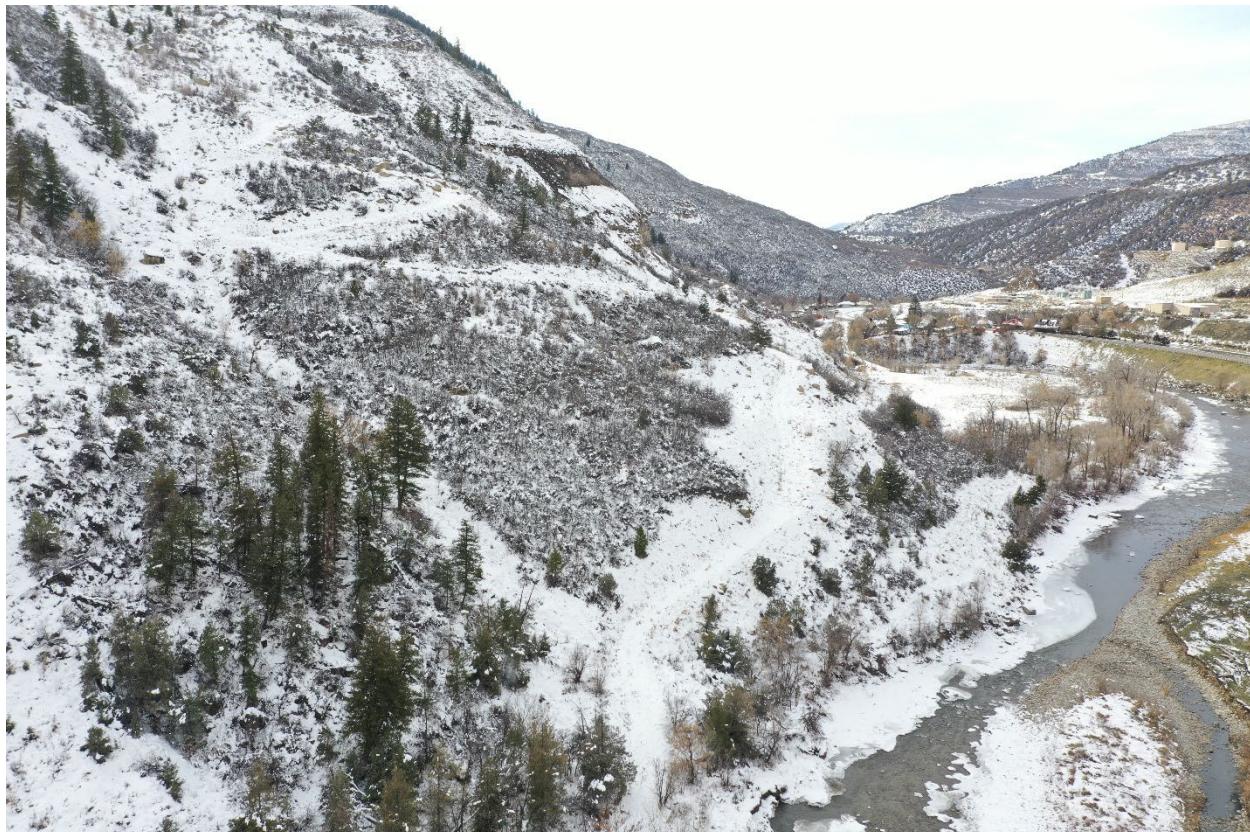
Figure 1: Overview of site from east

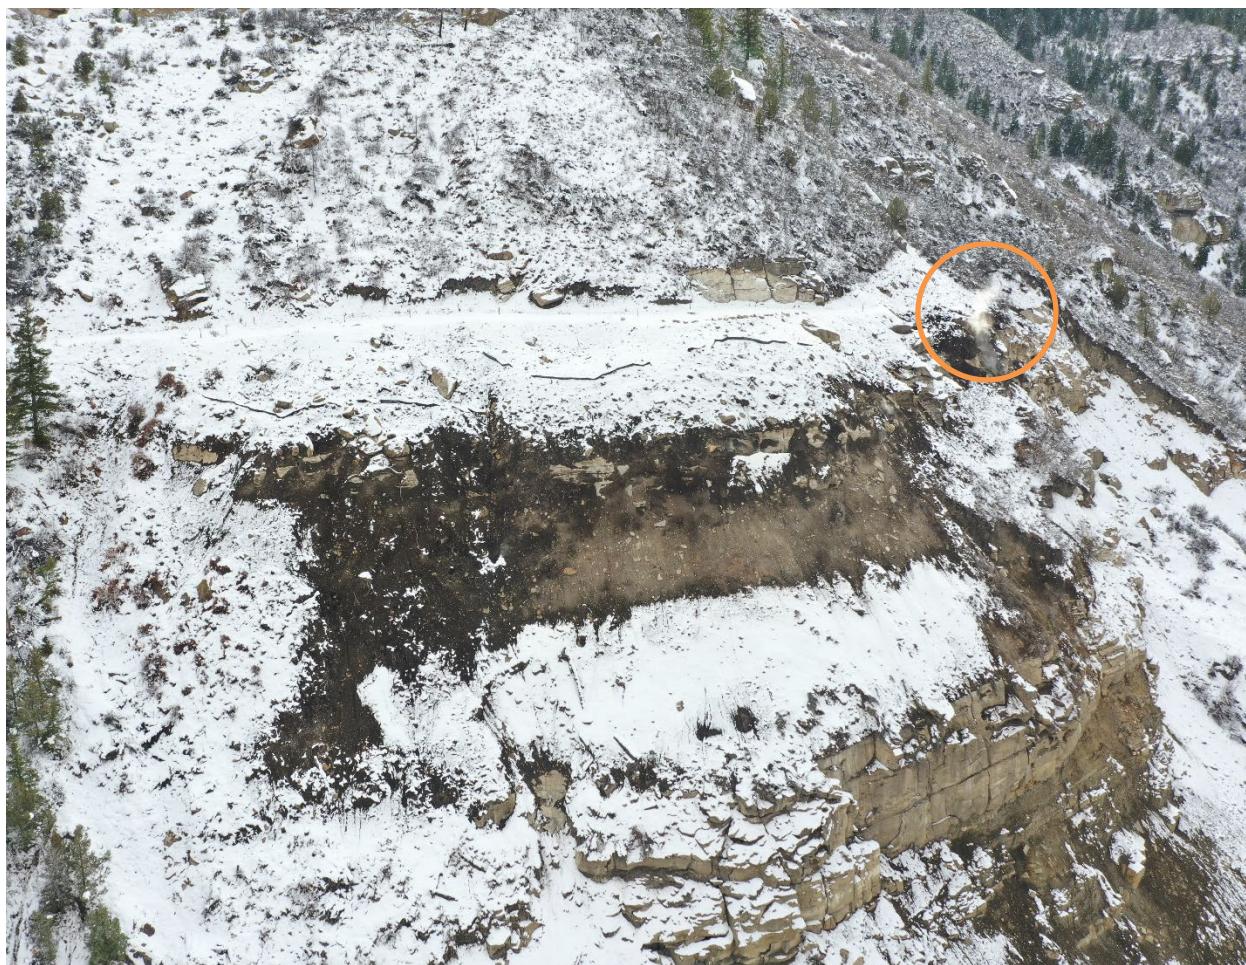
The scarpe and burned area did not show any signs of increased fire activity or instability. Smoke/steam could clearly be seen issuing from a crack between sandstone blocks just below the western end of the temporary pad. The pattern of melted snow shows that the ground was warm east of the vent, both below the sandstone bench that the temporary pad is constructed on, and below the bench below it.

Figure 2: Scarpe from southeast, vent visible to right of frame

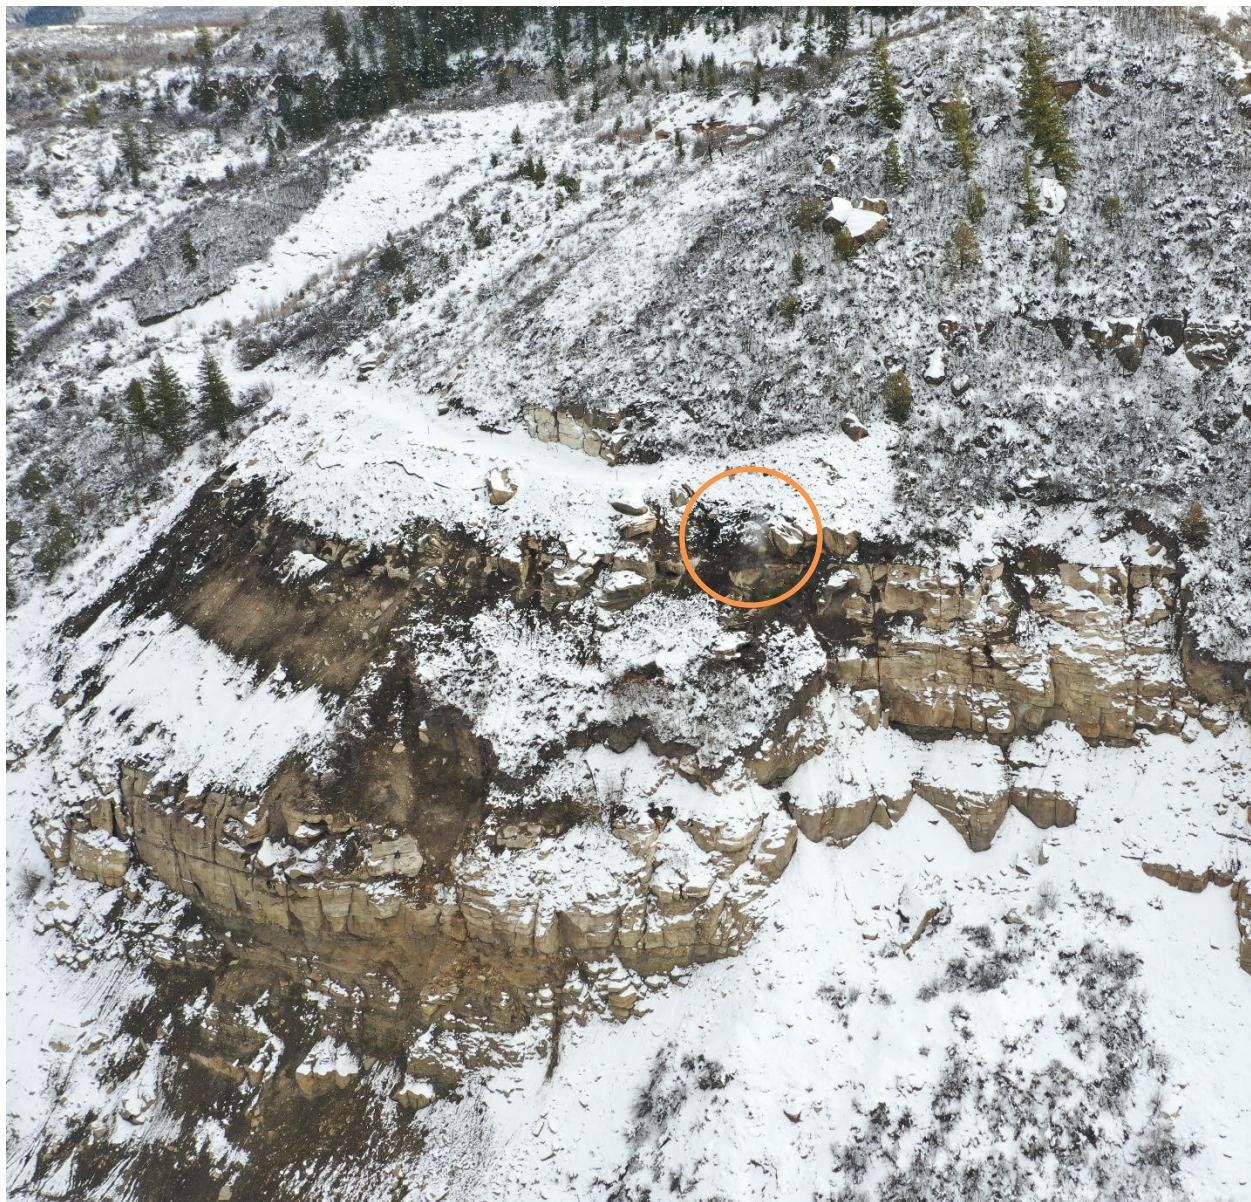
Figure 3: Scarpe from southwest, vent visible

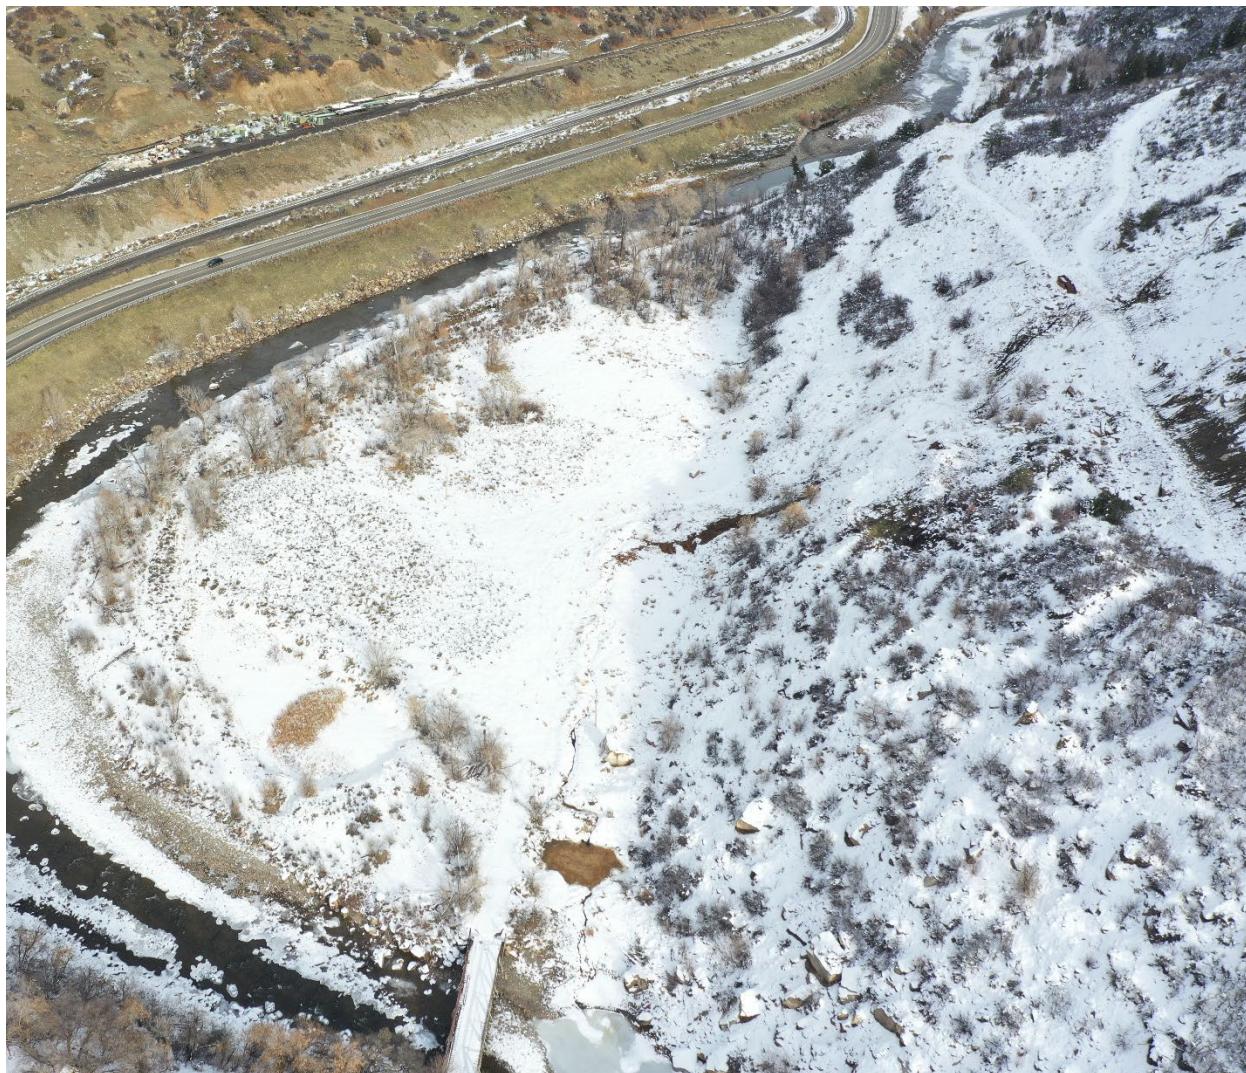
Figure 4: Bridge and reclaimed pad

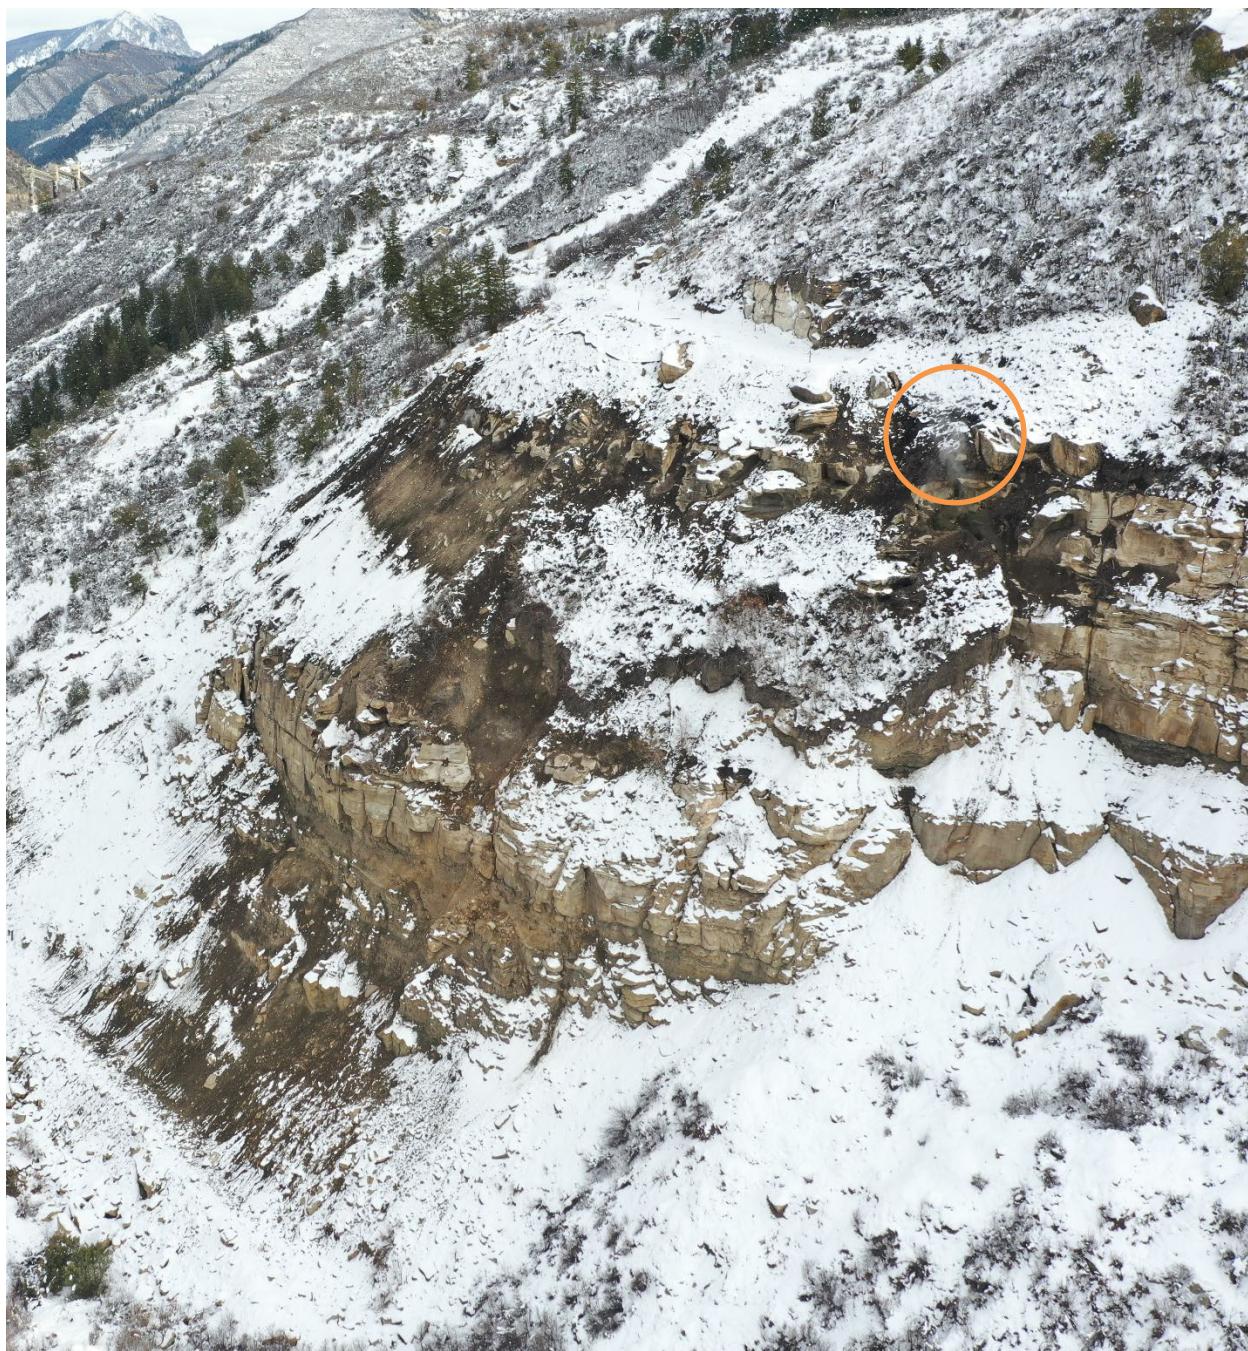
Figure 5: Slide area

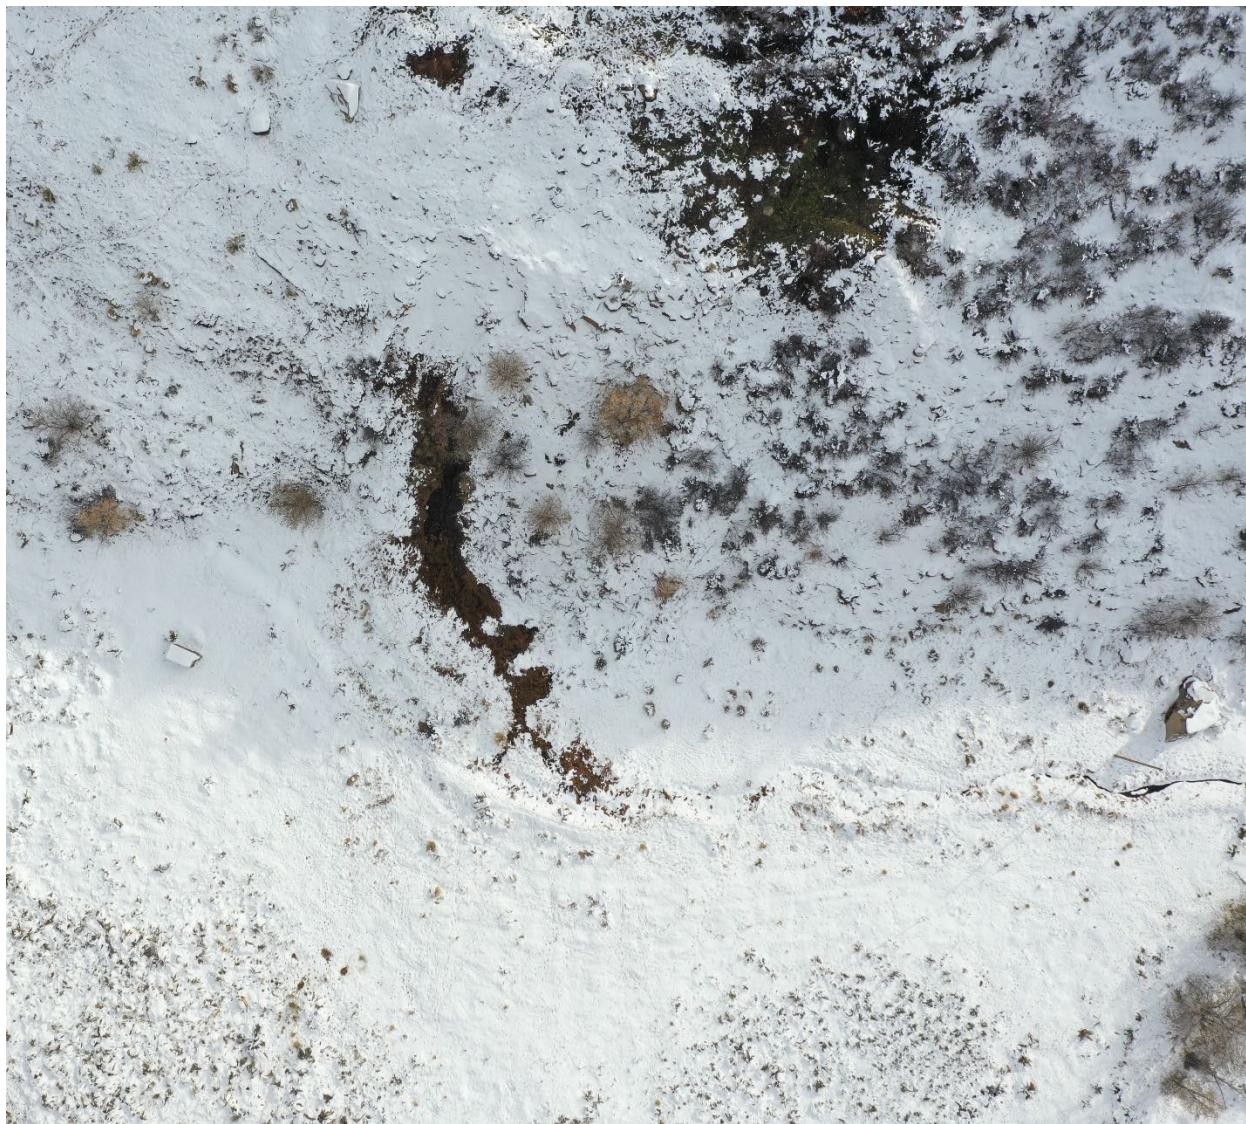
Warm water continued to seep from the toe of the slide area as can be seen by the pattern of melted snow.

Figure 6: Groundwater seep

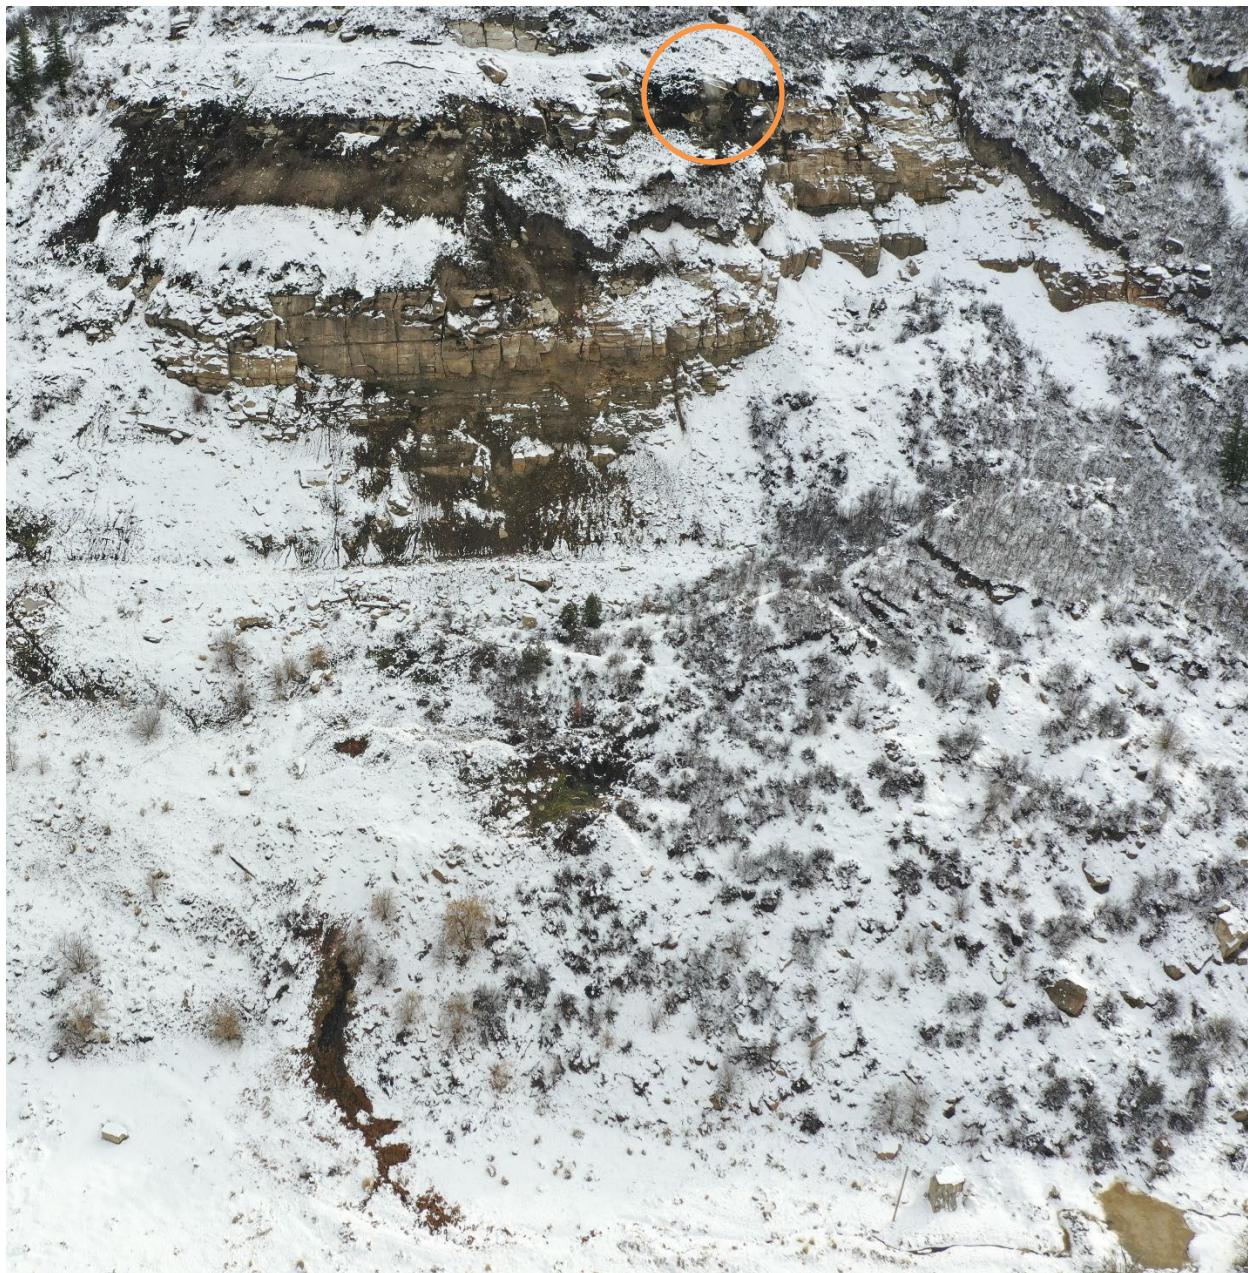
Figure 7: Slide area and seep

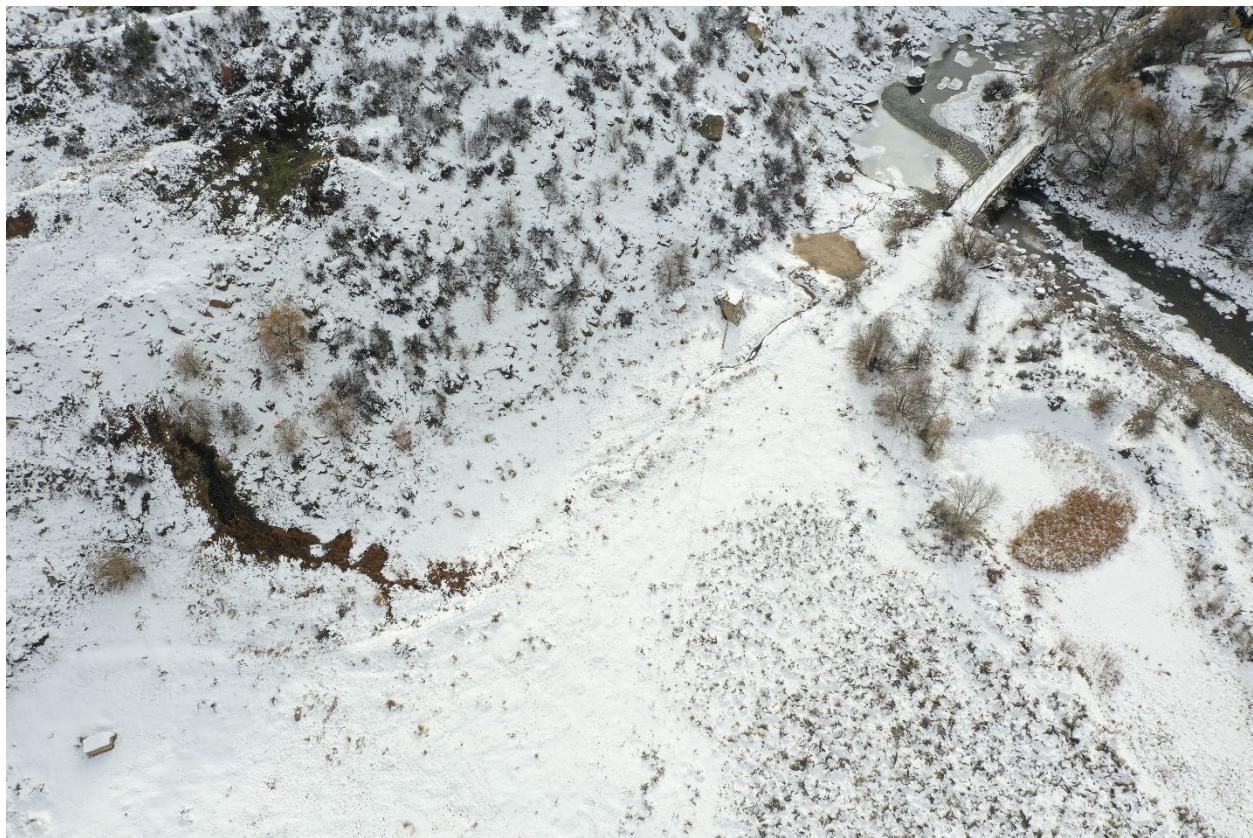
Figure 8: Seep, sinuous channel, bridge, reclaimed sediment pond
