MINERALS PROGRAM INSPECTION REPORT
PHONE: (303) 866-3567

MINE NAME: St Jude Mine	MINE/PROSPECTING ID#: M-1978-039-HR	MINERAL: Uranium and vanadiu	COUNTY: San Miguel
INSPECTION TYPE: Multi Person Inspection	WEATHER: Clear	INSP. DATE: October 9, 2025	INSP. TIME: 12:07
OPERATOR: Pinon Ridge Mining LLC	OPERATOR REPRESENTATIVE: Mike Rutter	TYPE OF OPERATION: 110d - Designated Limited Impact	
REASON FOR INSPECTION: Normal I&E Program	BOND CALCULATION TYPE:	BOND AMOUNT: \$108,830.00	
DATE OF COMPLAINT: NA	POST INSP. CONTACTS: None	JOINT INSP. AGENCY: None	
INSPECTOR(S): Lucas West	INSPECTOR'S SIGNATURE: 	SIGNATURE DATE: December 12, 2025

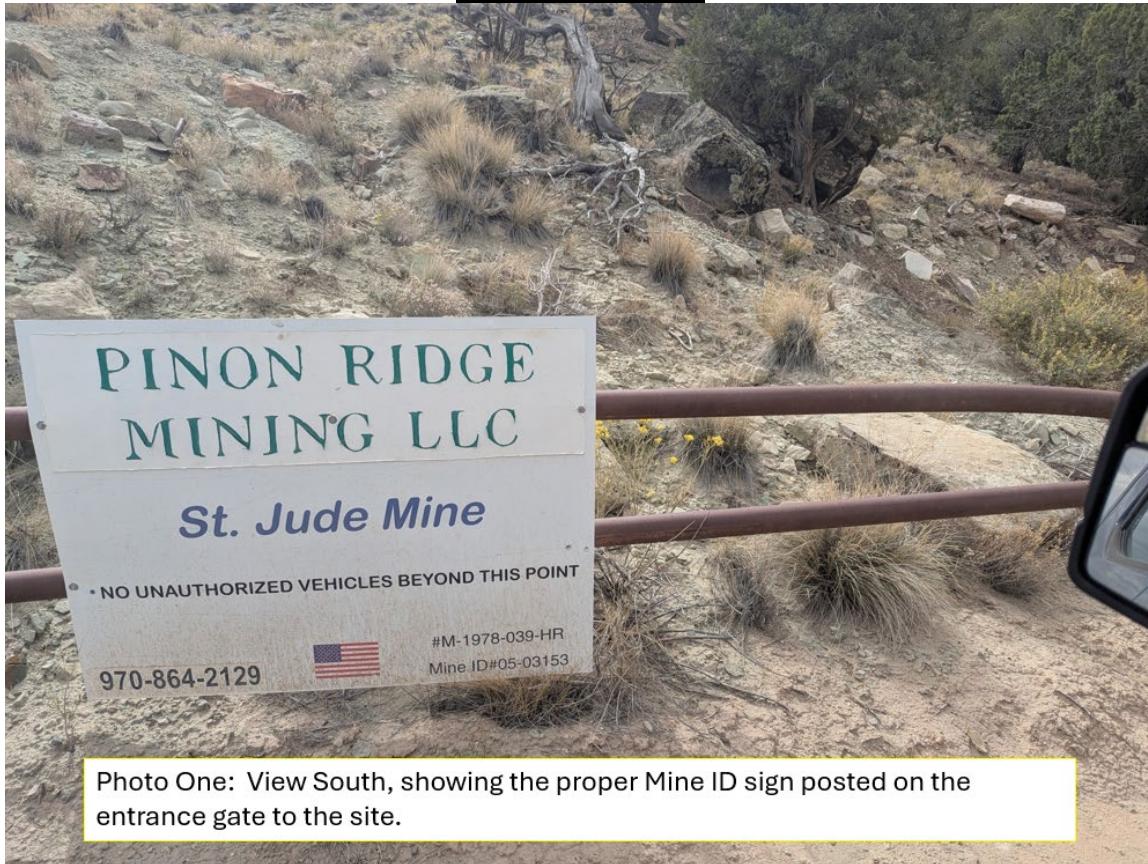
As seen in Photo One, the permit ID sign was observed at the entrance to the site. The permit boundary markers were also observed. All disturbances are contained within the permitted areas. The remote vent shaft sites were not inspected at this time. The diversion ditches and storm water control devices appear to be functioning as designed and no significant erosion was observed throughout the site. The main work area, adjacent to the portal and shops, appeared to be stable and in good condition. The portal was closed with the metal gates at the time of the inspection, but not backfilled with the earthen plug. The portal and it's structure are in excellent condition, shown in Photo Two.

Photo One: View South, showing the proper Mine ID sign posted on the entrance gate to the site.

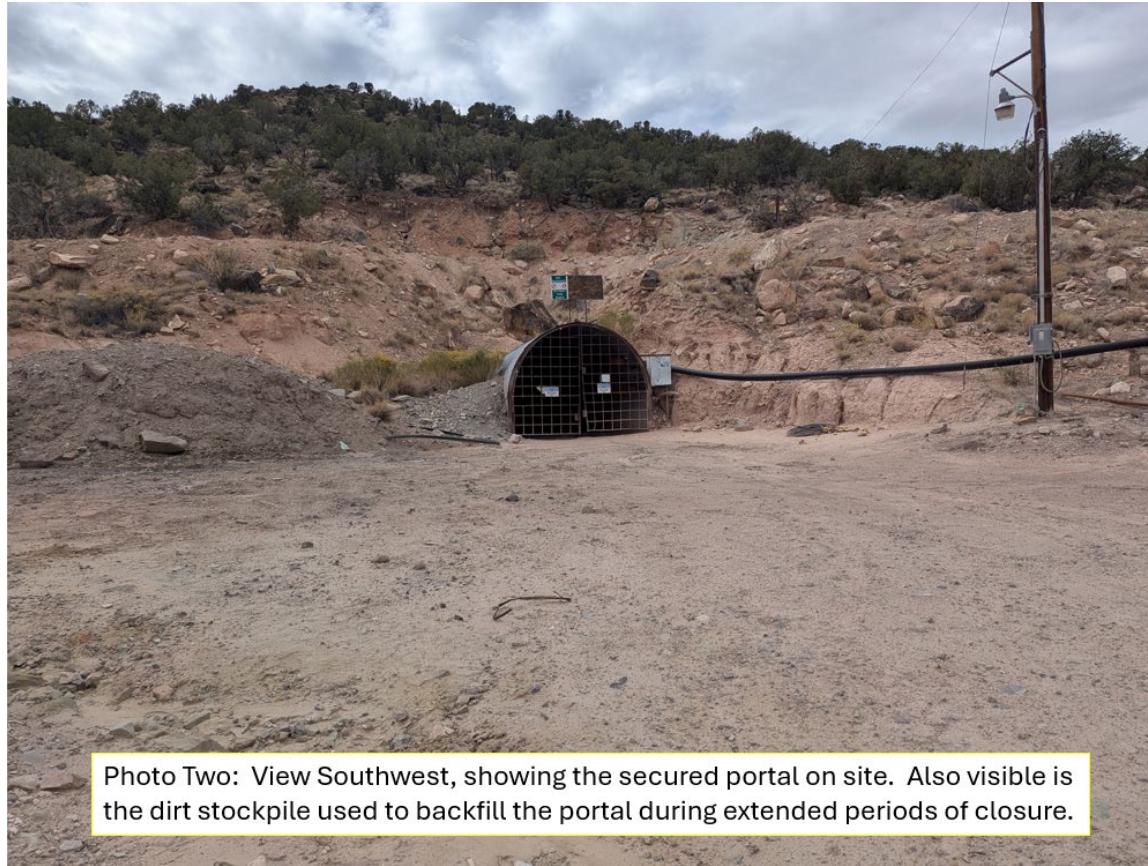
Photo Two: View Southwest, showing the secured portal on site. Also visible is the dirt stockpile used to backfill the portal during extended periods of closure.

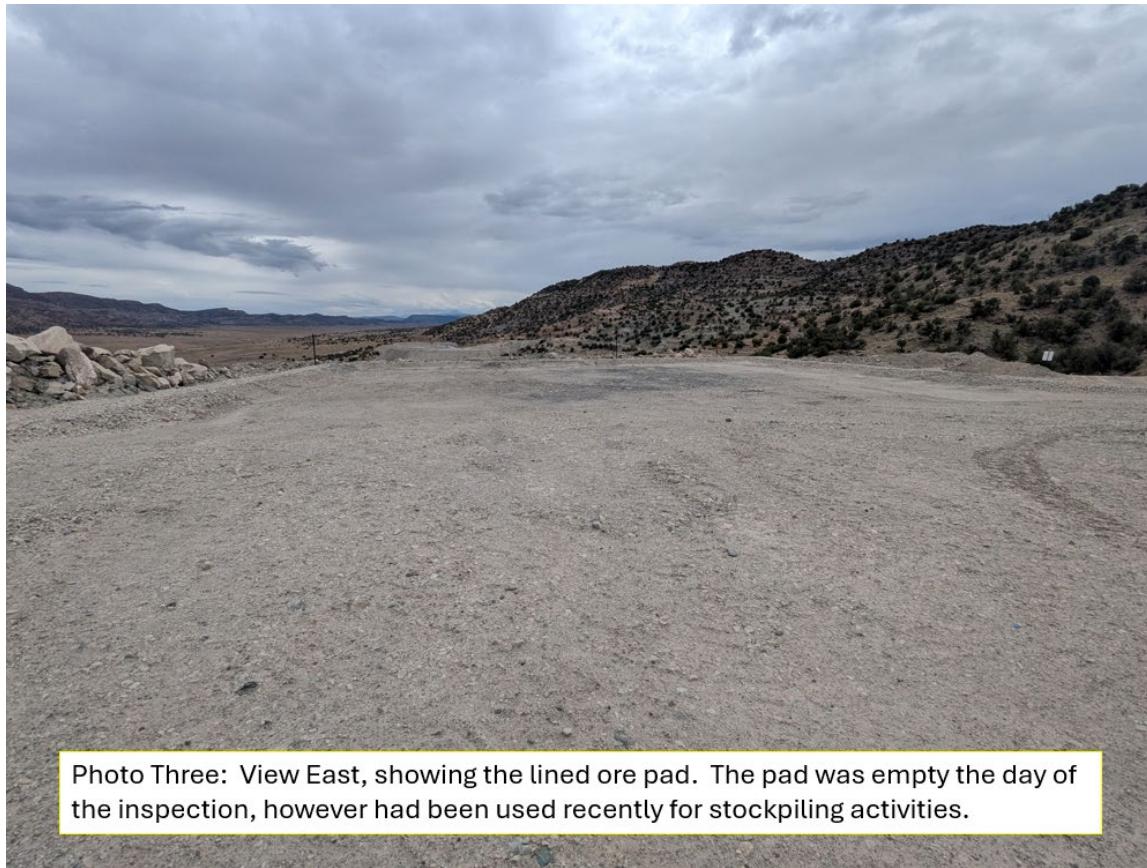
The lined Ore Pad was observed to be in good condition. The pad has been used for stockpiling ore, however no ore was currently being stored on the pad. All material has been shipped and the pad has been cleaned of all residual materials. The out slopes and berms of the pad appear stable. The pad can be seen in Photo Three. All work and shop facilities onsite were secured and appeared to be in good condition as seen in Photo Four. The small above ground fuel tanks have been removed from the site. The concrete pad, air tank and two compressor stations have been installed but were not in use at the time of the inspection. Photo Five shows the compressor station adjacent the portal. Various other items are observed on site however it was stored in an orderly fashion and was not a concern at this time. The waste rock dump storage area was observed and appears to be stable and in good condition. The out slopes show no signs of significant erosion.

Photo Three: View East, showing the lined ore pad. The pad was empty the day of the inspection, however had been used recently for stockpiling activities.

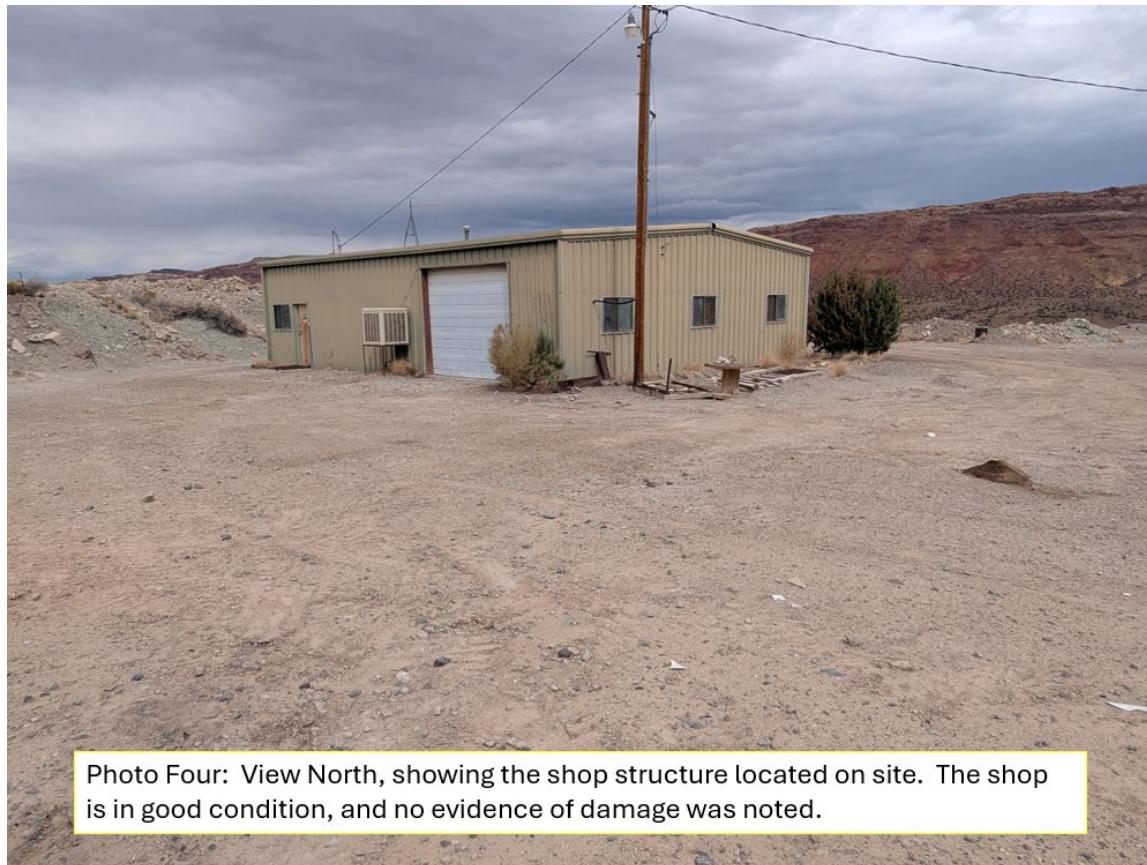
Photo Four: View North, showing the shop structure located on site. The shop is in good condition, and no evidence of damage was noted.

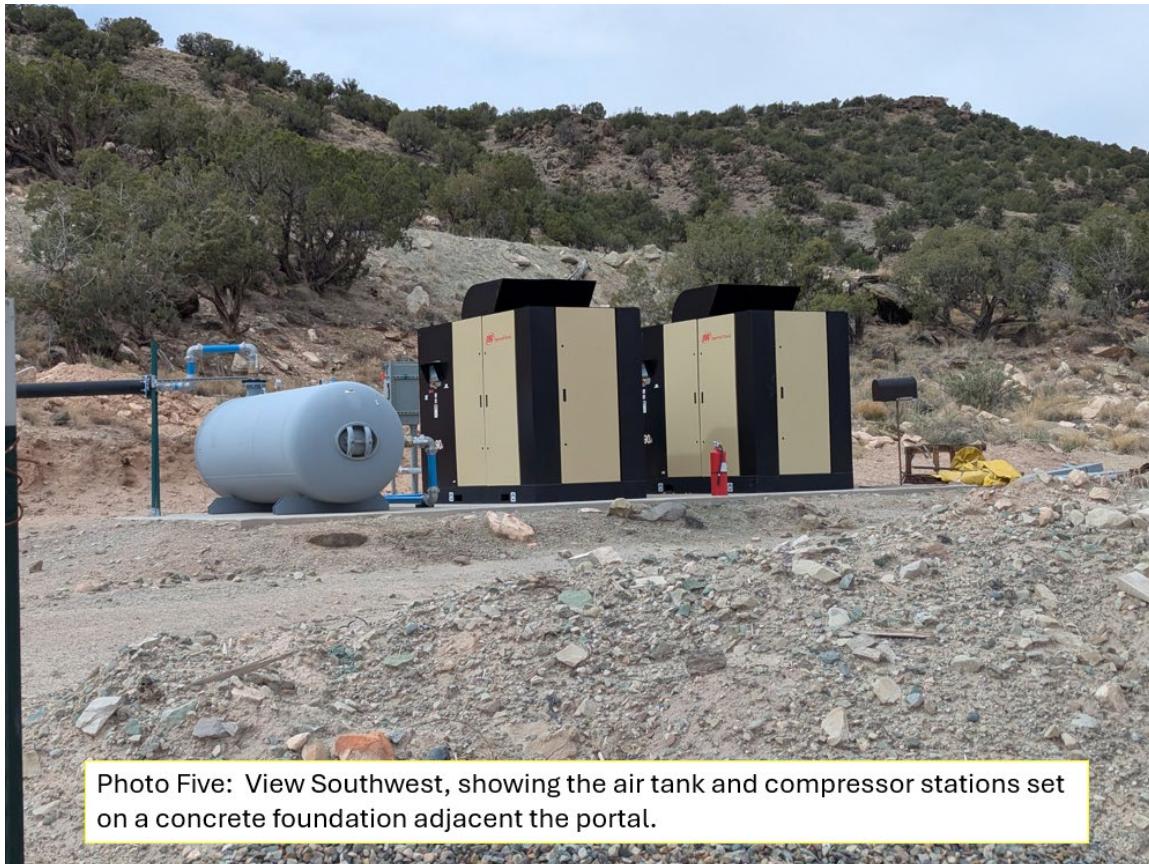
Photo Five: View Southwest, showing the air tank and compressor stations set on a concrete foundation adjacent the portal.
