MINERALS PROGRAM INSPECTION REPORT
PHONE: (303) 866-3567

MINE NAME: Black Obsidian	MINE/PROSPECTING ID#: M-1987-026	MINERAL: Stone	COUNTY: Custer
INSPECTION TYPE: Monitoring	WEATHER: Clear	INSP. DATE: November 17, 2025	INSP. TIME: 11:30
OPERATOR: Colorado Quarries Inc	OPERATOR REPRESENTATIVE: Aaron Tezak	TYPE OF OPERATION: 112c - Construction Regular Operation

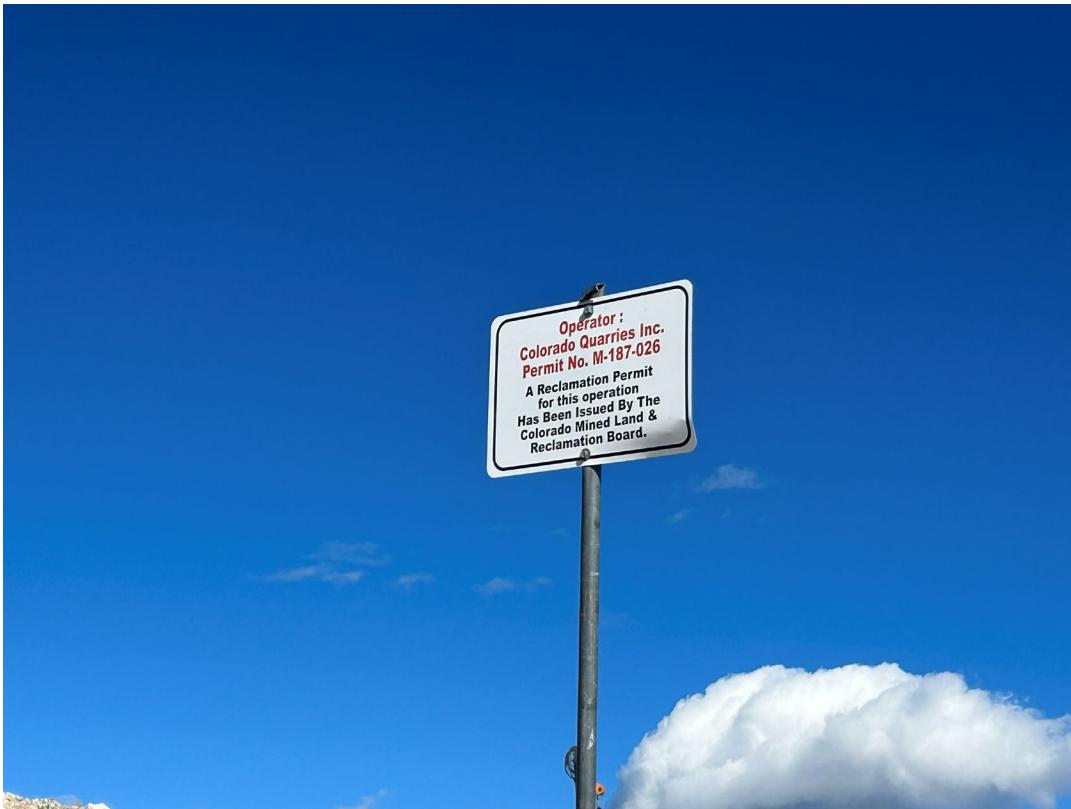
PROBLEM #1: The mine identification sign posted at the entrance of the mine site contains inaccurate information and/or does not meet required specifications. This is a problem for failure to post a mine identification sign as required by Section 3.1.12(1) of the rule. The Operator shall, at the entrance of the mine site post a sign, which shall be clearly visible from the access road, with a minimum size equaling one hundred and eighty-seven (187) square inches, such as eleven (11) inches in height and seventeen (17) inches in width, with appropriate font size, with the following: the name of the Operator, a statement that a reclamation permit for the operation has been issued by the Colorado Mined Land Reclamation Board; and the permit number.

The permit area has a locked and gated entrance, with a mine identification sign posted at the entrance. However, the permit number on the mine identification sign is incorrect (photo 1) showing "M-187-026" instead of the correct permit number "M-1987-026". This was cited as a problem in the Division's November 10, 2021 inspection report and was never resolved. **The incorrect permit number on the mine identification sign is cited as a problem in this report (Problem #1). The Operator will need to update the sign to have the correct permit number (M-1987-026) and provide photo documentation to the Division by the corrective action due date.**

Photo 1. The mine identification sign posted that needs to be corrected.

CORRECTIVE ACTIONS: The Operator shall, at the entrance of the mine site, post a sign which shall be clearly visible from the access road with the following: the name of the Operator, a statement that a reclamation permit for the operation has been issued by the Colorado Mined Land Reclamation Board; and the permit number (M-1987-026). The Operator shall submit photo documentation that a proper sign has been posted by the corrective action date.

CORRECTIVE ACTION DUE DATE: 1/17/26

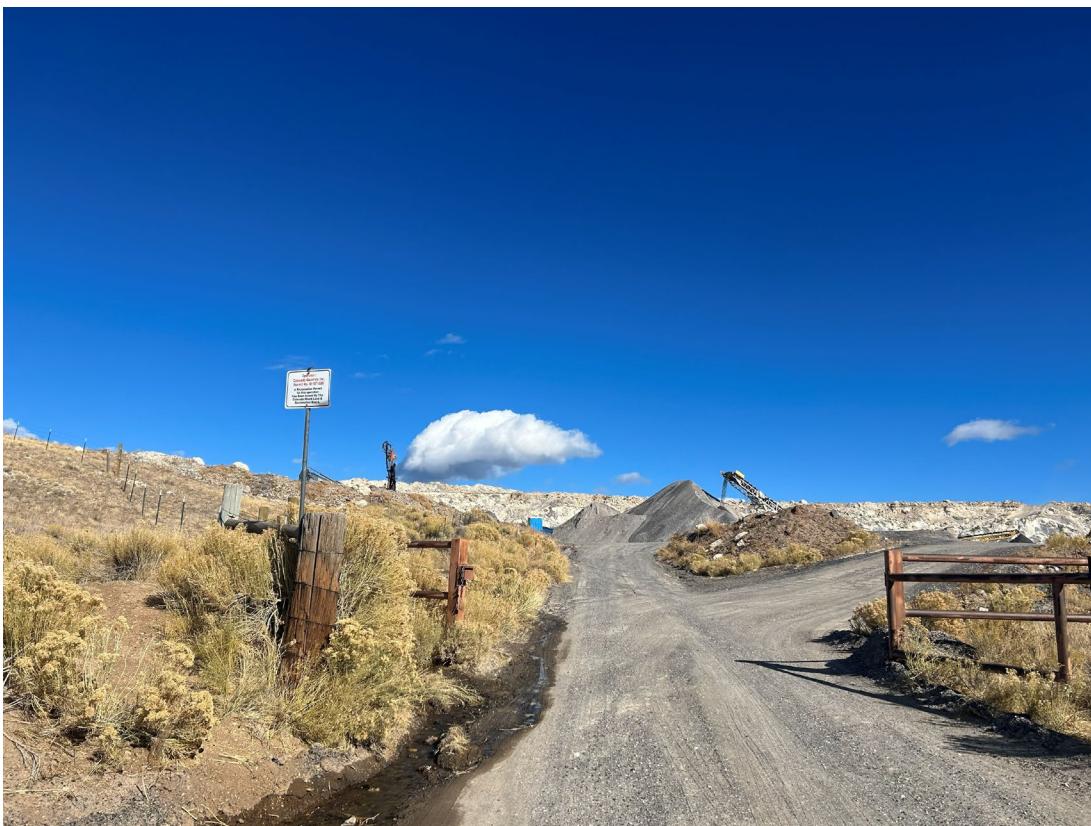
Photo 2. Looking northeast at the mine site entrance.

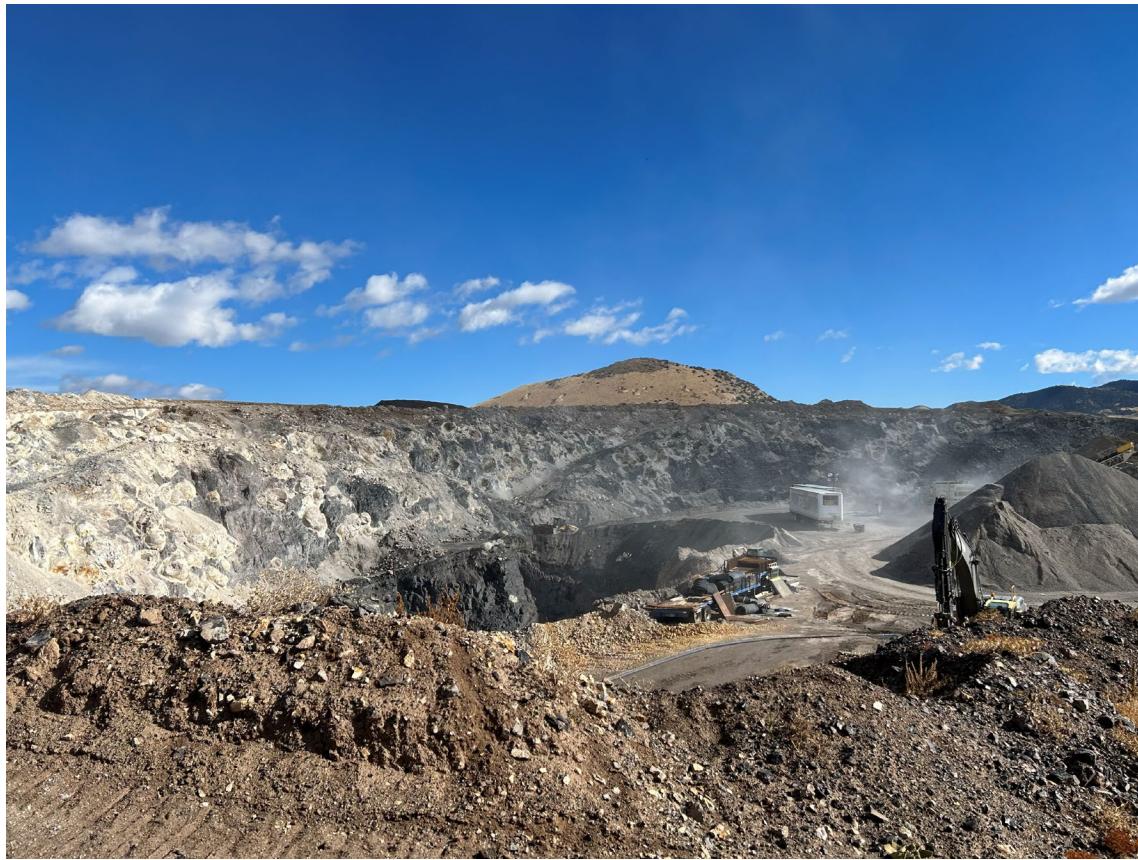
Photo 3. Looking east at the active quarry area.

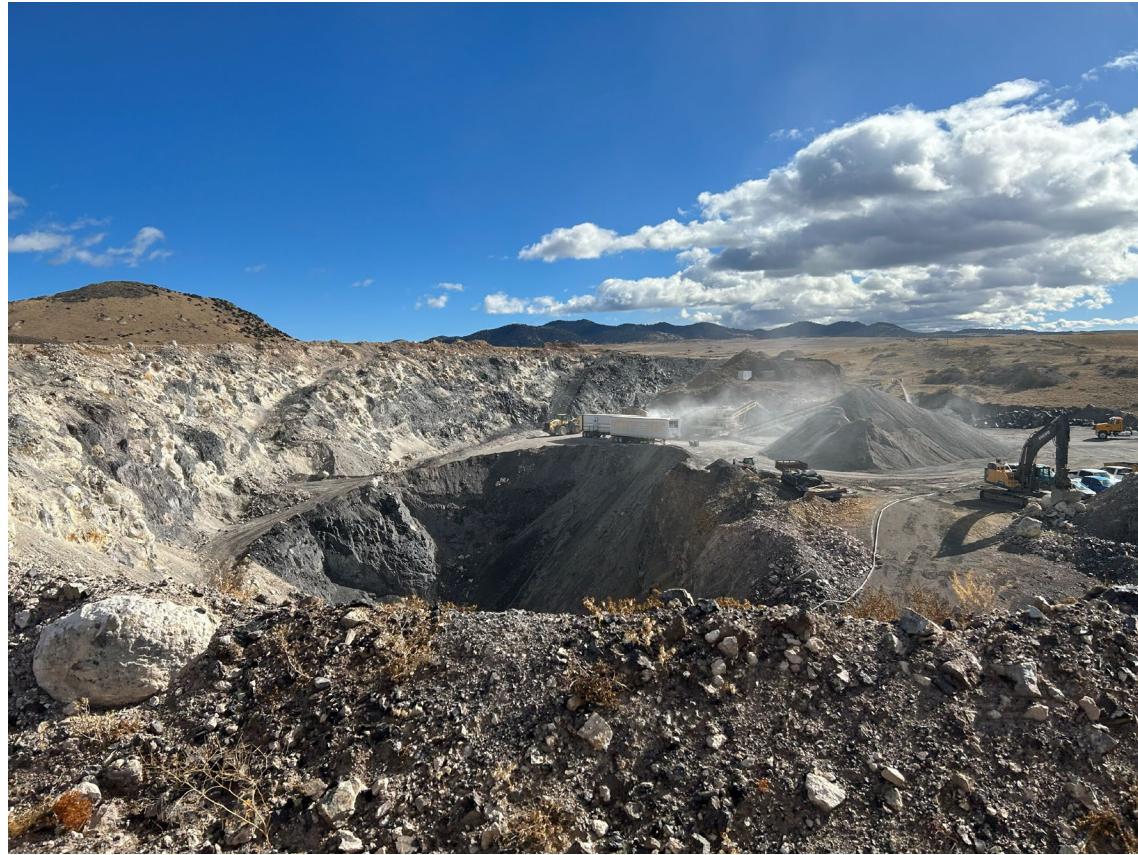
Photo 4. Looking southeast at the active quarry, showing the current quarry floor.

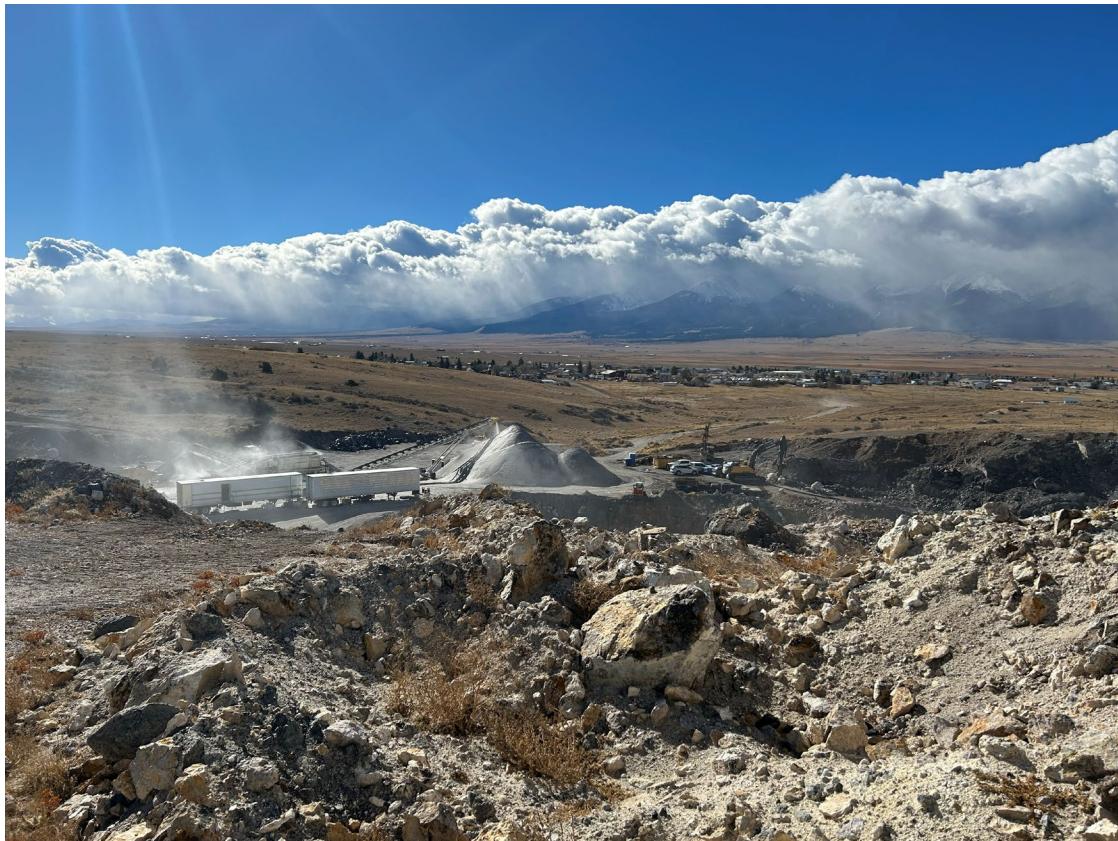
Photo 5. Standing on the highwall, looking southwest at the active quarry area. The crusher/conveyor depositing into the stockpile.

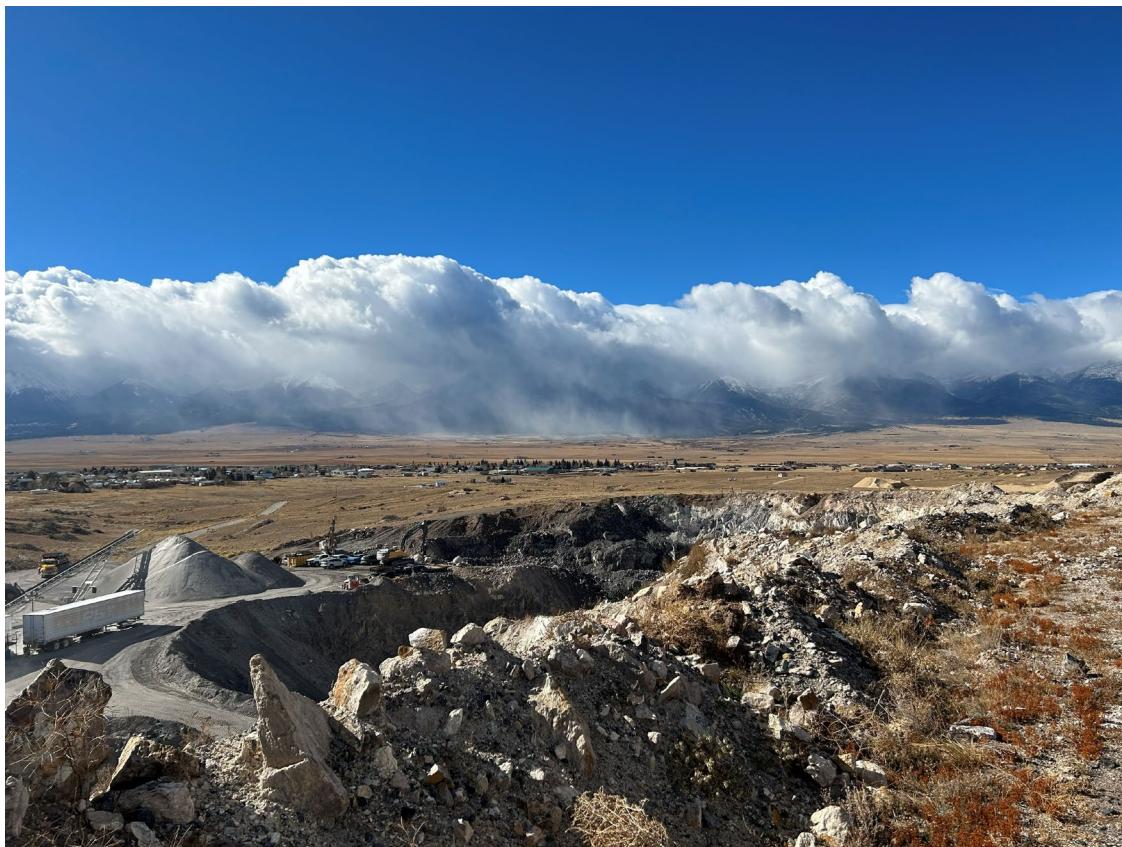
Photo 6. Standing on the highwall, looking west at the active quarry area.

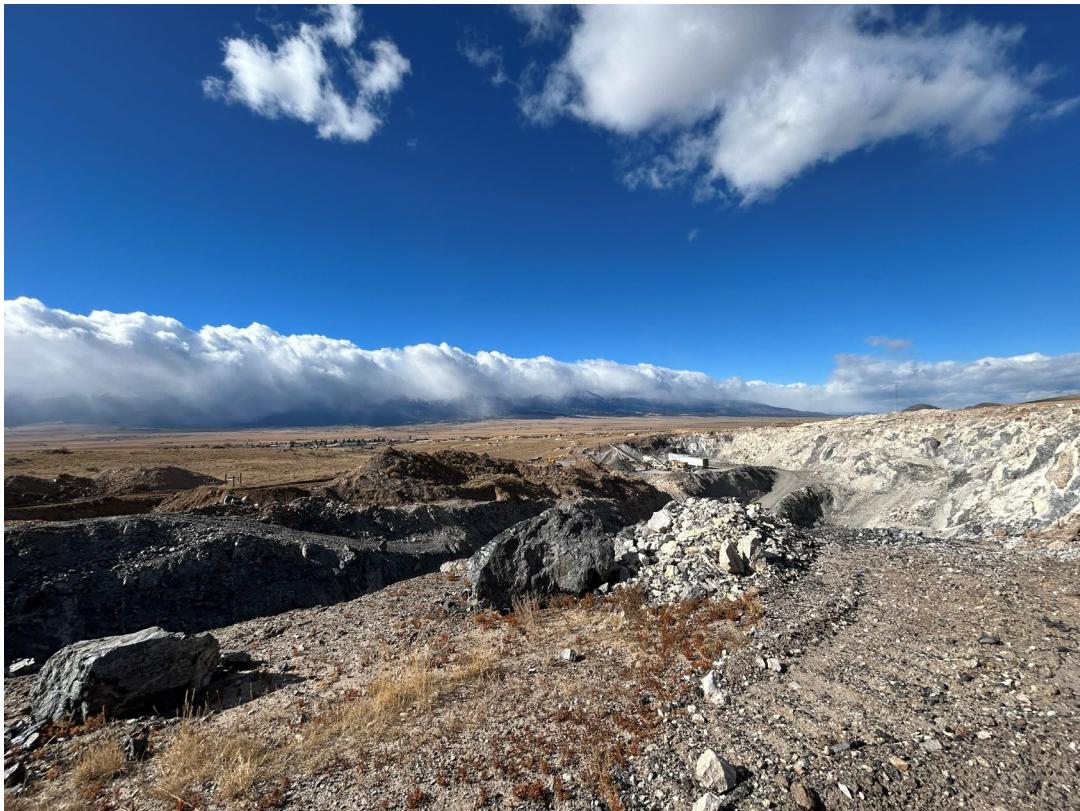
Photo 7. Looking northwest at the active quarry area.

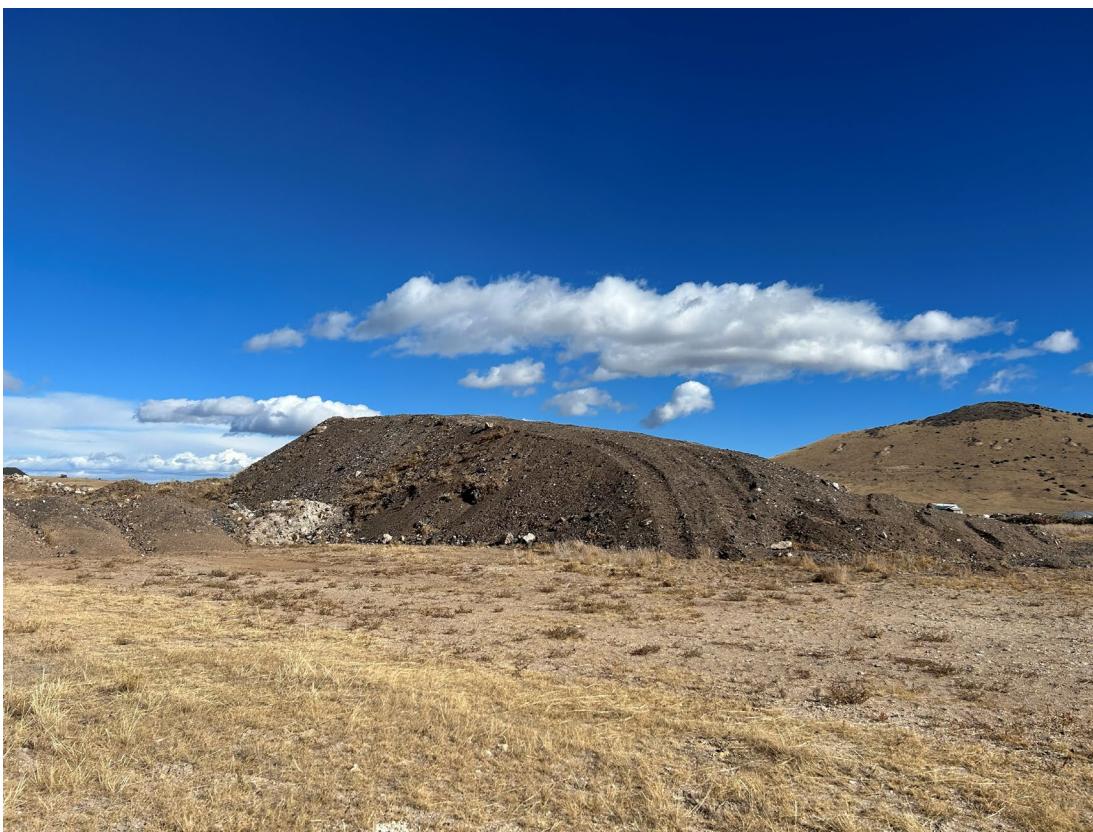
Photo 8. Looking northeast at one of the topsoil stockpiles located north of the quarry area.

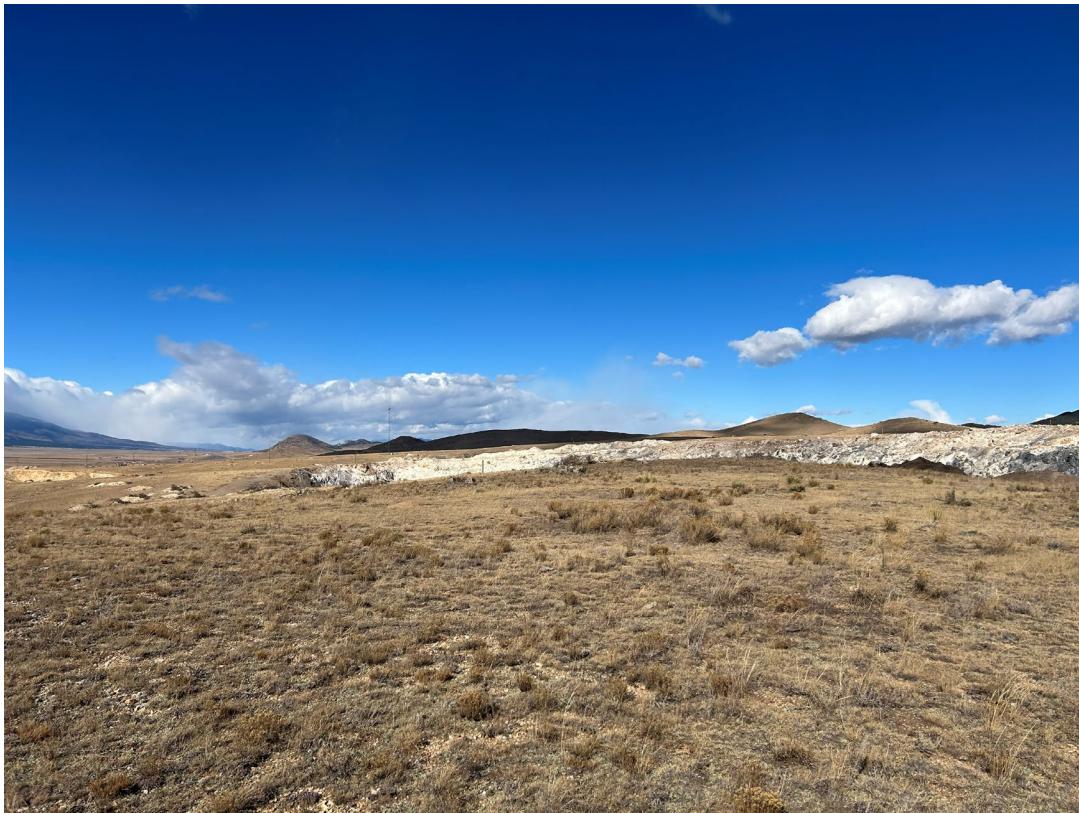
Photo 9. Standing just south of the active quarry, looking north across the permit area.

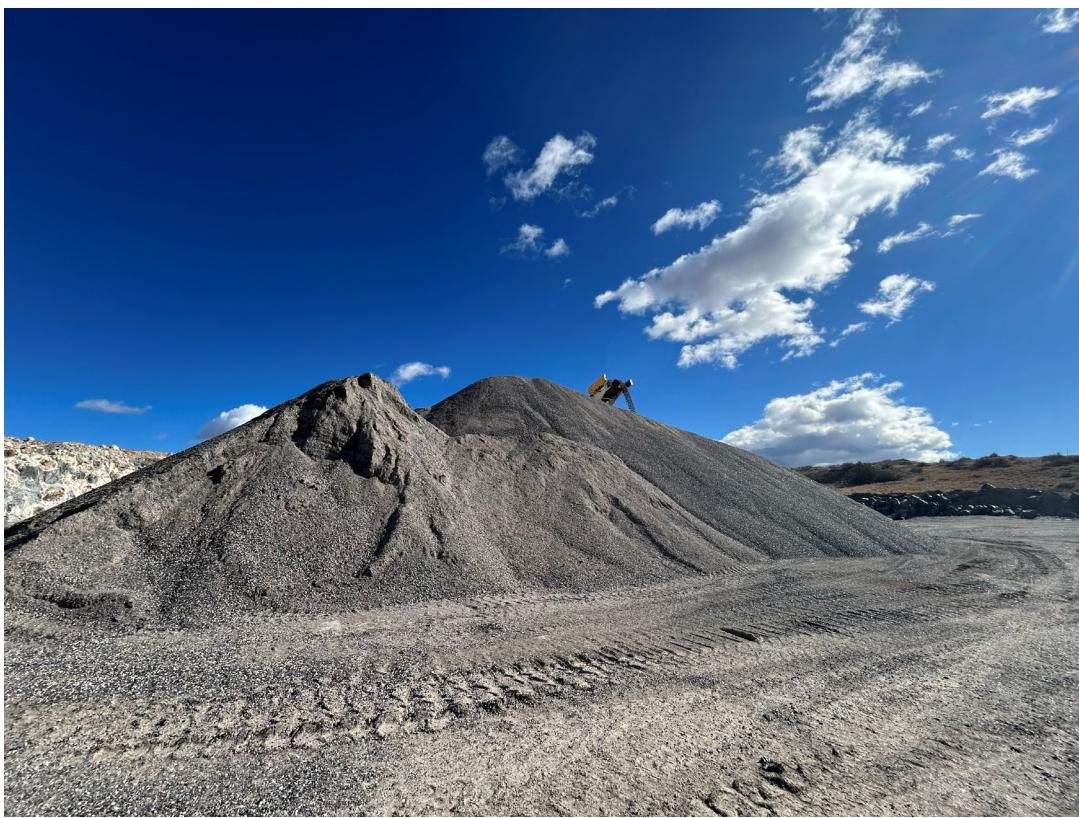
Photo 10. Standing on the operations pad, looking west at the processed material stockpile.
