MINERALS PROGRAM INSPECTION REPORT
PHONE: (303) 866-3567

MINE NAME: Cresson Project	MINE/PROSPECTING ID#: M-1980-244	MINERAL: Gold and silver	COUNTY: Teller
INSPECTION TYPE: Monitoring	WEATHER: Clear	INSP. DATE: December 10, 2025	INSP. TIME: 08:00
OPERATOR: Cripple Creek & Victor Gold Mining Company	OPERATOR REPRESENTATIVE: Jorge Ricaurte, Brian Doering, P. Barrella	TYPE OF OPERATION: 112d-3 - Designated Mining Operation	
REASON FOR INSPECTION: Normal I&E Program	BOND CALCULATION TYPE: None	BOND AMOUNT: \$333,471,401.00	
DATE OF COMPLAINT: NA	POST INSP. CONTACTS: None	JOINT INSP. AGENCY: None	
INSPECTOR(S): Patrick Lennberg	INSPECTOR'S SIGNATURE: 	SIGNATURE DATE: December 19, 2025

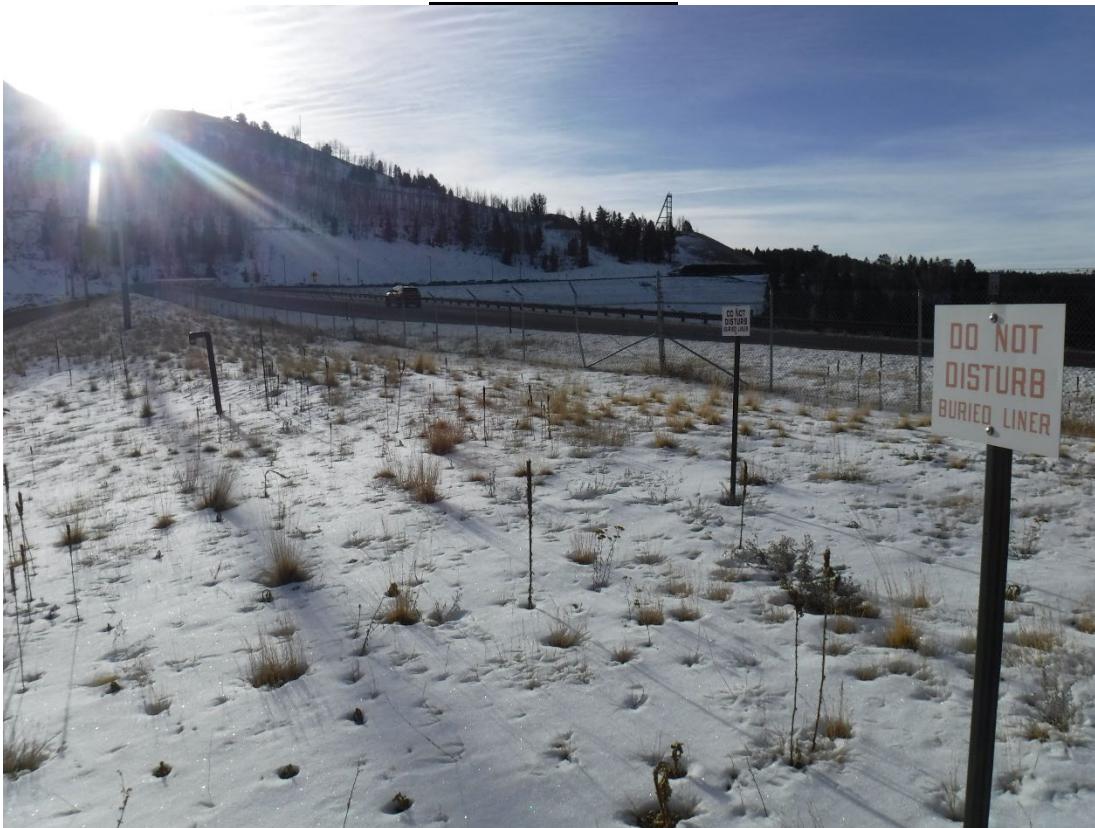
Photo 1: Looking SE along the crest of ADR2 dam and CO-67, standing west of the administrative building

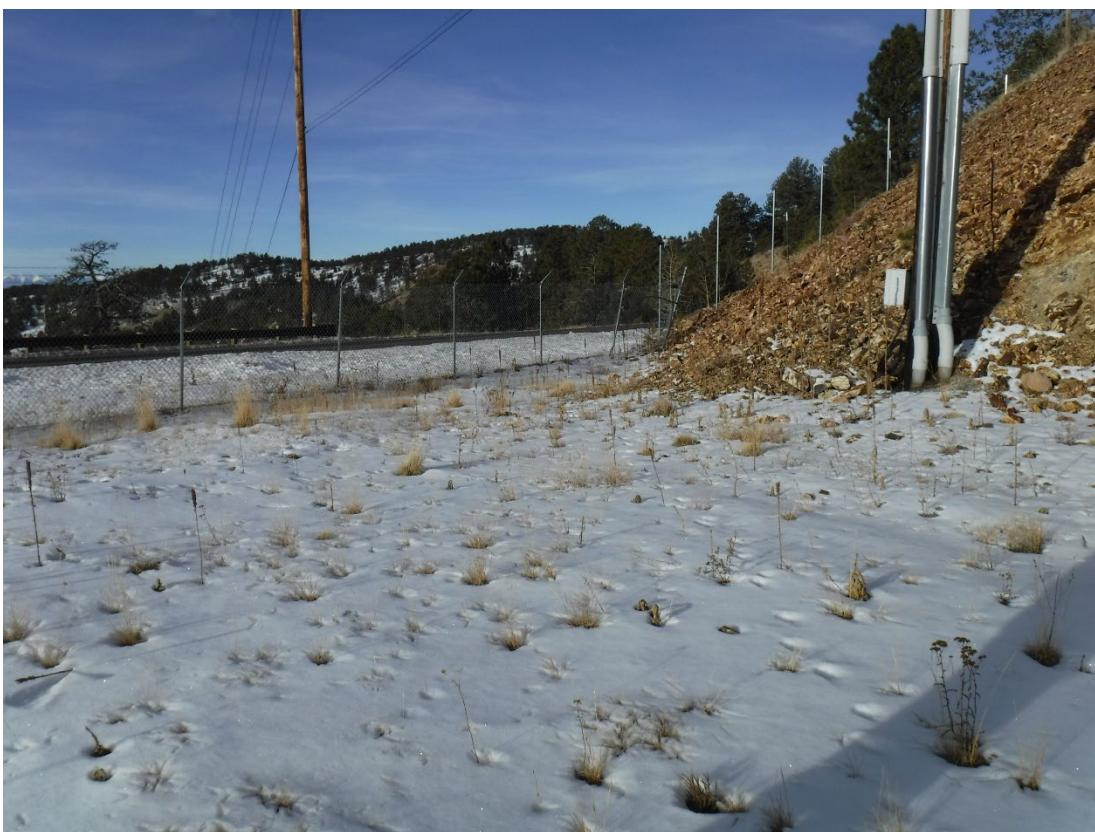
The area just west of the administrative facility at the toe of the rocky steep hillside where a power line crosses CO-67 is the lowest point where flow would be expected to discharge in an over-topping event. The Operator has provided to the Division a preliminary model on the flow path from an over-topping event. In this event flow would exit the site at this location flow along the north side of CO-67 for a short distance then crossing the road and running down the hillside. As modeled, the flow across the road is a short distance west of power pole. As flow continues in this area there is a certain portion of the predicted flow that will encounter topographic high, and flow will begin to flow down the western side of dam where it intersects with native material. Flow along the dam at this location could compromise the dam's structural integrity.

Photo 2: Looking W at the area where flow would exit the site in an over-topping situation

The Operator is evaluating possible mitigation measures that can be implemented to ensure that flow cannot reach the dam face to cause erosion and maintain flow in the natural drainage. The Division investigated the possibility of a culvert under the road that would act as preferential flow path under CO-67, however no culvert was found.

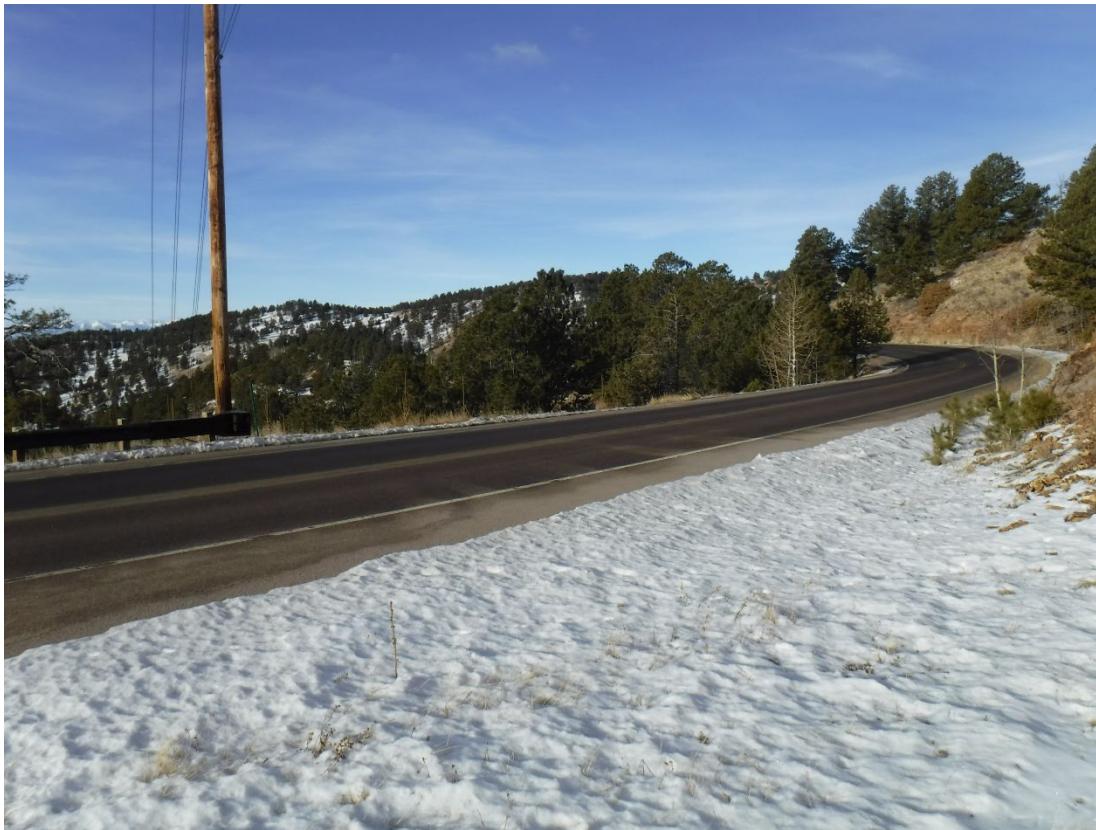
Photo 3: Looking at CO-67 just beyond the fenceline, looking west

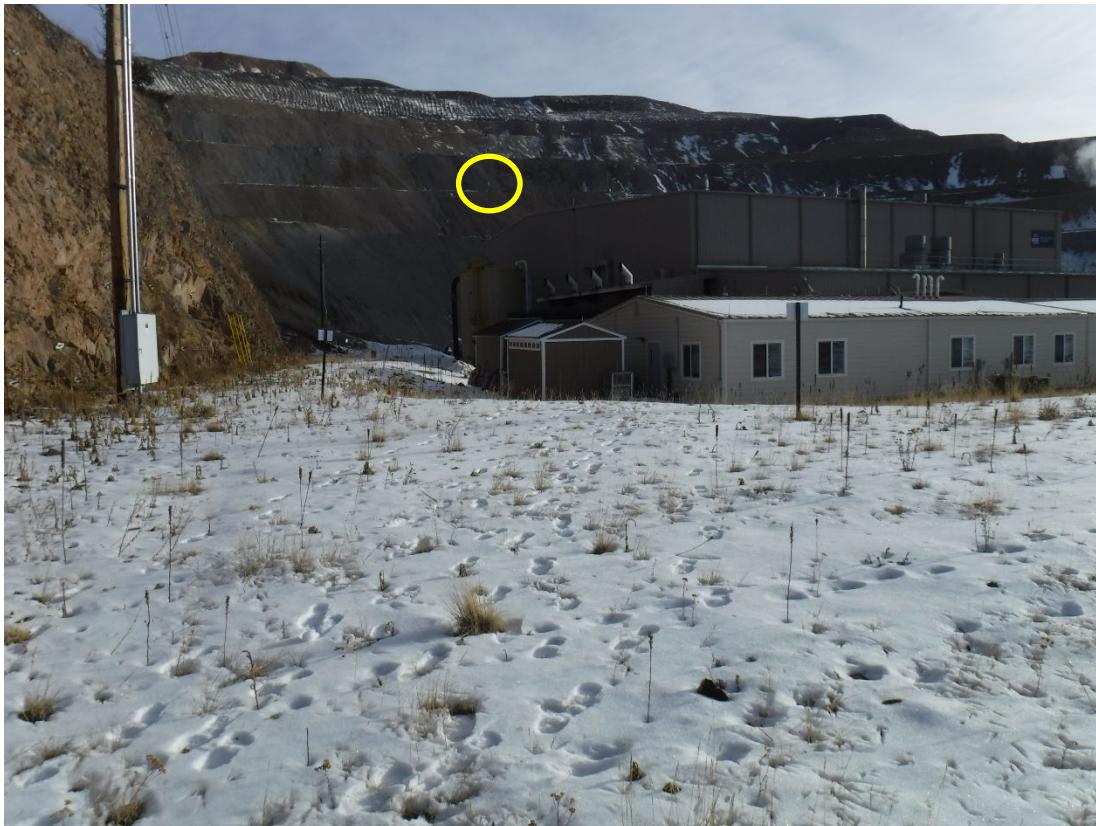
Photo 4: Looking towards the ADR2 administrative building from the fenceline, VWP drilling circled in yellow

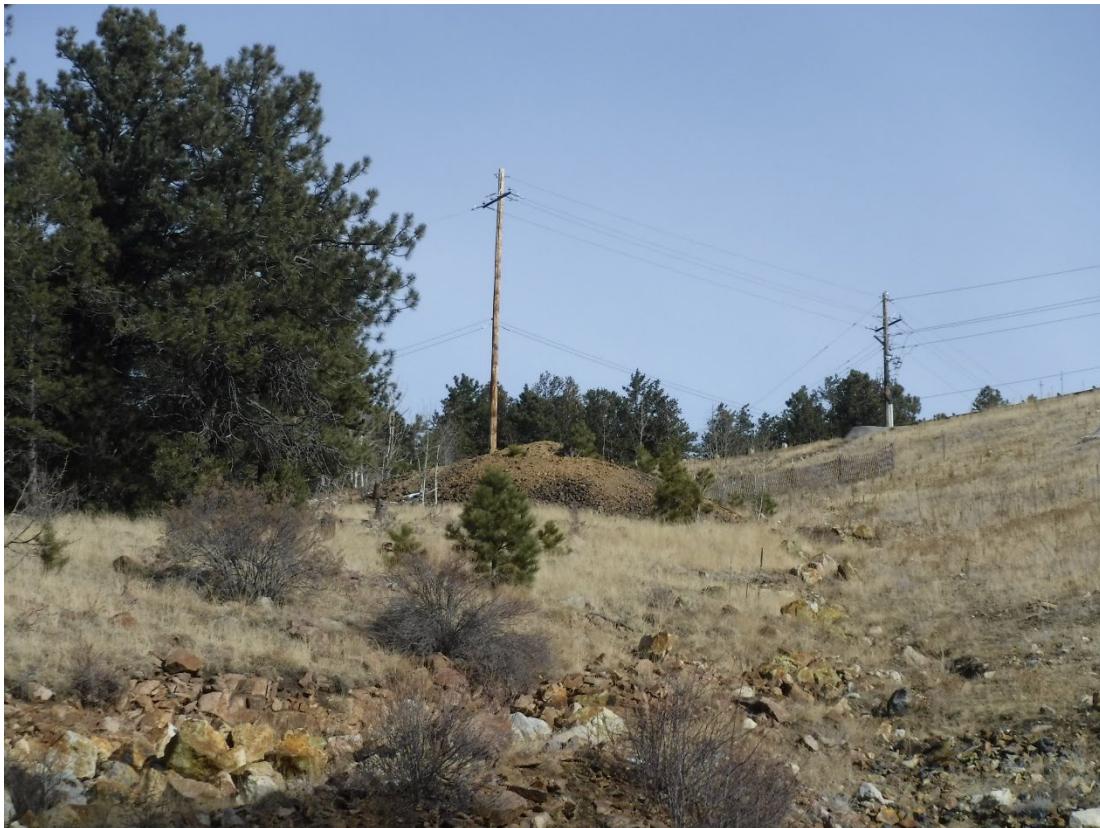
Photo 5: Looking up the westside the dam from the toe, the two power poles are the same poles in photo 2

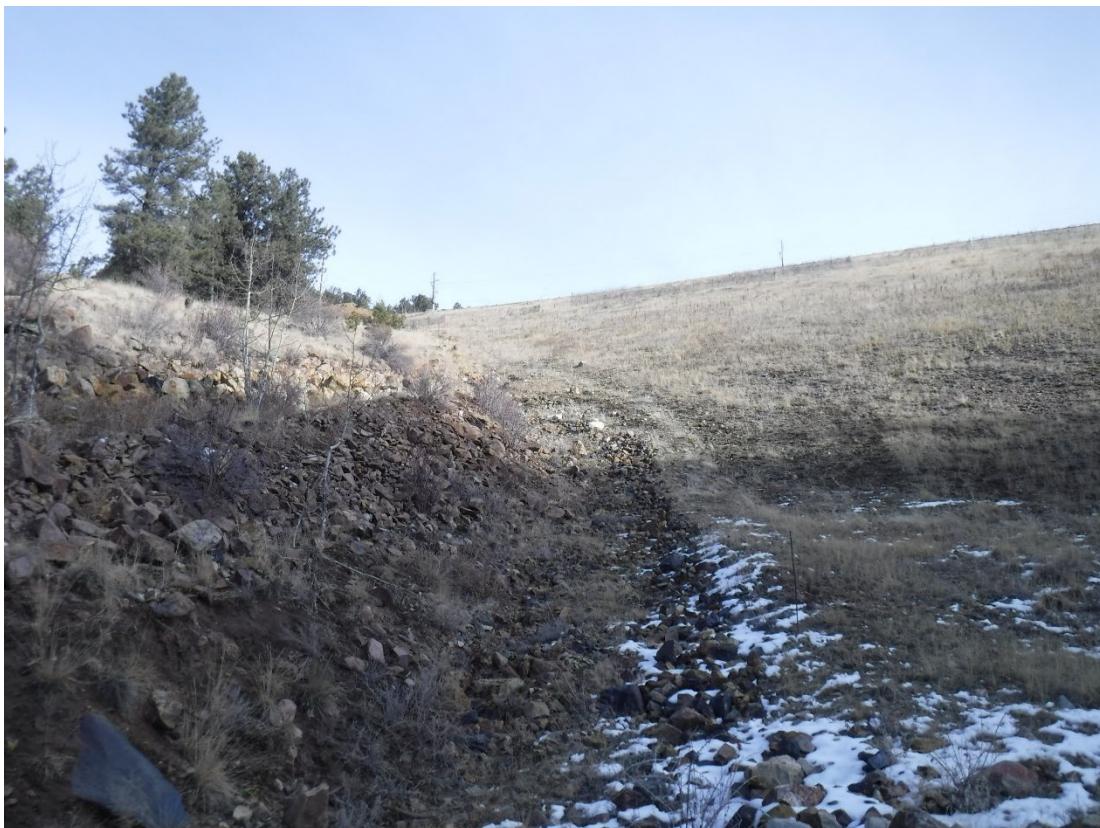
Photo 6: Looking up along the area where dam placed material meets native material

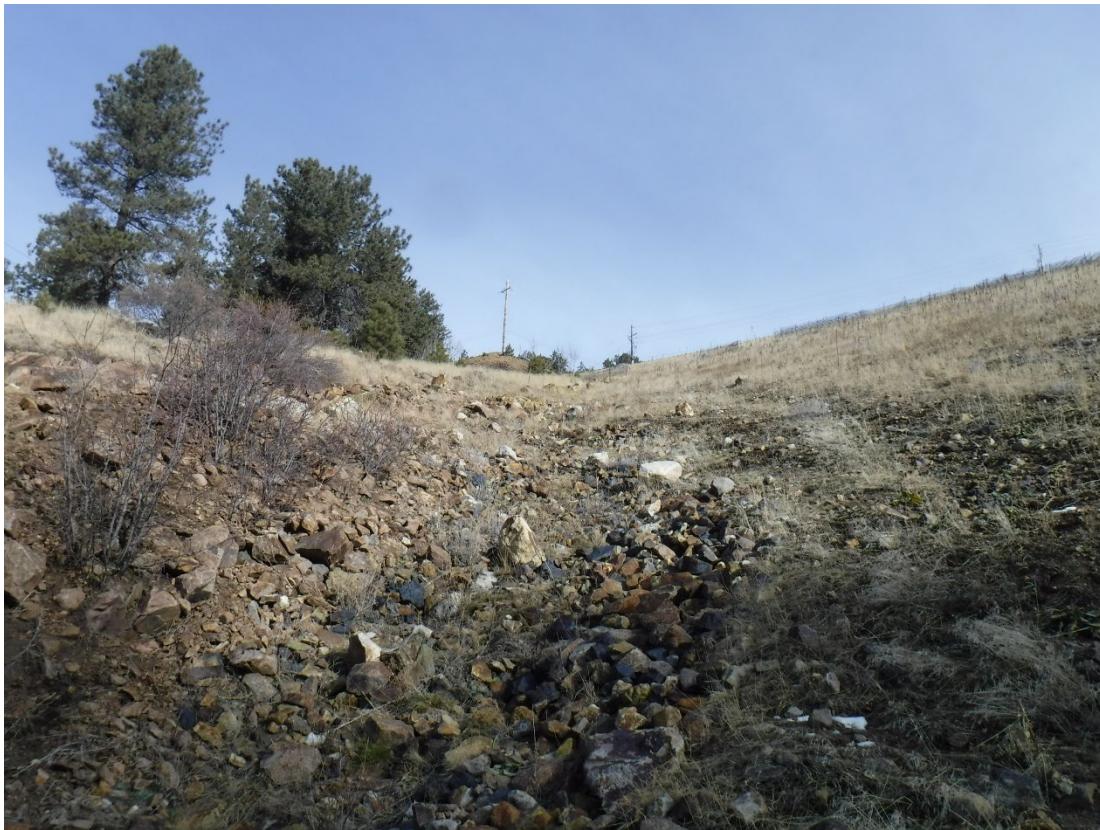
Photo 7: Another photo where dam placed material (right side of photo) meets native material (left side of photo)

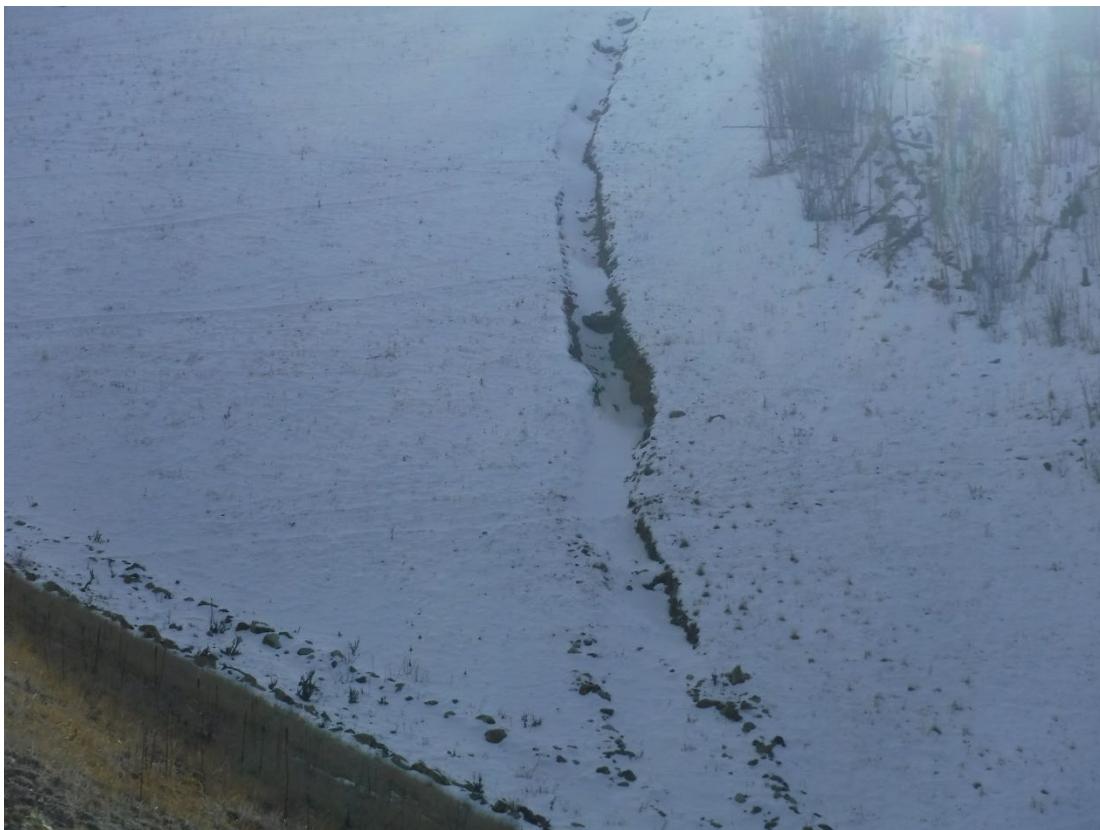
The Division did note erosion rills were occurring on the dam face. The rills appear to be occurring at locations where drainage from the road is being discharged to the dam face. At the opposite side of the dam from where the inspector was observing where over-topping flows were modeled to occur, there appears to be a deep rill. Due to snow covering the ground the Division will inspect these areas in 2026 as possible maintenance items for the Operator.

Photo 8: Deep erosion feature on the other side of the dam, zoomed in

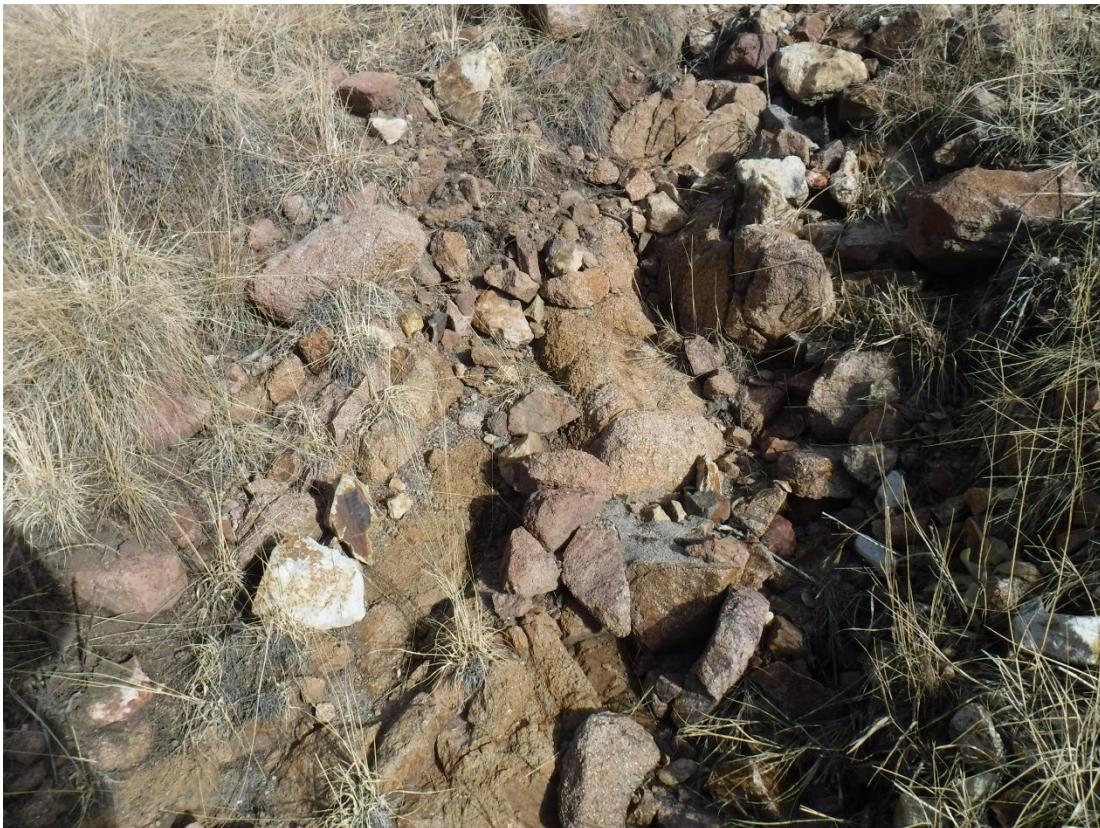
Photo 9: Thin veneer of soil over bedrock adjacent to dam material

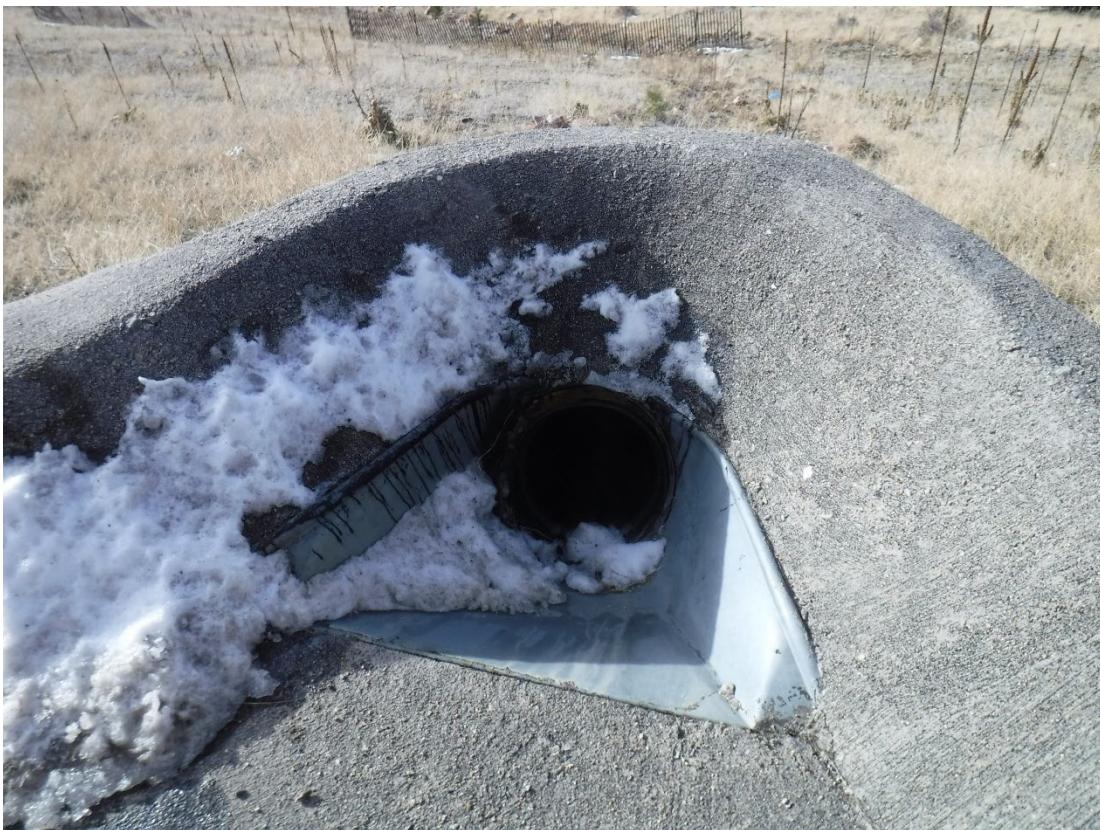
Photo 10: Road drain to dam face

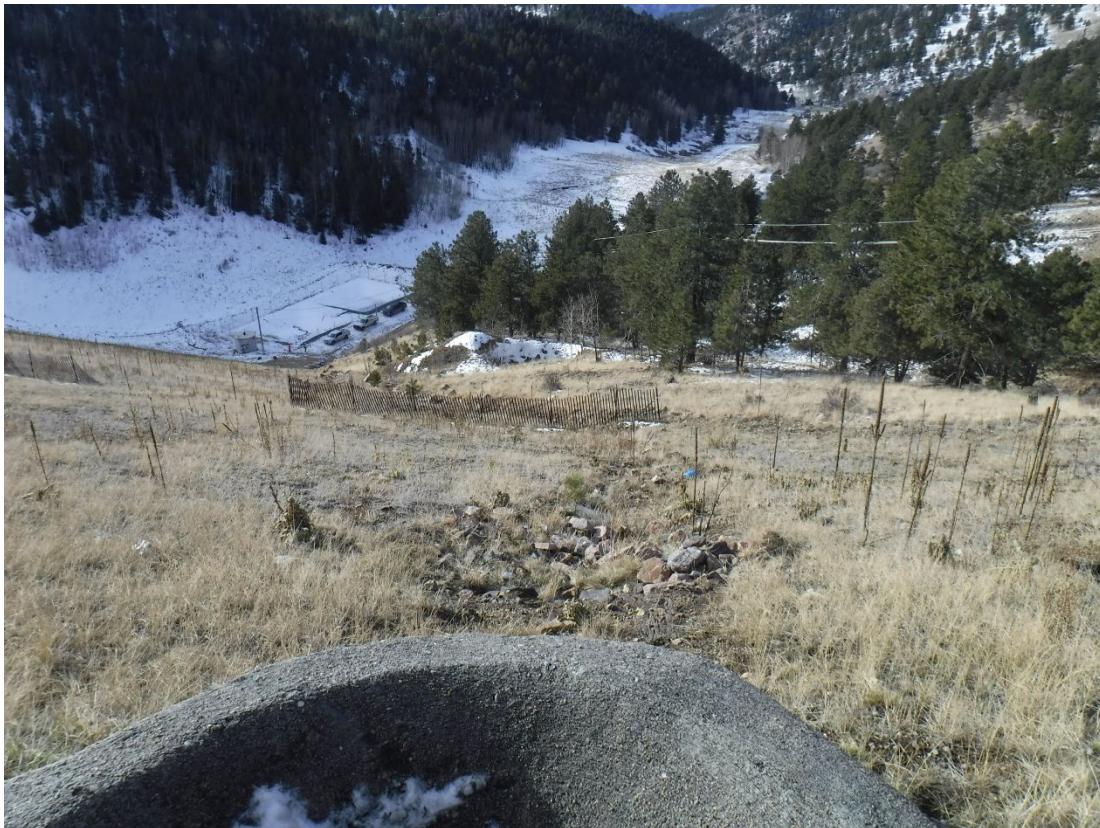
Photo 11: Looking down dam face from road drain

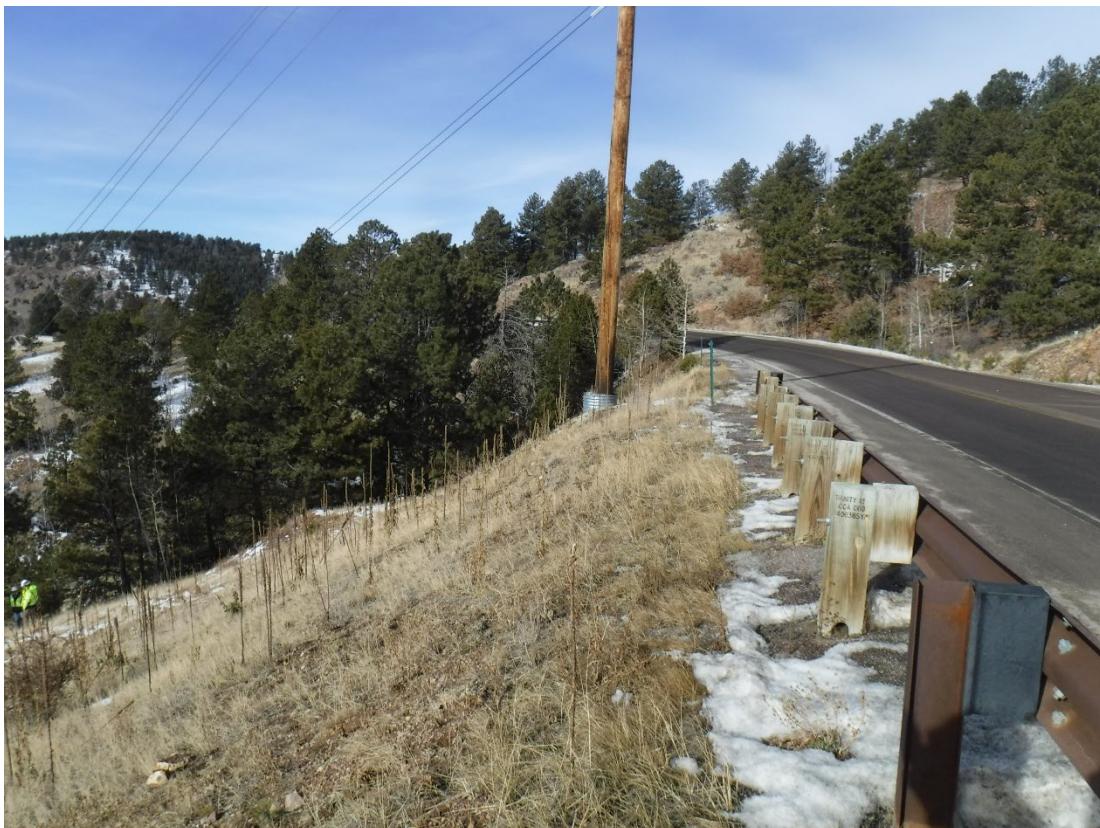
Photo 12: The area to the left of the pole is the approximate location where flow would begin to make its way to the dam face

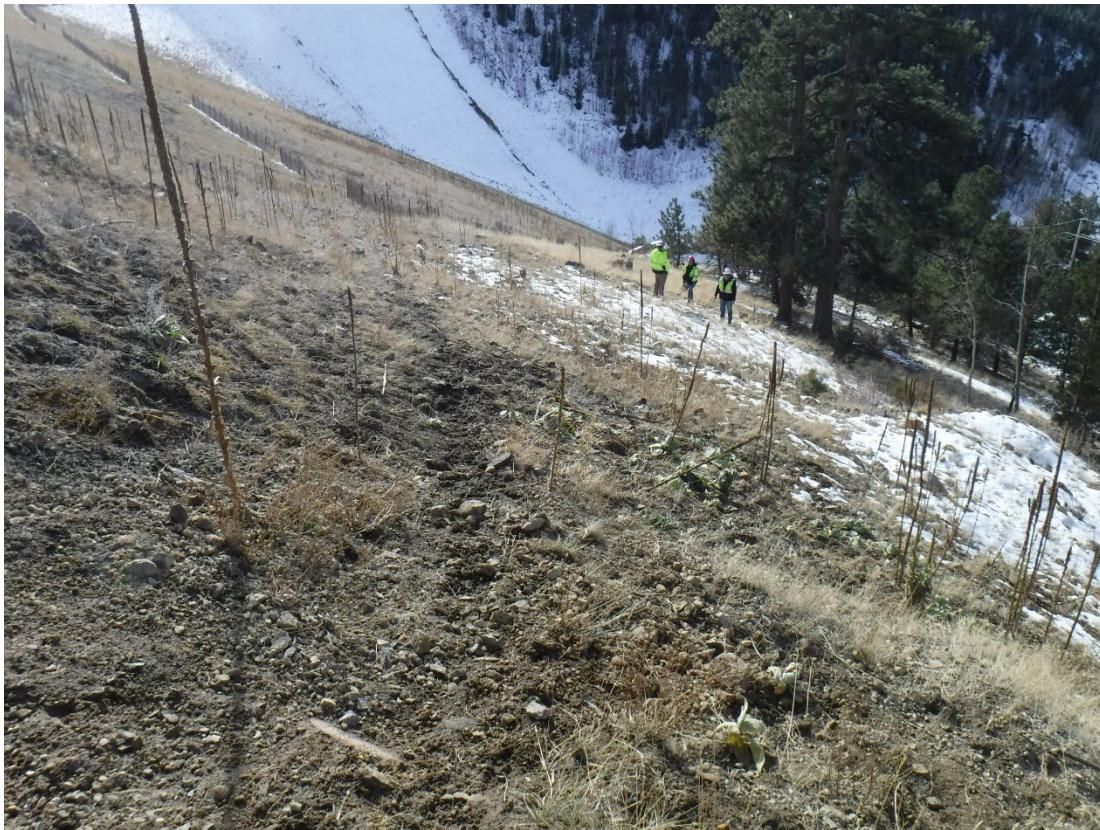
Photo 13: Looking east to where flow would begin to make its way to the dam face, power pole is just outside of photo to the left

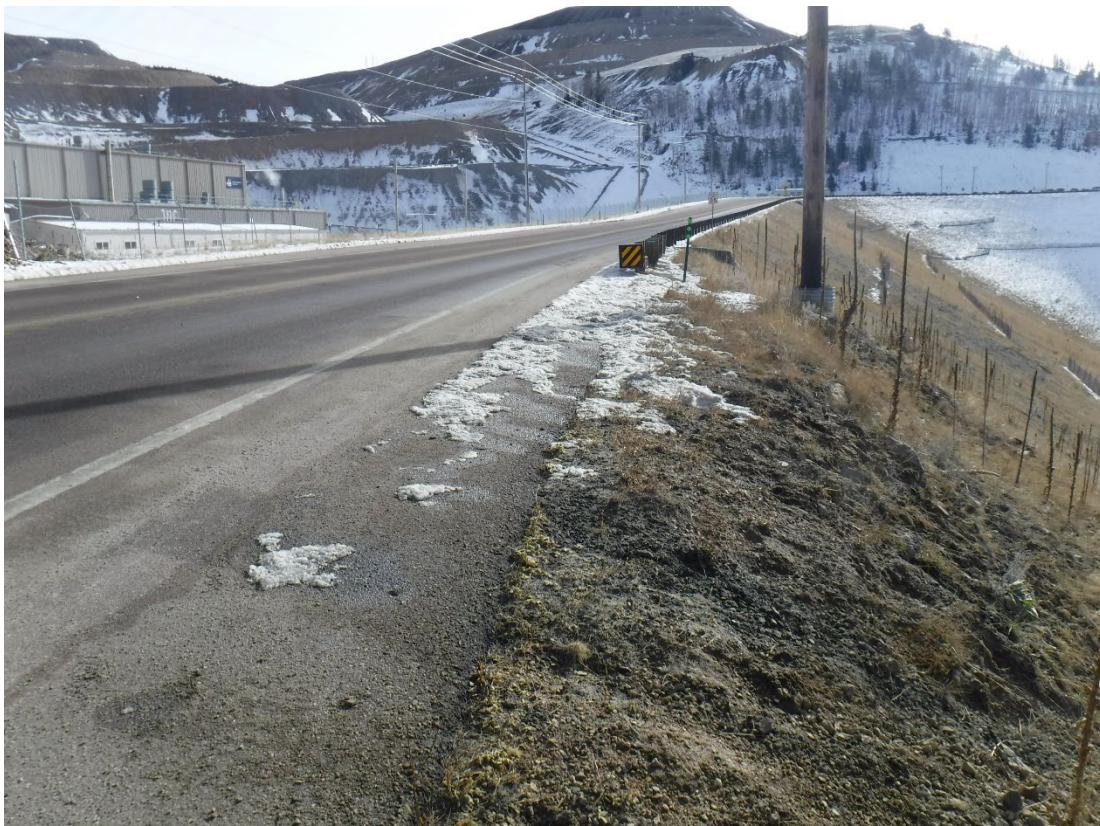
Photo 14: Looking east along roadway in the approximate location where flow would cross the road

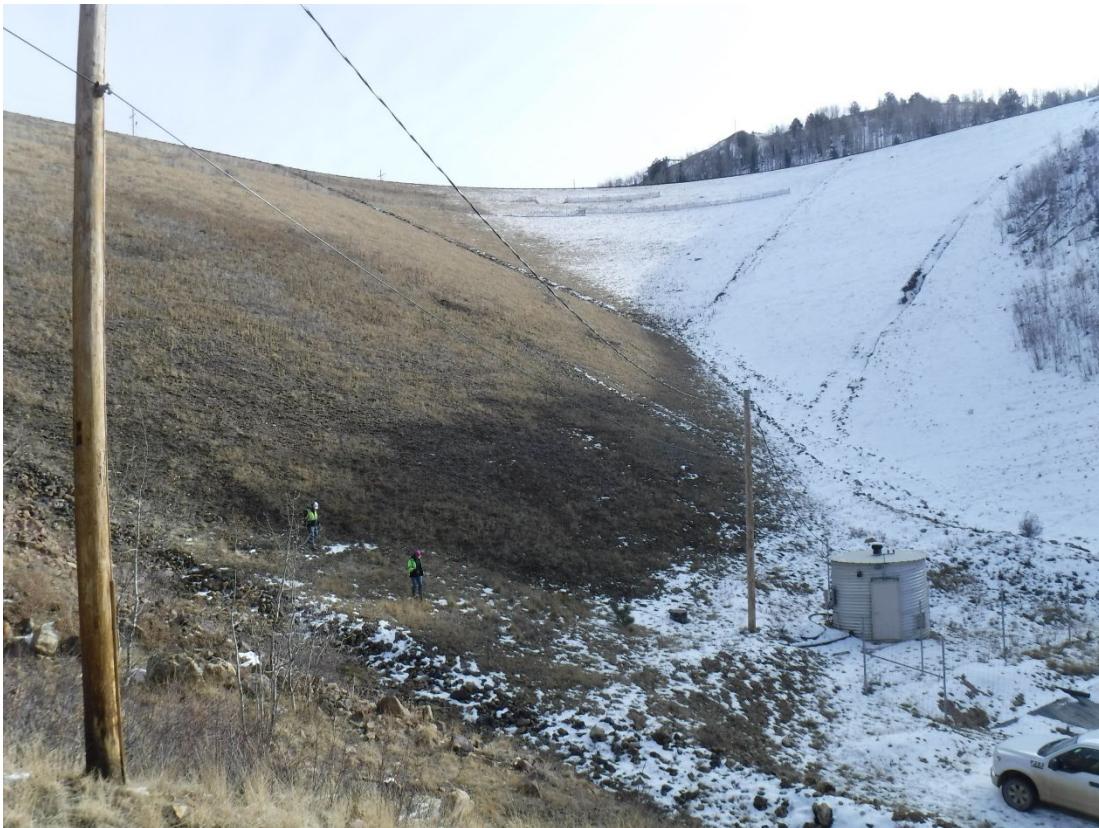
Photo 15: Overview of the dam face from near the toe

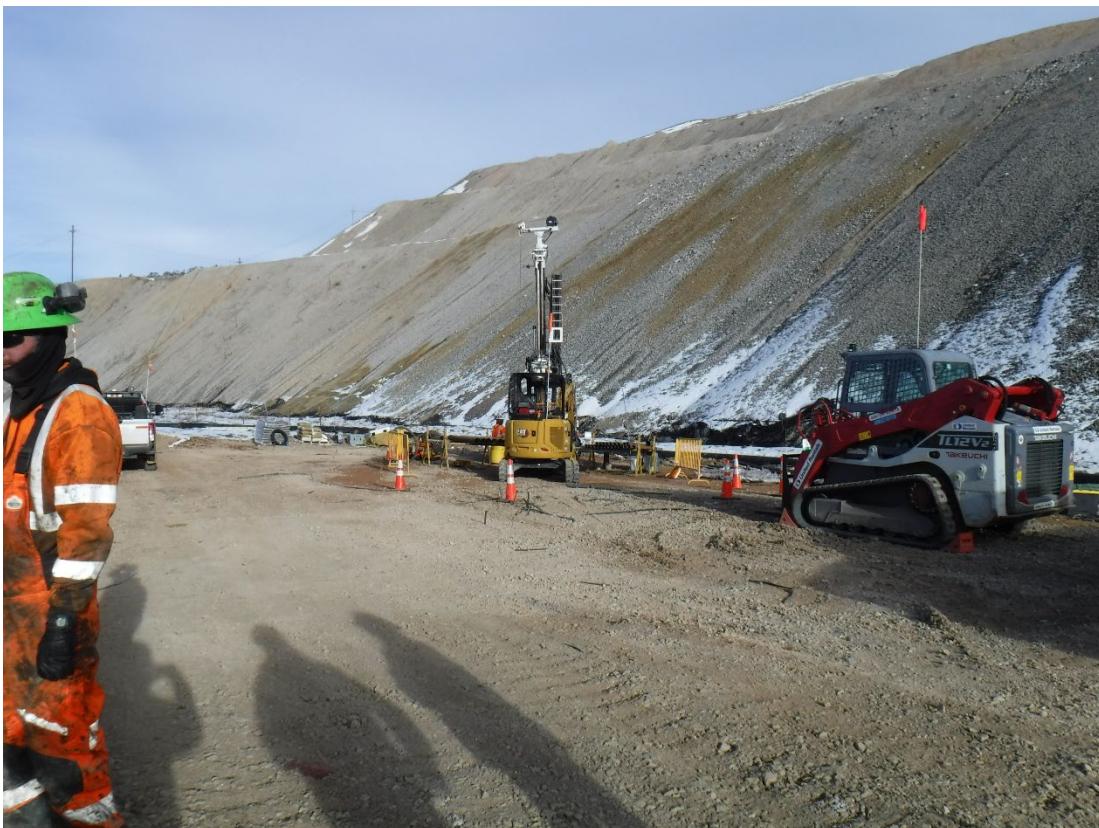
The Division observed the drilling of a vibrating wire piezometer (VWP) north of ADR2. Drilling is being accomplished using sonic drilling methods and the observed location is expected to reach a depth of 270 feet below ground surface (ft bgs). Prior to drilling at this location, another VWP was installed to a depth of 170 ft bgs. The VWPs are being installed in the PSSA, at ADR2, to help verify the capacity of the PSSA, adjust for drawdown in the correlation of VWP level and remaining pond capacity, and help establish new alert and reporting levels. Additionally, in-situ samples are being collected during drilling to evaluate physical properties of the material to provide site specific physical inputs for development of the water balance model. Also, during drilling the Operator is collecting in-situ water infiltration information, at various depths, to corroborate the data collected from the physical samples collected at that depth.

Photo 16: Sonic drilling rig at the VWP location

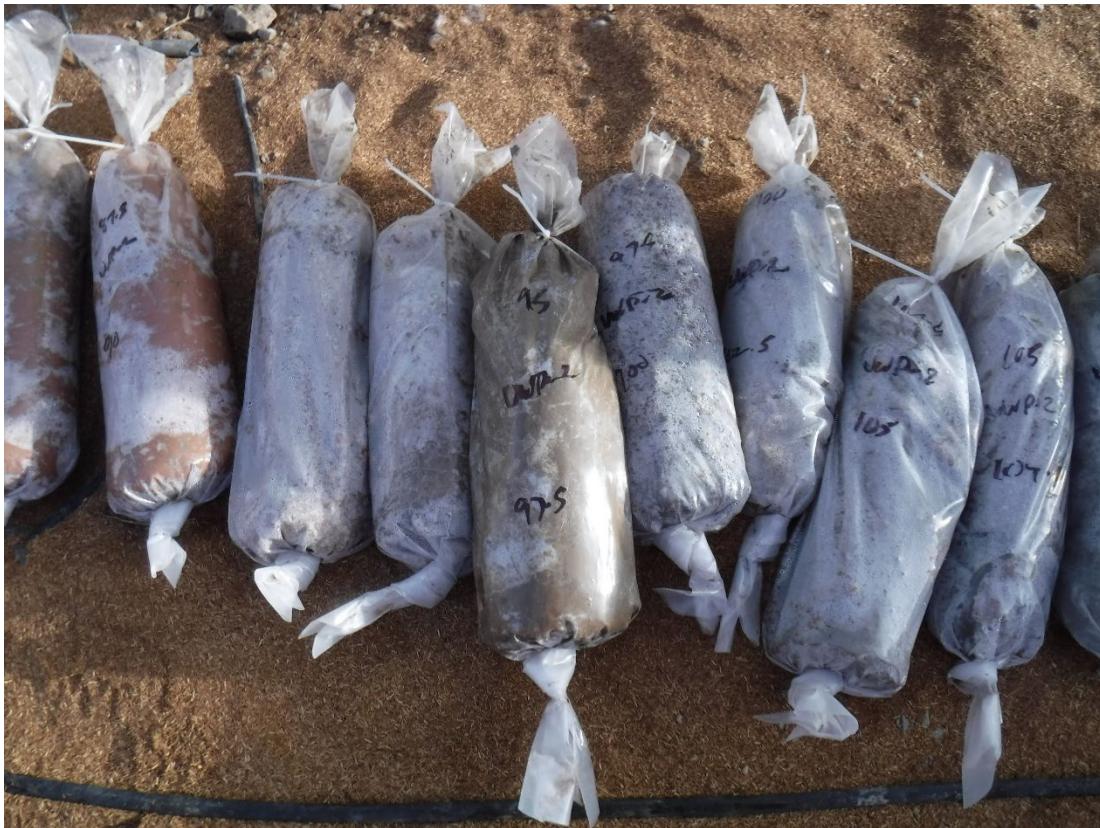
Photo 17: Typical drill rig samples

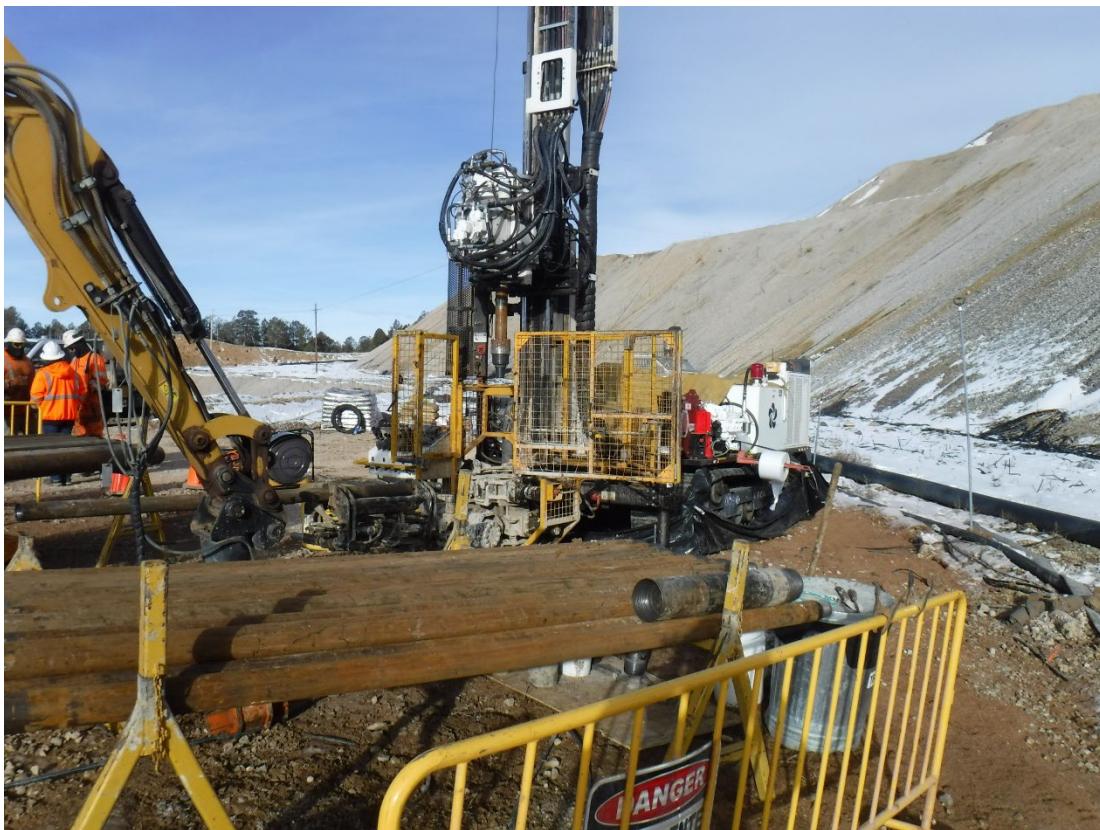
Photo 18: Drill rig set-up

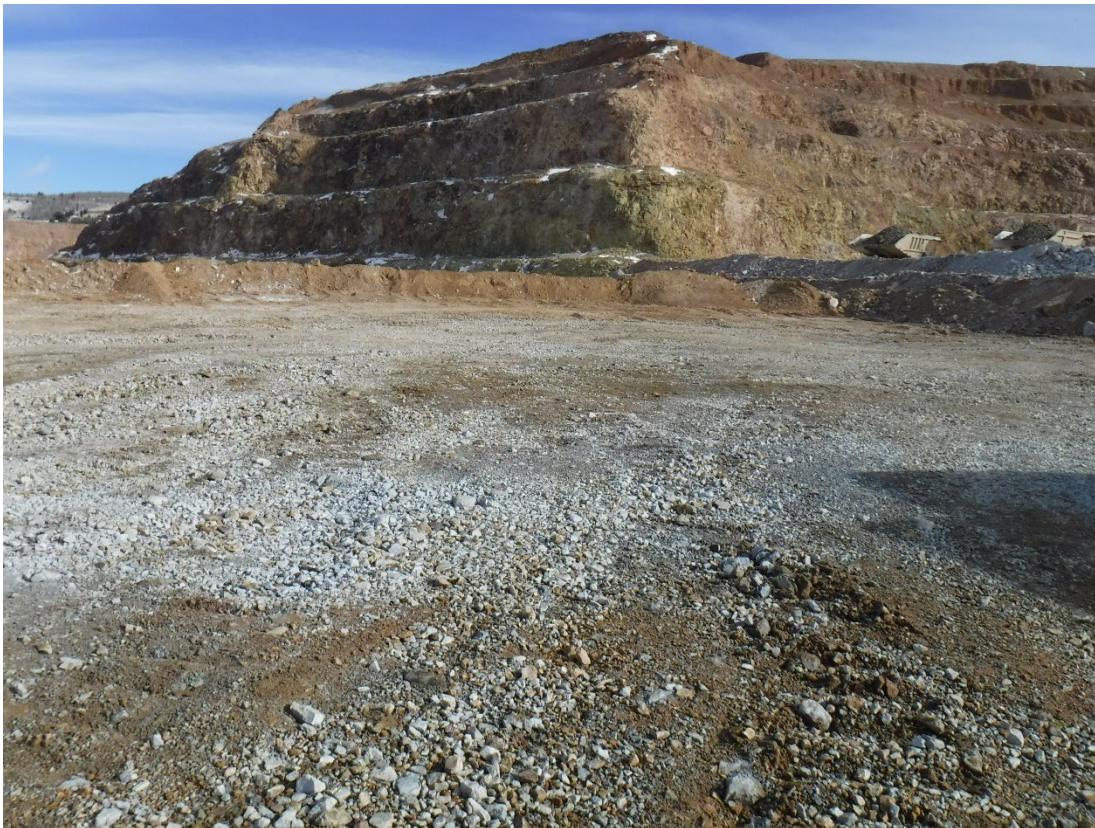
The Schist Island Backfill area was observed from ground level. However, as the inspector arrived, hauling activities were stopping for the holiday party and no material was being placed. The Operator was placing material in two locations, the high compaction area forming the "rind" face and an area of low compaction towards the center of the fill area. The low compaction area can have material placed in 10-foot lifts and material placed needs to meet the specification of 5 feet or less in two out of 3 dimensions. The high compaction area material specification is 2 feet or less in two out of 3 dimensions. The Operator will be transitioning to just placing high compaction material to avoid confusion with placement crew and to better manage the unpredictable nature of the material being generated for backfill.

Photo 19: Schist Island backfill, high compaction "rind" foreground and low compaction material near haul trucks

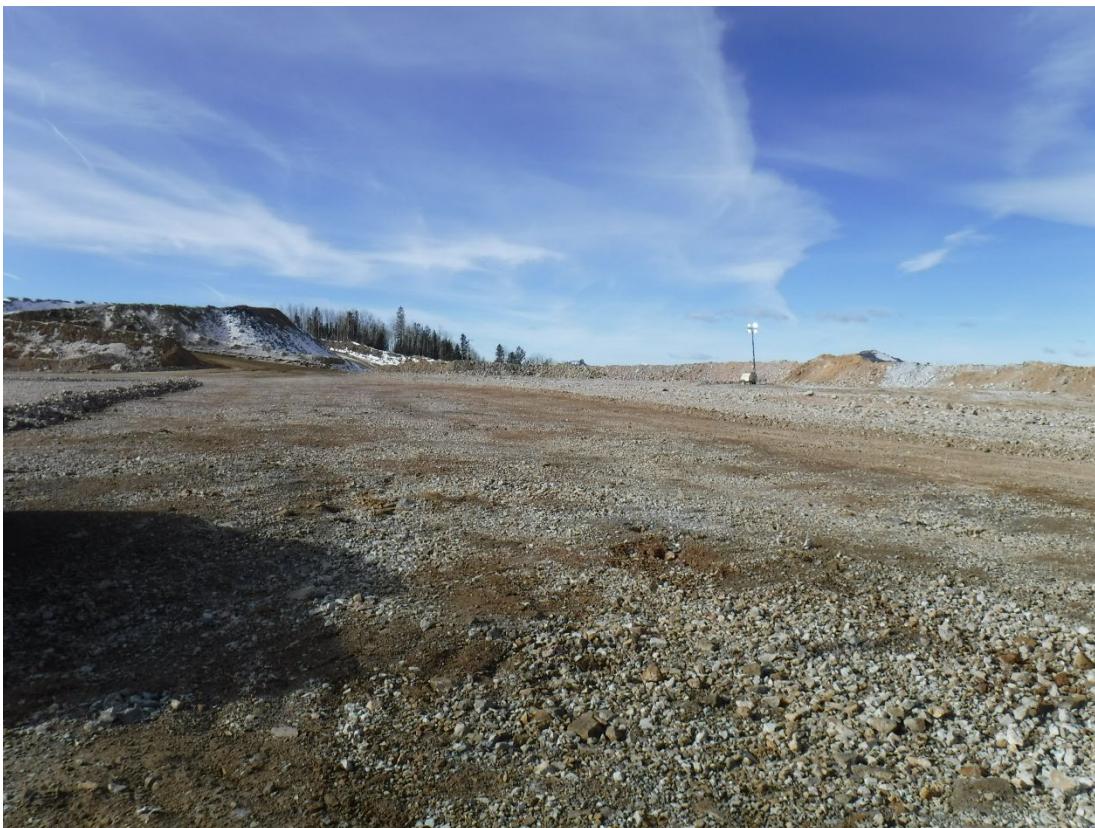
Photo 20: Schist Island backfill, high compaction "rind" looking west

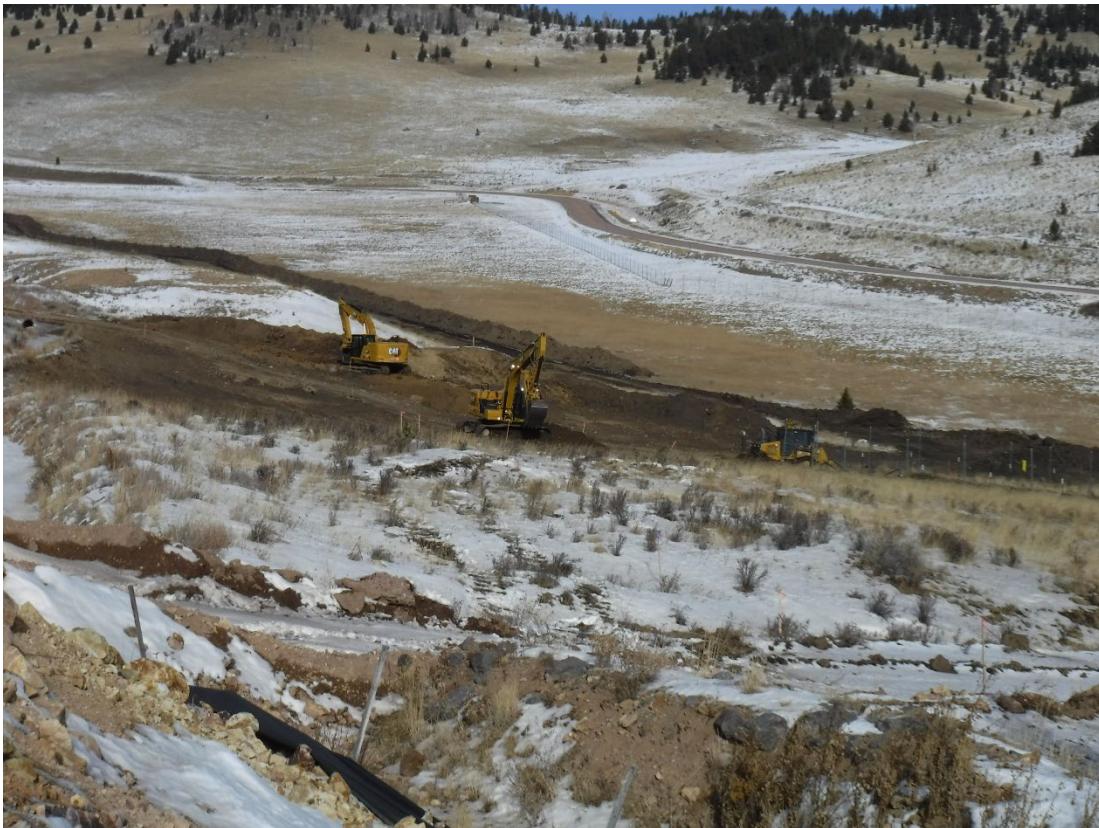
In addition, the Operator had equipment that was beginning to clear, grub, and grade the area where the pump-back system storage vessels are going be located.

Photo 21: Grassy Valley pump-back construction near GVMW-28

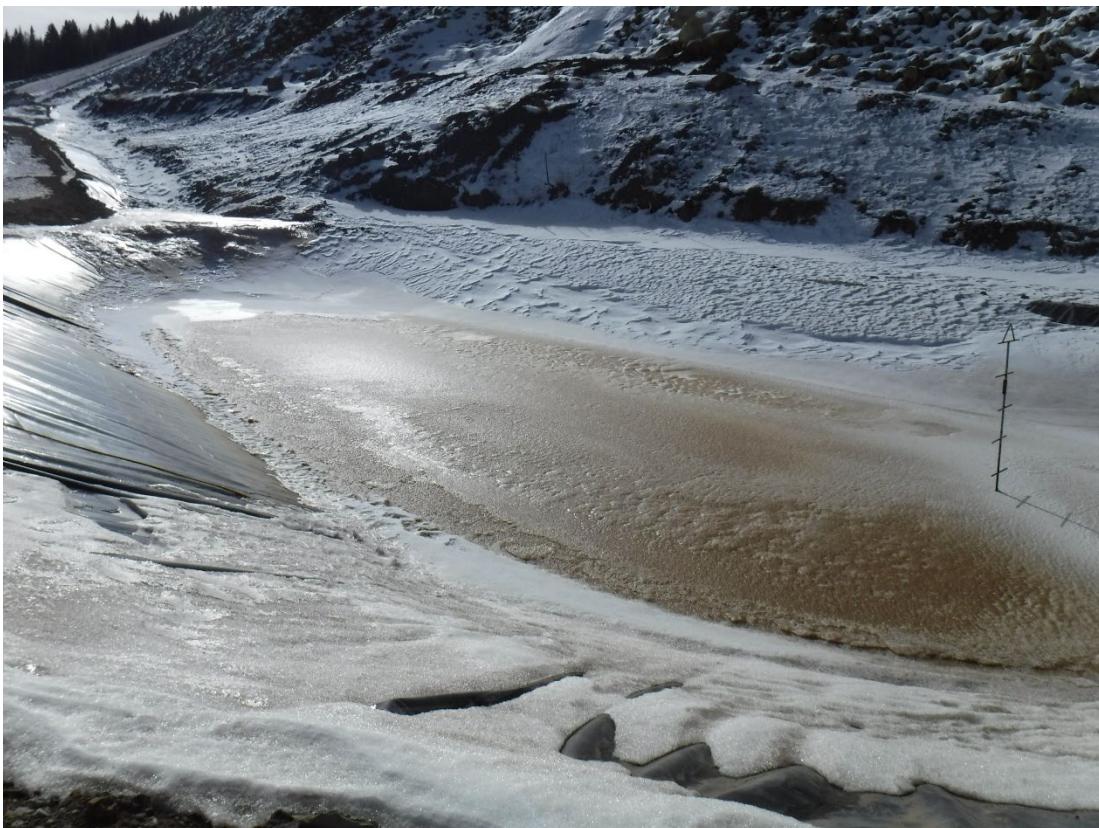
Photo 22: Seep 1 collection pond
