MINERALS PROGRAM INSPECTION REPORT
PHONE: (303) 866-3567

MINE NAME: Cresson Project	MINE/PROSPECTING ID#: M-1980-244	MINERAL: Gold and silver	COUNTY: Teller
INSPECTION TYPE: Monitoring	WEATHER: Clear	INSP. DATE: December 10, 2025	INSP. TIME: 08:00
OPERATOR: Cripple Creek & Victor Gold Mining Company	OPERATOR REPRESENTATIVE: Jorge Ricaurte, Brian Doering, P. Barrella	TYPE OF OPERATION: 112d-3 - Designated Mining Operation	
REASON FOR INSPECTION: Normal I&E Program	BOND CALCULATION TYPE: None	BOND AMOUNT: \$333,471,401.00	
DATE OF COMPLAINT: NA	POST INSP. CONTACTS: None	JOINT INSP. AGENCY: None	
INSPECTOR(S): Patrick Lennberg	INSPECTOR'S SIGNATURE: 	SIGNATURE DATE: December 19, 2025

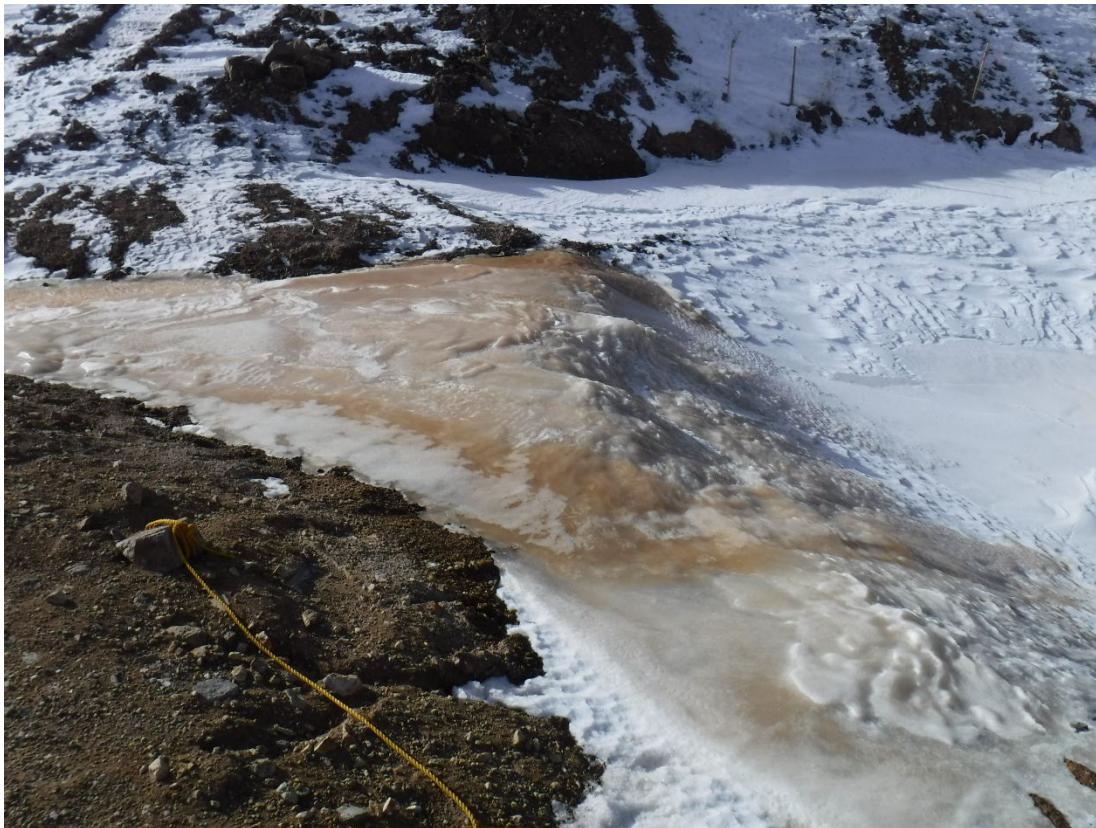
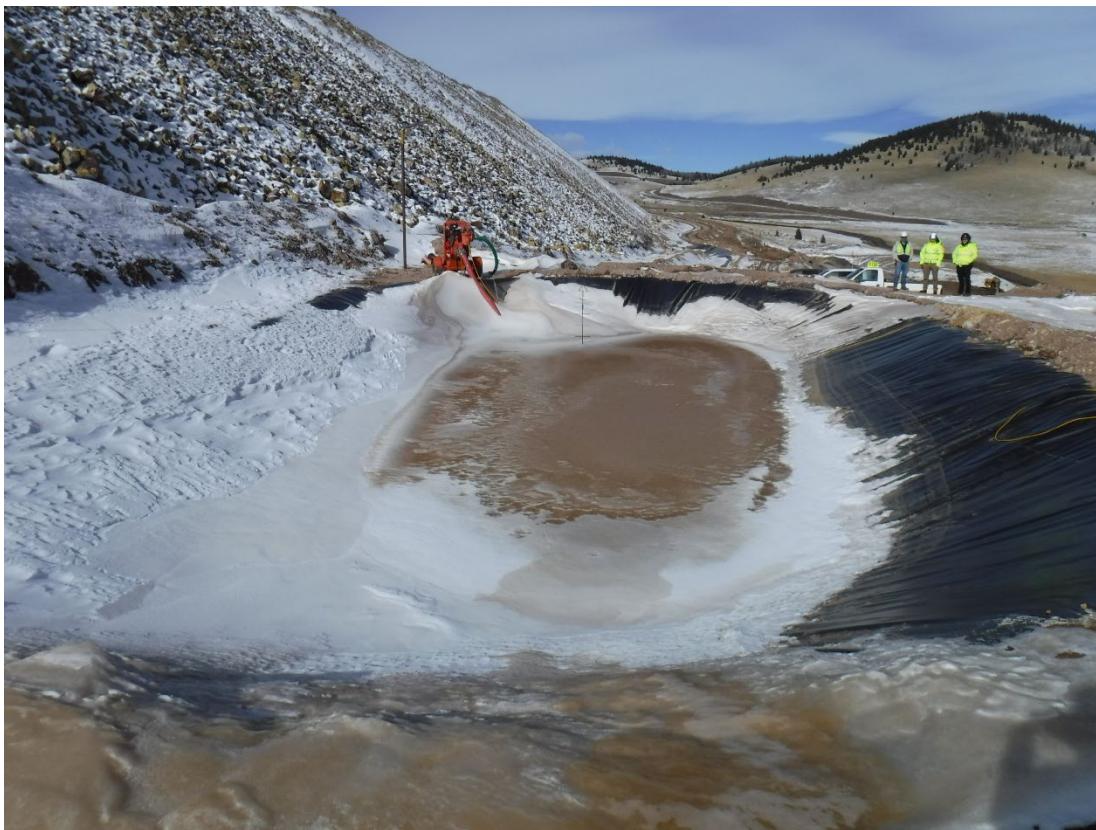
Photo 23: Inflow to the Seep 1 collection pond

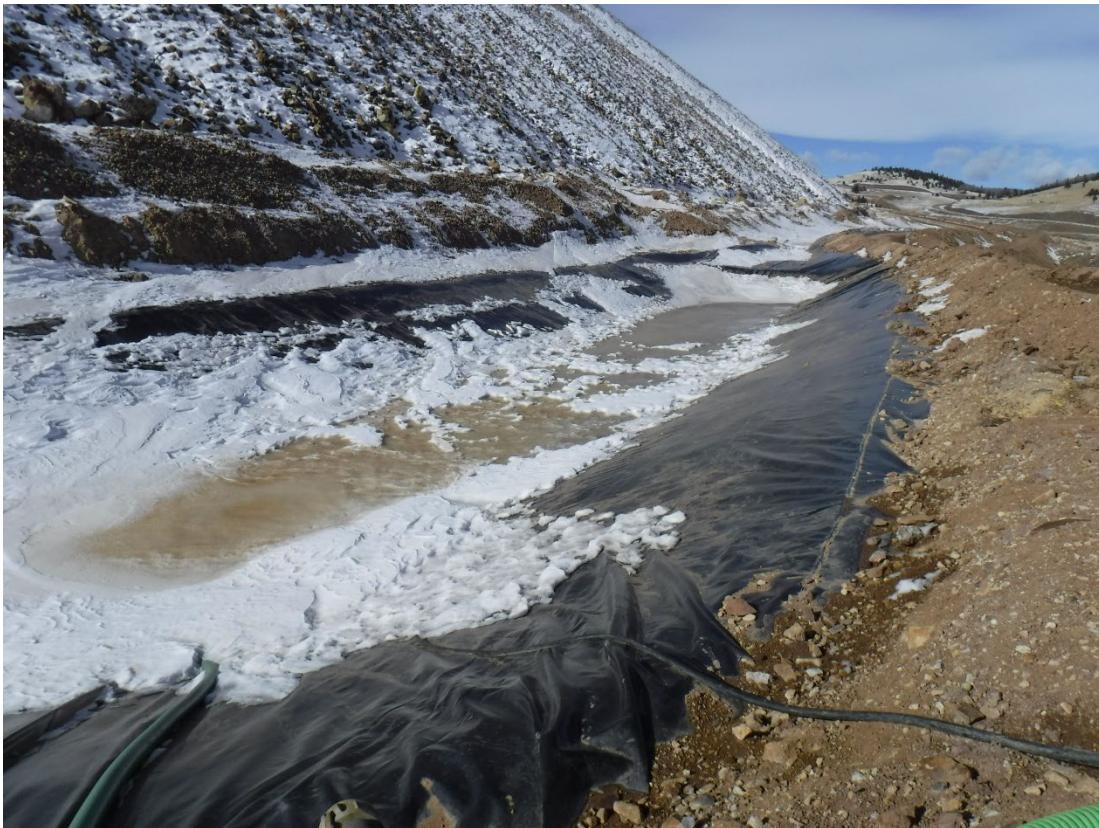
Photo 25: Seep 3/4 collection pond

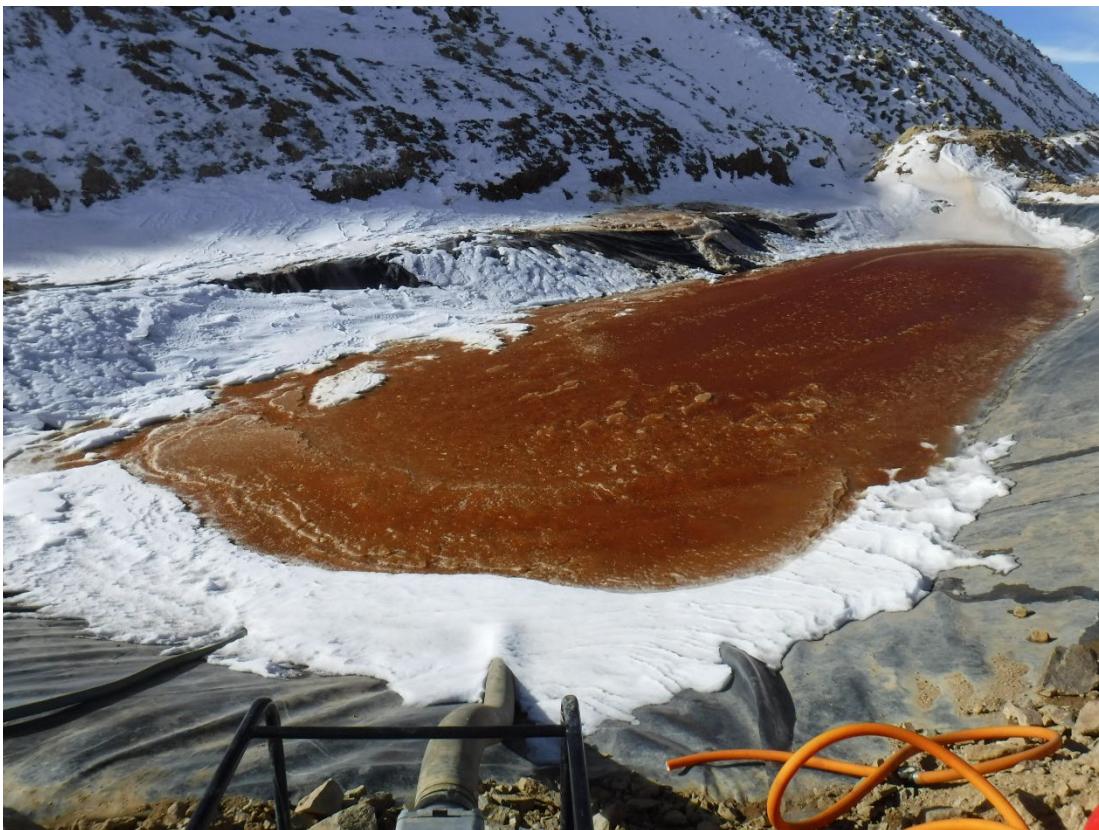
Photo 26: Seep 2 collection pond

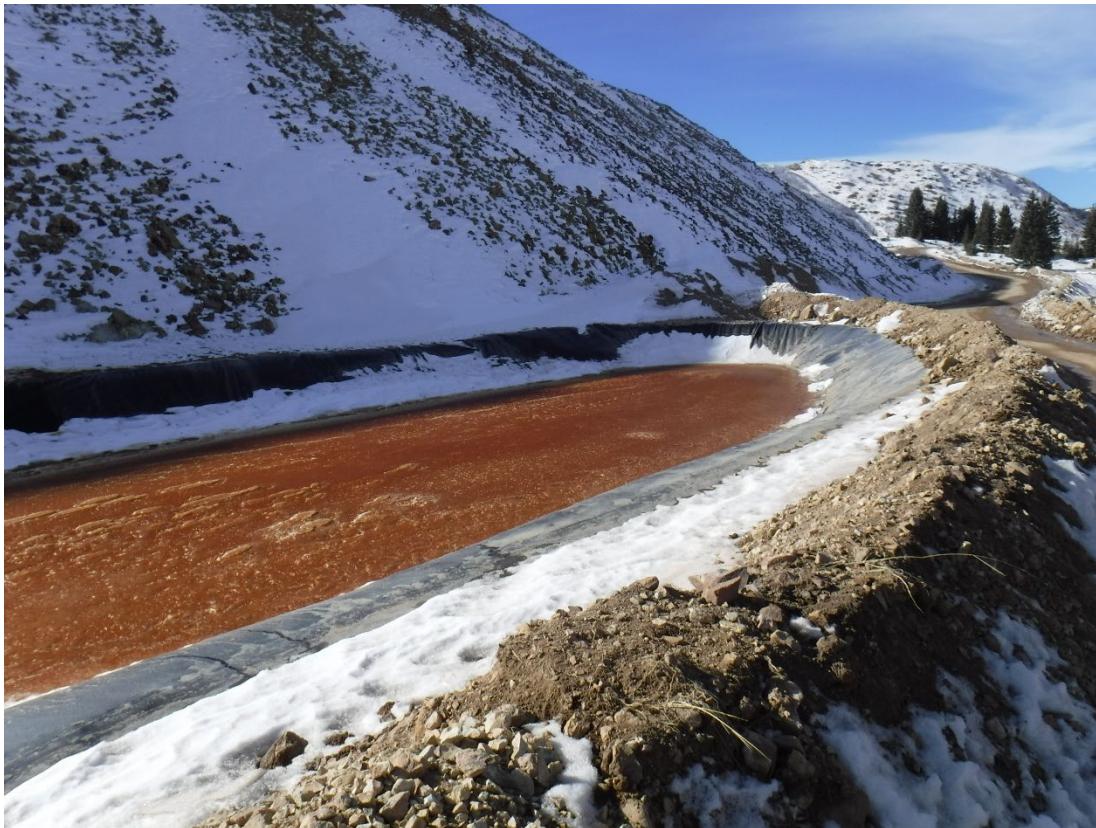
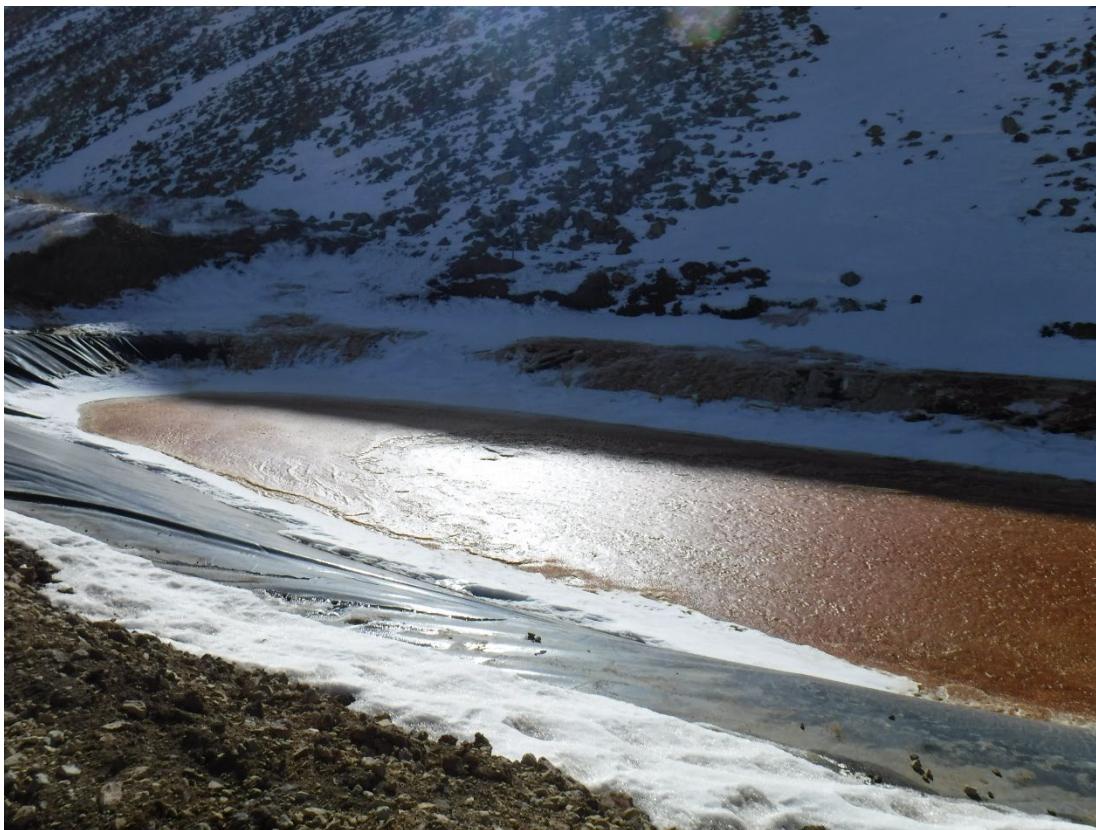
Photo 27: Seep 5 collection pond
