MINERALS PROGRAM INSPECTION REPORT
PHONE: (303) 866-3567

MINE NAME: Ragsdale Reservoirs	MINE/PROSPECTING ID#: M-2020-007	MINERAL: Gravel, borrow material for construction, overburden and sand	COUNTY: Weld
INSPECTION TYPE: Surety Release Inspection	WEATHER: Windy	INSP. DATE: December 9, 2025	INSP. TIME: 11:00
OPERATOR: L. G. Everist, Incorporated	OPERATOR REPRESENTATIVE: Lynn Mayer Shults	TYPE OF OPERATION: 112c - Construction Regular Operation	
REASON FOR INSPECTION: Surety Release Requested (SR-1)	BOND CALCULATION TYPE: Complete Bond	BOND AMOUNT: \$3,535,000.00	
DATE OF COMPLAINT: NA	POST INSP. CONTACTS: None	JOINT INSP. AGENCY: None	
INSPECTOR(S): Ursula Armstrong	INSPECTOR'S SIGNATURE:

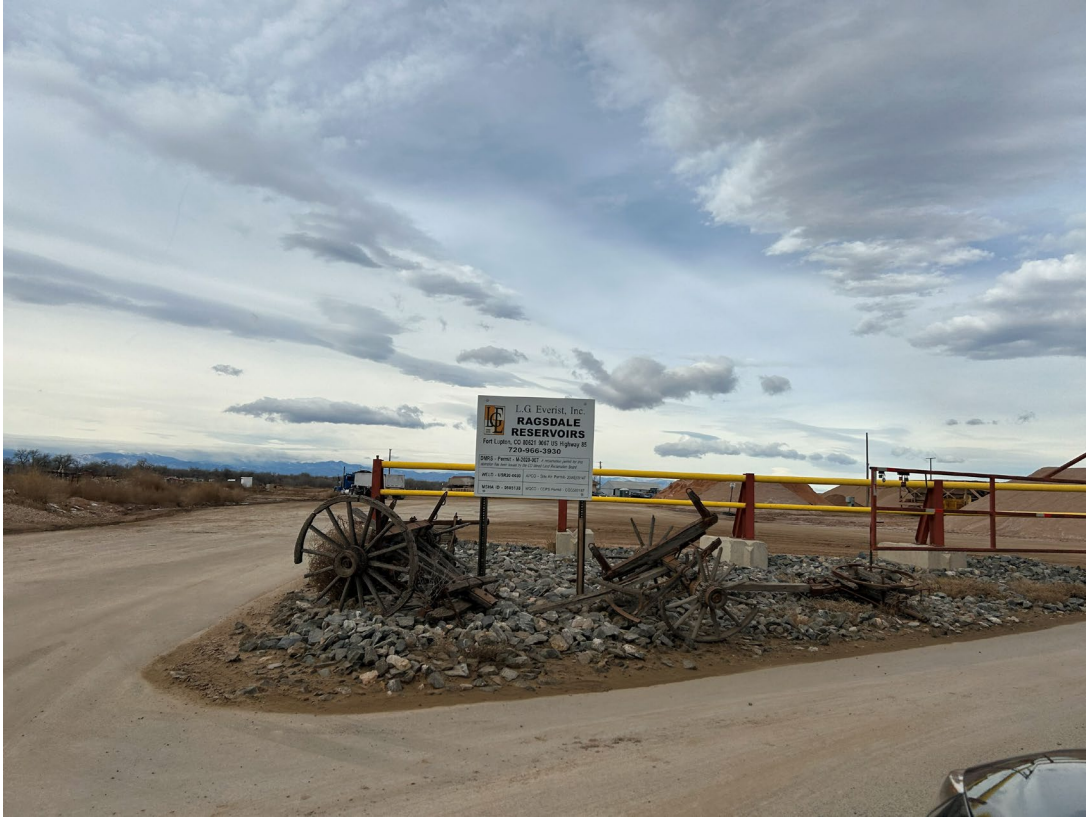
Photo 1. Mine identification sign posted at entrance.

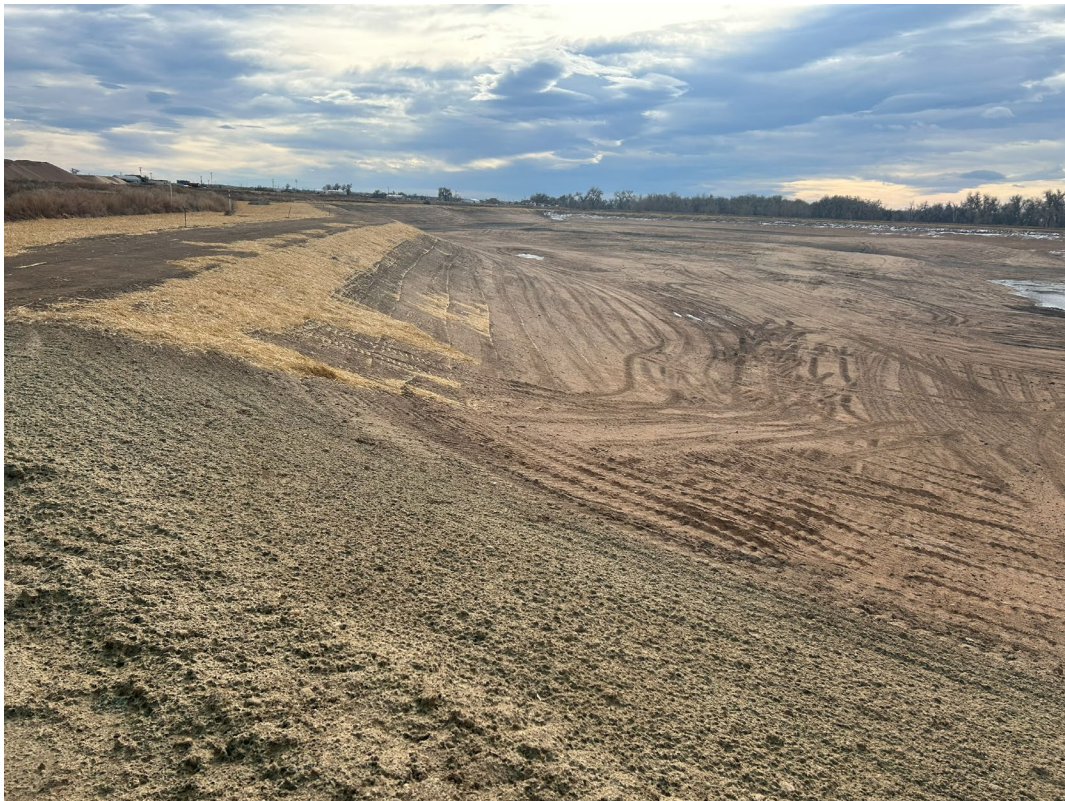
Photo 2. Standing at the northeast corner of the Phase 1 area, looking south.

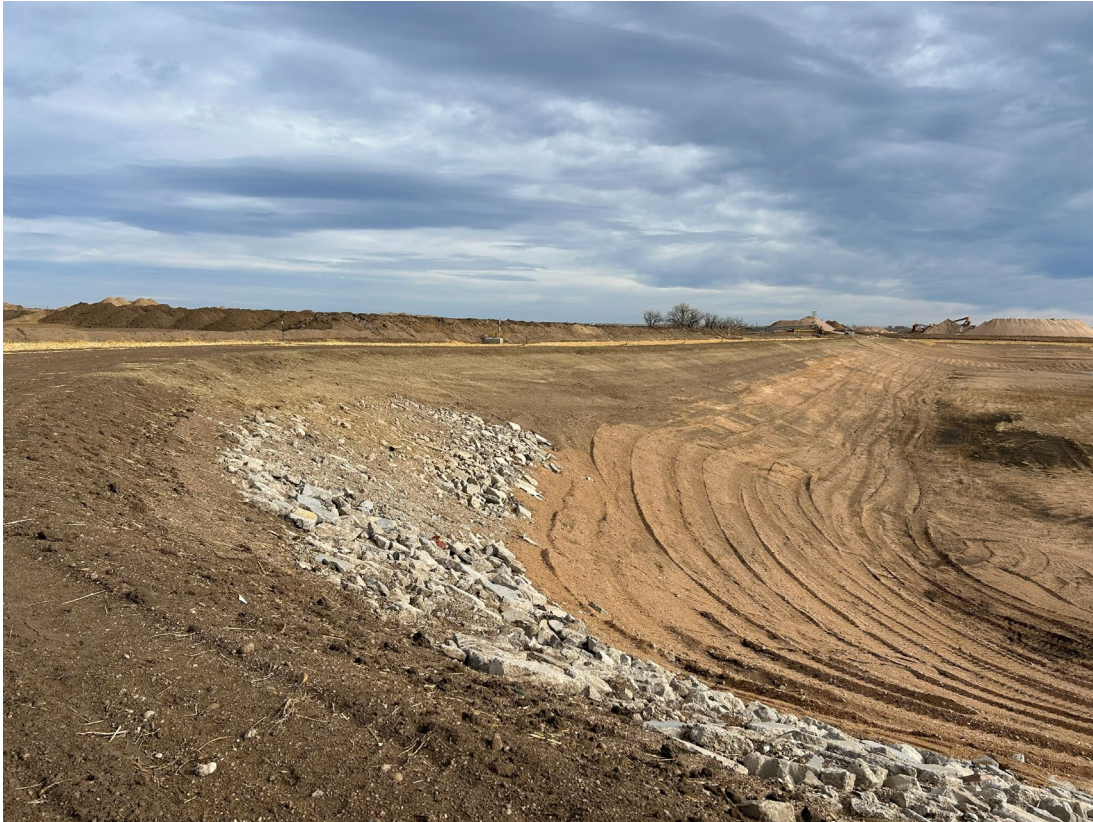
Photo 3. Standing at the northwest corner of the Phase 1 area, looking northeast. The bank armoring is in the foreground.

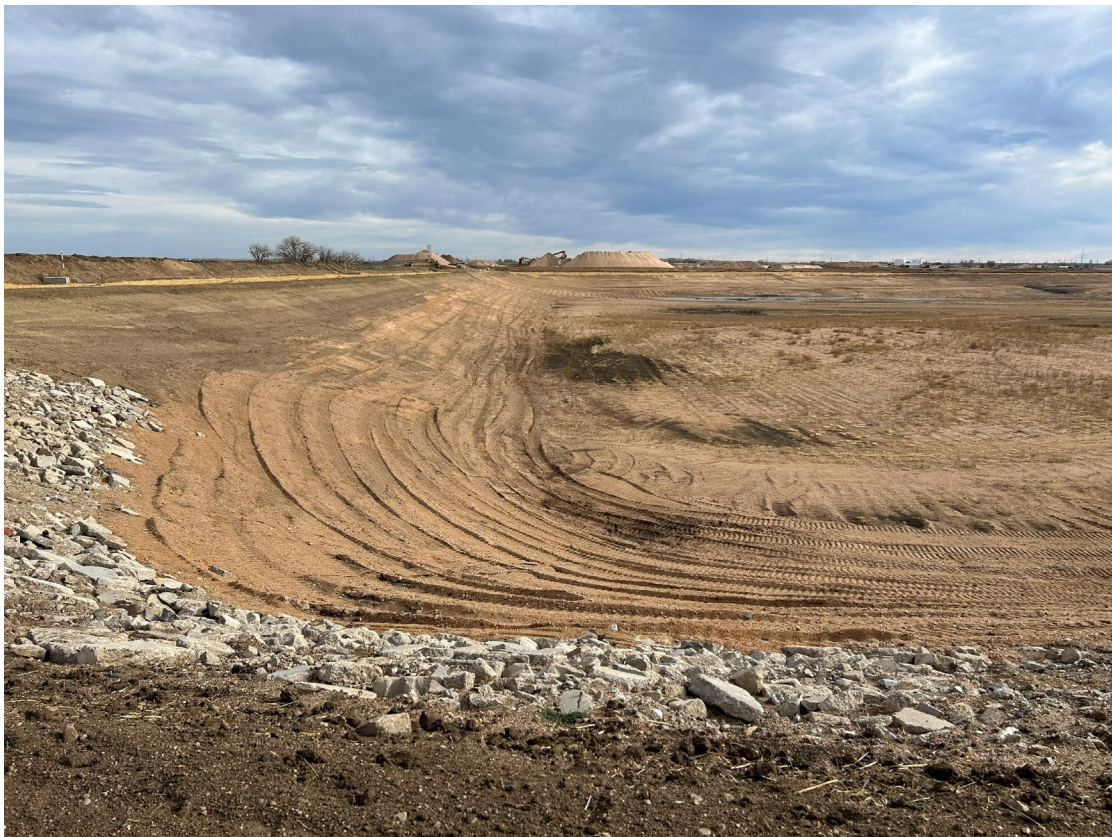
Photo 4. Standing at the northwest corner of the Phase 1 area, looking east. The bank armoring is in the foreground.

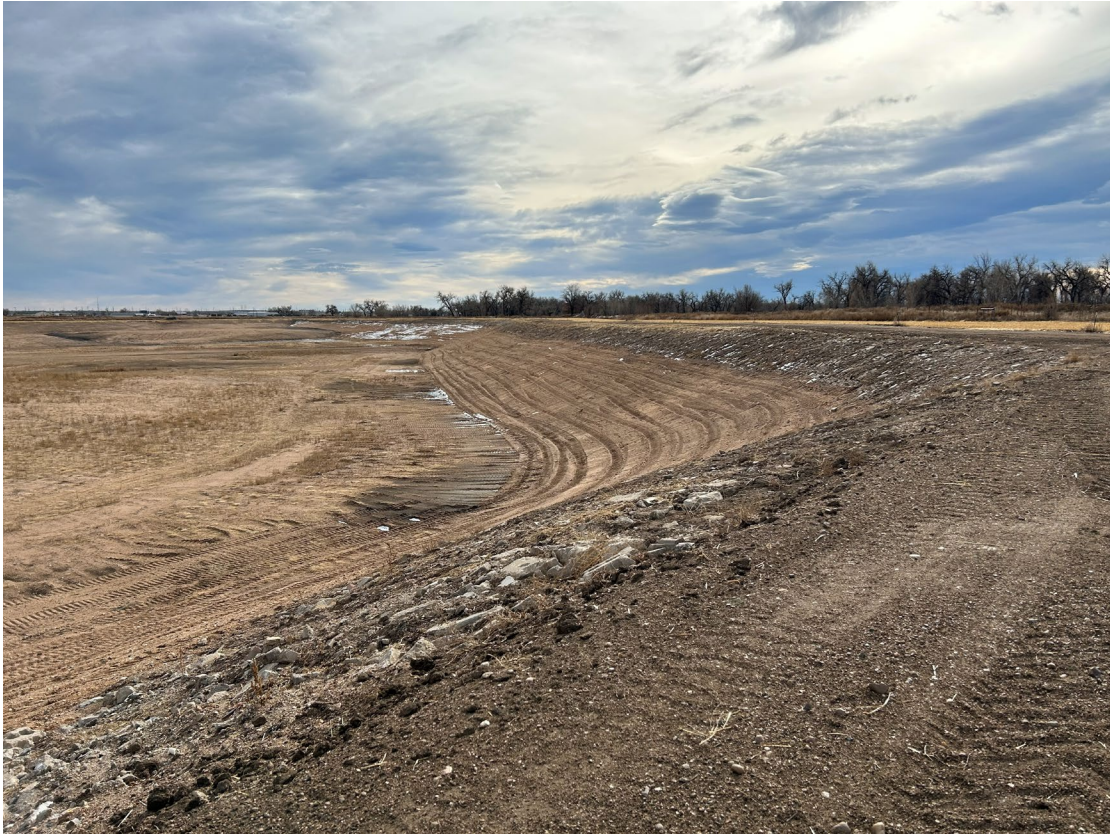
Photo 5. Standing at the northwest corner of the Phase 1 area, looking south.

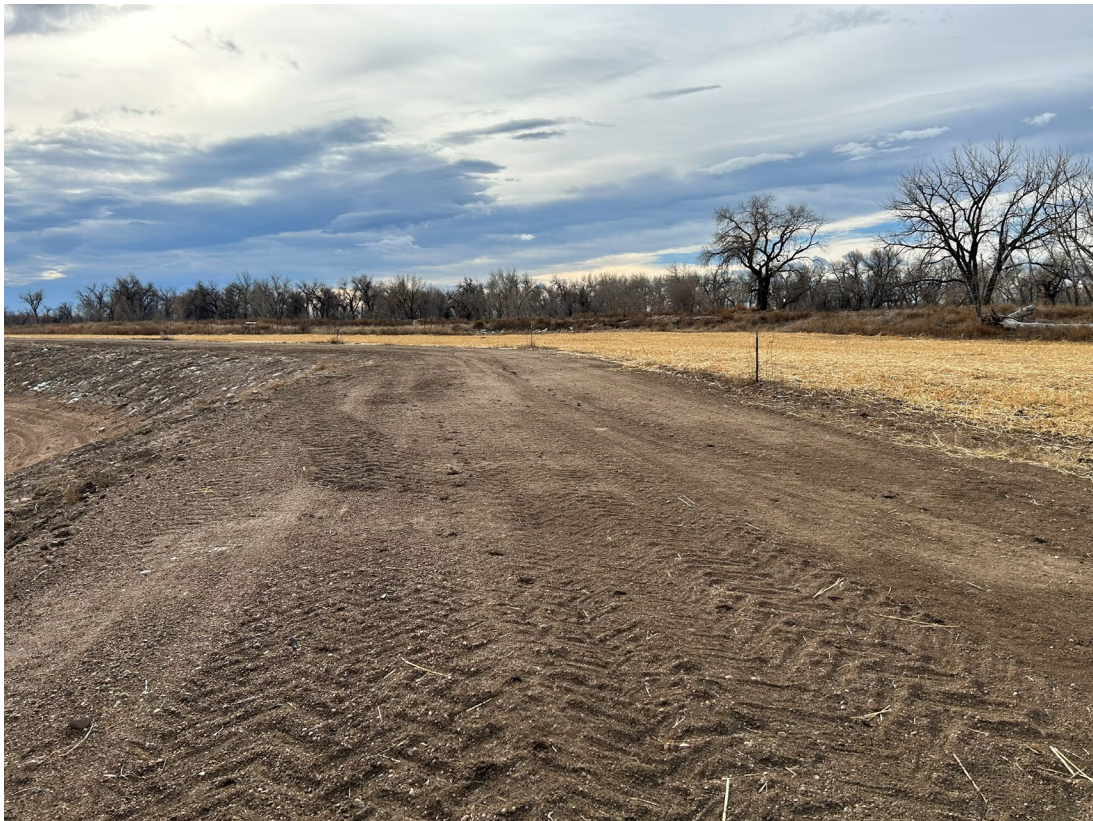
Photo 6. Standing at the northwest corner of the Phase 1 area, looking southeast at the road.

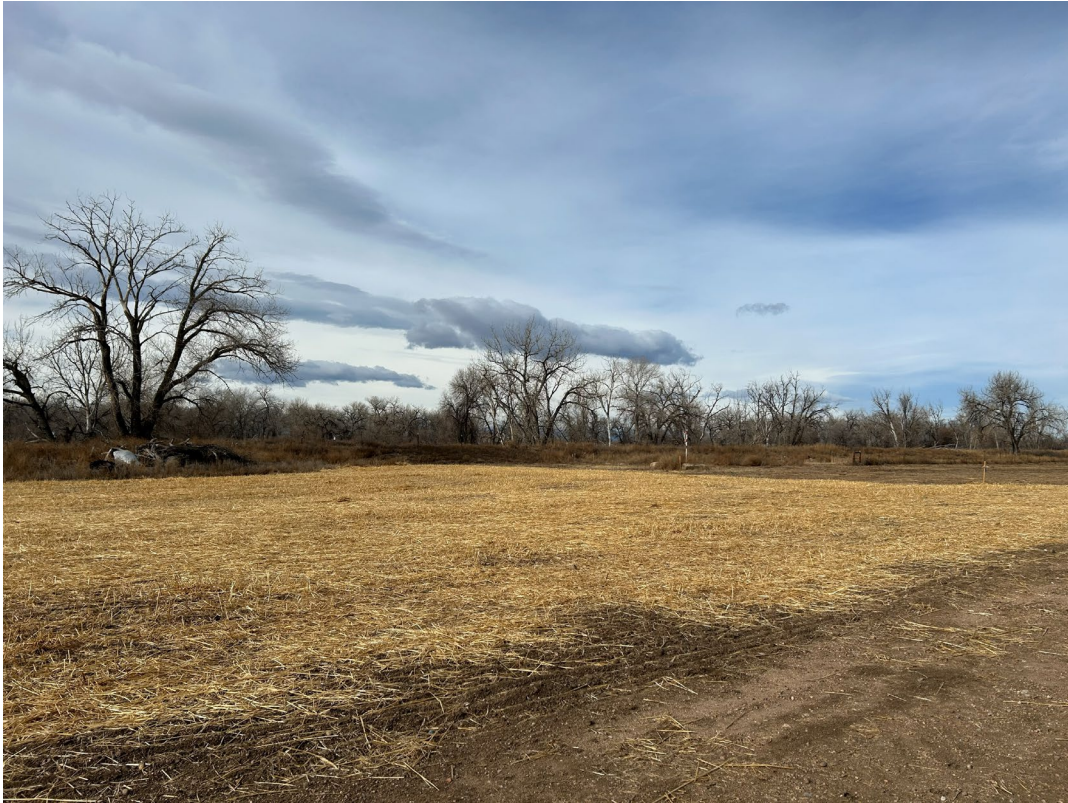
Photo 7. Standing at the northwest corner of the Phase 1 area, looking northwest.

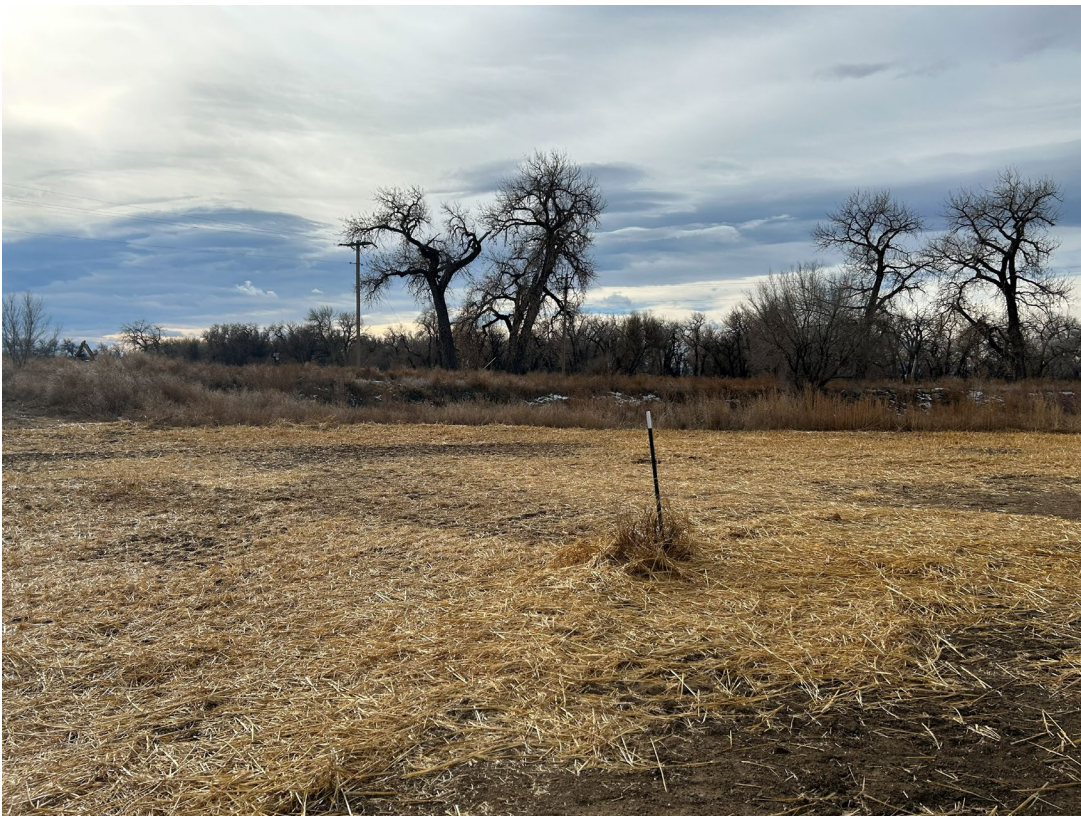
Photo 8. Standing on the road, looking west. The T-post marks the slurry wall.

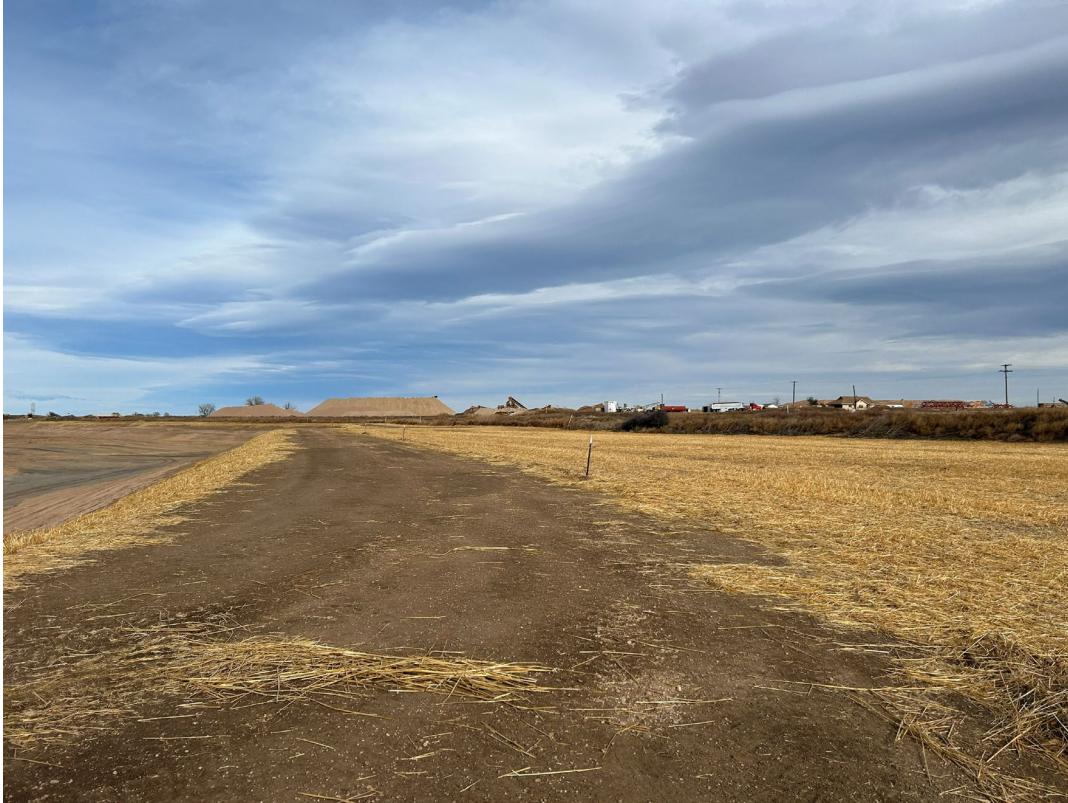
Photo 9. Standing at the southern tip of the Phase 1 area, looking north.

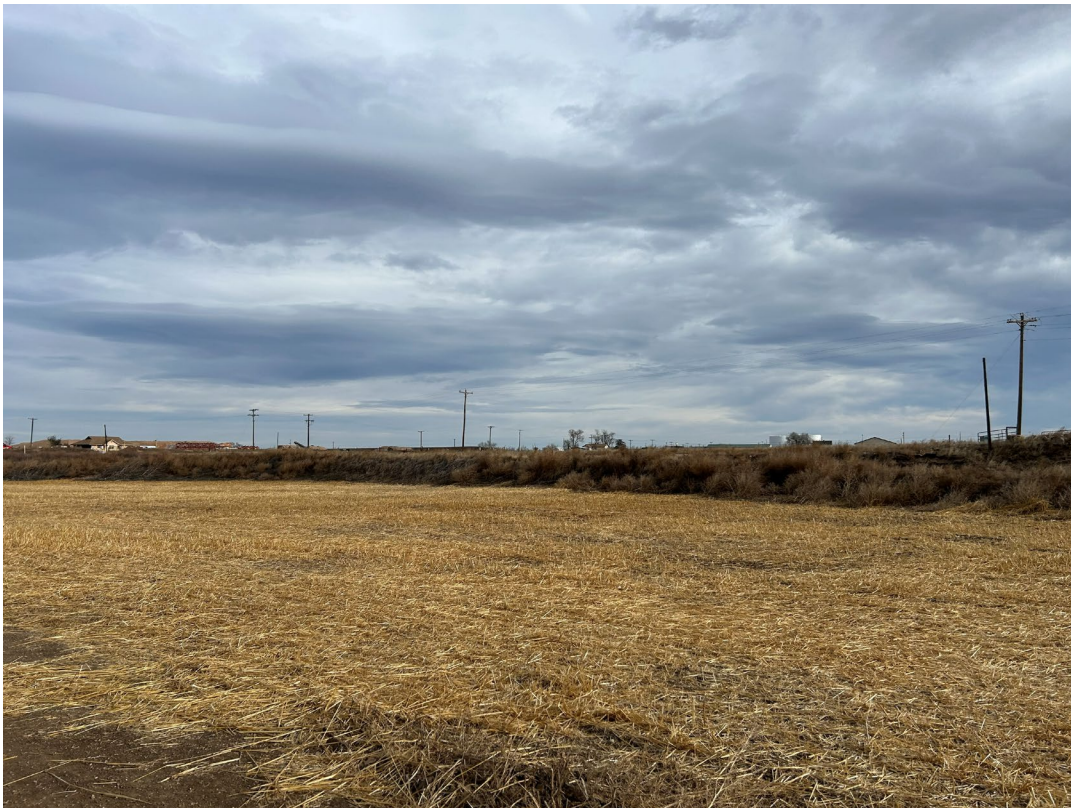
Photo 10. Standing at the southern tip of the Phase 1 area, looking east.

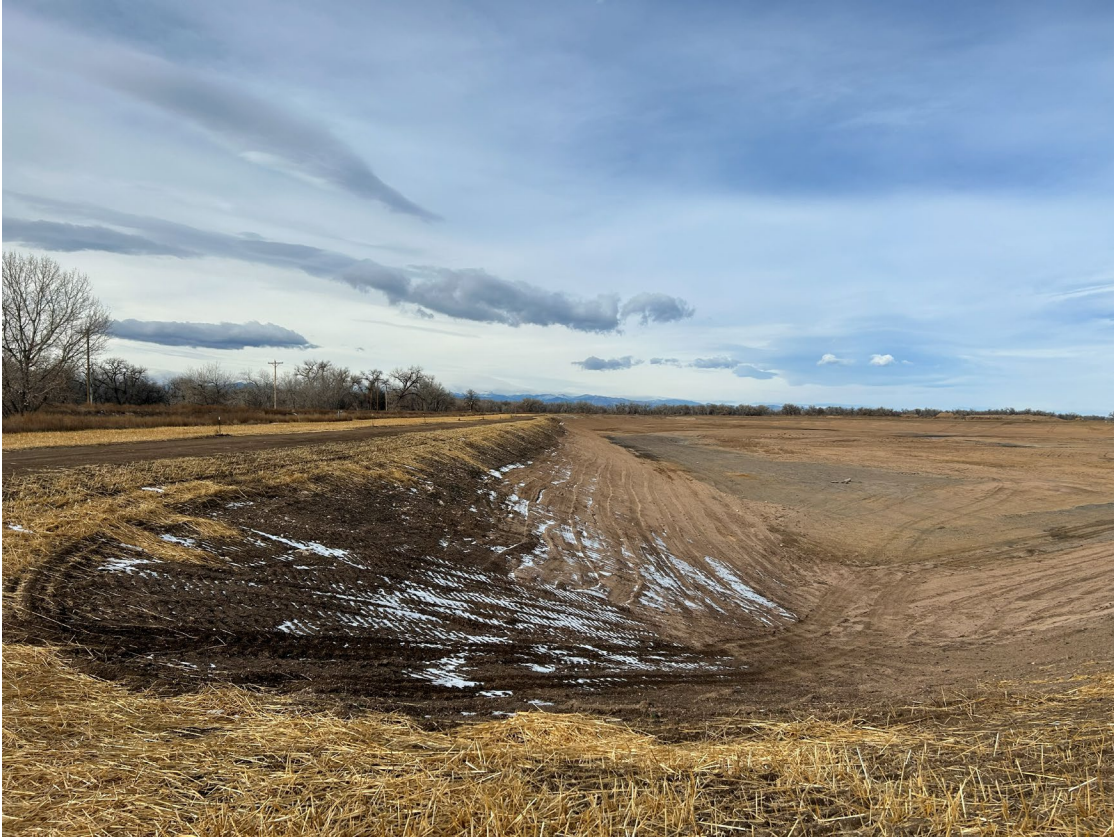
Photo 11. Standing at the southern tip of the Phase 1 area, looking northwest.

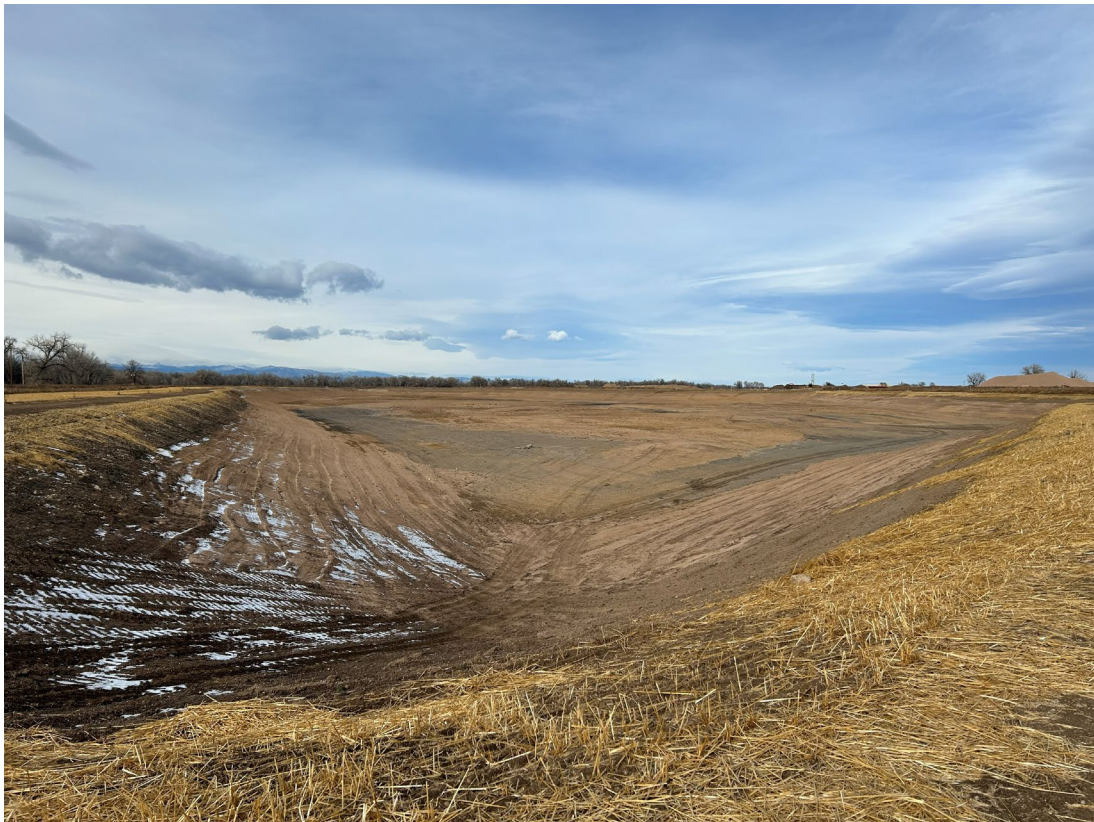
Photo 12. Standing at the southern tip of the Phase 1 area, looking northwest.

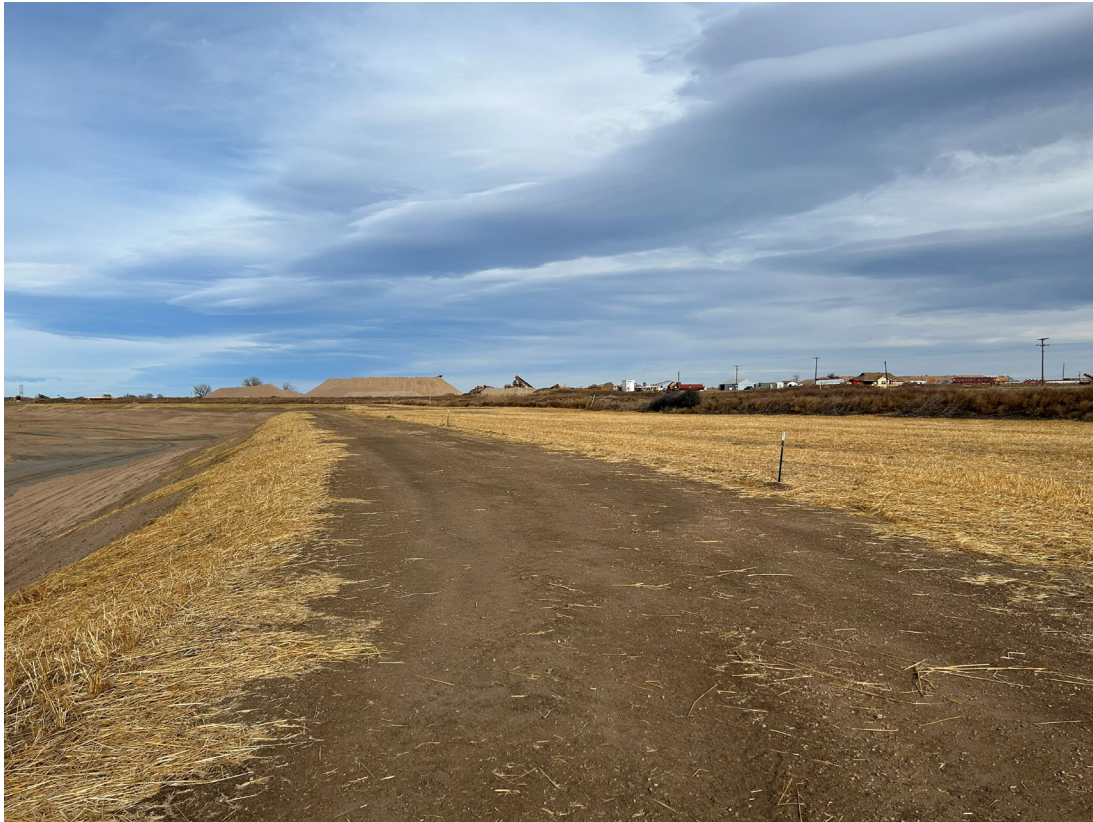
Photo 13. Standing at the southern tip of the Phase 1 area, looking north.

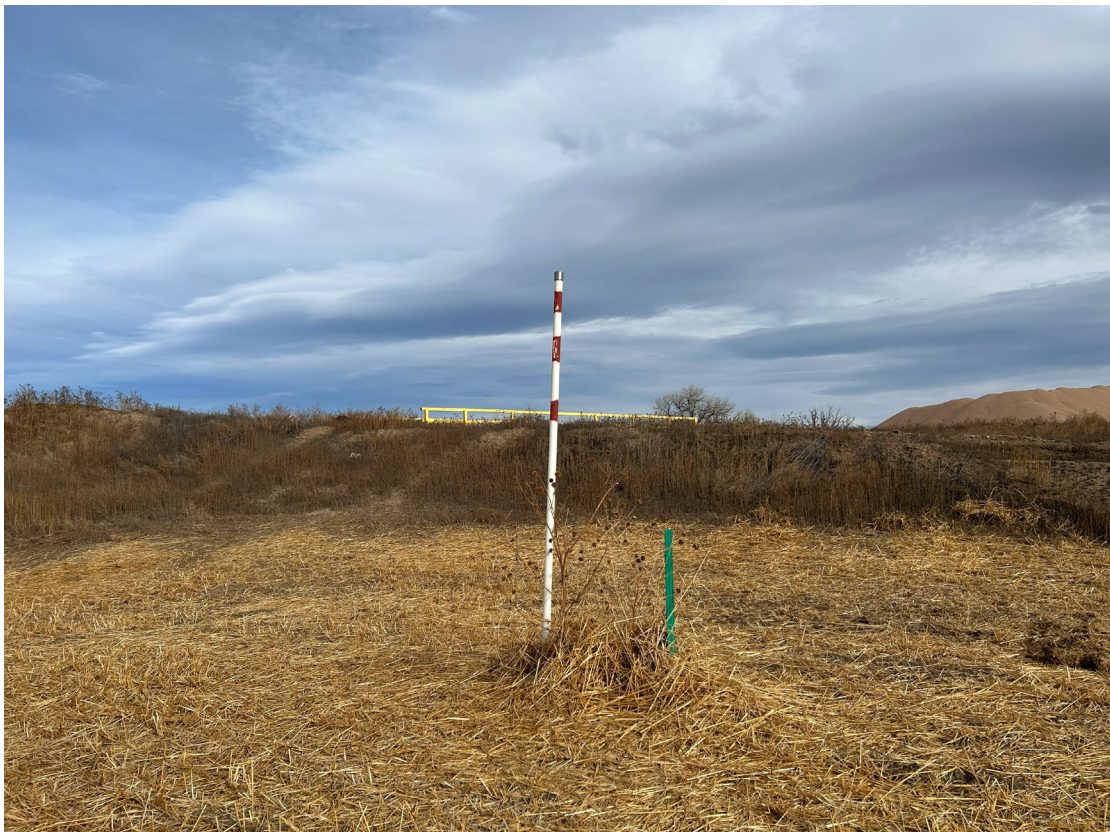
Photo 14. Standing at the northeast corner of the Phase 1 area, looking north. The plastic piping with red stripes indicates the underdrain location.

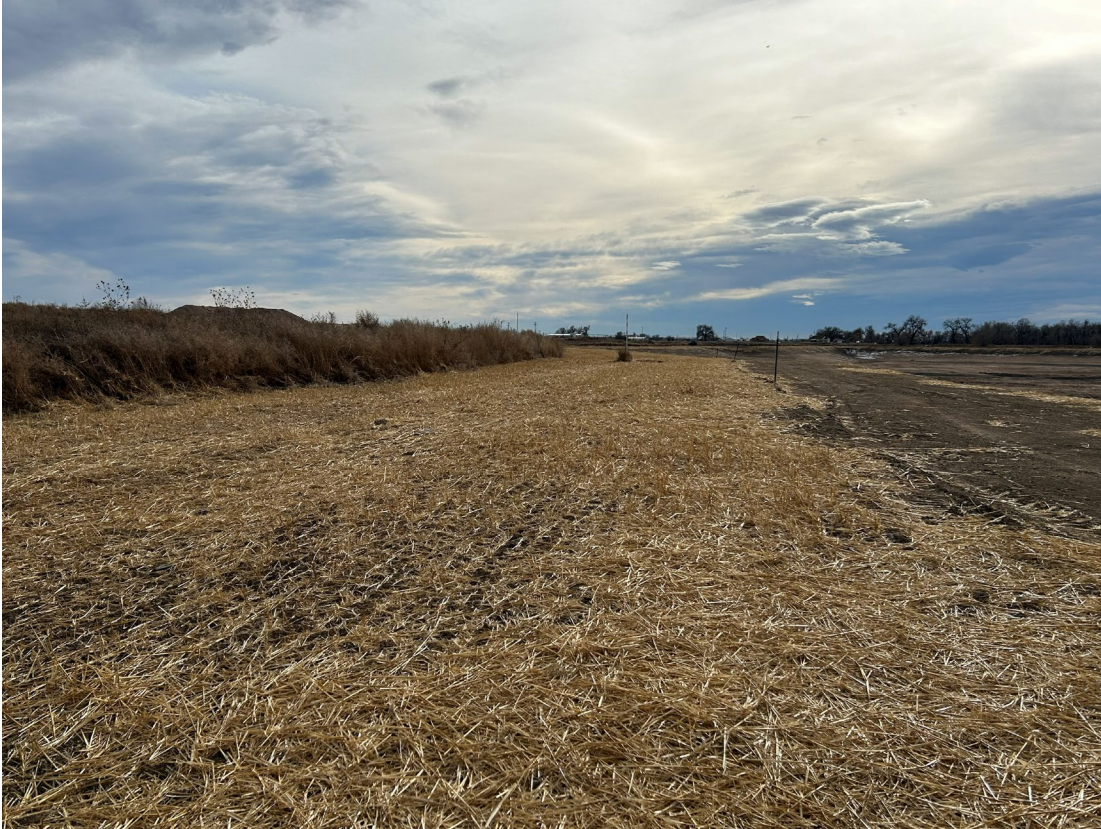
Photo 15. Standing at the northeast corner of the Phase 1 area, looking south at the revegetated area.

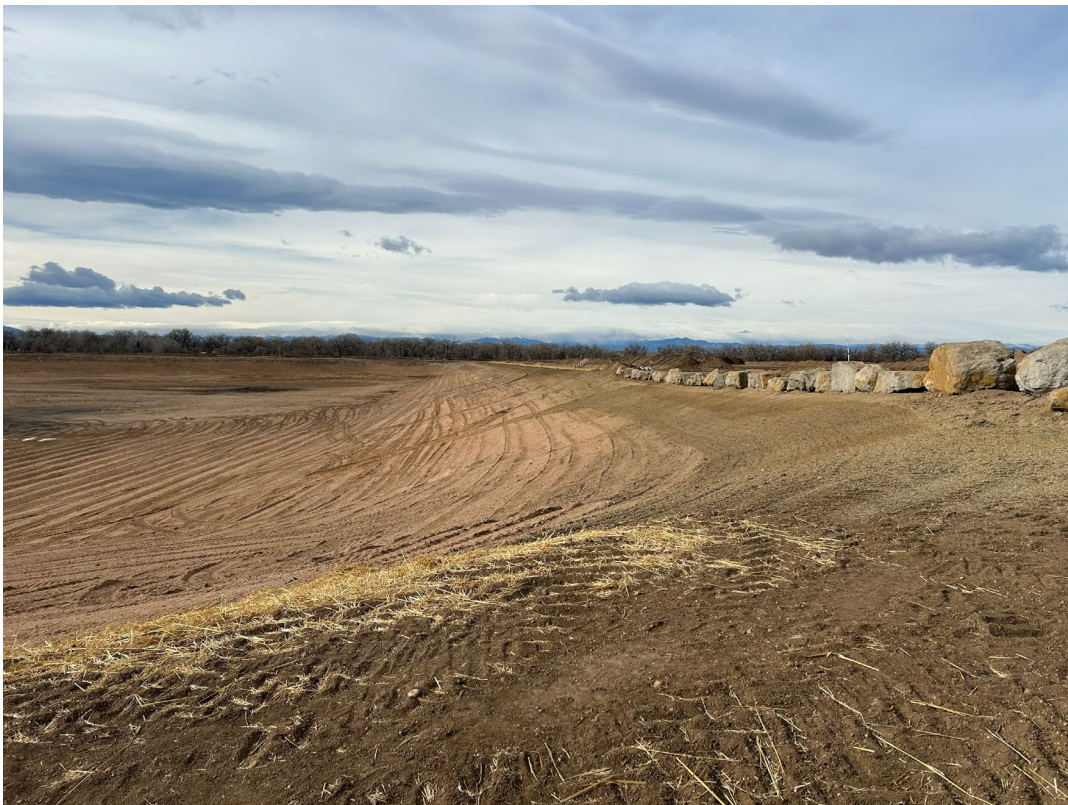
Photo 16. Standing at the northeast corner of the Phase 1 area, looking west. The boulders separate the reclaimed area from the active haul road.

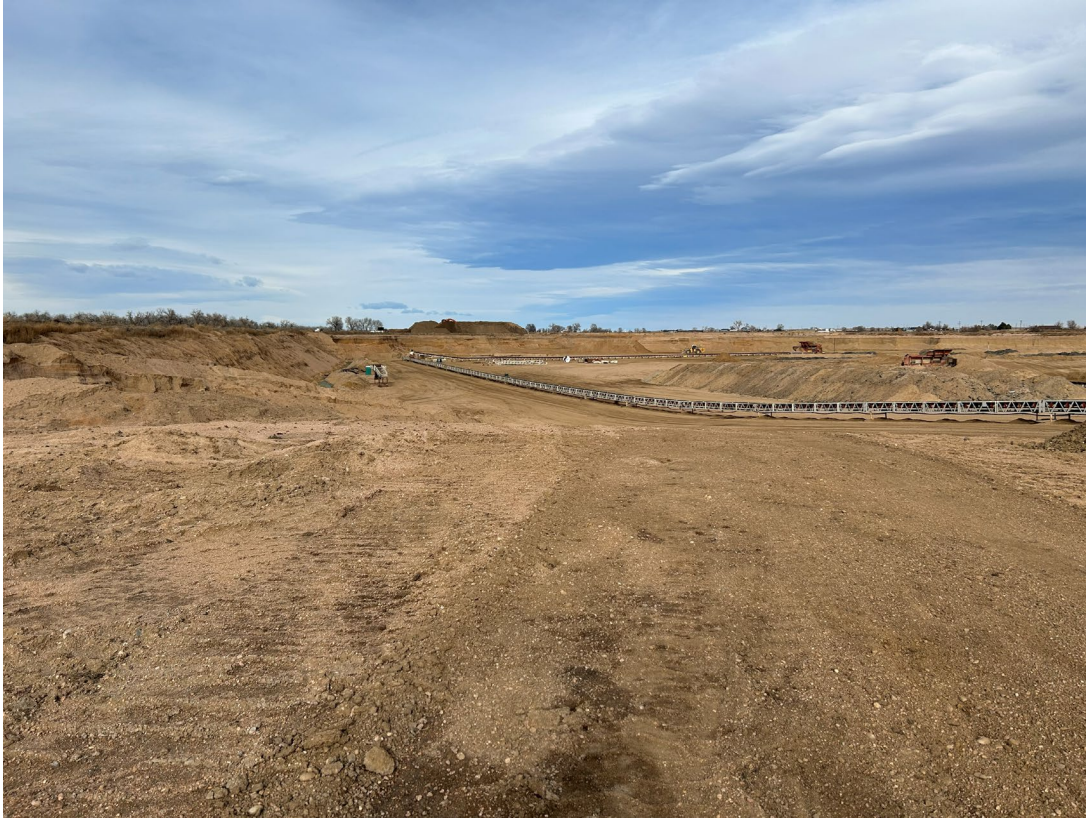
Photo 17. Looking north at the active Phase 2 area.
