COLORADO DIVISION OF RECLAMATION, MINING AND SAFETY
MINERALS PROGRAM INSPECTION REPORT
PHONE: (303) 866-3567

MINE NAME: Una Pit	MINE/PROSPECTING ID#: M-1980-080	MINERAL: Sand and gravel	COUNTY: Garfield
INSPECTION TYPE: Monitoring	INSPECTOR(S): Dustin M. Czapla	INSP. DATE: November 15, 2011	INSP. TIME: 10:00
OPERATOR: Grand Junction Concrete Pipe Co.	OPERATOR REPRESENTATIVE: Ivan Geer	TYPE OF OPERATION: 112c - Construction Regular Operation

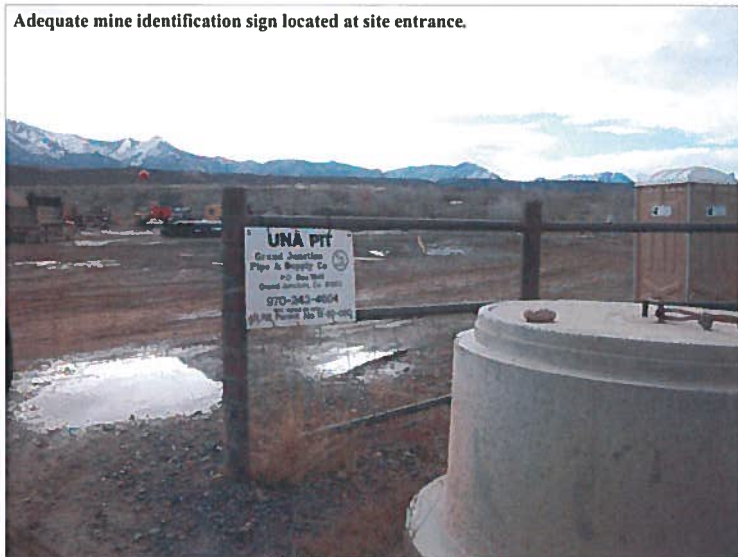
Adequate mine identification signage was noted at the entrance to the site in accordance with Rule 3.1.12(1).

Adequate mine identification sign located at site entrance.

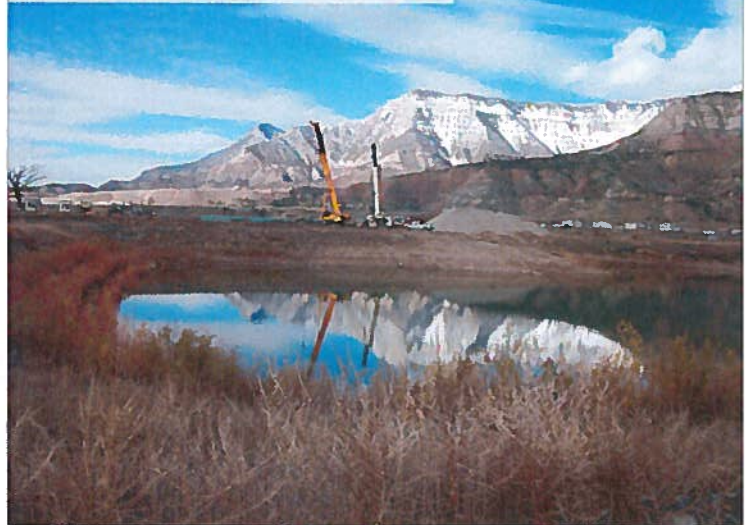
It was noted during this inspection that two additional ponds have been created north of the older pond. Only a portion of the smaller pond, approximately located at 39.397742°, -108.102696°, appears to fall within the mining area established through TR1. The larger pond lies partly within and north of the plant and stockpile area and does not appear to fall within the mining area established through TR1. This pond is approximately located at 39.399440°, -108.103371°. Slopes constructed around the three ponds did appear stable. It appears though, that the Mine Plan and/or Reclamation Plan will need to be revised in order for the operation to be compliant.

View facing west from southeast corner of north pond.

CORRECTIVE ACTIONS: The operator shall submit a Technical Revision, with the required \$216 revision fee, to update and clarify the current approved mine plan to reflect existing and proposed activities by the corrective action date.

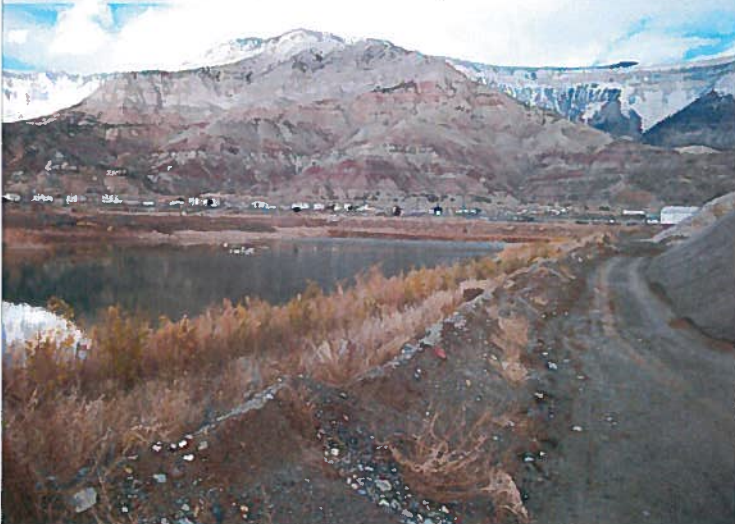
View facing north from southeast corner of north pond.

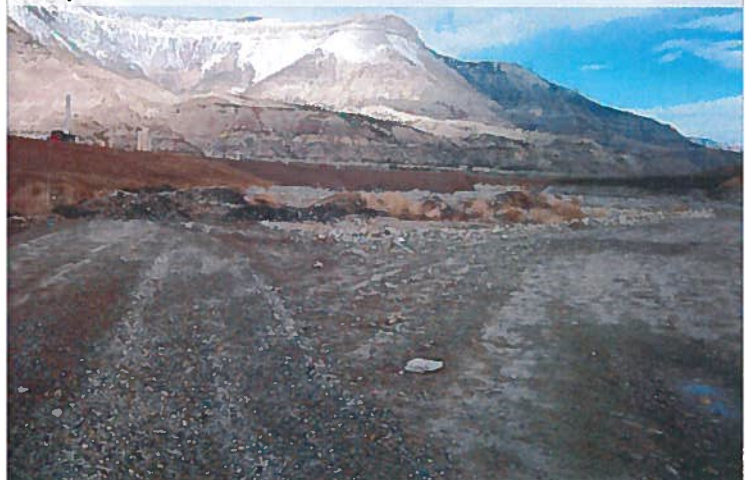
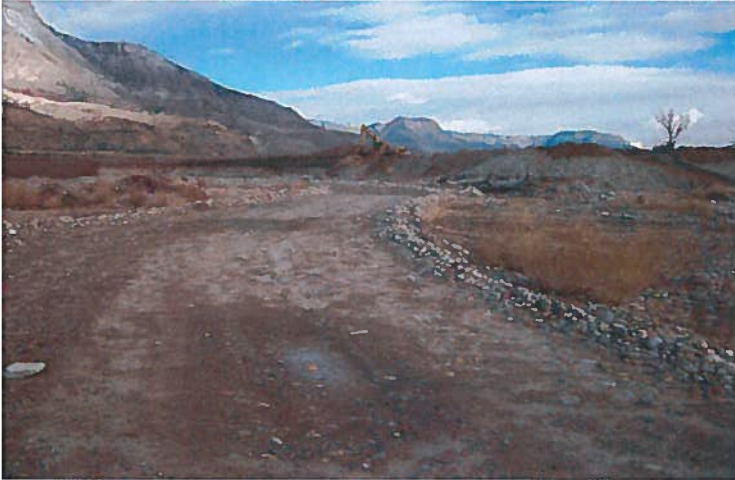
The active area of mining observed during this inspection was focused in the northeast portion of the site. Much of the highwall slopes outside of the active area of mining had been reclaimed to 3H:1V.

View toward northeast end of pit. Highwall reclamation was progressing from west to east. Stripping of overburden was occurring in the northeast portion of the pit, progressing easterly.

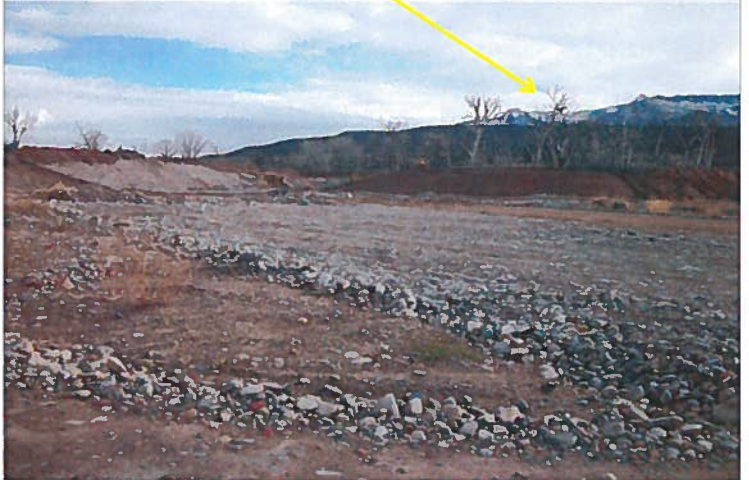
View facing east toward the island that is to remain in place as part of the approved mining/reclamation plan (TR2). An eagles nest was observed in one of the cottonwoods on the island.

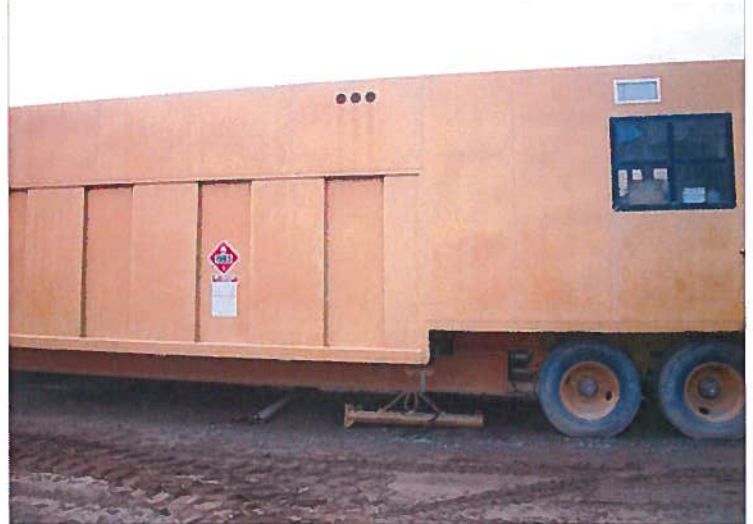
Fuel stored on site was adequately contained by two 10,000 gallon mobile containers, one located near the processing area and another located near the wash plant in the southwest portion of the permit area.

Fuel stored on site contained in 10,000 gallon mobile storage unit.

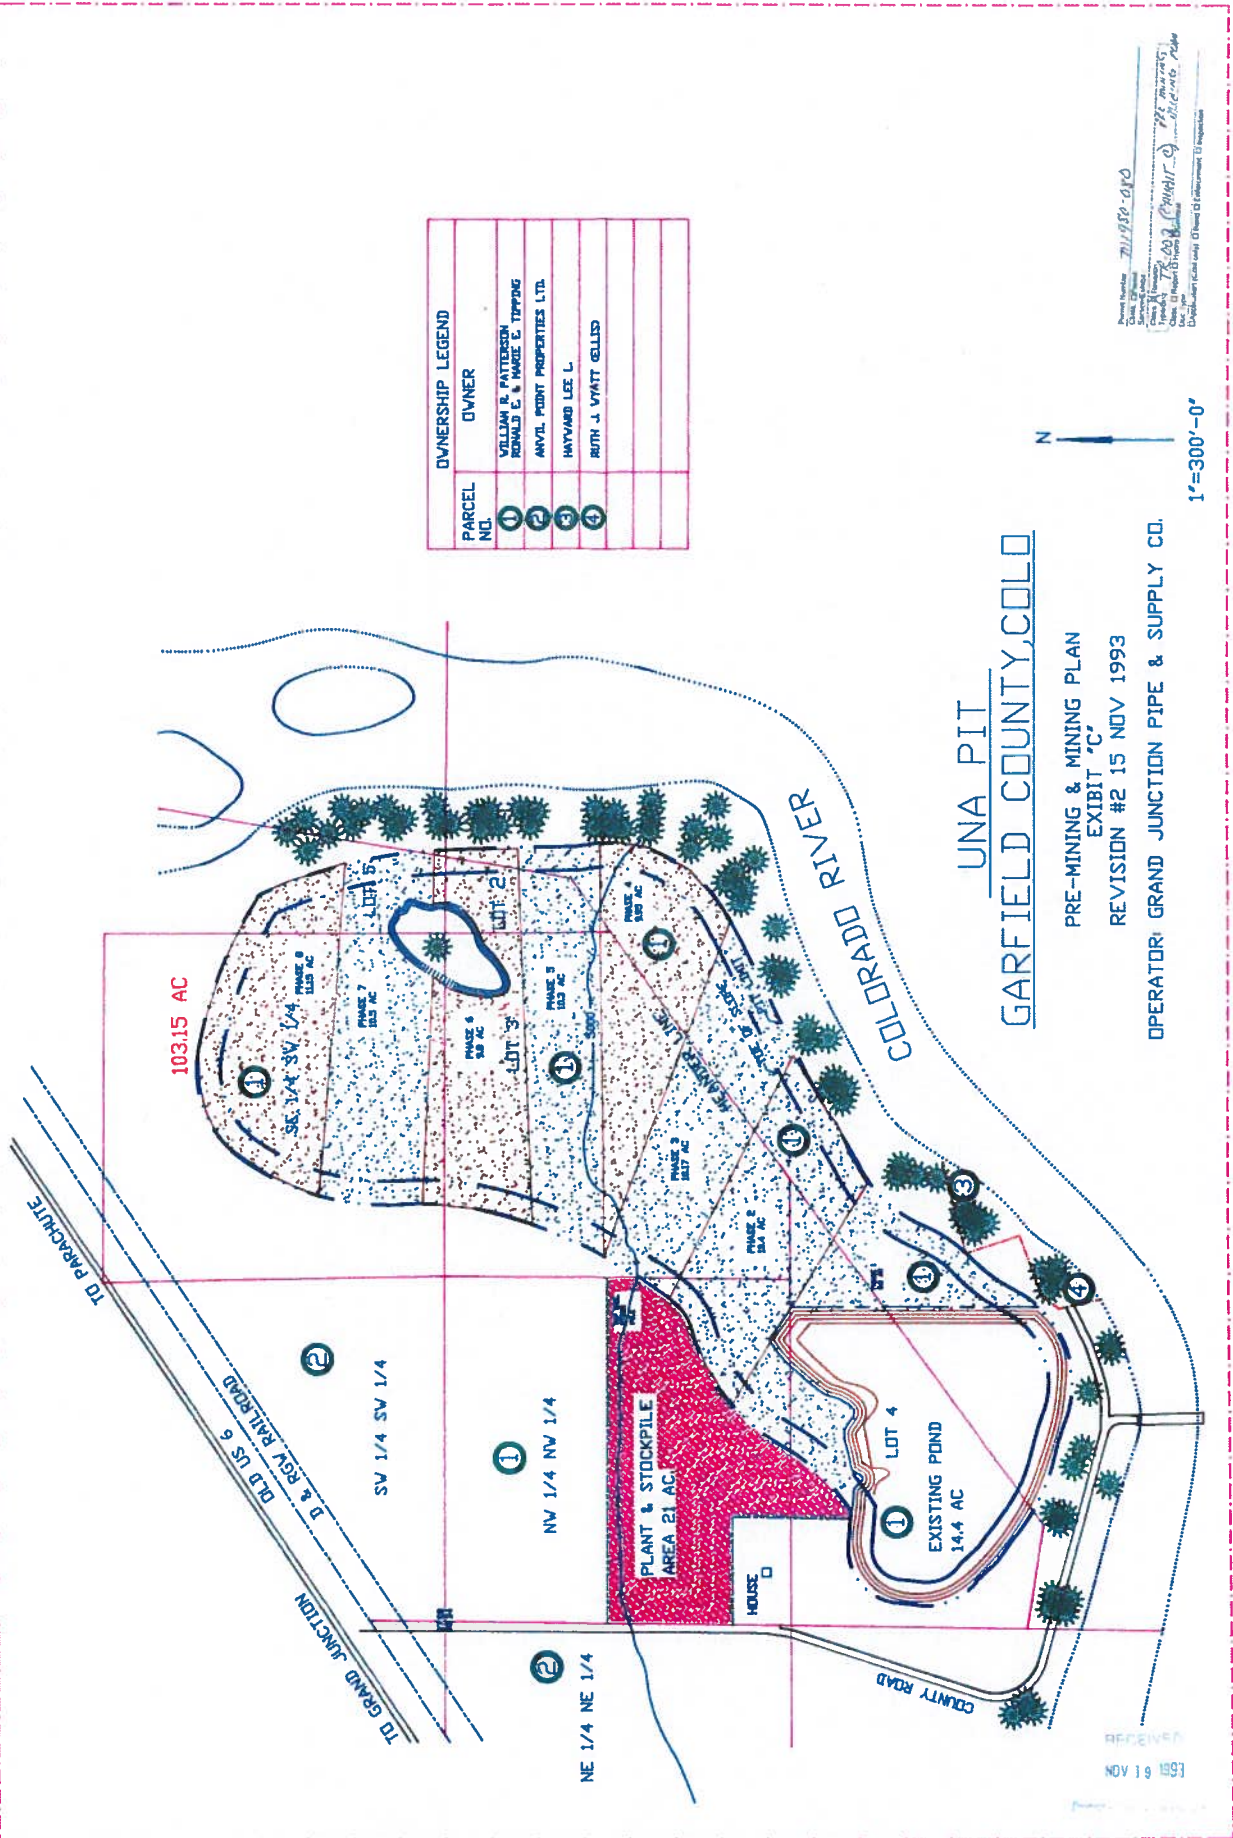
PRE-MINING & MINING PLAN
EXHIBIT "C"
REVISION #2 15 NOV 1993
OPERATOR: GRAND JUNCTION PIPE & SUPPLY CO.

1. Leave the stockpile area in its original location. This will eliminate the need to disturb additional area and reduce the size of the stockpile site by 4 acres when this area is mined. See Revised Exhibit "C".
2. Revise the Mining Plan reducing the size of the area to be mined from 124 acres to 103 acres. The reason for this is to move the mined area closer to the river reducing the amount of overburden to be removed and leaving a larger buffer zone between adjacent properties. See Revised Exhibit "C".

3. Phase the mining operation into 8 phases of approximately 10 acres each. Mining would start adjacent to the existing pond and proceed in a northeasterly direction. A smaller operation would reduce the size of the area disturbed at any given time thus reducing the amount of the reclamation bond required. See Revised Exhibit "C".
4. Reduce the amount of the reclamation bond from \$188,160.00 to \$78,000.00. This amount was determined by calculating reclamation costs to:
