**COLORADO DIVISION OF RECLAMATION, MINING AND SAFETY
MINERALS PROGRAM INSPECTION REPORT
PHONE: (303) 866-3567**

MINE NAME: Juniper Quarry	MINE/PROSPECTING ID#: M-1982-141	MINERAL: Limestone	COUNTY: Moffat
INSPECTION TYPE: Monitoring	INSPECTOR(S): Dustin M. Czapla	INSP. DATE: November 18, 2011	INSP. TIME: 12:00
OPERATOR: Moffat Limestone Company	OPERATOR REPRESENTATIVE: None	TYPE OF OPERATION: 112c - Construction Regular Operation

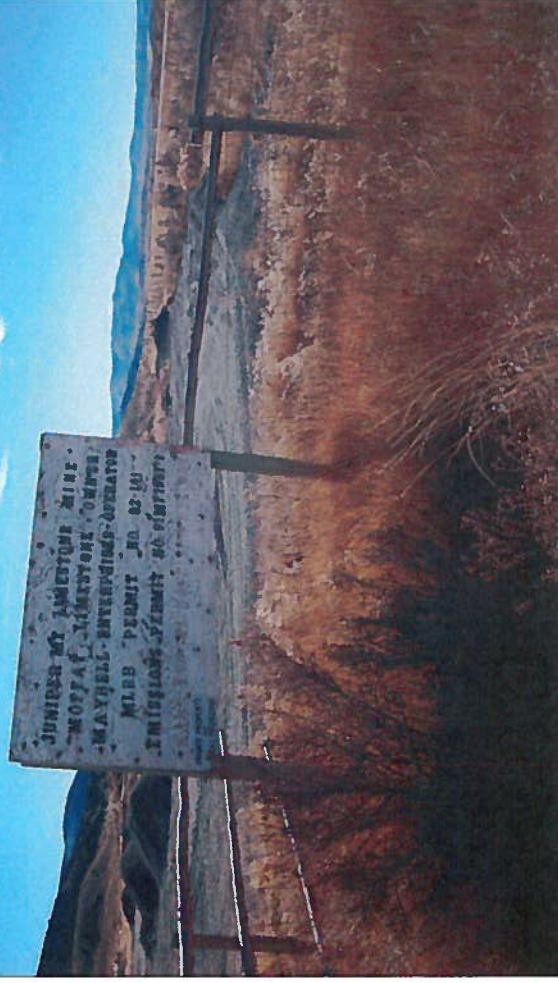
Adequate mine identification signage was noted at the entrance to the site in accordance with Rule 3.1.12(1). The sign was located at the intersection of the access road and CR57, at an approximate GPS location 40.48079°, -108.06742°.

Mine identification sign located at site entrance from CR57. Approximate GPS coordinates at site entrance are 40.48079, -108.06742.

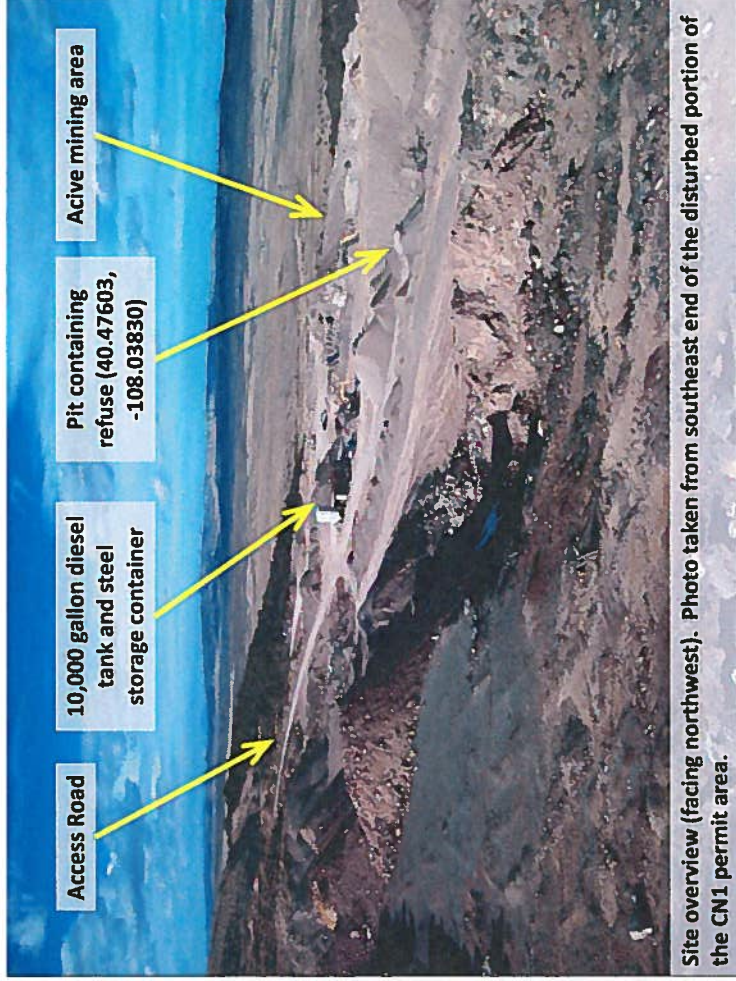
Site overview (facing northwest). Photo taken from southeast end of the disturbed portion of the CN1 permit area.

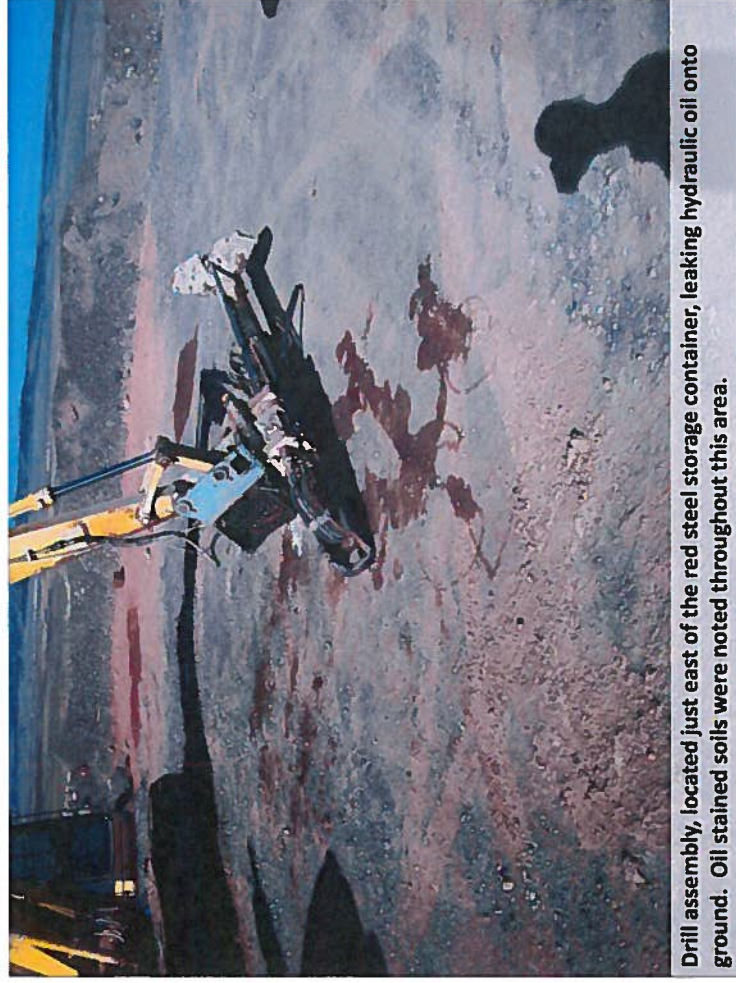
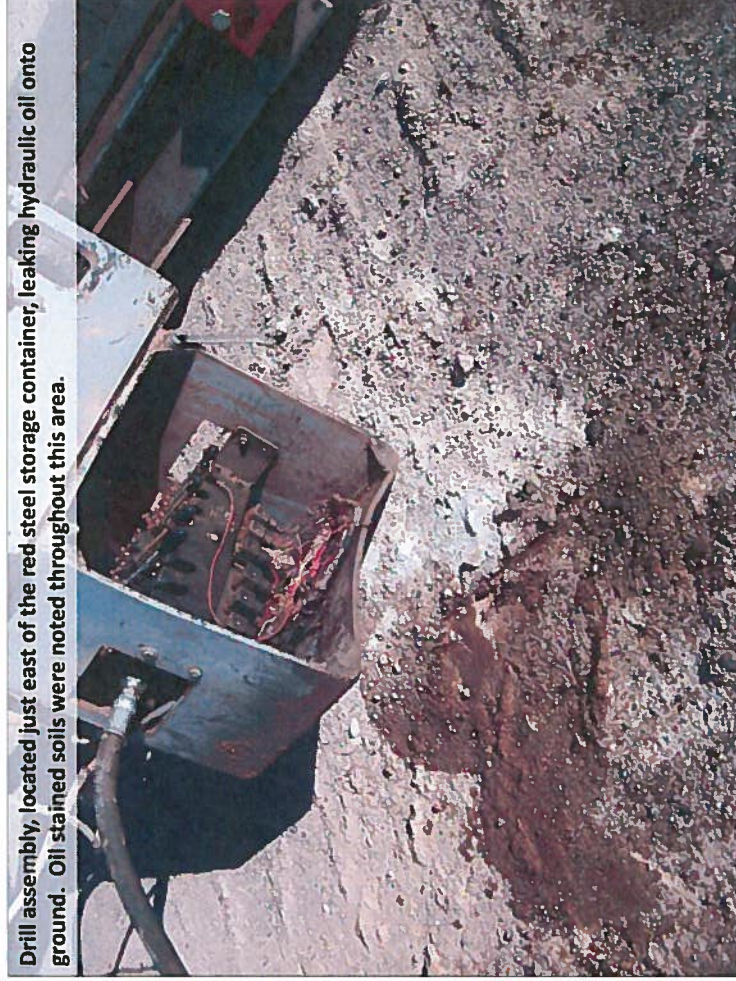
Drill assembly, located just east of the red steel storage container, leaking hydraulic oil onto ground. Oil stained soils were noted throughout this area.

CORRECTIVE ACTIONS: The operator shall immediately remediate the spill and submit a final report to the Division containing at least the following information:

- 1.) A description of how the spill was cleaned up containing at a minimum - the appropriate maps, volumes removed, sample locations, analytical data, and photo documentation.
- 2.) Evidence in the form of a receipt that the contaminated soil was disposed of by an approved method (such as sent to an approved landfill, land farming, recycling center, etc.).

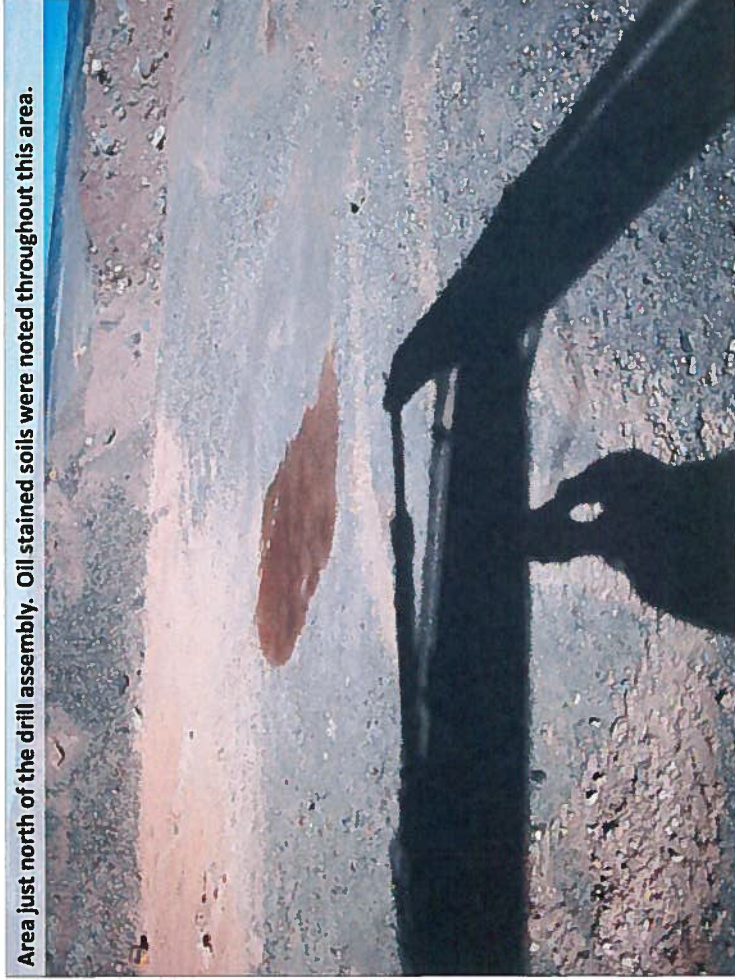
Area just north of the drill assembly. Oil stained soils were noted throughout this area.

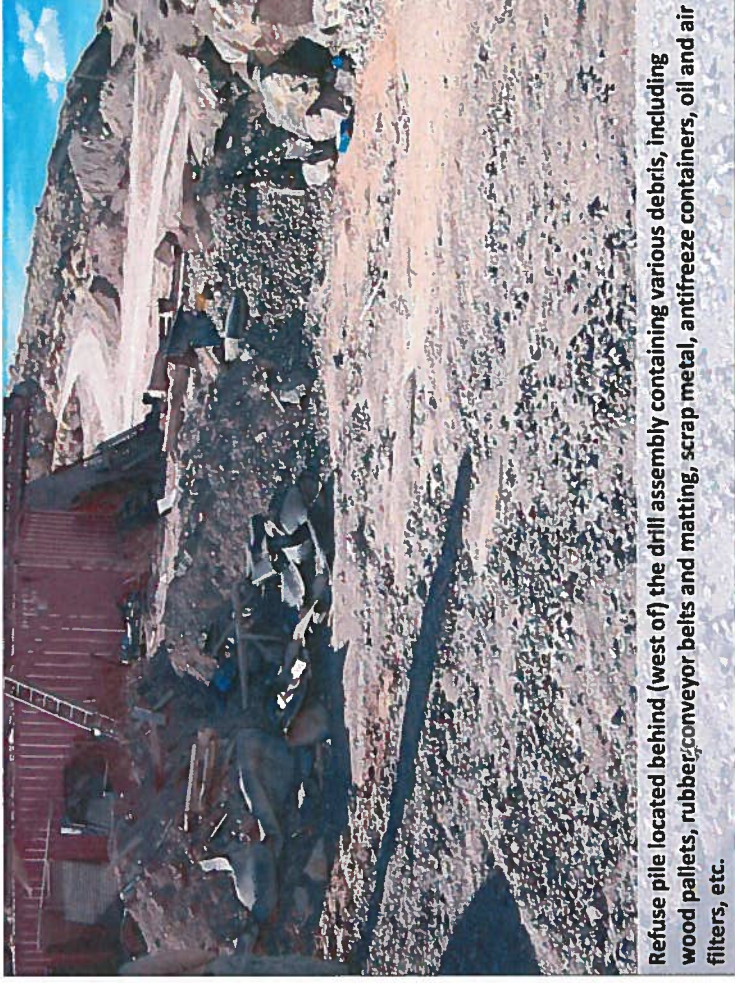
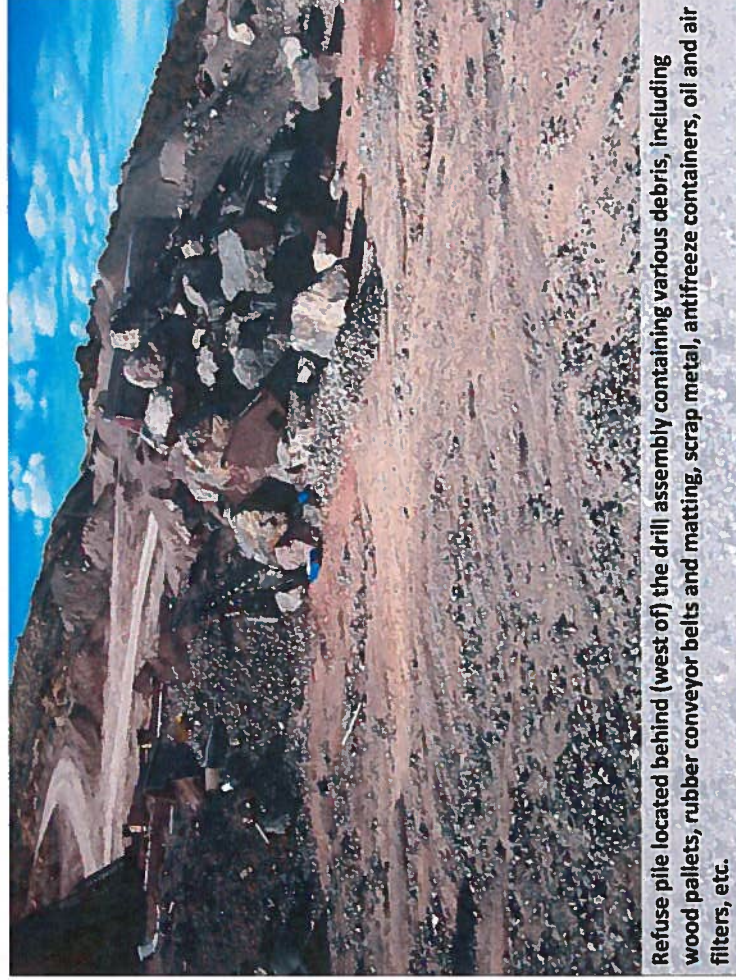
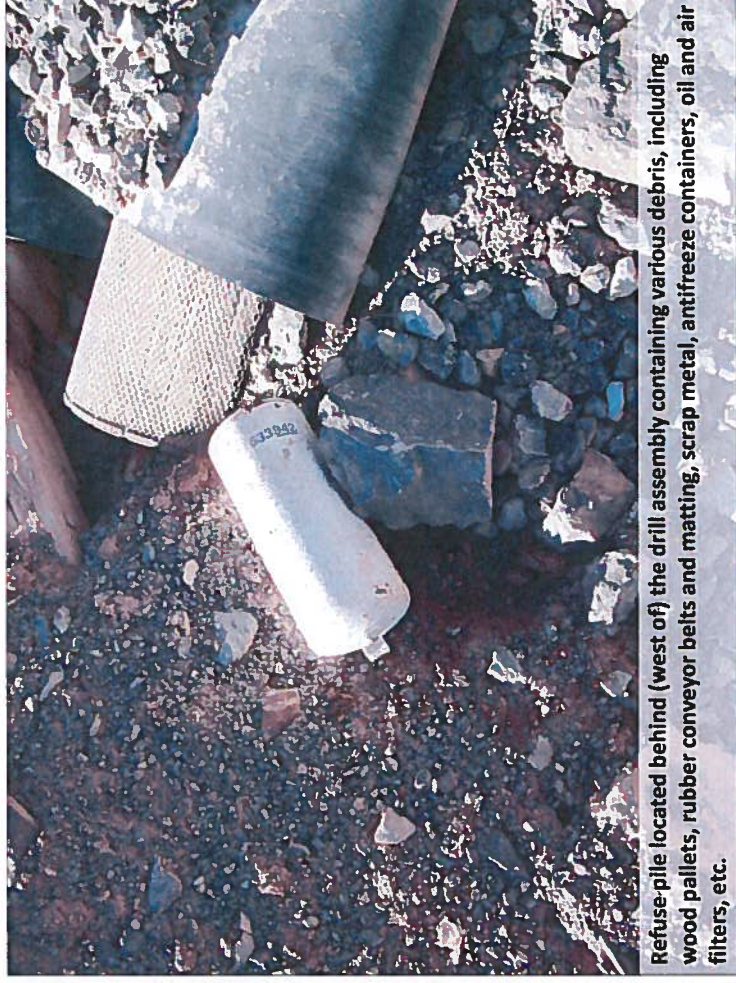
Refuse pile located behind (west of) the drill assembly containing various debris, including wood pallets, rubber conveyor belts and matting, scrap metal, antifreeze containers, oil and air filters, etc.

CORRECTIVE ACTIONS: The operator shall submit a written notice to the Division with photo documentation, that the trash has been removed from the site by the corrective action date.

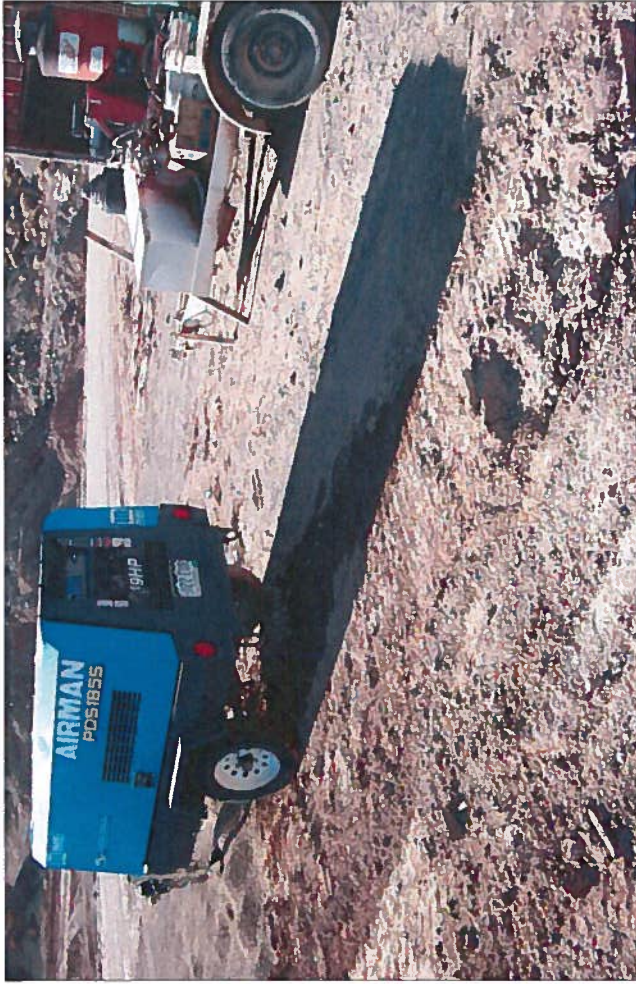
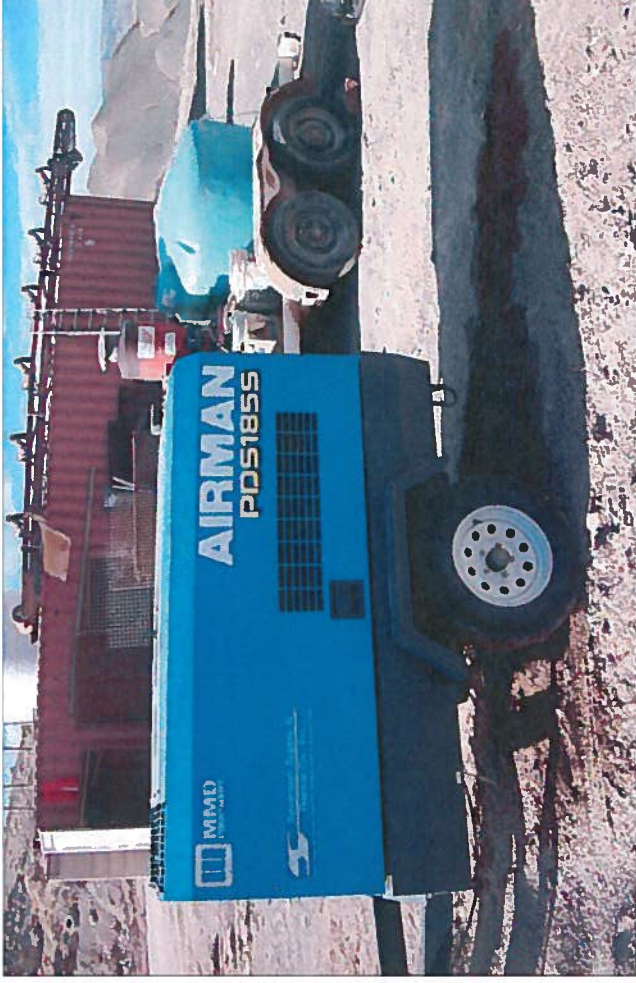
Air compressor, located just east of the red steel storage container. Oil and/or diesel soaked soil was noted around this machine. Fines had recently been used to cover up some of the saturated soils in front of the compressor.

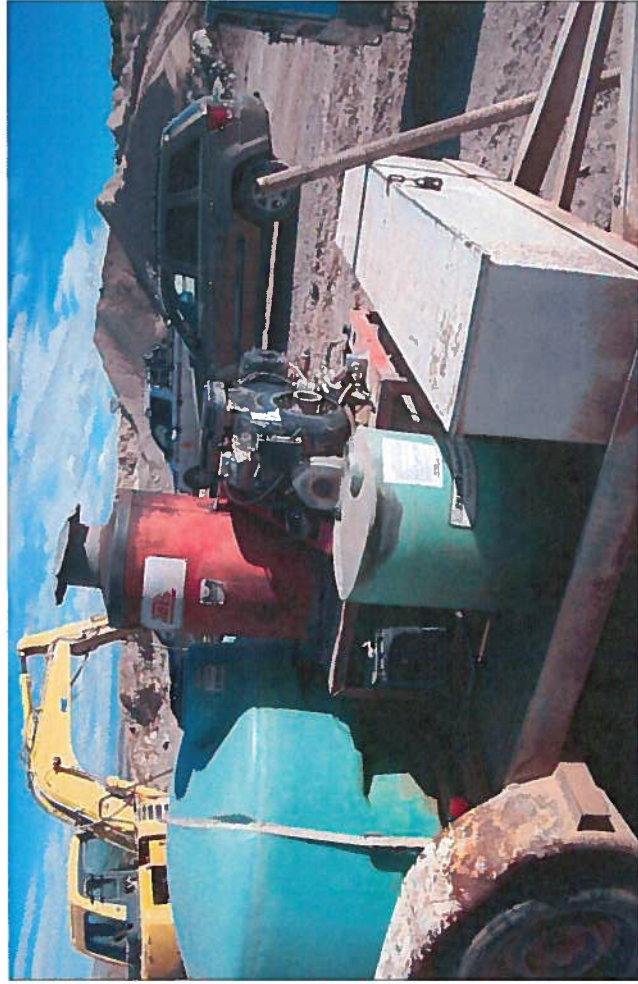
Pressure washer, located just east of the red steel storage container. Oil and/or diesel soaked soil was noted in front of this trailer. Fines had recently been used to cover up some of the saturated soils.

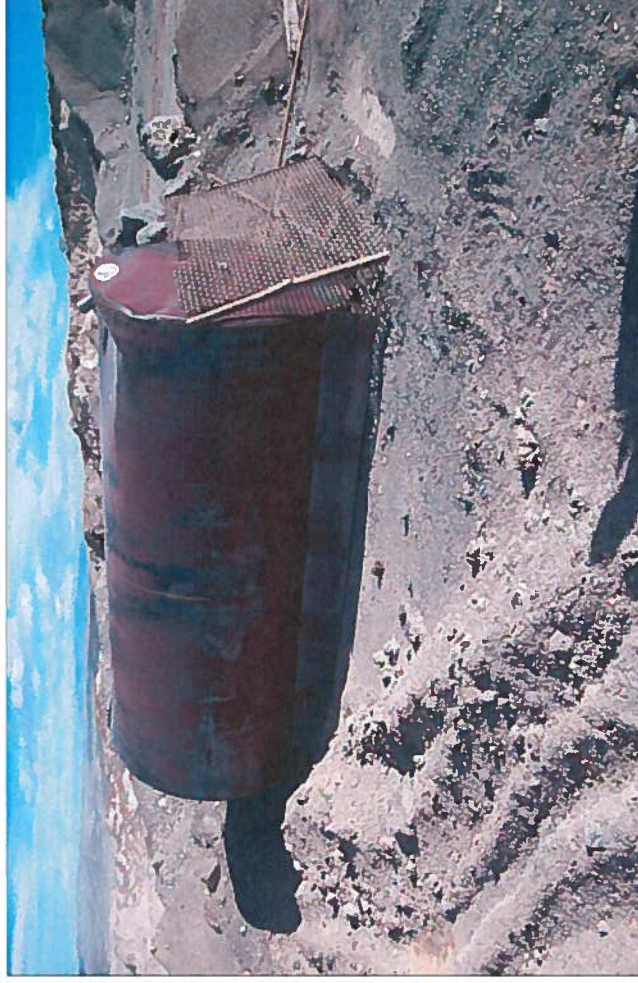
Fuel storage tank located just north of the steel storage container was empty during this inspection.

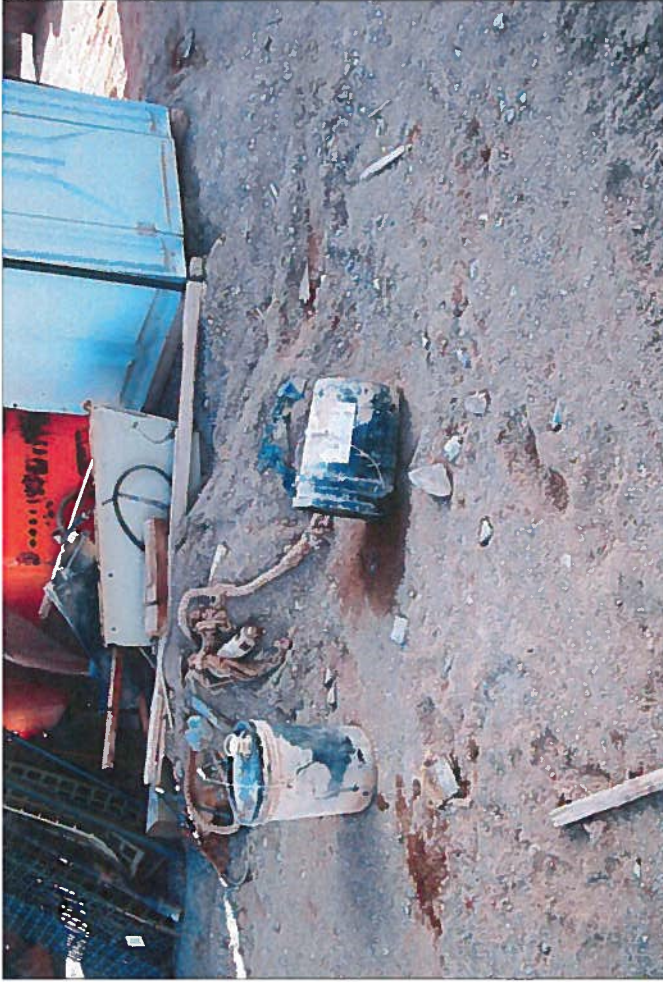
Hydraulic fluid buckets and other refuse were scattered around the steel storage container area. Soils saturated with oil and/or diesel were observed throughout the area.

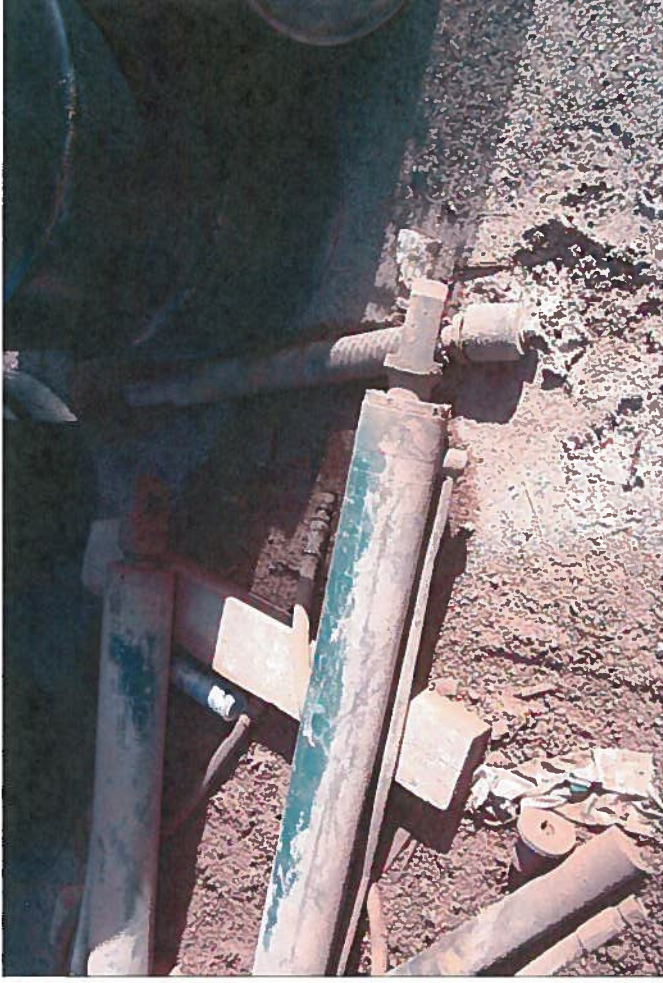
Hydraulic fluid containers and equipment components stored on the east side of the steel storage container. Components were leaking hydraulic fluid directly onto the ground.

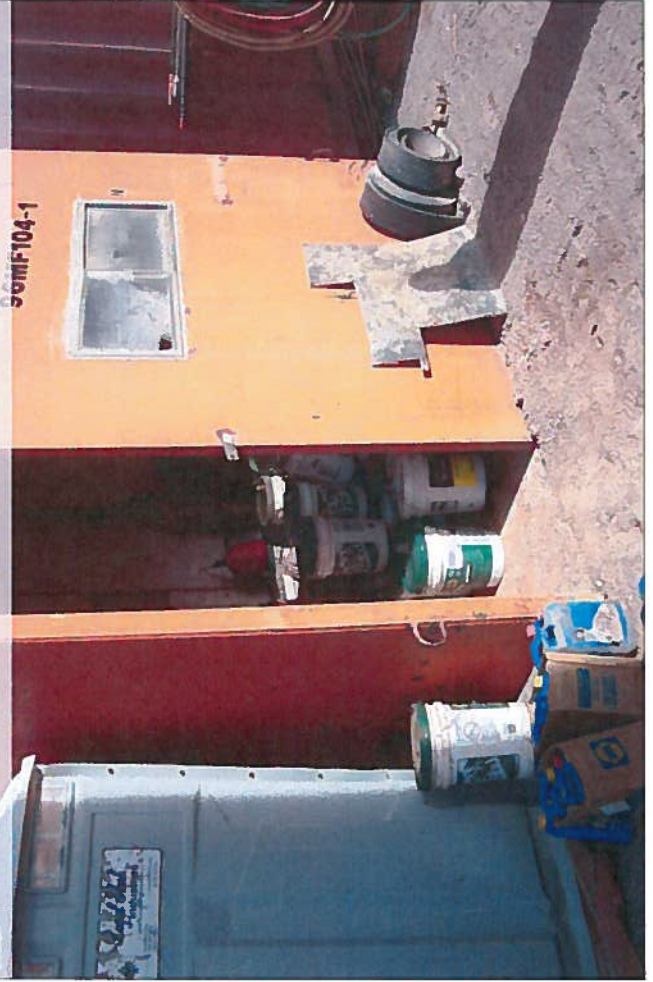
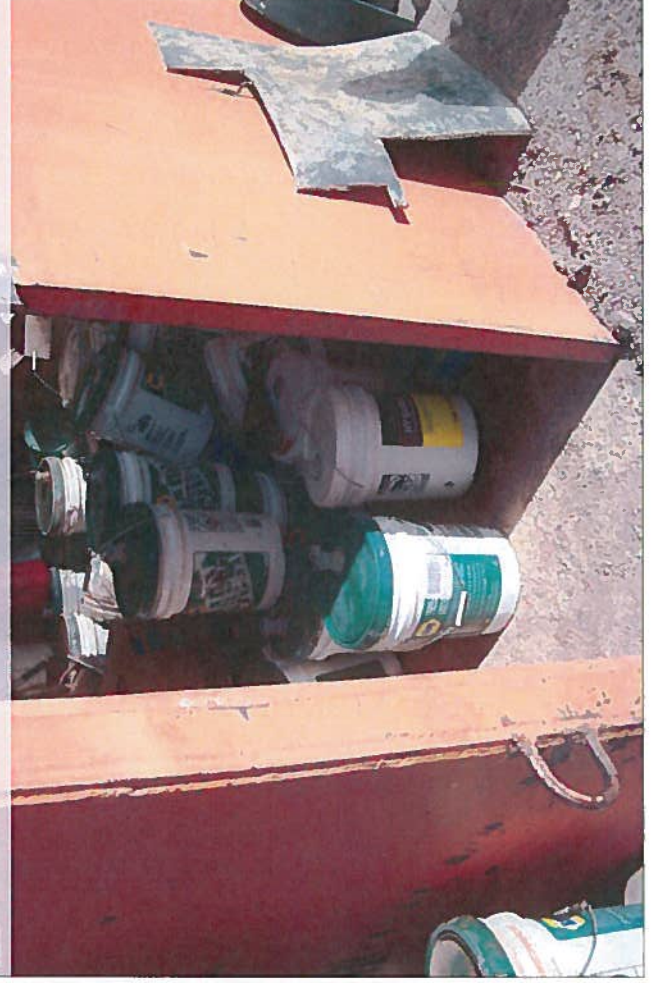
Storage shed located adjacent to the west side of the red steel storage container. Most of the hydraulic fluid buckets shown in this shed were empty. Most of the antifreeze containers were not.

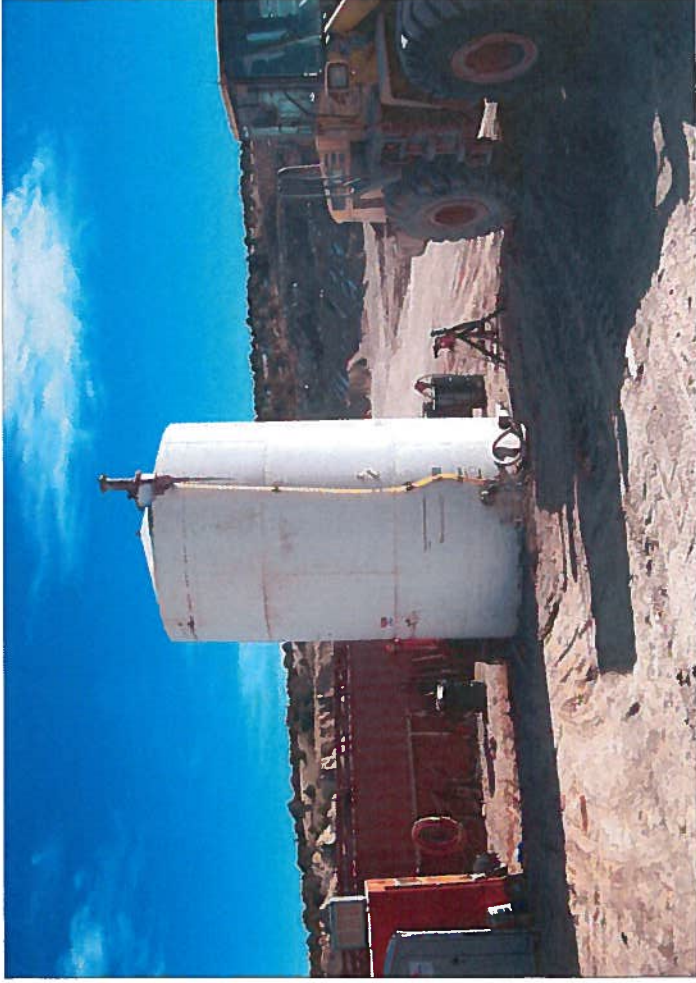
10,000 gallon diesel storage container lacking any secondary containment structure.

CORRECTIVE ACTIONS: All storage tanks, petroleum and any hazardous materials on site for any period of time shall have appropriate secondary containment. The site will also have to comply with all applicable SPCC requirements. Supply photo documentation that any fuel or hazardous materials containers are stored properly - including applicable secondary containment structures by the corrective action date. Note that secondary containment structures shall consist of an impermeable containment which could contain all contents of the tanks and various containers (when full) plus 10% of the total capacity. The operator may also provide photo documentation that all containers have been removed from the site on or before the corrective action date.

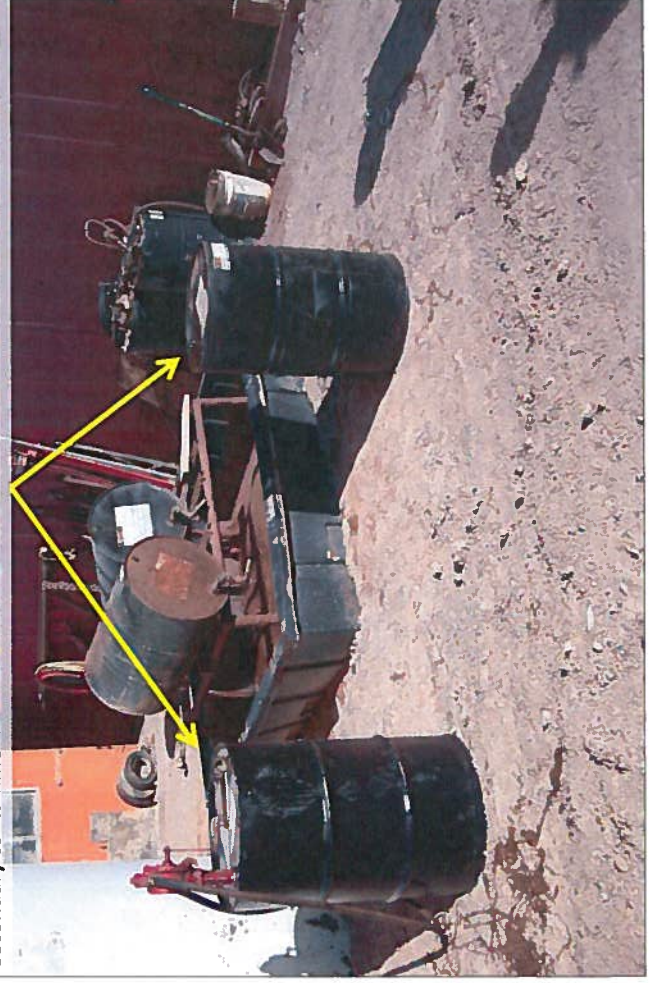
55 gallon drum containing engine oil, located in front (south) of the 10,000 gallon diesel storage container and the plastic containment structure, lacked secondary containment. Saturated soil was observed around the base of this container.

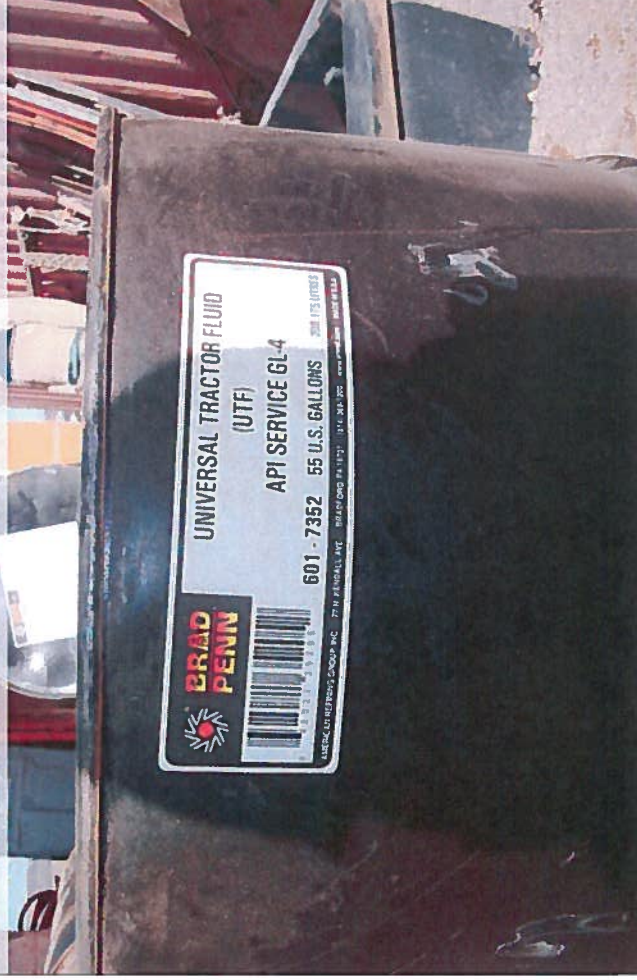
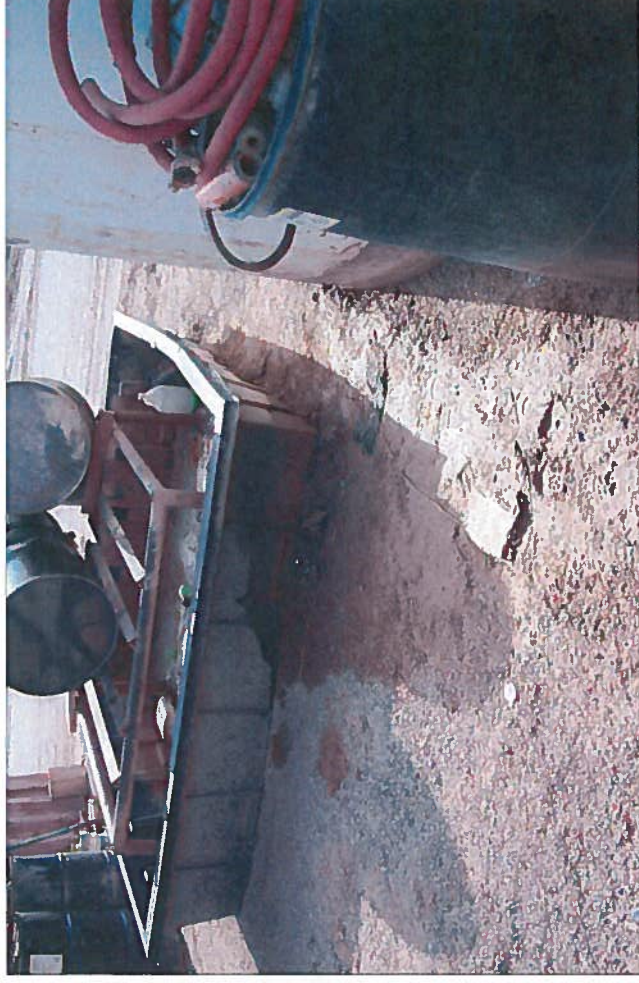
Fluid was observed leaking onto the ground from the northwest corner of the plastic containment structure, which contained 55 gallon drums of engine oil (right) and hydraulic fluid (left), and several one gallon antifreeze containers.

Fluid was observed leaking onto the ground from the northwest corner of the plastic containment structure, which contained 55 gallon drums of engine oil and hydraulic fluid, and several one gallon antifreeze containers.

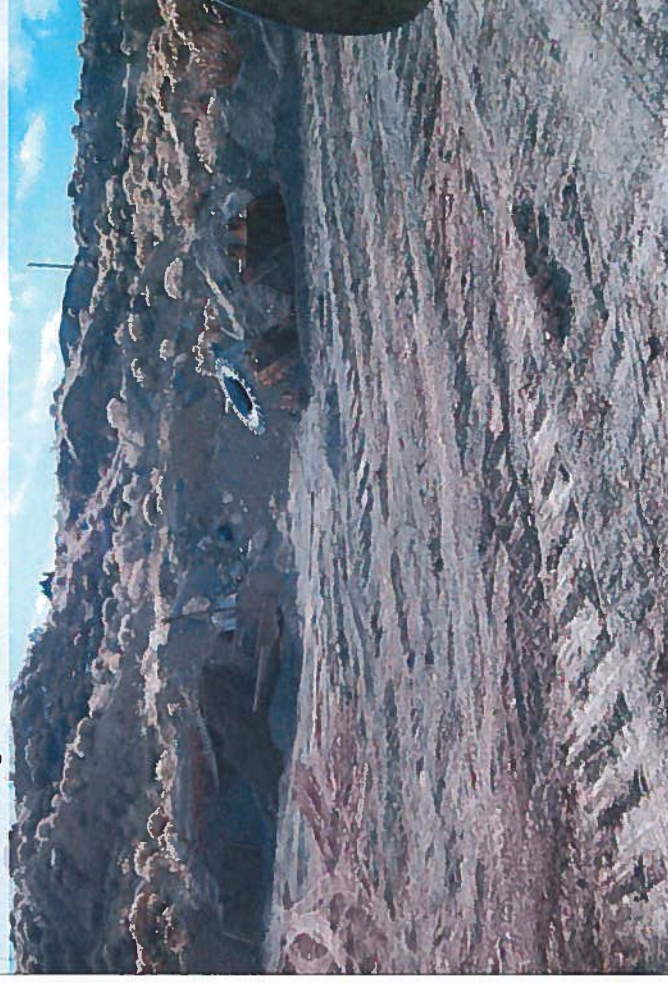
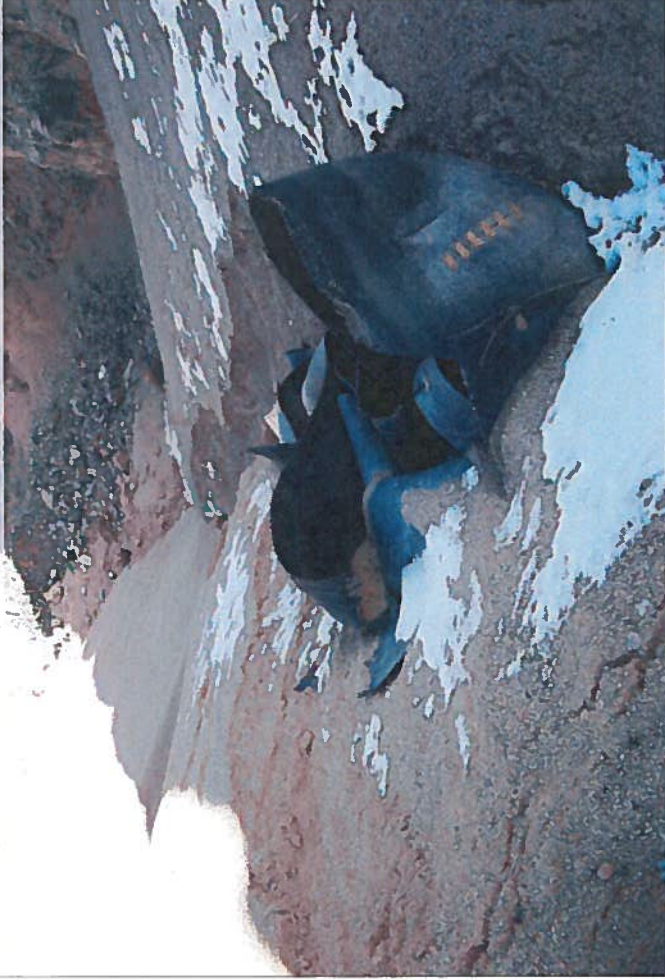
There was a pit (approximate GPS coordinates: 40.47603°, -108.03830°) located approximately 300 feet southeast of the previously discussed area. A used conveyor belt, buckets, oil filters and other refuse were noted in this pit. It appeared that backfilling of the pit with fines was occurring from west to east.

View facing northeast into a pit containing refuse, such as an old conveyor belt, hydraulic fluid buckets, and oil filters. Photograph was taken at GPS point 40.47603, -108.03830.

View facing northeast into a pit containing refuse, such as an old conveyor belt, hydraulic fluid buckets, and oil filters. Photograph was taken at GPS point 40.47603, -108.03830. Much of the south and west portions of this pit had been backfilled with fines.

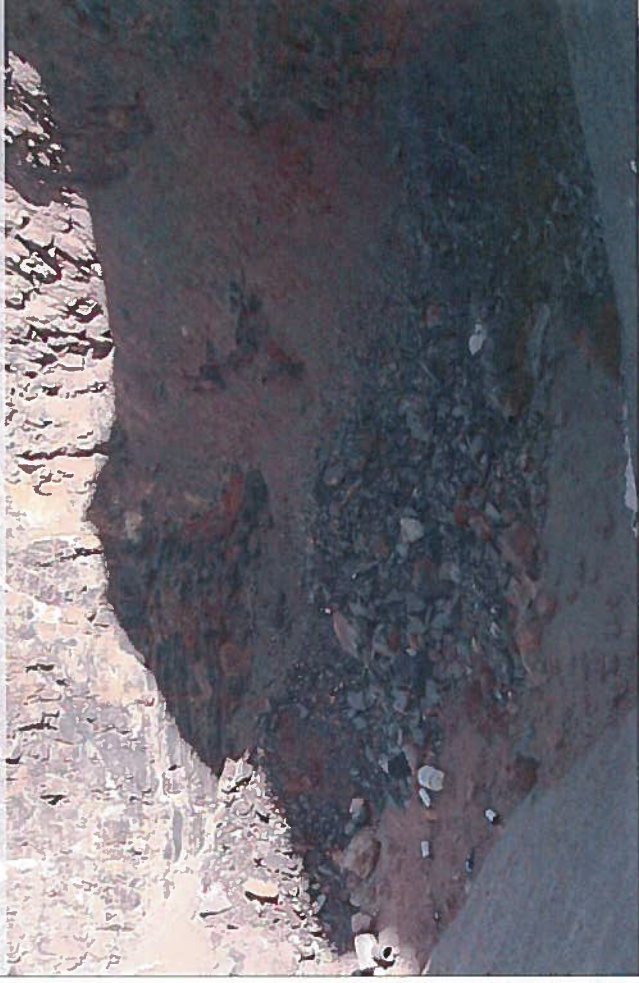
A rock pile (approximate GPS coordinates: 40.47569°, -108.03818°) was located approximately 400 feet southeast of the previously discussed storage area. Rocks in this pile were notably stained by oil and/or hydraulic fluid. Drainage from this area is to the north. Fines appeared to have been recently placed over the area below (north of) the rock pile. One puddle was observed though, in the area below the rock pile, containing a significant amount of an oily substance (see photos).

Some rocks in this pile were notably soaked and/or stained by oils. Pile was approximately located at GPS point 40.47569, -108.03818.

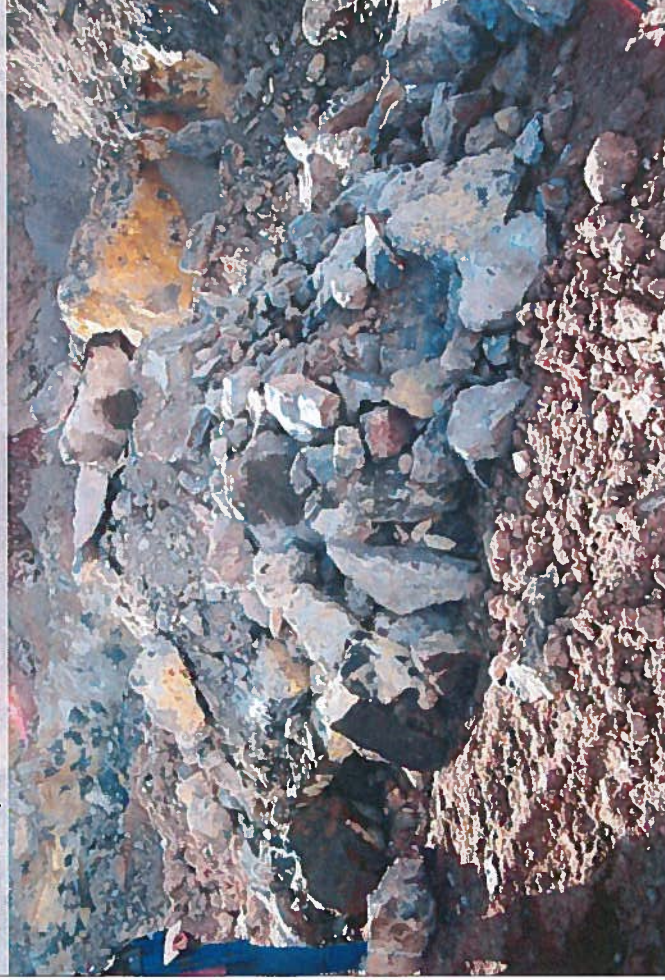
The drainage from the rock pile appeared to have been recently covered by fines. An oily puddle was noted down gradient of the pile. View is facing south.

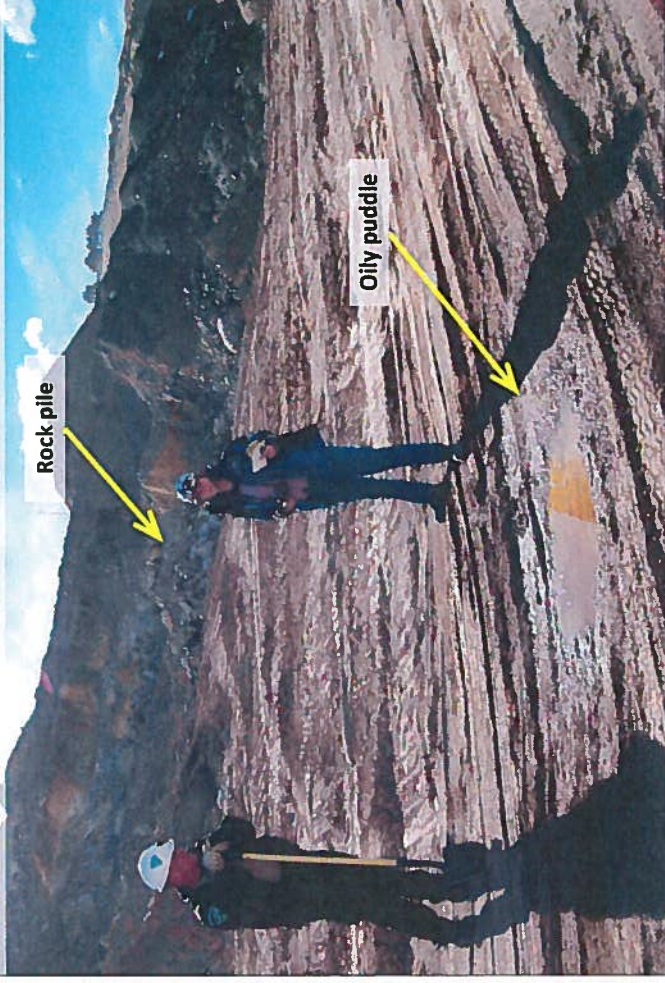
Oily puddle noted down gradient of the rock pile containing oil soaked and stained rocks.

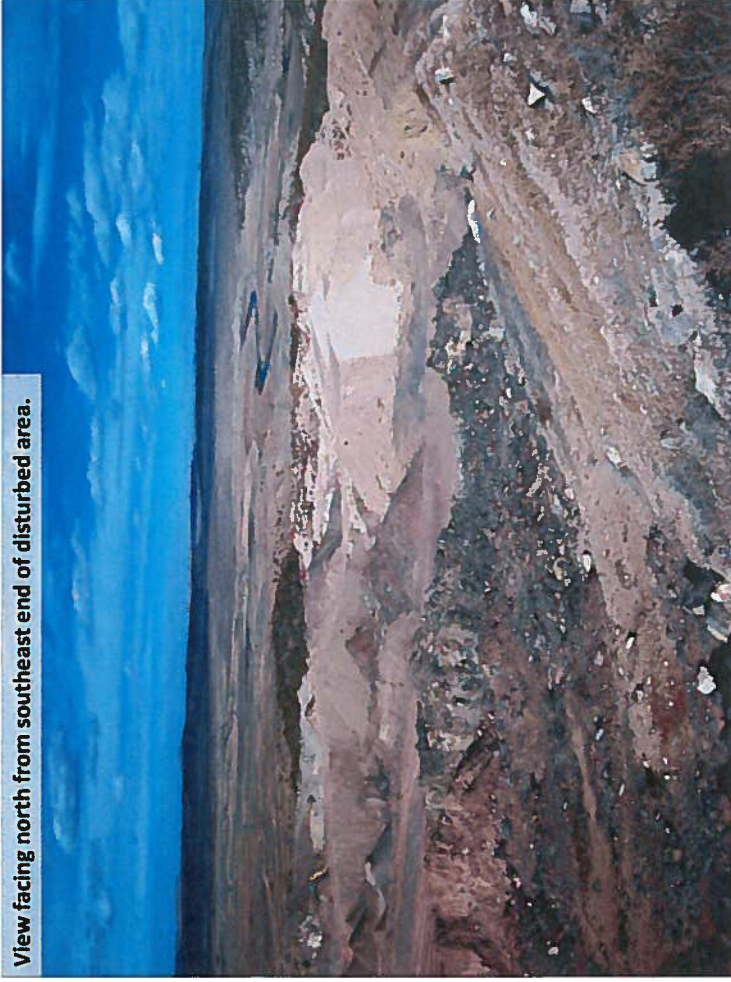
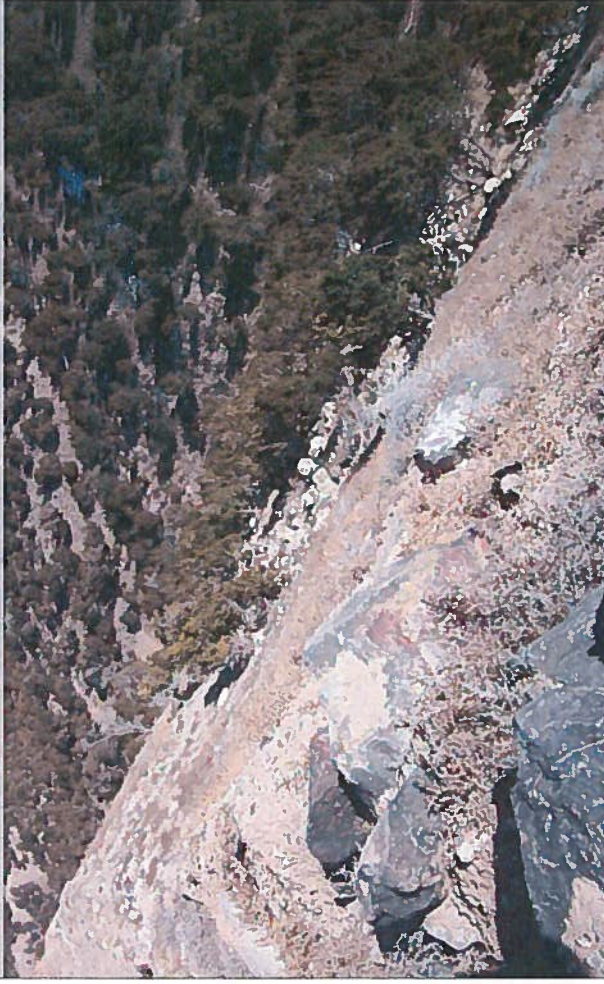
As stated previously in this report, adequate boundary markers were not observed during this inspection, so it was unclear during this inspection whether or not the entire disturbance by the operation has been contained within the approved affected area. A particular area of concern is the drainage along the east side of the mine site. Boulders and some finer materials appeared to have been pushed and/or washed into the drainage, and the operation may have failed to protect areas outside of the affected land from slides or damage.

View facing north down the drainage located on the east side of the permit area. Some boulders and finer materials had been pushed/washed into the drainage from the mine site. Adequate permit boundary markers were not observed during this inspection, so it was unclear whether any of this material lied outside of the approved affected area.

View into the drainage located on the east side of the permit area. Some boulders and finer materials had been pushed/washed into the drainage from the mine site. Adequate permit boundary markers were not observed during this inspection, so it was unclear whether any of this material lied outside of the approved affected area.

CORRECTIVE ACTIONS: The operator shall conduct a survey and replace the boundary markers in the correct location(s). The operator shall provide proof to the Division that this has been done by the corrective action date.

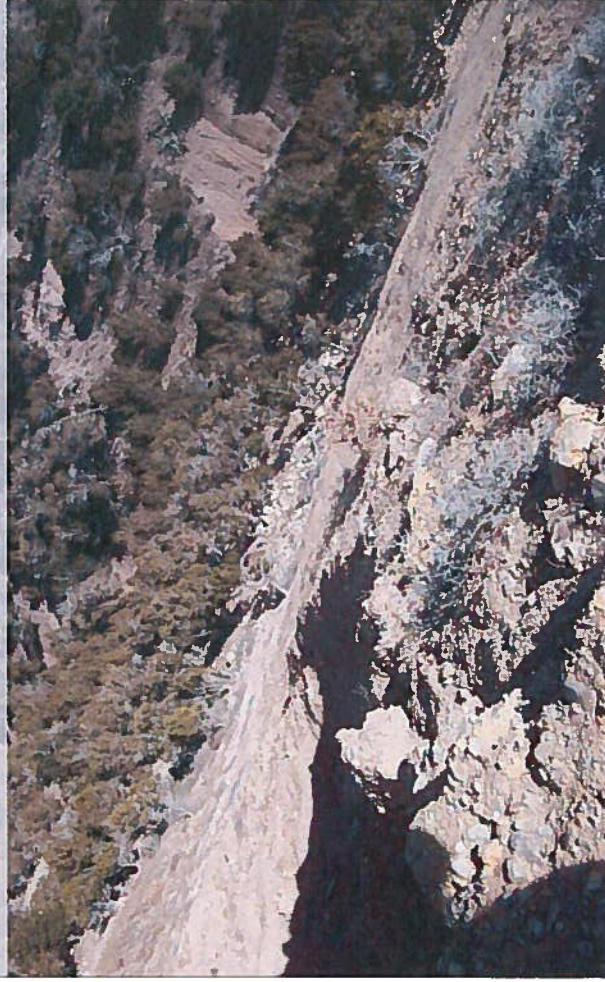
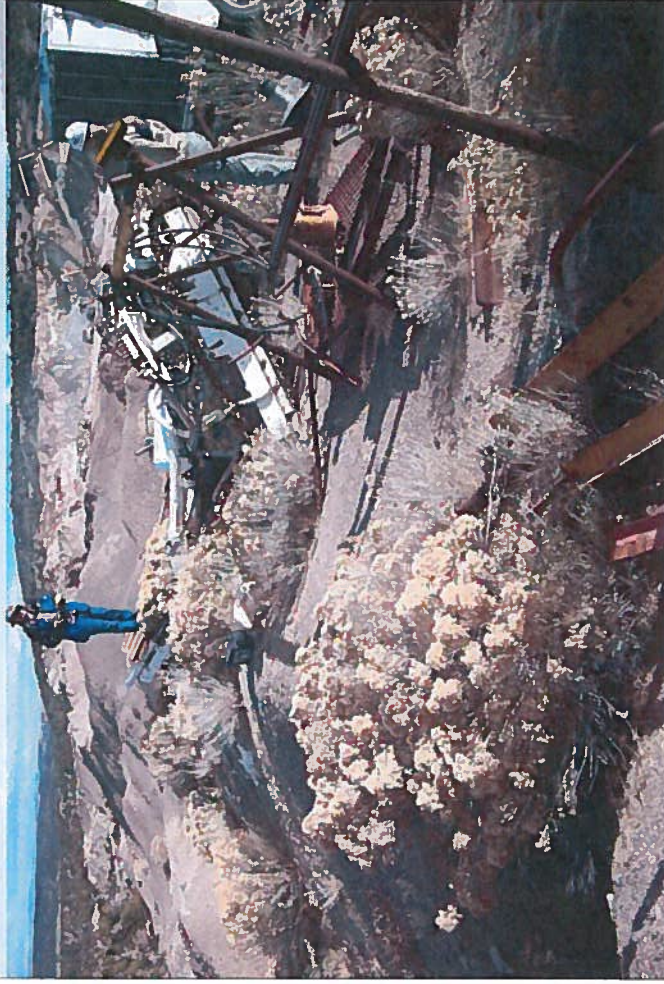
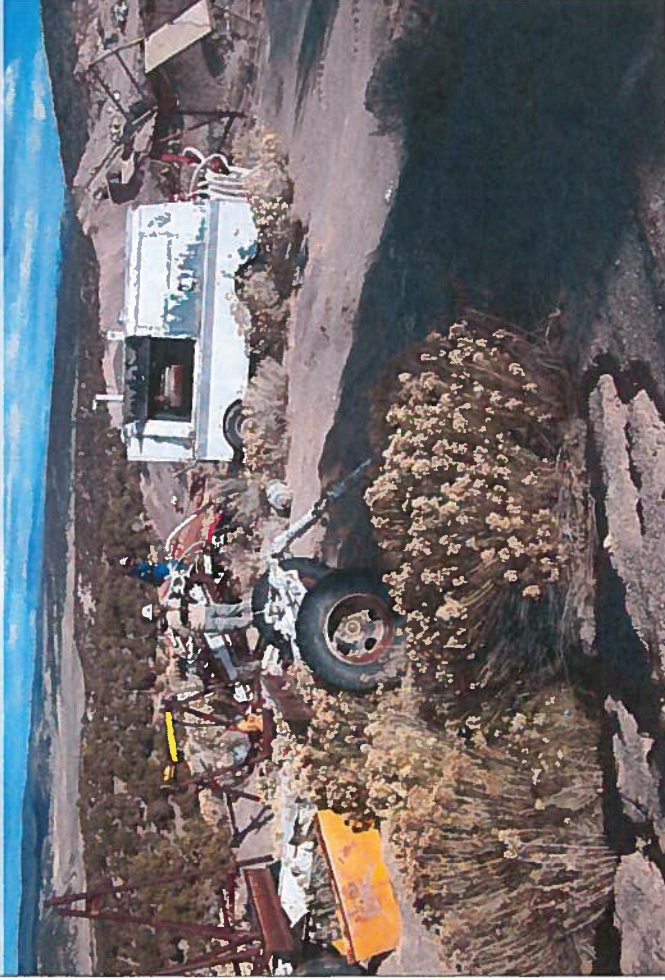
A refuse pile was noted just west of the active pit area (approximate GPS coordinates: 40.47765°, -108.04134°) containing old equipment, scrap metal and hoses, tires, a battery and other such refuse. Several small gullies had formed on the slope just north of the refuse pile, and it appeared that runoff from the pit access road exits the site directly through this pile.

Refuse pile located at northwest end of disturbed area, at approximate GPS location 40.47765, -108.04134.

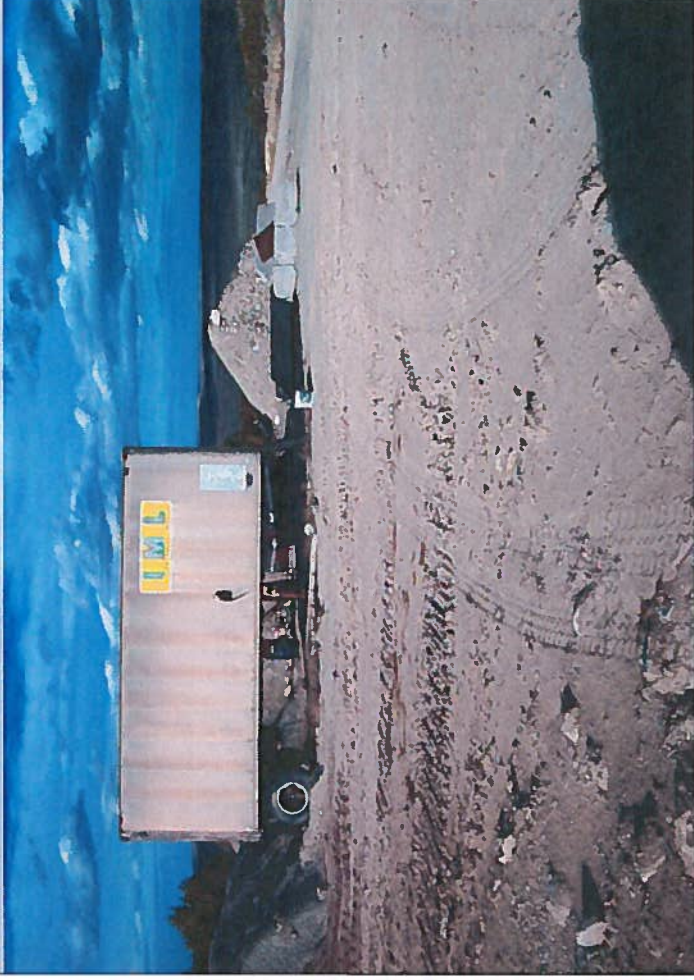
A trailer was located at the northwest end of the site, near the site entrance. The trailer contained various items such as oil containers, grease, and what appeared to be a strand of detonating cord. Two 55 gallon drums were located outside (north of) the trailer. One was used as a trash container. The other was approximately half full of some type of oil. This container was not labeled and was not capped.

View of trailer contents.
