**COLORADO DIVISION OF RECLAMATION, MINING AND SAFETY
MINERALS PROGRAM INSPECTION REPORT
PHONE: (303) 866-3567**

MINE NAME: Juniper Quarry	MINE/PROSPECTING ID#: M-1982-141	MINERAL: Limestone	COUNTY: Moffat
INSPECTION TYPE: Monitoring	INSPECTOR(S): Dustin M. Czapla	INSP. DATE: November 18, 2011	INSP. TIME: 12:00
OPERATOR: Moffat Limestone Company	OPERATOR REPRESENTATIVE: None	TYPE OF OPERATION: 112c - Construction Regular Operation

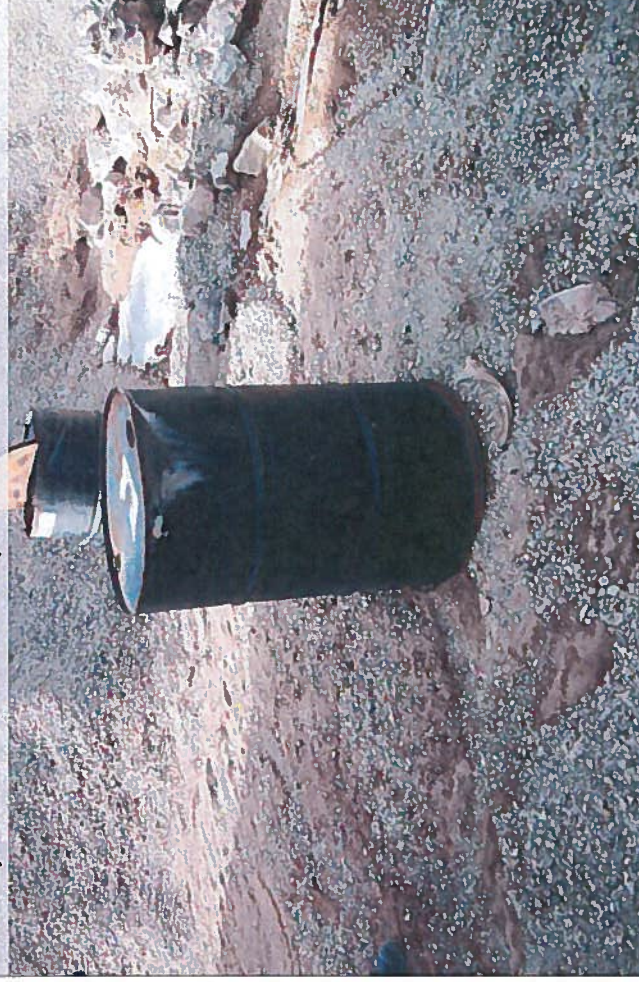
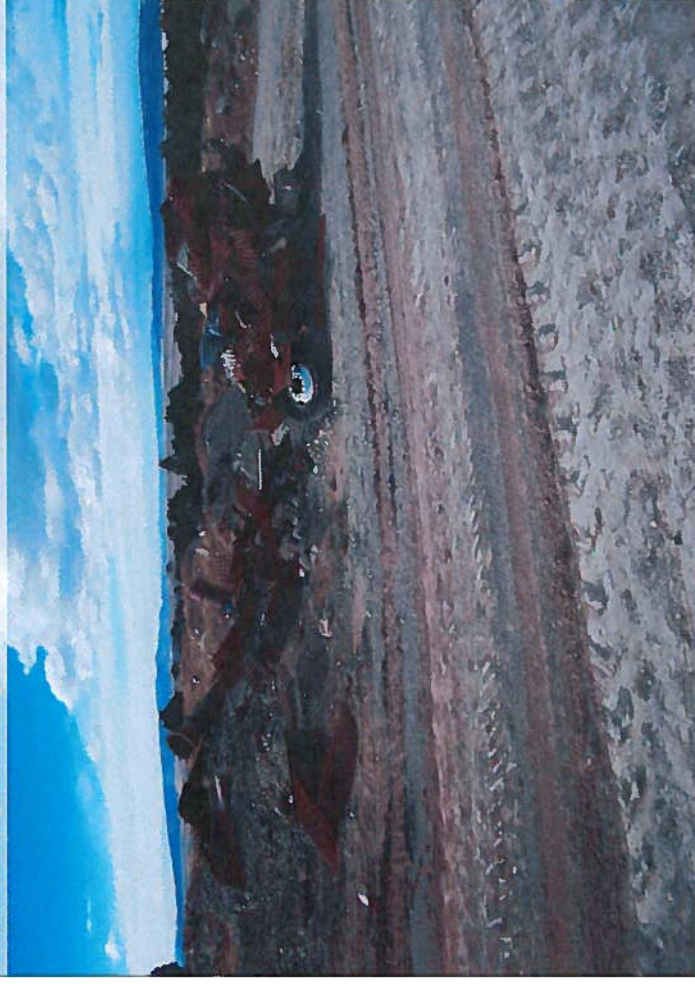
Another refuse pile was located south of the trailer containing mostly scrap metal, such as screens, culverts and piping, a refrigerator and other debris. It was unclear during this inspection if all of this material was related to this mine site.

View of refuse pile located just south of the trailer stored in northwest part of AM-1 area.
