COLORADO DIVISION OF RECLAMATION, MINING AND SAFETY
MINERALS PROGRAM INSPECTION REPORT
PHONE: (303) 866-3567

MINE NAME: West Rifle Pit	MINE/PROSPECTING ID#: M-1981-006	MINERAL: Sand and gravel	COUNTY: Garfield
INSPECTION TYPE: Monitoring	INSPECTOR(S): Dustin M. Czapla	INSP. DATE: March 8, 2012	INSP. TIME: 09:00
OPERATOR: Central Aggregates, Inc.	OPERATOR REPRESENTATIVE: Gilbert Lee	TYPE OF OPERATION: 112c - Construction Regular Operation

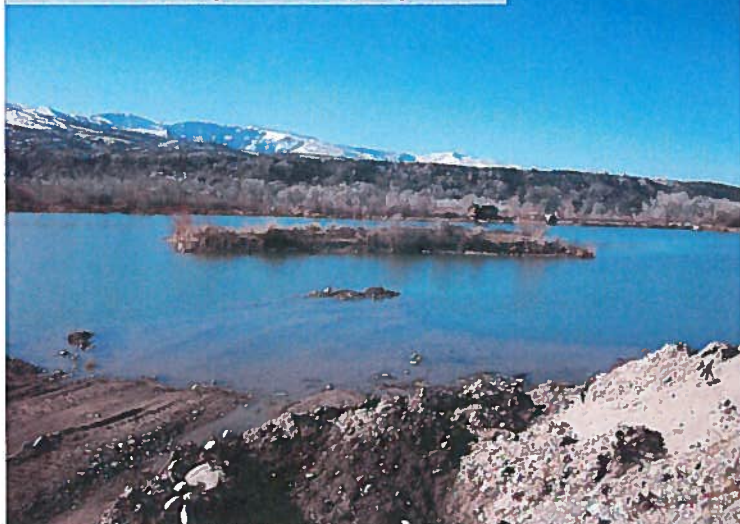
View from north-central part of lake bank, facing southwest.

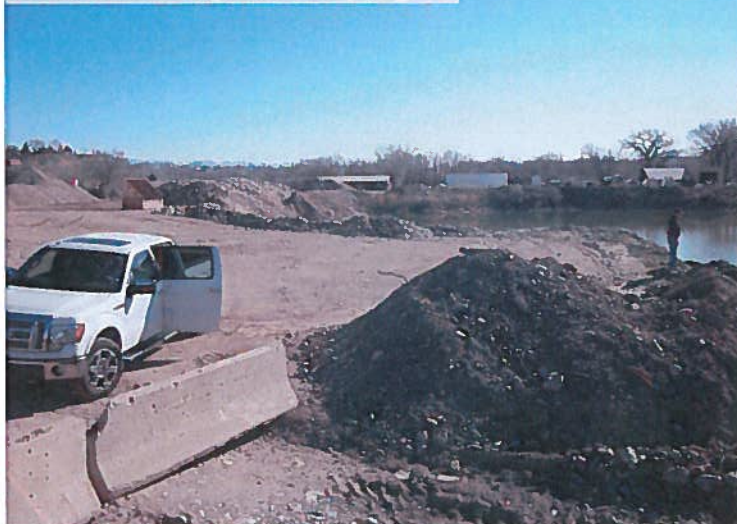
View from north-central part of lake bank, facing east.

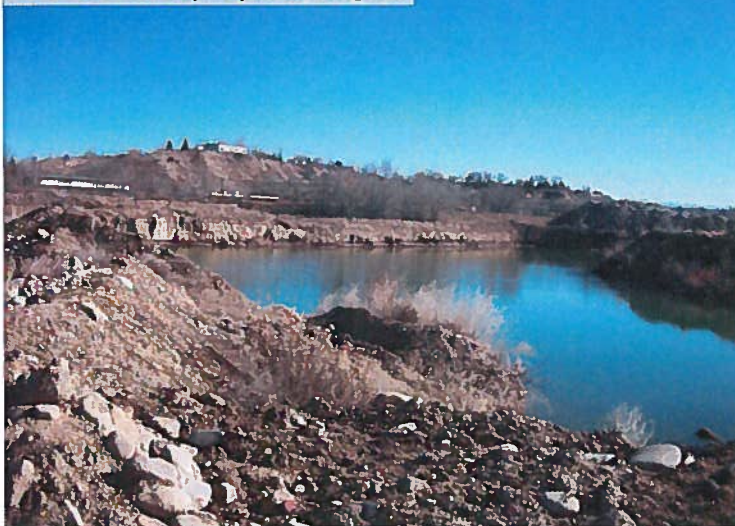
View from west side of pit in parcel D, facing east.

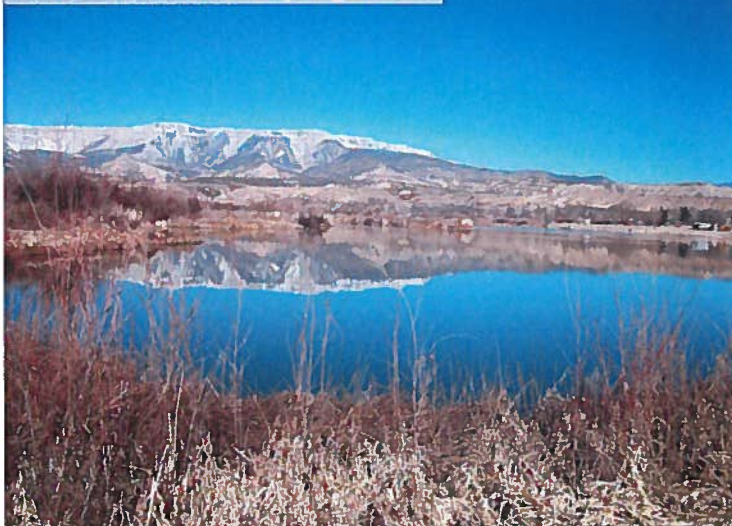
View from southeast corner of lake, facing northwest.

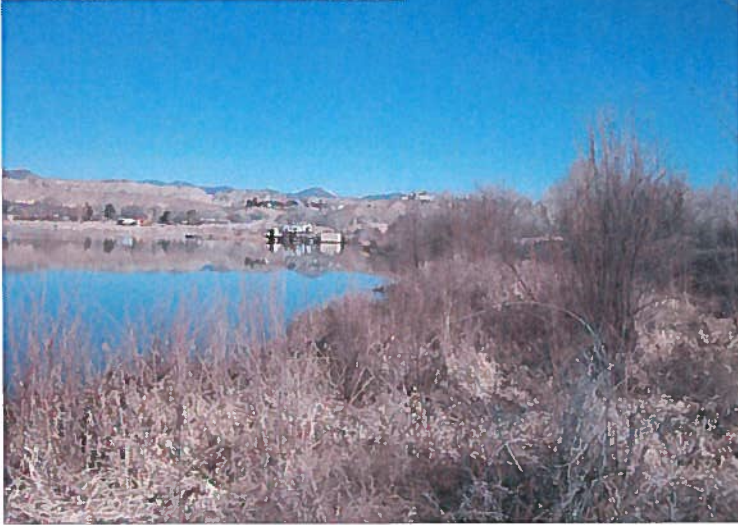
View from southeast corner of lake, facing north.

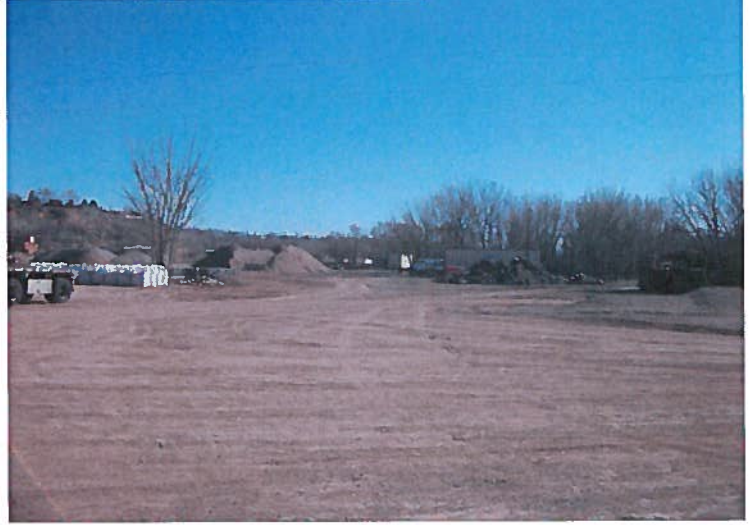
View from north side of office building, facing east.

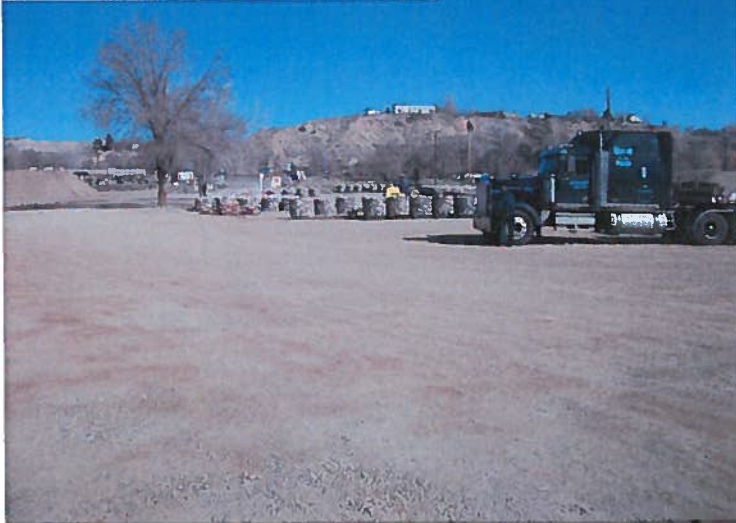
View from north side of office building, facing north.

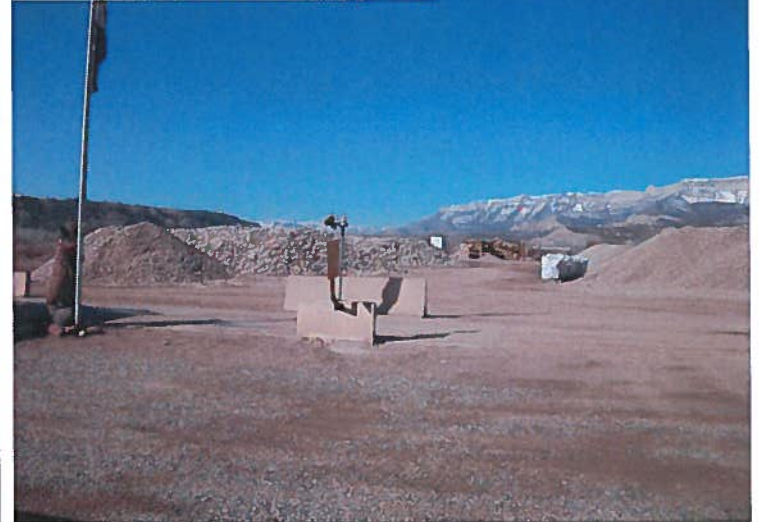
View from north side of office building, facing west.
