**COLORADO DIVISION OF RECLAMATION, MINING AND SAFETY**  
**MINERALS PROGRAM INSPECTION REPORT**  
**PHONE: (303) 866-3567**

<b>MINE NAME:</b> Mamm Creek Sand & Gravel	<b>MINE/PROSPECTING ID#:</b> M-2000-113	<b>MINERAL:</b> Sand and gravel	<b>COUNTY:</b> Garfield
<b>INSPECTION TYPE:</b> Monitoring	<b>INSPECTOR(S):</b> Dustin M. Czapla	<b>INSP. DATE:</b> March 8, 2012	<b>INSP. TIME:</b> 11:00
<b>OPERATOR:</b> Lafarge West, Inc.	<b>OPERATOR REPRESENTATIVE:</b> Steve Fisk	<b>TYPE OF OPERATION:</b> 112c - Construction Regular Operation

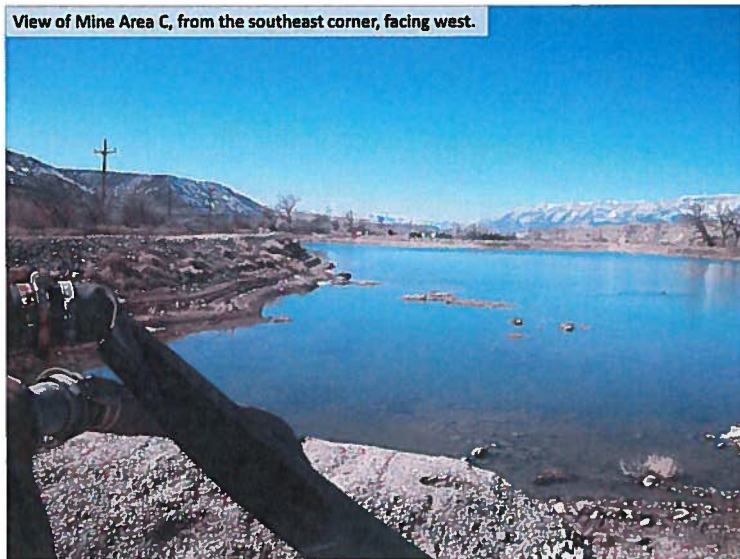
Mine Area C has also been mined out and is mostly reclaimed. Slopes around this pond were approximately 2H:1V. So grading slopes to 3H:1V or less, topsoiling and seeding remains to be completed in this area. A drill pad has been constructed in the southwest portion of this area.

View of Mine Area C, from the southeast corner, facing west.

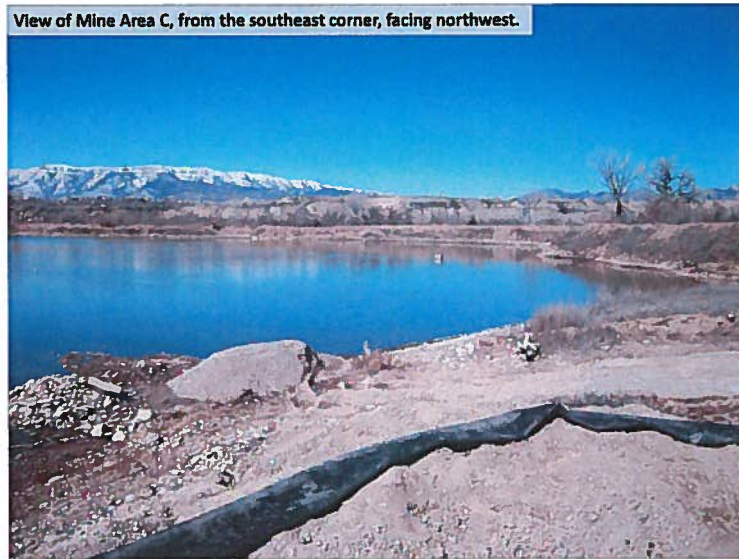
View of Mine Area C, from the southeast corner, facing northwest.

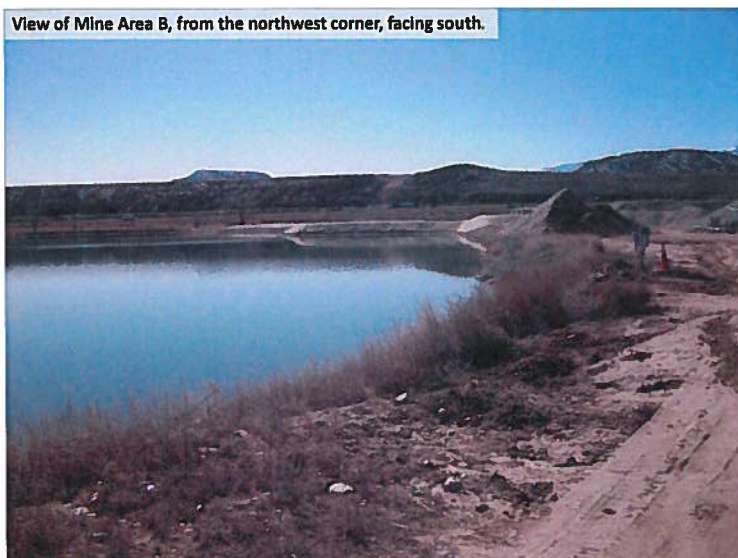
Mine area B has been mined out as well and was undergoing reclamation during this inspection. The slopes of the lake were graded to 3H:1V or flatter, and most had been seeded and mulched. The south bank of the Colorado River, adjacent to the northeast portion of this area, experienced significant erosion during the last year's high spring-runoff event. Construction efforts to stabilize the affected bank, authorized through an Army Corp of Engineers Permit, were occurring during this inspection. Reconfiguration of the inflow structure in this area, that had experienced some erosion during last year's runoff, had been completed prior to this inspection. The outflow structure appeared stable and seemed to have functioned properly during the last year's high spring-runoff event. A drill pad has been constructed in the southeast portion of this area.

View of Mine Area B, from the northwest corner, facing south.

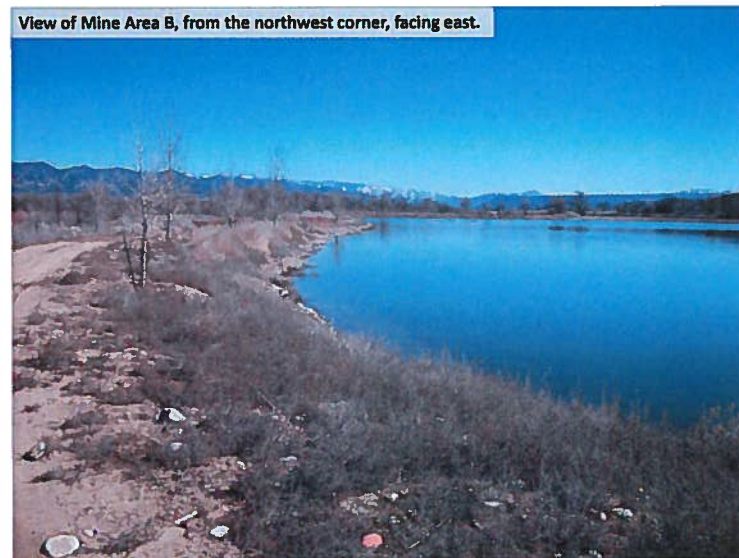
View of Mine Area B, from the northwest corner, facing east.

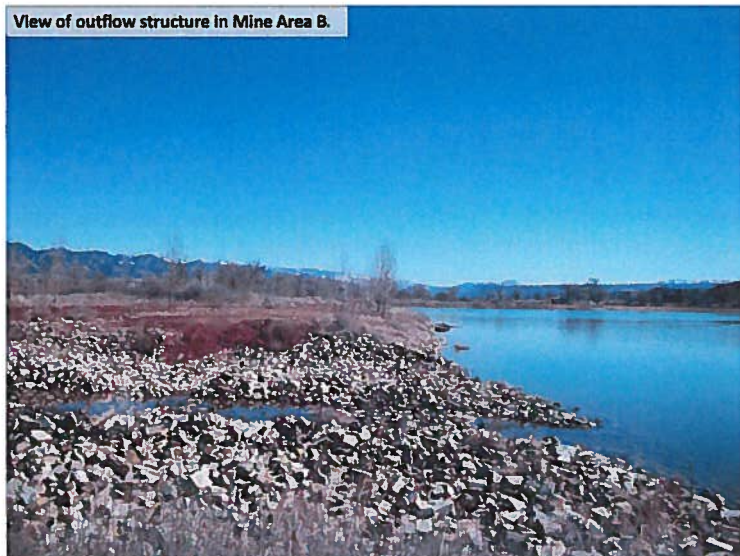
View of outflow structure in Mine Area B.

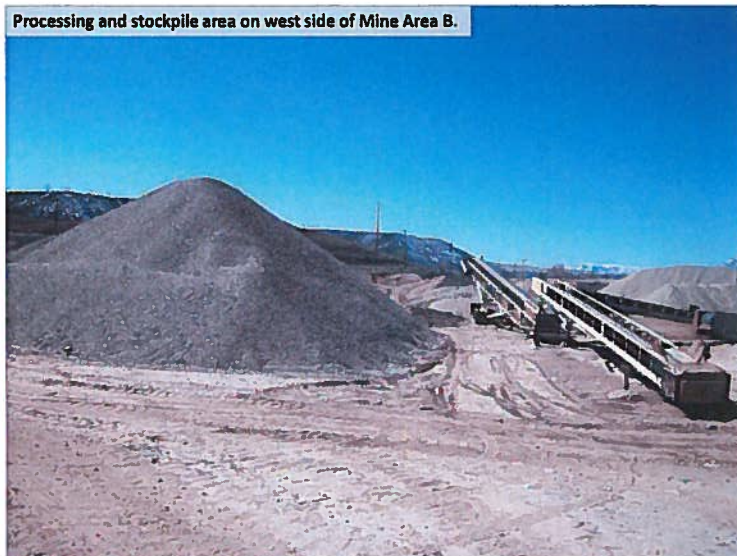
Processing and stockpile area on west side of Mine Area B.

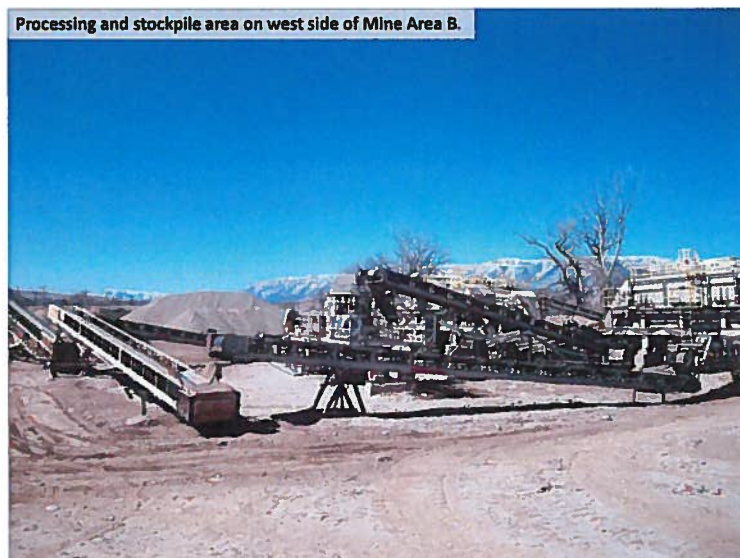
Processing and stockpile area on west side of Mine Area B.

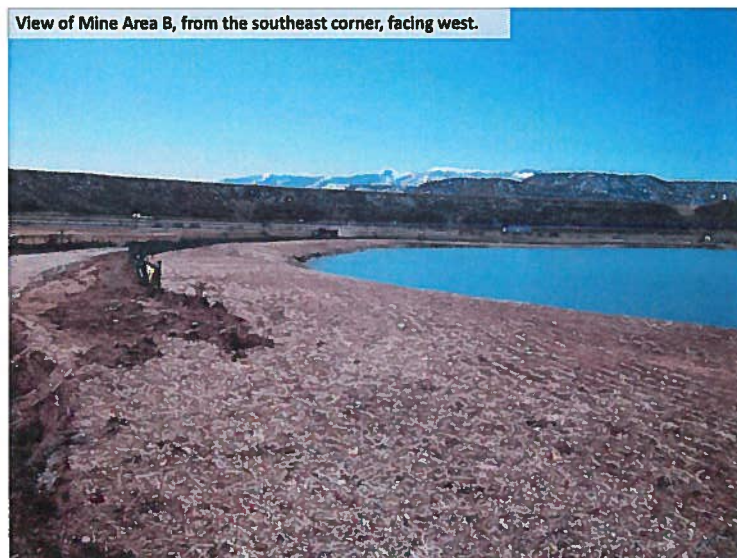
View of Mine Area B, from the southeast corner, facing west.

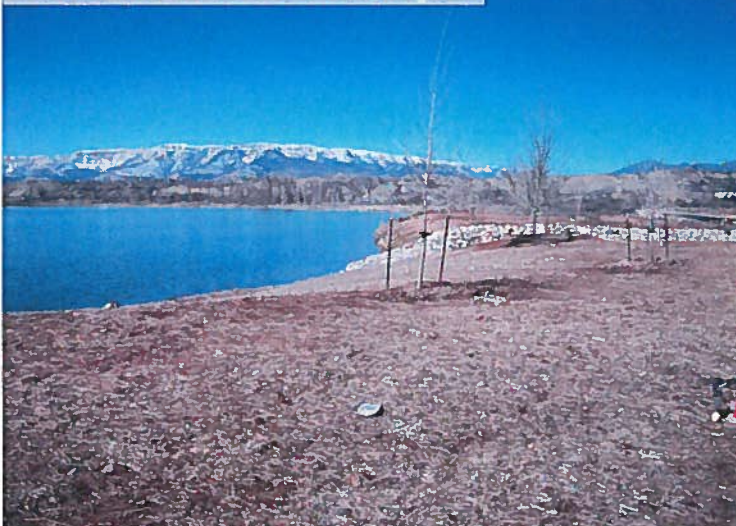
View of Mine Area B, from the northeast corner, facing west.

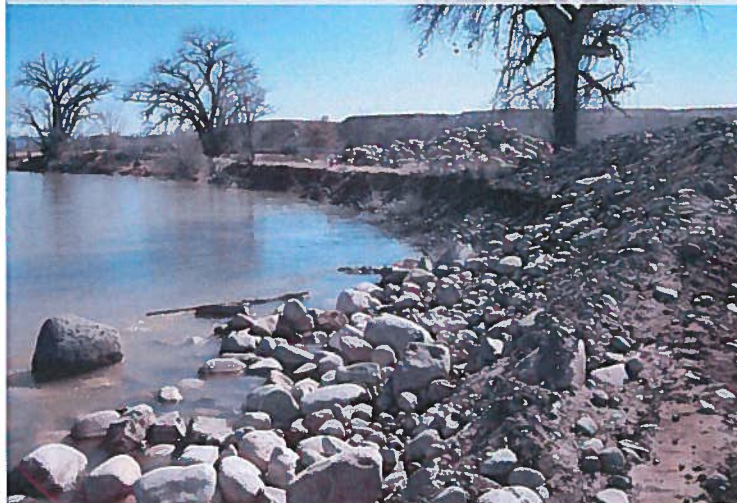
View of the south bank of the Colorado River, just upstream of the inflow structure in Mine Area B, that was affected during the last year's high spring-runoff. View is facing upstream.

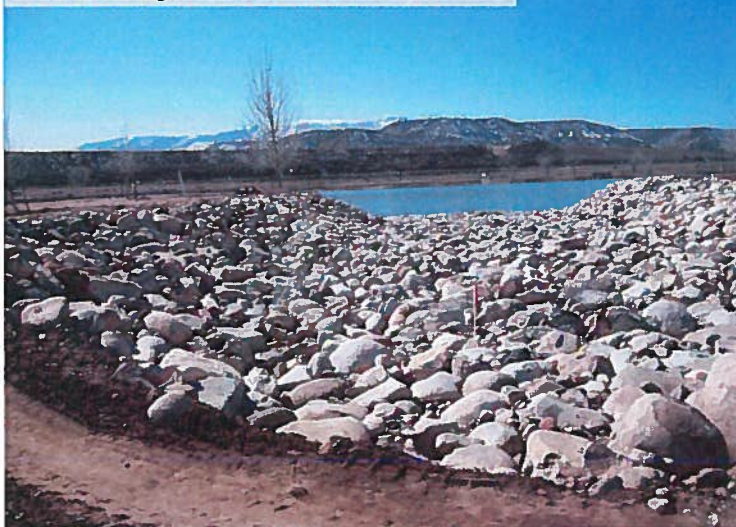
View of the reconfigured inflow structure located in Mine Area B.

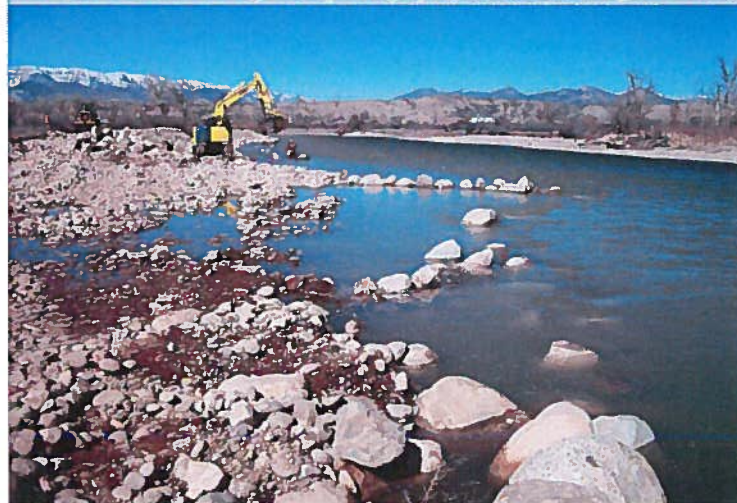
View of the south bank of the Colorado River, just downstream of the inflow structure in Mine Area B, that was affected during the last year's high spring-runoff. View is facing downstream.

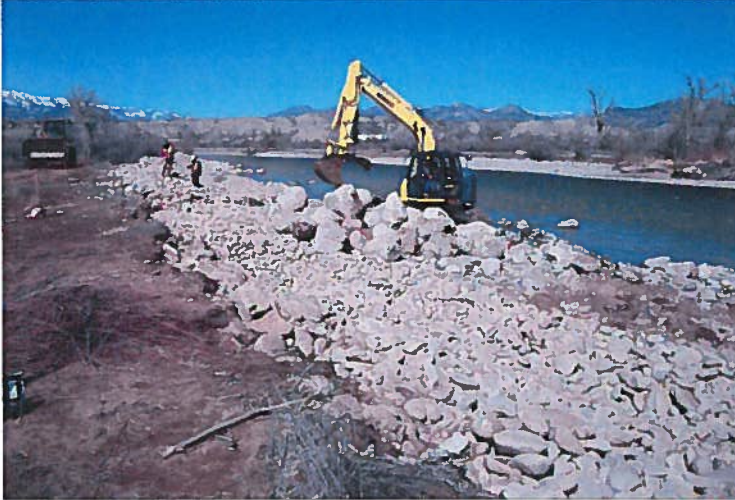
View of the south bank of the Colorado River, just downstream of the inflow structure in Mine Area B, that was affected during the last year's high spring-runoff. View is facing downstream.

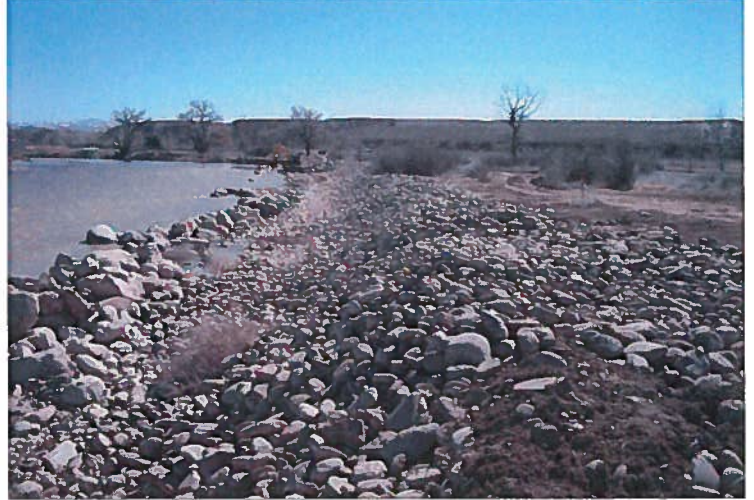
View of the south bank of the Colorado River, just downstream of the inflow structure in Mine Area B, that was affected during the last year's high spring-runoff. View is facing upstream.

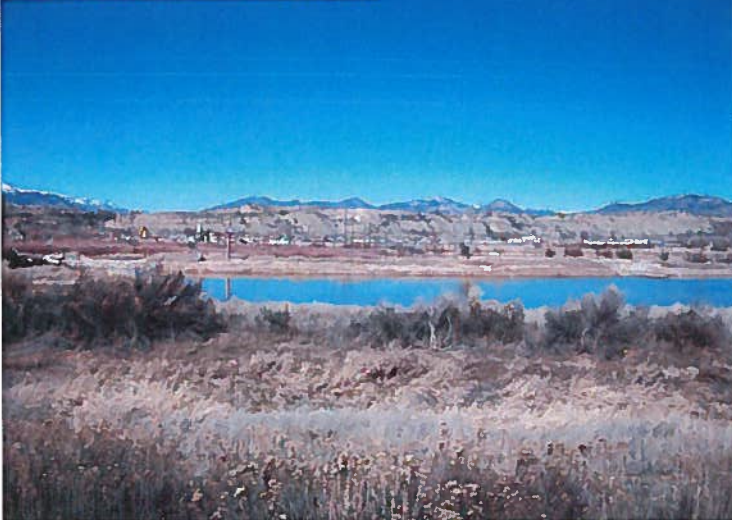
Mine Area E has been mined out and is mostly reclaimed. The banks of the pond appeared stable and well vegetated. The inflow and outflow structures appeared stable and seemed to have functioned properly during the last year's high spring-runoff event. The west portion of this area is used for equipment storage.

View of Mine Area E, from CR316, facing north.

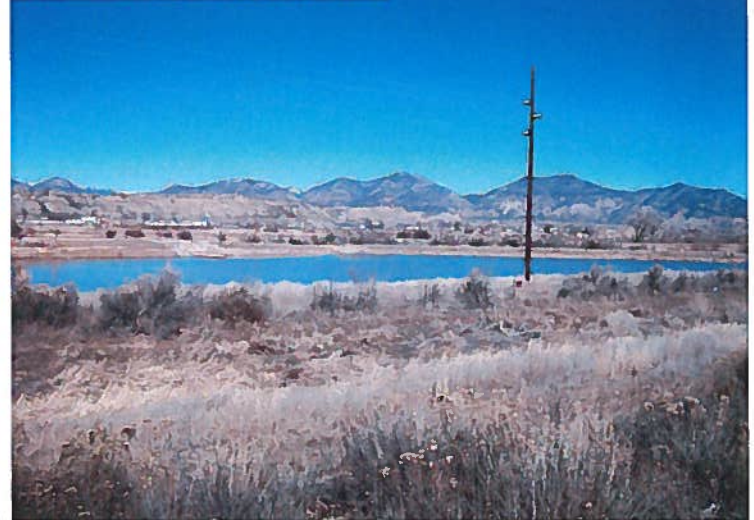
View of Mine Area E, from CR316, facing north.
