COLORADO DIVISION OF RECLAMATION, MINING AND SAFETY
MINERALS PROGRAM INSPECTION REPORT
PHONE: (303) 866-3567

MINE NAME: Williams Fork Pit	MINE/PROSPECTING ID#: M-1984-168	MINERAL: Sand and gravel	COUNTY: Moffat
INSPECTION TYPE: Monitoring	INSPECTOR(S): Dustin M. Czapla	INSP. DATE: March 27, 2012	INSP. TIME: 10:30
OPERATOR: Williams Fork Mining Company	OPERATOR REPRESENTATIVE: Forrest Luke	TYPE OF OPERATION: 112c - Construction Regular Operation

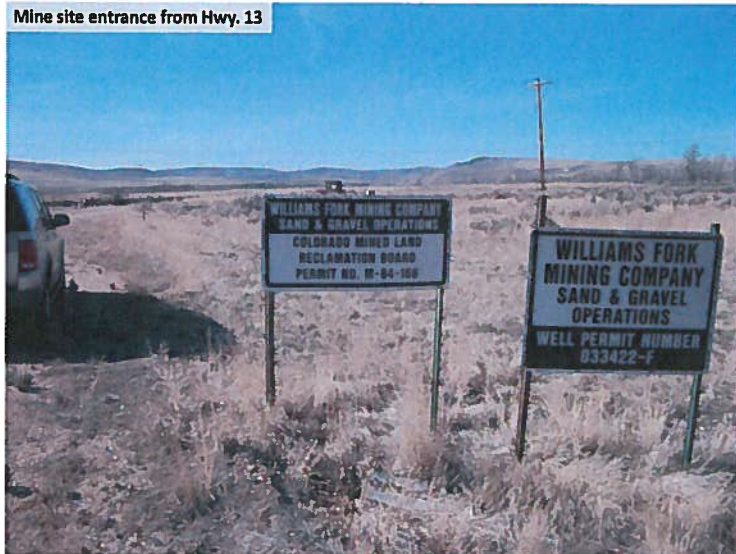
Adequate mine identification signage was noted at the entrance to the site.

Mine site entrance from Hwy. 13

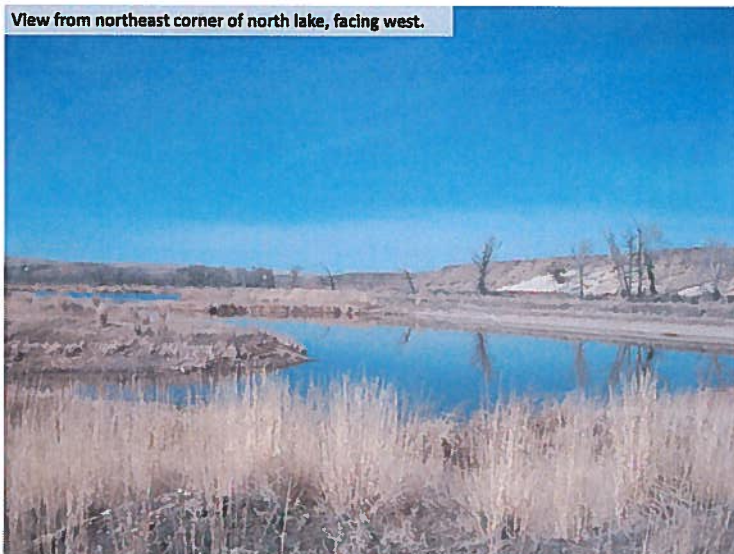
View from northeast corner of north lake, facing west.

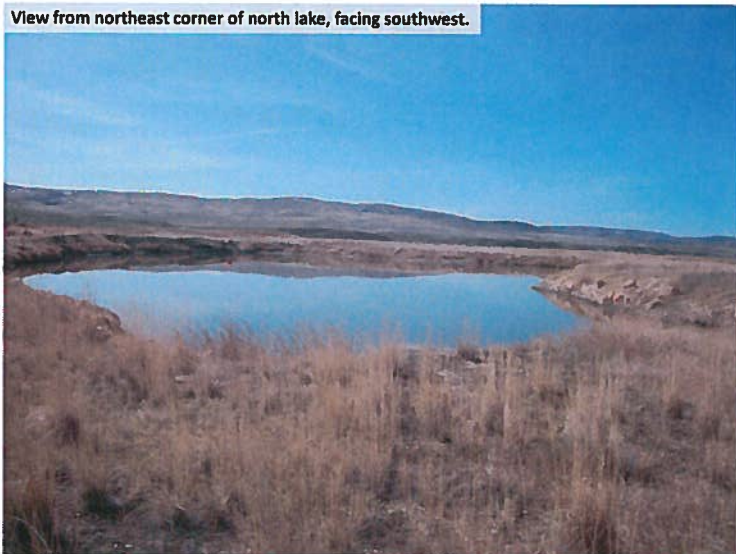
View from northeast corner of north lake, facing southwest.

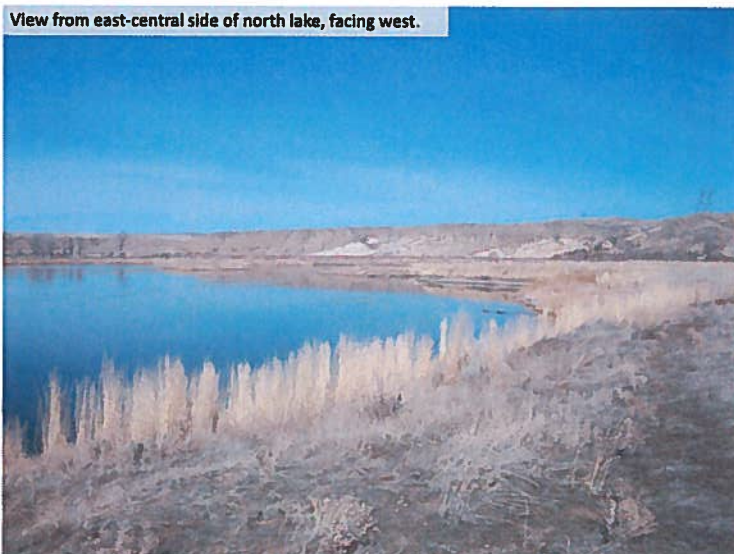
View from east-central side of north lake, facing west.

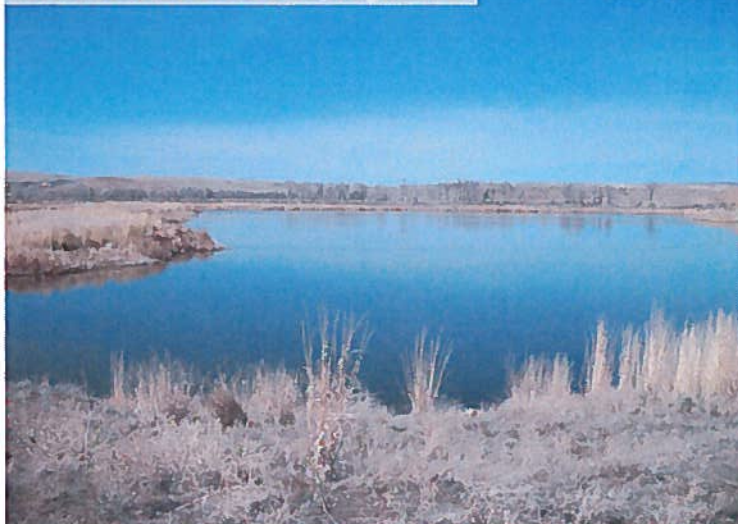
View from east-central side of north lake, facing southwest.

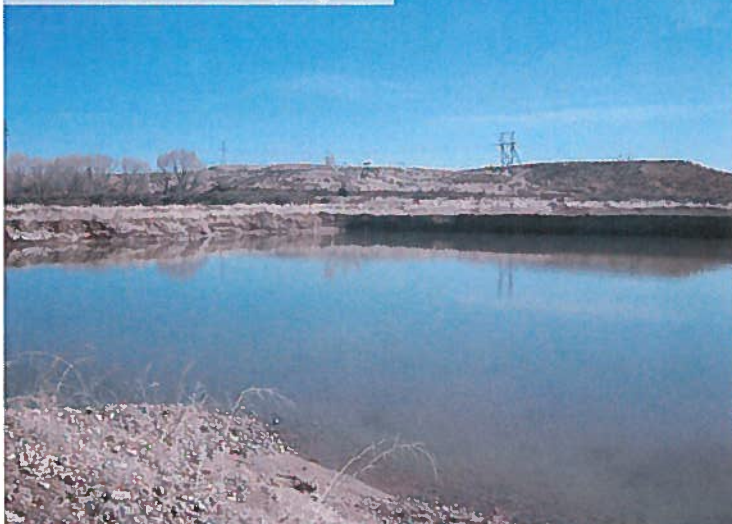
View from north side of south lake, facing east.

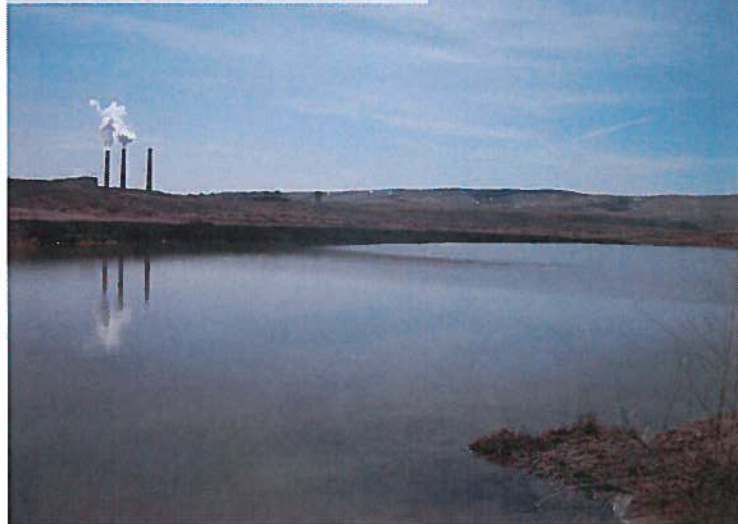
View from north side of south lake, facing southeast.

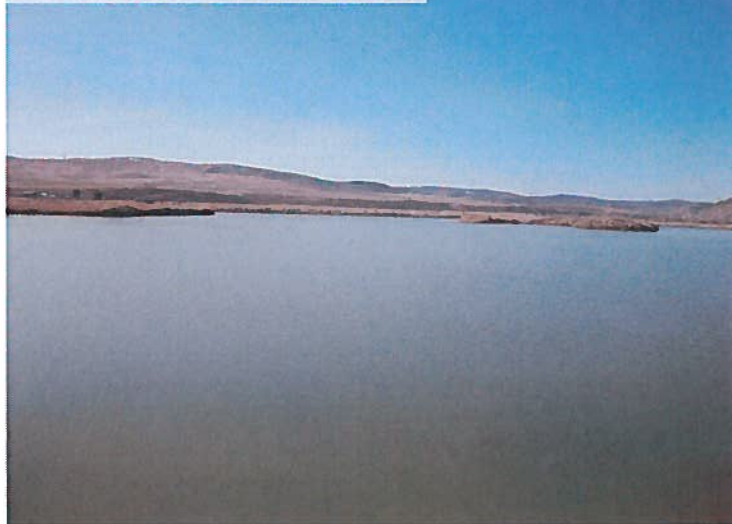
View from north side of south lake, facing southeast.
