Subject: Seneca IIW Mine C1982057 March 13 2012 Complete Inspection

COLORADO DIVISION OF RECLAMATION, MINING AND SAFETY COAL PROGRAM INSPECTION REPORT

Permit Number: C-1982-057	County: Routt				
Mine Name: Seneca II-W Mine	Operation Type: Surface				
Operator: Seneca Coal Company, LLC	Permit Status: Active				
Operator Address:	Ownership: Federal				
Mr Roy Karo	_				
37796 Routt County Road 53	Operator Representative Present:				
P.O. Box 670					
Hayden, CO 81639	Roy Karo				
•					
Operator Representative Signature: (Field Issuance Only)

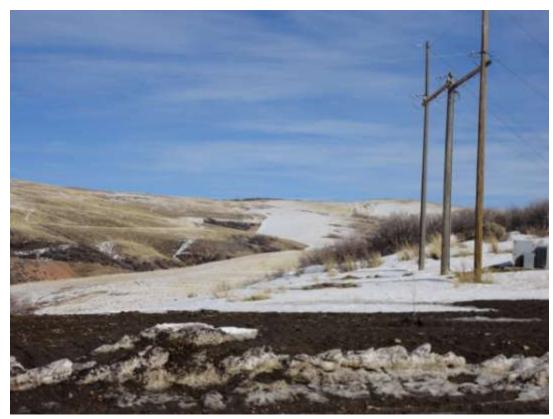
A Pit/Upper 006 Drainage

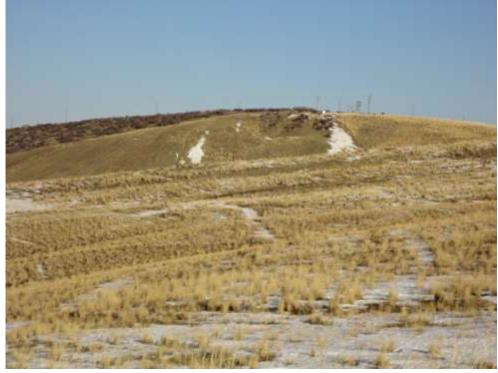
B Pit and Substation

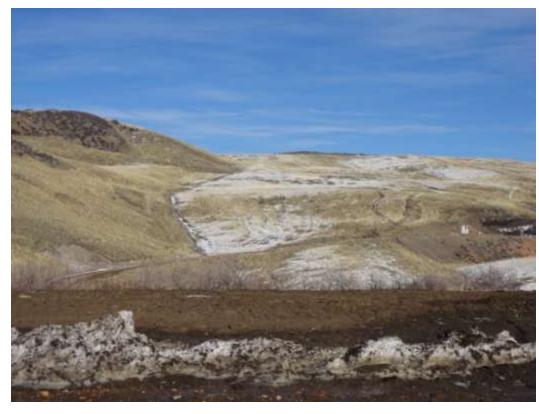
006 Drainage and Oil well site

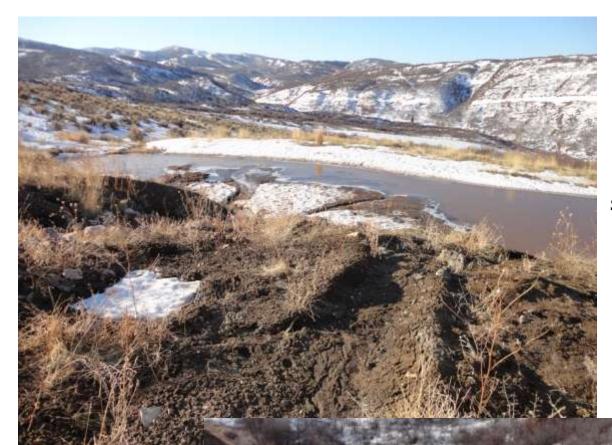
Ponds 005 and 006 were both discharging. Stock tanks T-1, T-2, T-3, and T-5 all held water. Stock Tank T-3 will need to be cleaned out this year; there was a fair amount of sediment in a delta at the outlet of Culvert A-1. Ponds 009, 015, 016, and 017 and Stock Tanks 18, 20, 25, 26, and 27 were inaccessible. The reconstructed section of Gulch 006 appeared to be stable.

Sediment Delta in Stock Tank T2

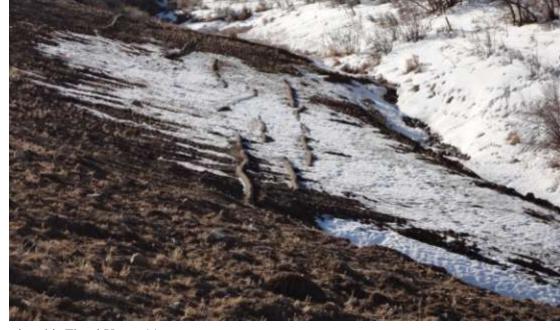
Reconstructed 006 Gulch
