Re: King I Mine, C-1981-035
Don May, P.E.: Quarterly Inspection
4th Quarter 2011

INSPECTION REPORT

Site: National King Coal Mine, GCC Energy , Hesperus, Colorado

Inspection Date: 4th Quarter Inspection, Dec 14, 2011

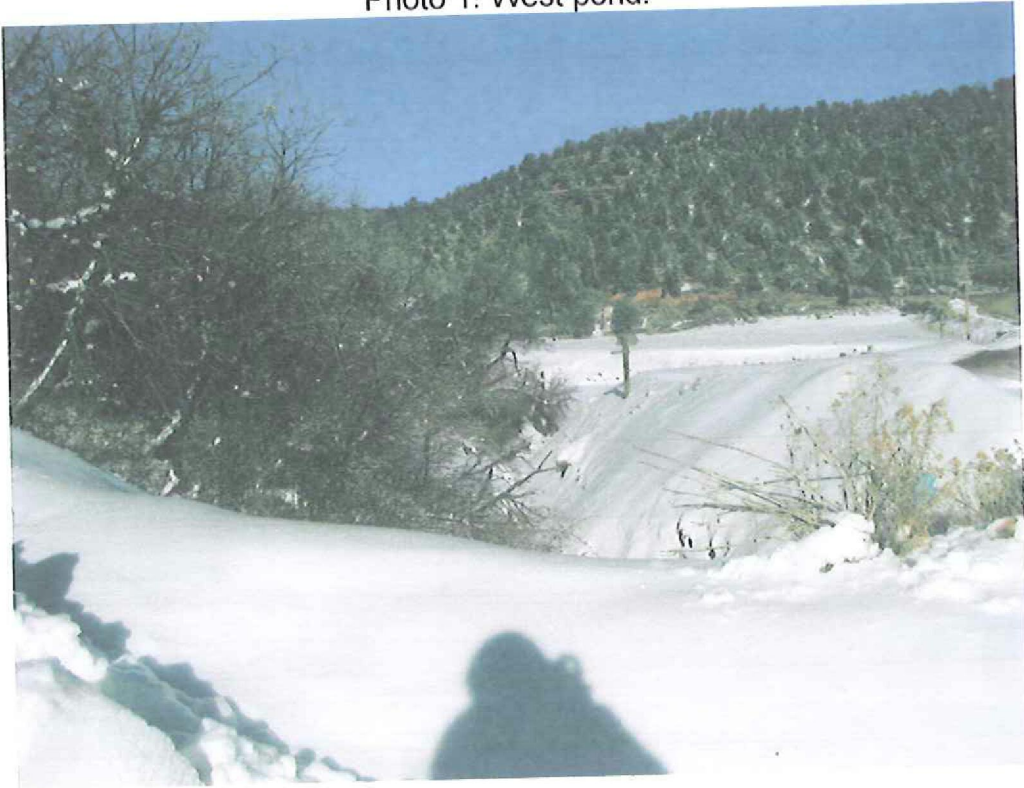
Ponds: Photograph 1 shows the west pond and photo 2 the east pond. Both ponds appear to operating properly. The inlets, outlets and embankments of both ponds are generally in good condition although the depth of both ponds should be checked and sediment removed to assure the design volume.

Photo 1. West pond.

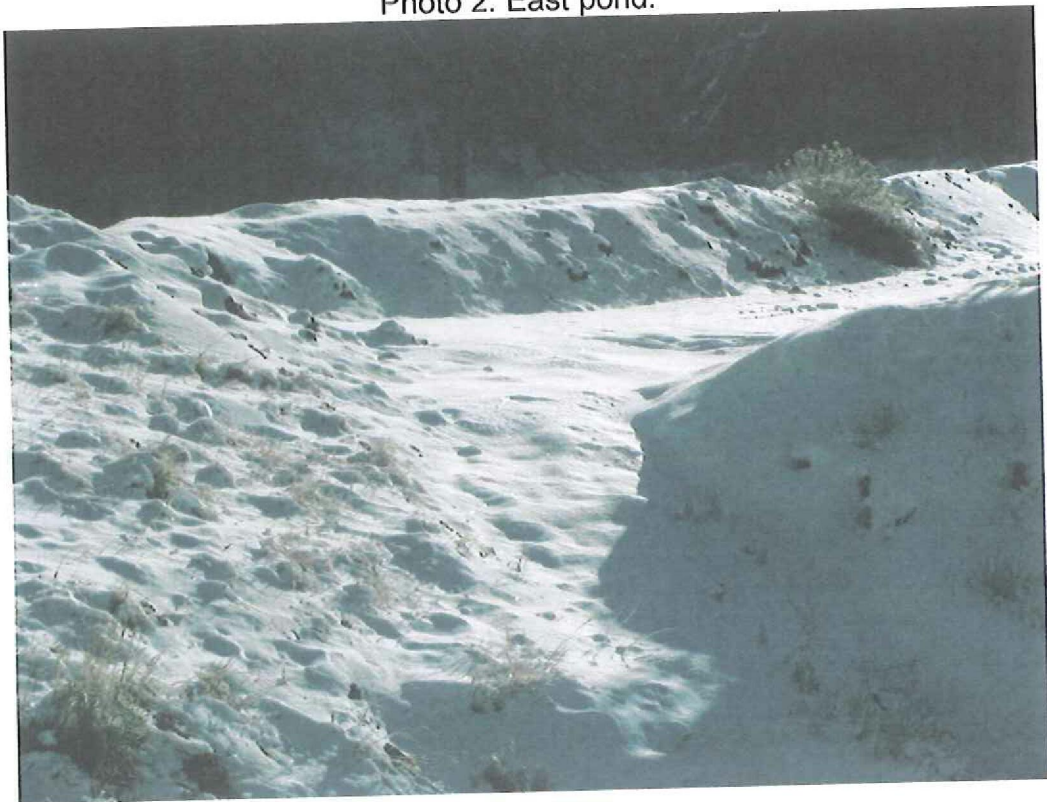
Photo 2. East pond.

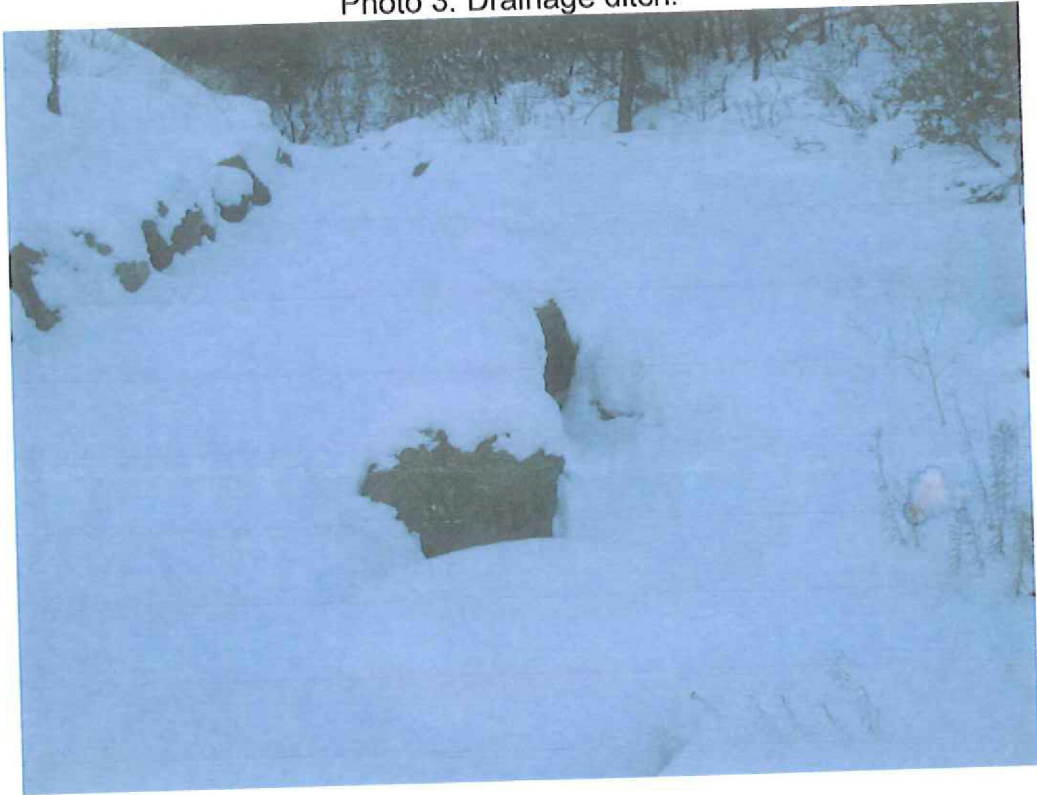
Drainage Ditches: The rock lined "dirty" drainage ditch that carries water from the top of the waste pile is shown in photograph 3. Flow in an area on the left bank, looking downstream, approximately half way down the channel appears to be jumping the channel bank and eroding the adjacent hillside, as mentioned in the previous report. In the spring the channel should be modified to prevent overtopping in this area. Photograph 4 shows one of the inlet-outlet drainage areas in the upper yard. All pipe and drainage grate inlets should be checked and cleared of blockage. In the Sept 2011 inspection one or more drainage grates was covered with debris. Snow cover prevented detailed inspection. These grates should be cleaned in the spring. Care should be taken not to bury drainage grates or ditches with the new fill being placed in the yard area.

Photo 3. Drainage ditch.

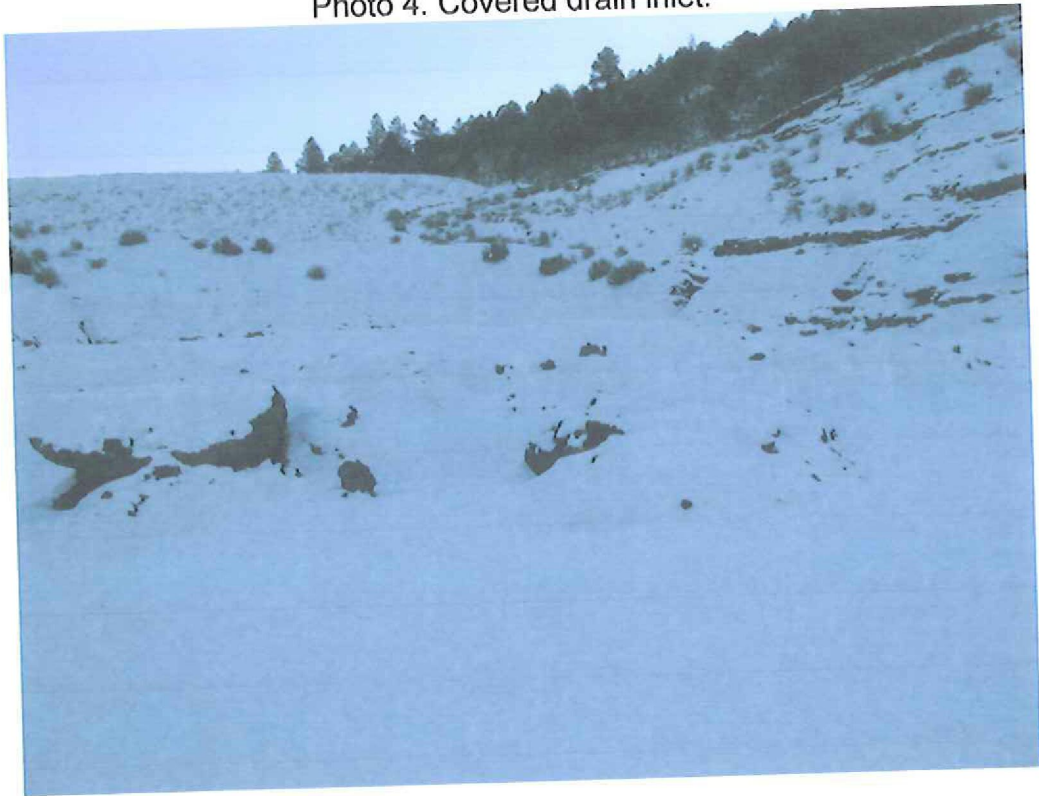
Photo 4. Covered drain inlet.

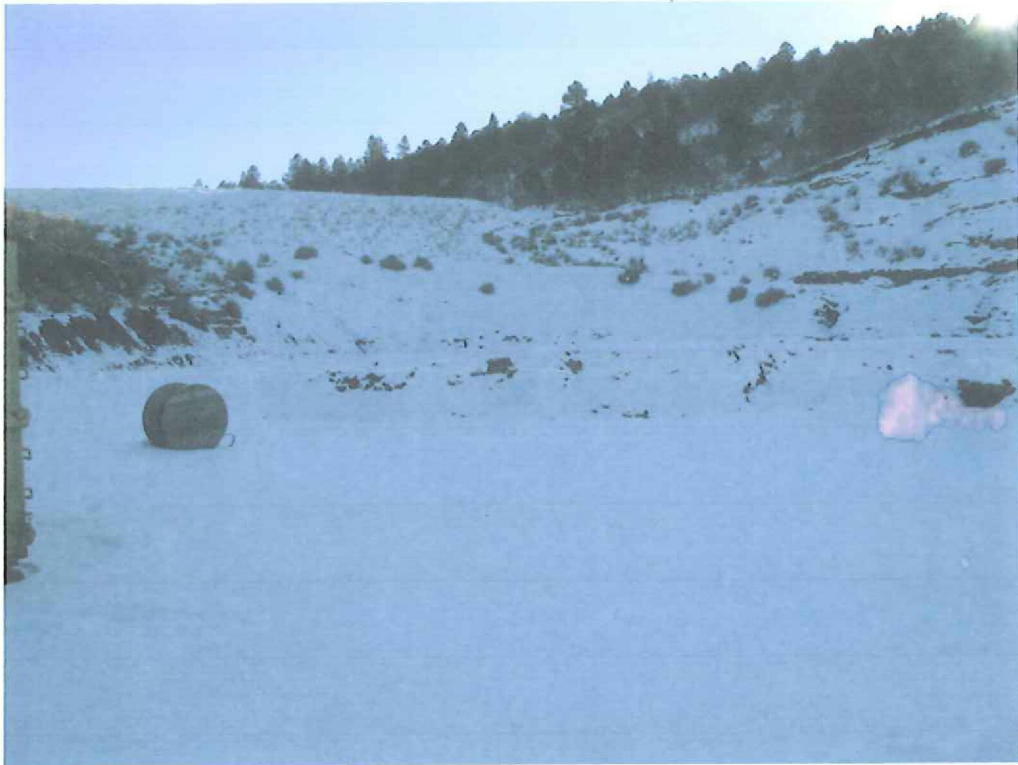
Coal Waste Pile: In general the waste rock refuse pile is in good condition. The face of the pile appears stable and shows no signs of unwarranted erosion although snow is covering the pile. This is shown in photo 5. The slope and compaction of the placed material should be checked to assure they meet the design requirements. As reported previously, a significant amount of mine waste has been stockpiled in the upper yard, adjacent to the toe of the waste pile and where the coal storage pile used to be.

Photo 5. Face of refuse pile.
