COLORADO DIVISION OF RECLAMATION, MINING AND SAFETY
MINERALS PROGRAM INSPECTION REPORT
PHONE: (303) 866-3567

MINE NAME: Martin Pit 1-A	MINE/PROSPECTING ID#: M-1990-140	MINERAL: Sand and gravel	COUNTY: Moffat
INSPECTION TYPE: Monitoring	INSPECTOR(S): Dustin M. Czaplá	INSP. DATE: March 27, 2012	INSP. TIME: 11:30
OPERATOR: Duran & Pearce Contractors, Inc.	OPERATOR REPRESENTATIVE: Derek Duran	TYPE OF OPERATION: 110c - Construction Limited Impact

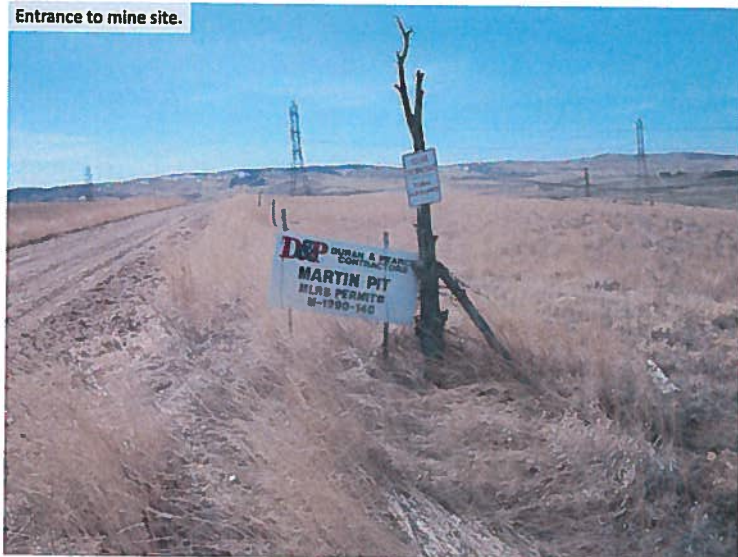
Adequate mine identification signage was noted at the site.

Entrance to mine site.

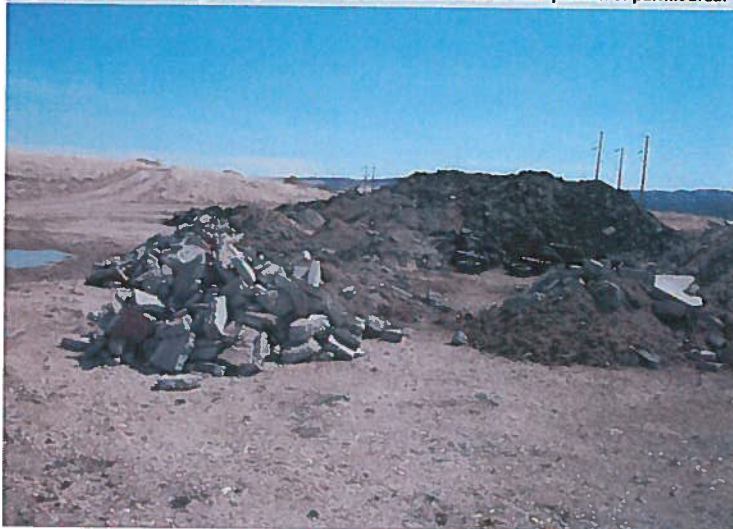
Asphalt and concrete fragments, old tires, old equipment and debris were observed in the western portion of the permit area. If the Operator intends to use any of the concrete or asphalt fragments for backfill material, than notice must be provided to the Division in accordance with Rule 3.1.5(9).

Asphalt and concrete fragments, tires and other refuse located in west portion of permit area.

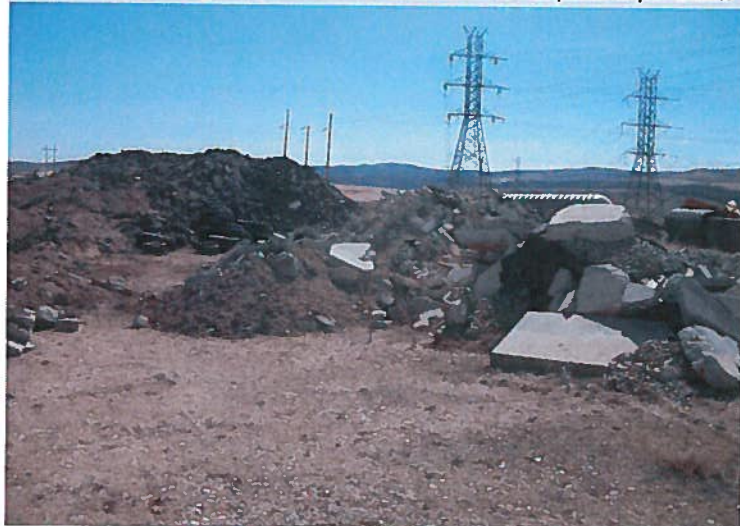
Asphalt and concrete fragments, tires and other refuse located in west portion of permit area.

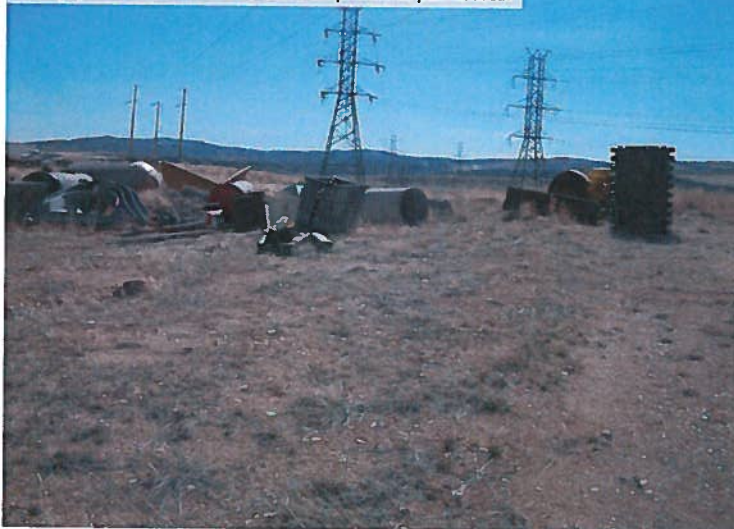
Old equipment and refuse located in west portion of permit area.

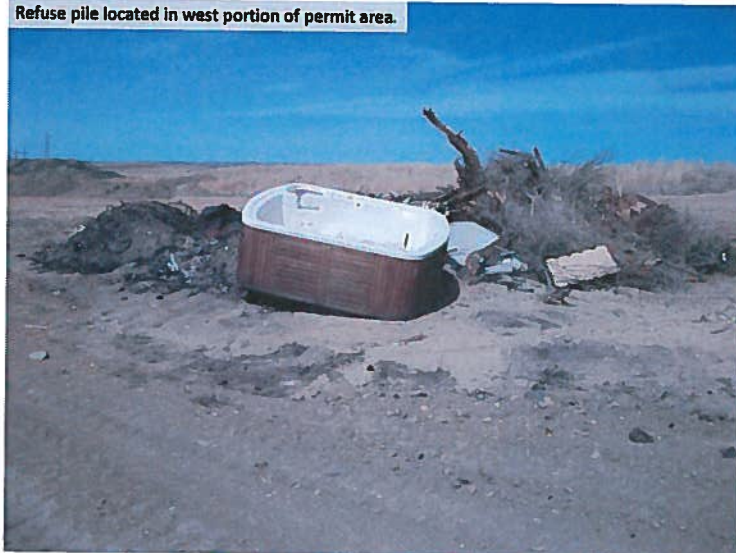
Refuse pile located in west portion of permit area.

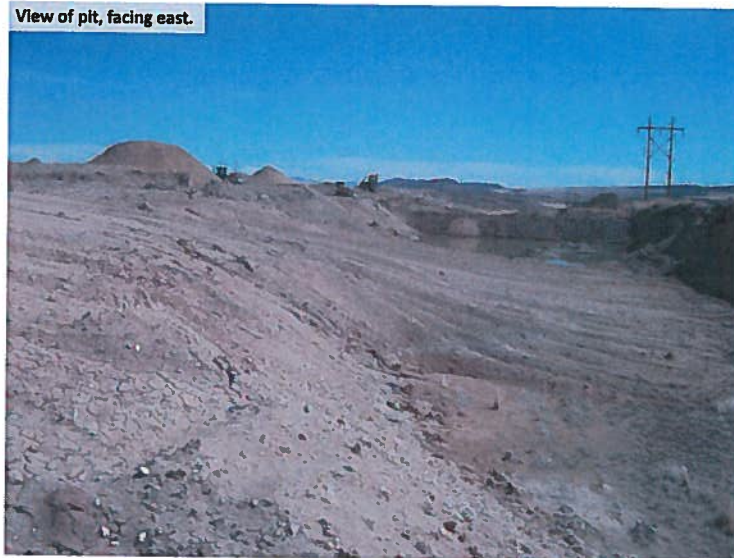
A pit was located in the south-central part of the permit area. The pit appeared to be approximately 1 acre in size. The south mine face of the pit was mostly vertical. Much of the remainder of the pit had been graded to 3H:1V or less. The approved Reclamation Plan for this site requires that all reclaimed slopes be no steeper than 4H:1V. The near vertical mine face along the south portion of the pit is near the south permit boundary, so reclamation costs will be calculated based on material volumes required for backfilling the slopes instead of for a cut and fill method.

Approximately one foot of water was observed in the excavated pit. This site is located on a ridge, so this water was likely collected from spring runoff and not groundwater. Seeps were not observed in the pit walls.

View of pit, facing east.

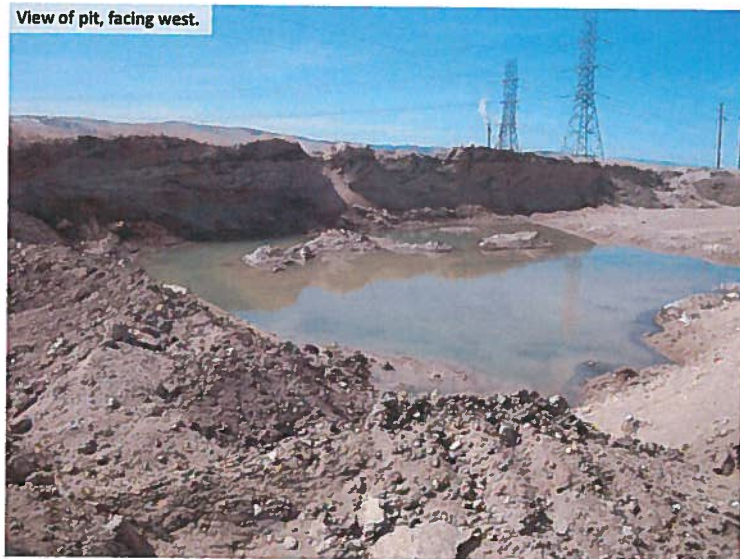
View of pit, facing west.

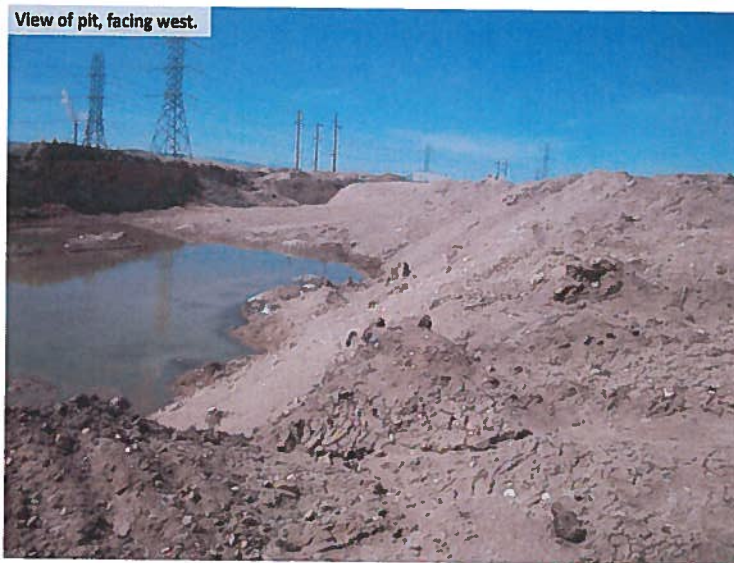
View of pit, facing west.
