COLORADO DIVISION OF RECLAMATION, MINING AND SAFETY
MINERALS PROGRAM INSPECTION REPORT
PHONE: (303) 866-3567

| MINE NAME: Wagner Pit | MINE/PROSPECTING ID#: M-2010-002 | MINERAL: Sand and gravel | COUNTY: Moffat |
| INSPECTION TYPE: Monitoring | INSPECTOR(S): Dustin M. Czapla | INSP. DATE: March 28, 2012 | INSP. TIME: 10:00 |

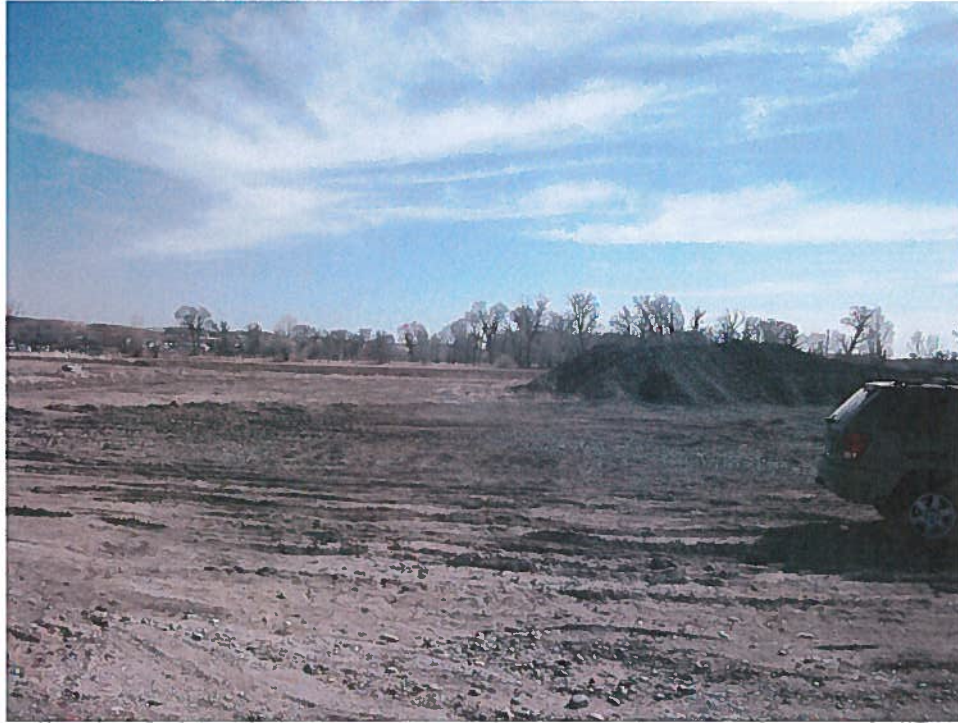
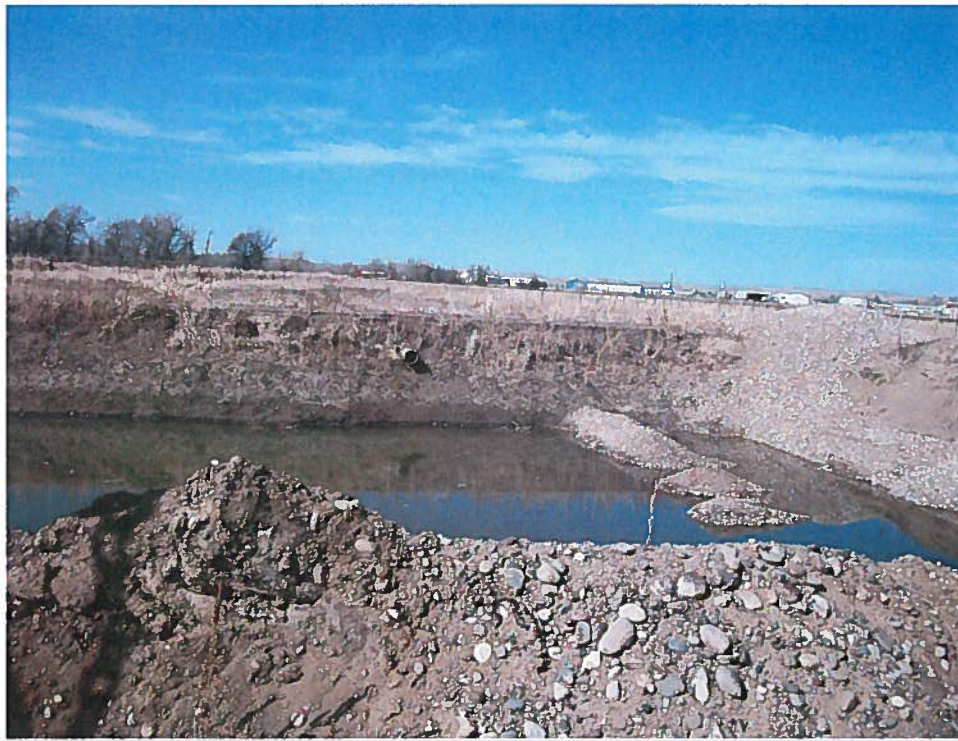
Adequate mine identification signage was not noted at the entrance to the site.

Mining at the site has not yet commenced. However, two wash ponds have been constructed in the west part of the permit area which are used to wash basalt rock extracted from the Wagner Rock site (M-1999-018). A small stock pile of gravel was located in the central part of the permit area.
