**COLORADO DIVISION OF RECLAMATION, MINING AND SAFETY**  
**MINERALS PROGRAM INSPECTION REPORT**  
**PHONE: (303) 866-3567**

<b>MINE NAME:</b> Wand Pit	<b>MINE/PROSPECTING ID#:</b> M-2010-007	<b>MINERAL:</b> Sand and Gravel	<b>COUNTY:</b> Moffat
<b>INSPECTION TYPE:</b> Monitoring	<b>INSPECTOR(S):</b> Dustin M. Czapla	<b>INSP. DATE:</b> March 28, 2012	<b>INSP. TIME:</b> 11:00
<b>OPERATOR:</b> Northwest Aggregates, Inc.	<b>OPERATOR REPRESENTATIVE:</b> P.J. Nichols	<b>TYPE OF OPERATION:</b> 110c - Construction Limited Impact

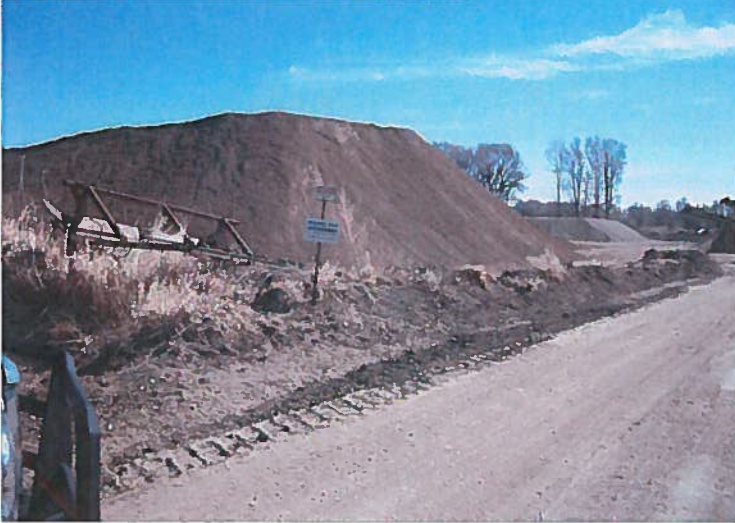
Entrance to mine site located at 40.505352°, -107.504427°

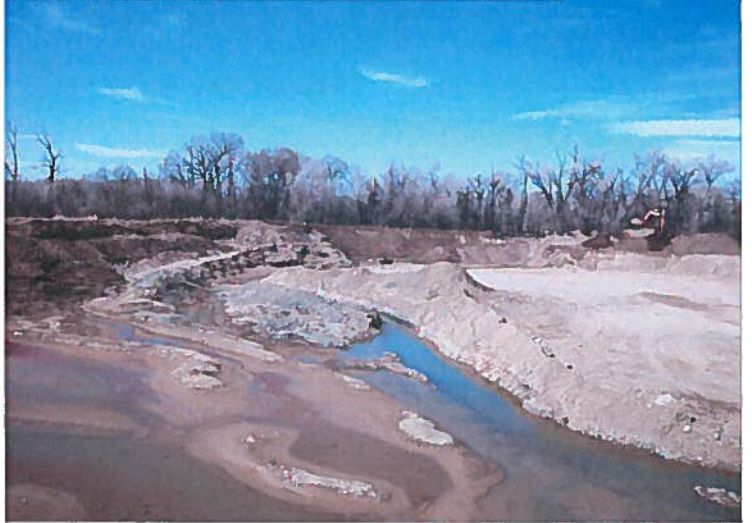
View toward southwest corner of the site, from the east side of the pit.

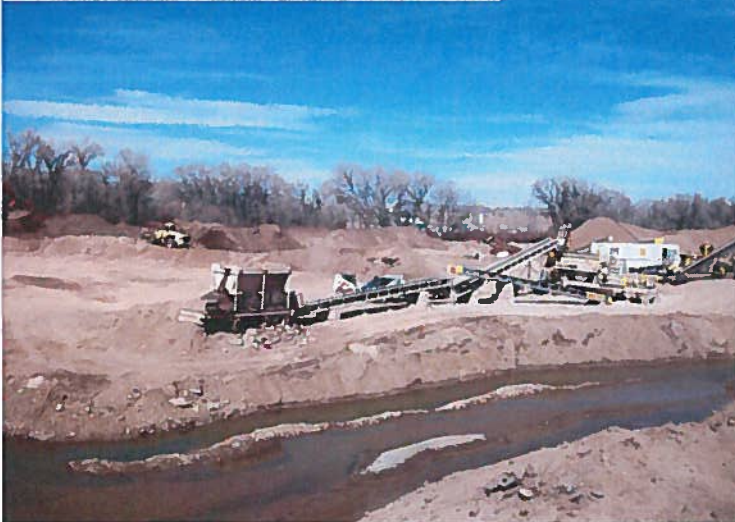
View toward west part of the site, from the east side of the pit.

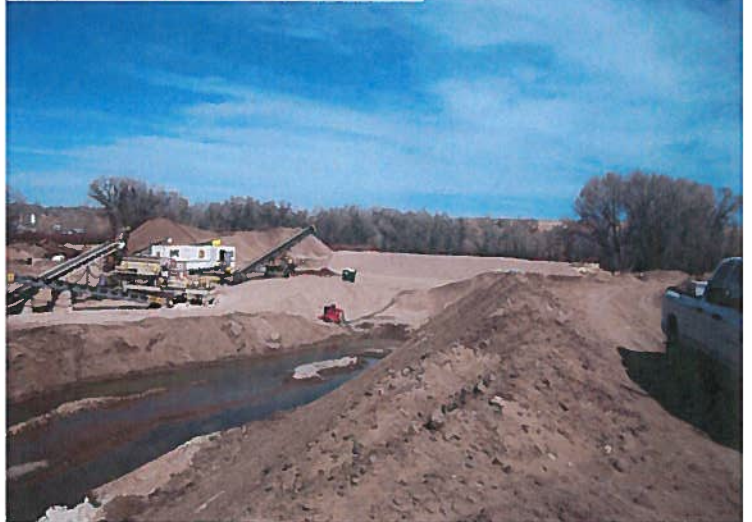
View toward the north along the east side of the pit.

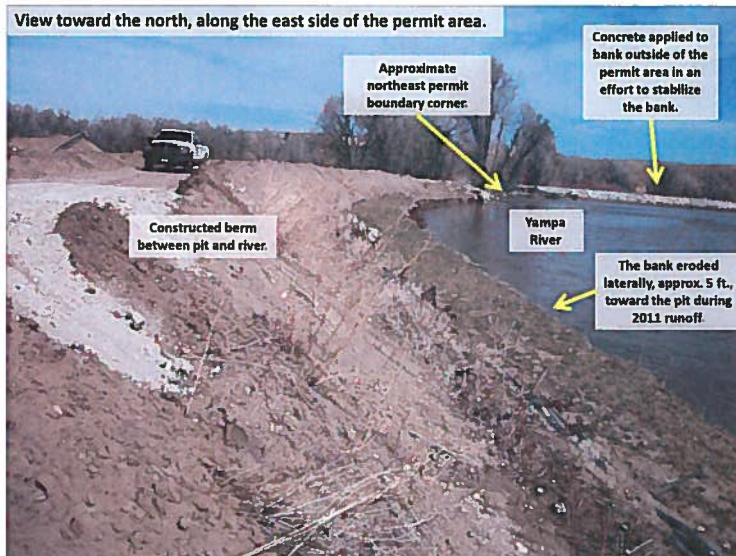
View toward the north, along the east side of the permit area.

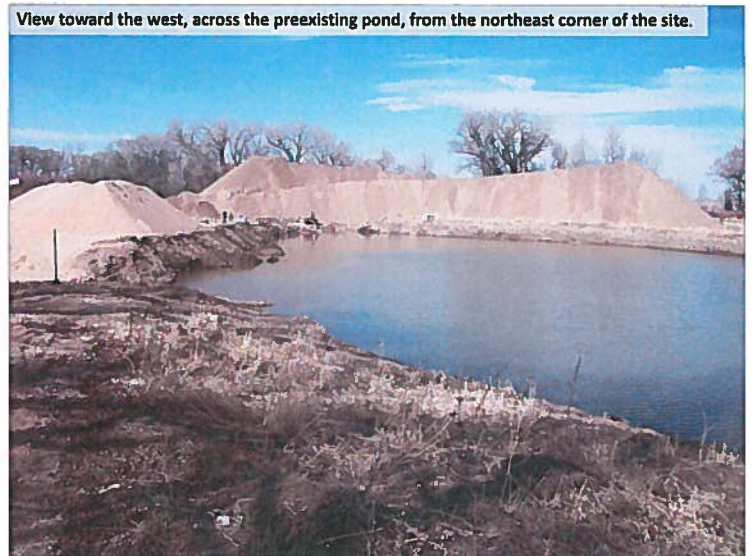
View toward the west, across the preexisting pond, from the northeast corner of the site.
