COLORADO DIVISION OF RECLAMATION, MINING AND SAFETY
MINERALS PROGRAM INSPECTION REPORT
PHONE: (303) 866-3567

MINE NAME: Perkins Sandstone	MINE/PROSPECTING ID#: M-2006-016	MINERAL: Sandstone	COUNTY: Dolores
INSPECTION TYPE: Illegal(Unpermitted Operation)	INSPECTOR(S): Kate A. Pickford	INSP. DATE: November 30, 2011	INSP. TIME: 12:30
OPERATOR: McStone Aggregates, LLC	OPERATOR REPRESENTATIVE:	TYPE OF OPERATION: 112c - Construction Regular Operation

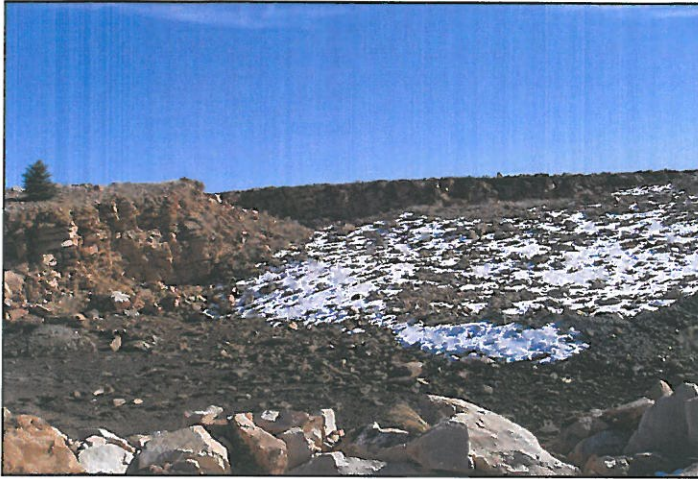
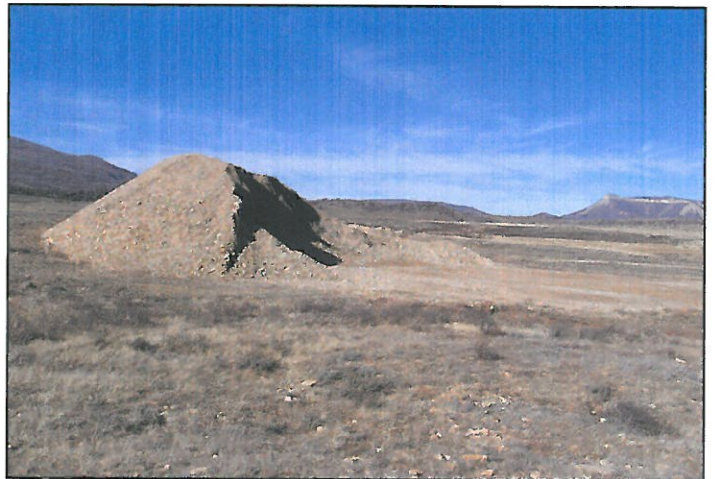
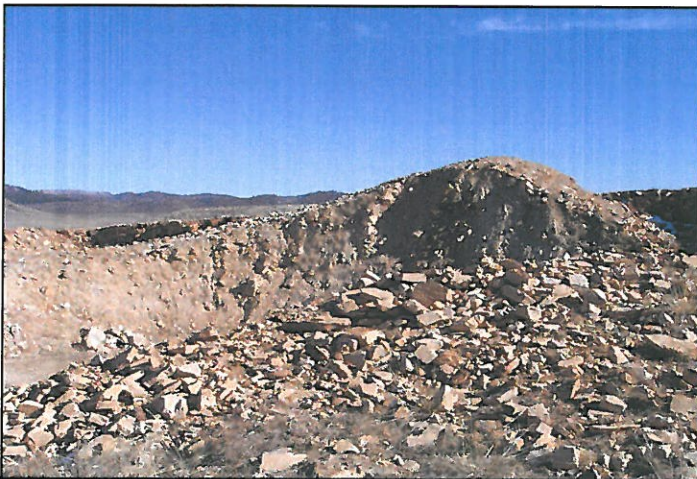
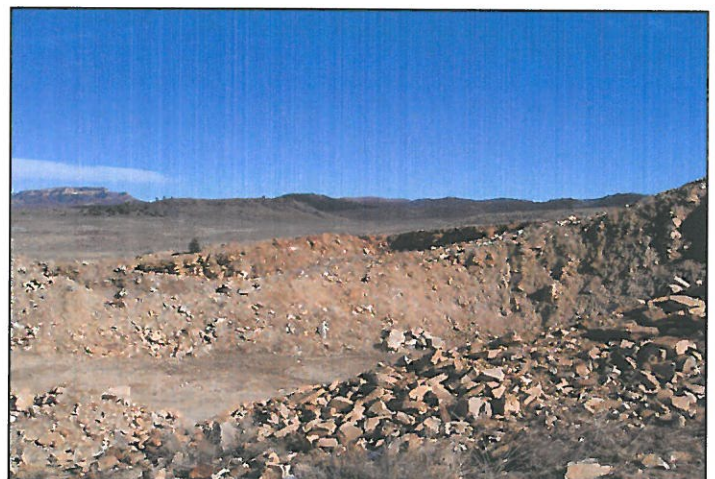
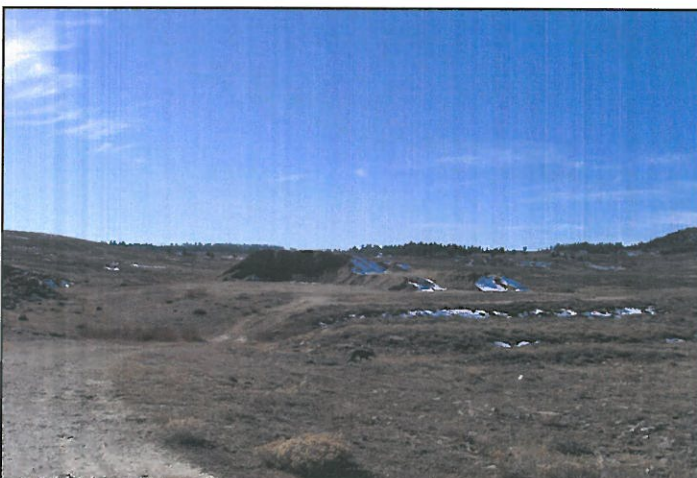
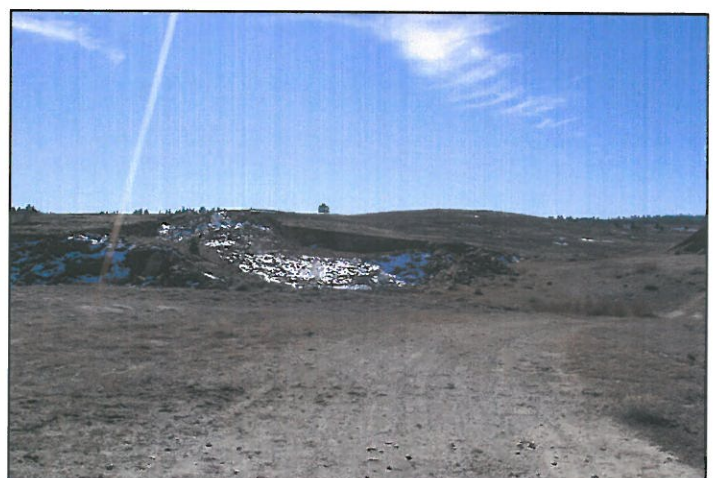
PHOTOGRAPHS

This inspection was conducted at part of the Division of Reclamation Mining, and Safety monitoring program. The site consists of an exposed rock wall, approximately 20 feet high, a stockpile of material, some additional surface disturbance and some rubble placed along a slope that leads into the adjacent drainage. No problems were observed during this inspection. The current bond amount is adequate for reclamation.
